# Trinity Oilfield Services & Rentals, LLC

## Environmental Site Summary & Closure Request

Site Name: Corral Draw 2 SWD NMOCD Reference#: 2RP-4340

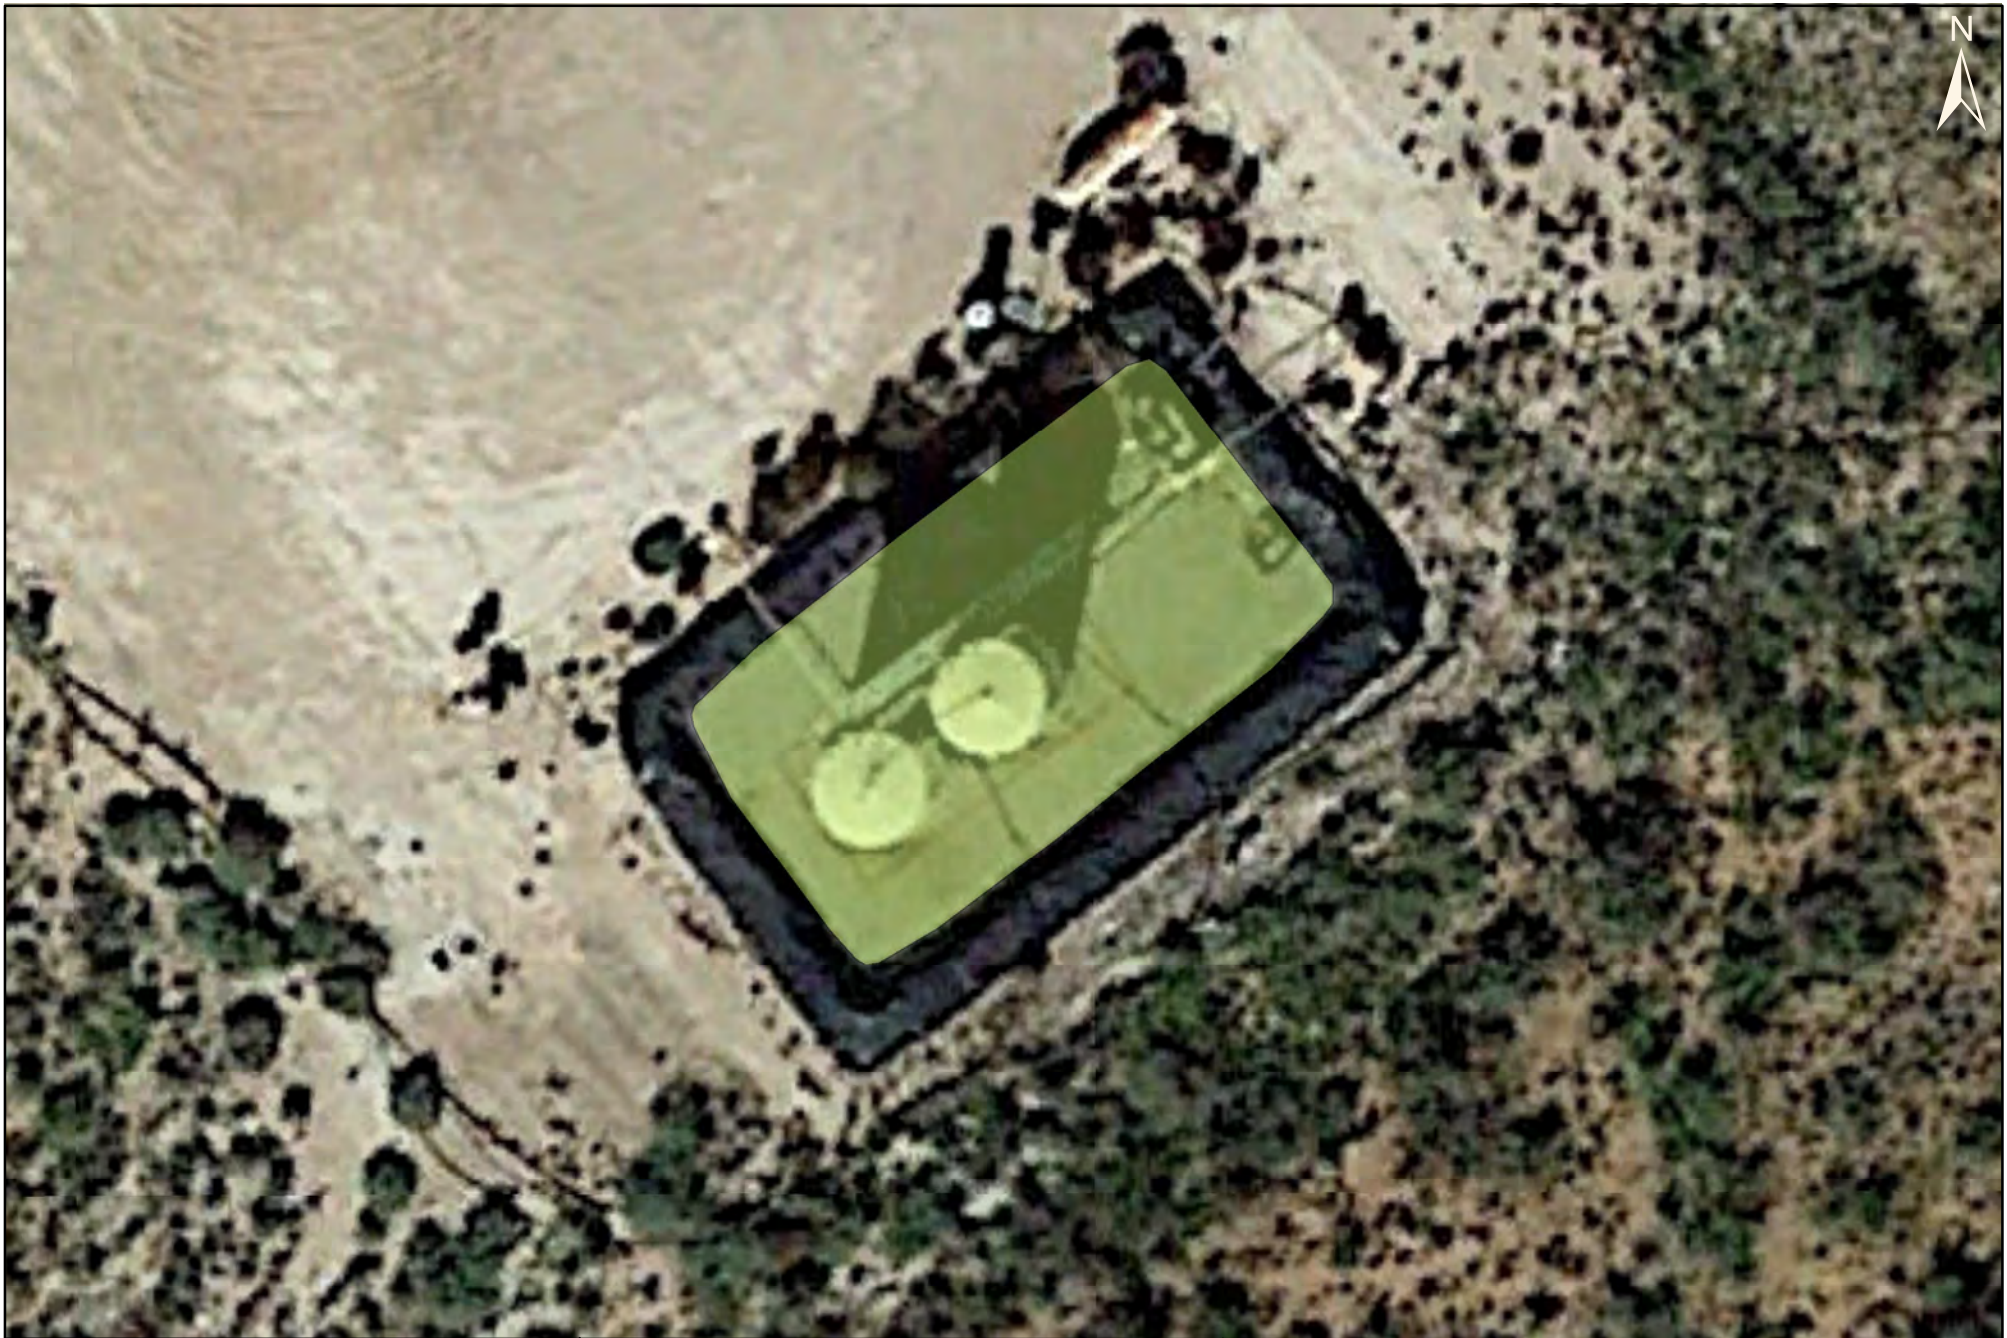
**Figure 2**  
**Aerial Map**  
**OXY USA, Inc.**  
**Corral Draw 2 SWD**  
**Eddy County, New Mexico**  
**NMOCD Reference #: 2RP-4340**

On July 28, 2017, OXY USA, Inc. (OXY), discovered a release at its Corral Draw 2 salt water disposal (SWD) facility. A produced water tank overflowed, resulting in the release of approximately 35 bbls of produced water. The release was completely confined to the plastic-lined containment area surrounding the SWD and affected an area inside the containment measuring approximately 2,030 square feet.

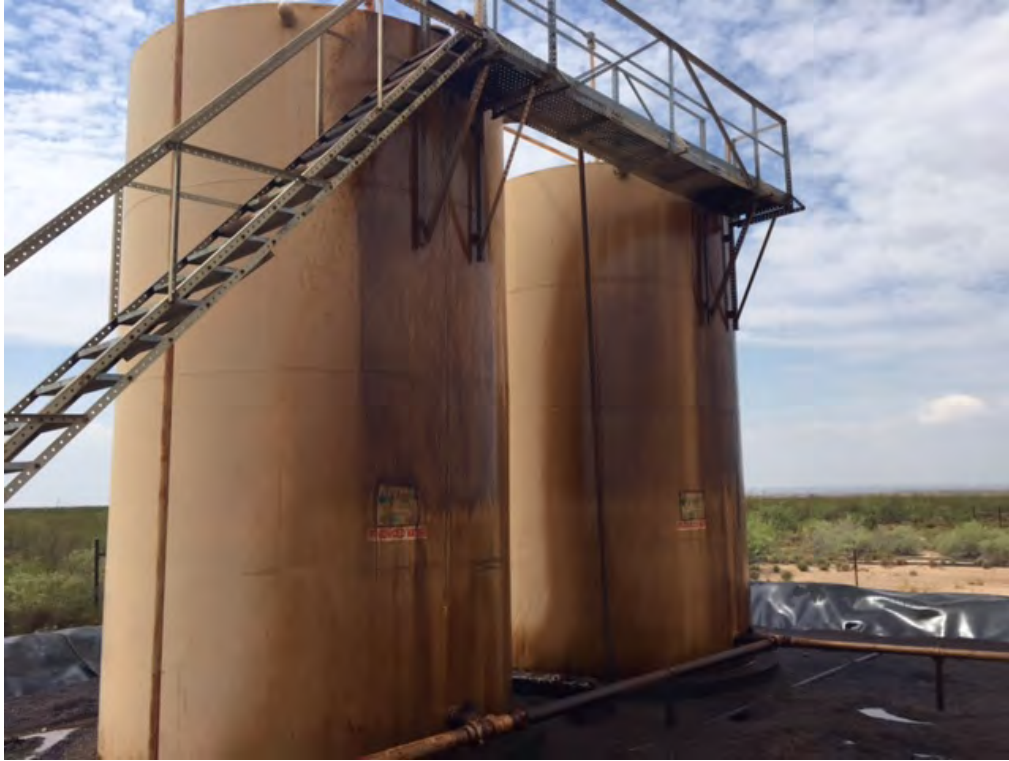
Corral Draw 2 SWD – Release (Looking South-Southwest)

From August 3 through 8, 2017, Trinity Oilfield Services & Rentals, LLC (Trinity), conducted remediation of the release site. Impacted gravel atop the plastic liner was hand-excavated and hauled to R360 (NMOCD Permit #NM-01-00061) for disposal. Following removal of the gravel, the liner was inspected for holes and tears, and none were discovered. The on-site storage tanks and liner were then pressure washed and steam-cleaned, and clean gravel was placed back atop the liner.

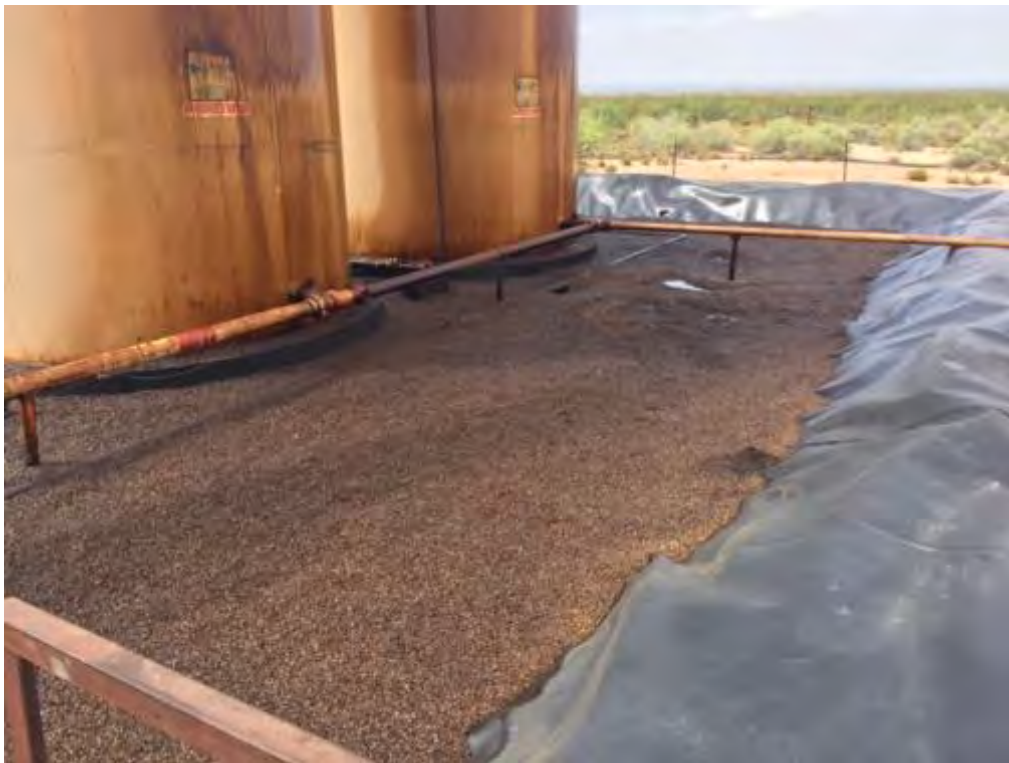
Corral Draw 2 SWD - Release (Looking South-Southwest)

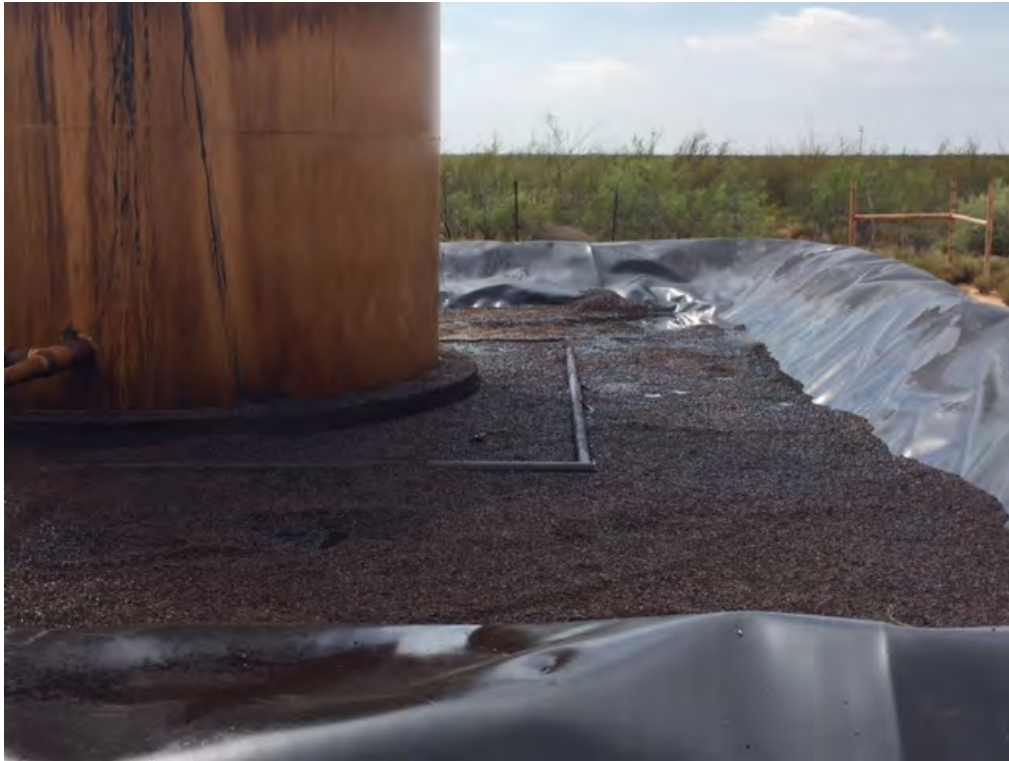
Corral Draw 2 SWD – Release (Looking South-Southeast)

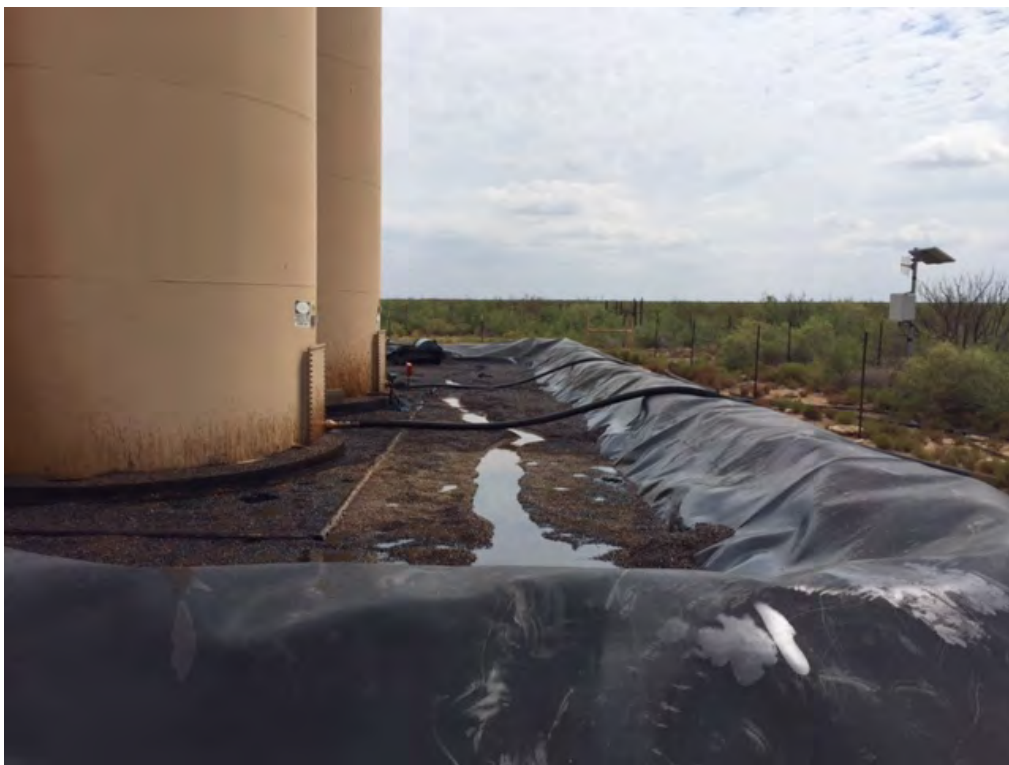
Corral Draw 2 SWD – Release (Looking Northeast)

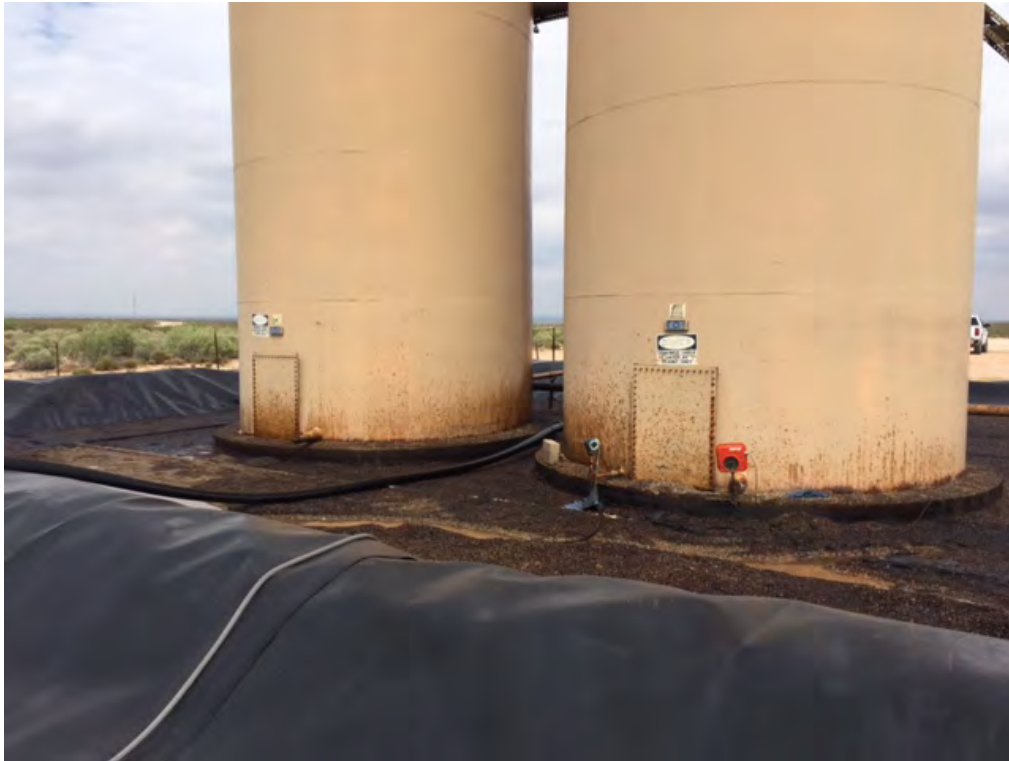
Corral Draw 2 SWD – Release (Looking North-Northwest)

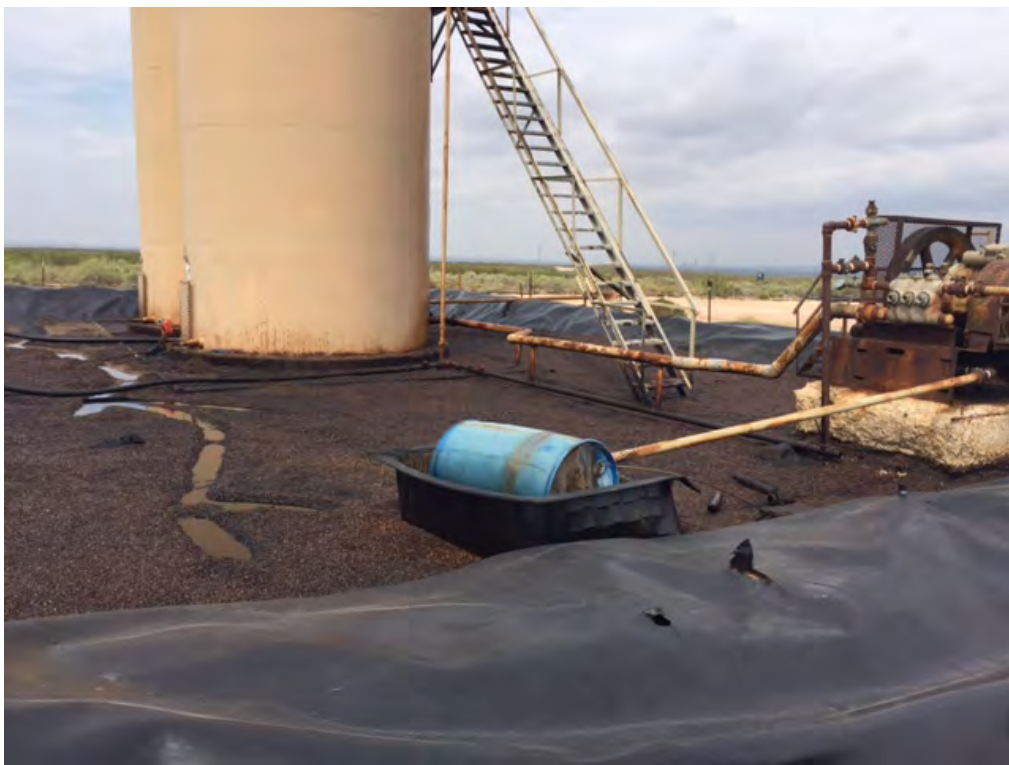
Corral Draw 2 SWD – Release (Looking West)

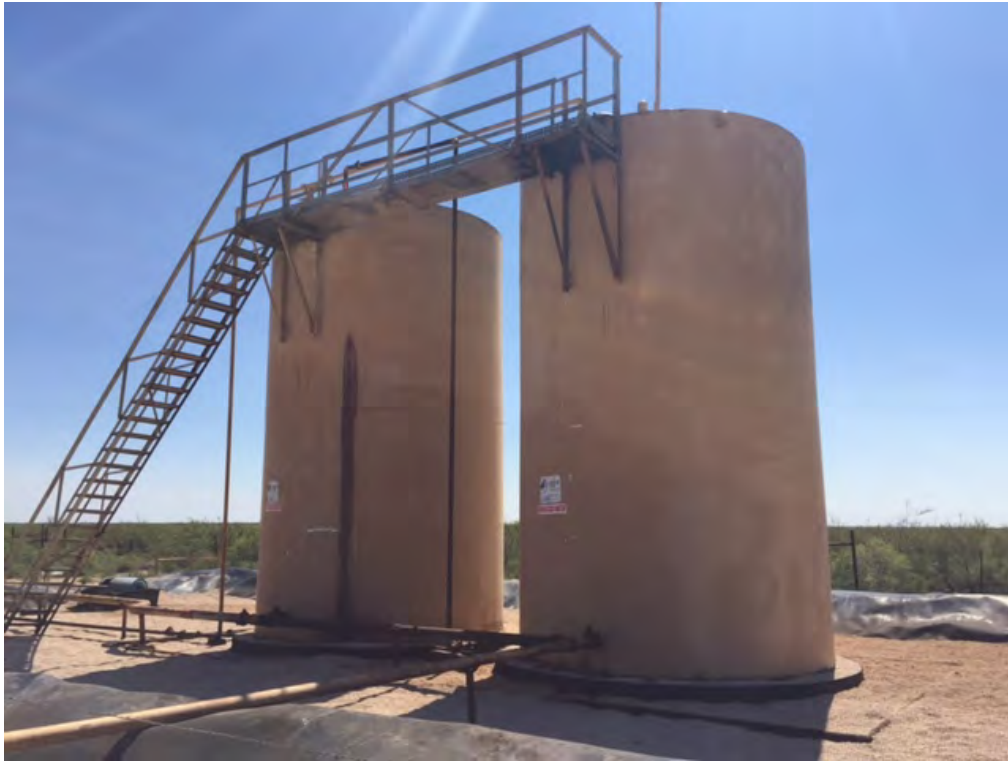
Corral Draw 2 SWD – Post-Remediation (Looking Southeast)

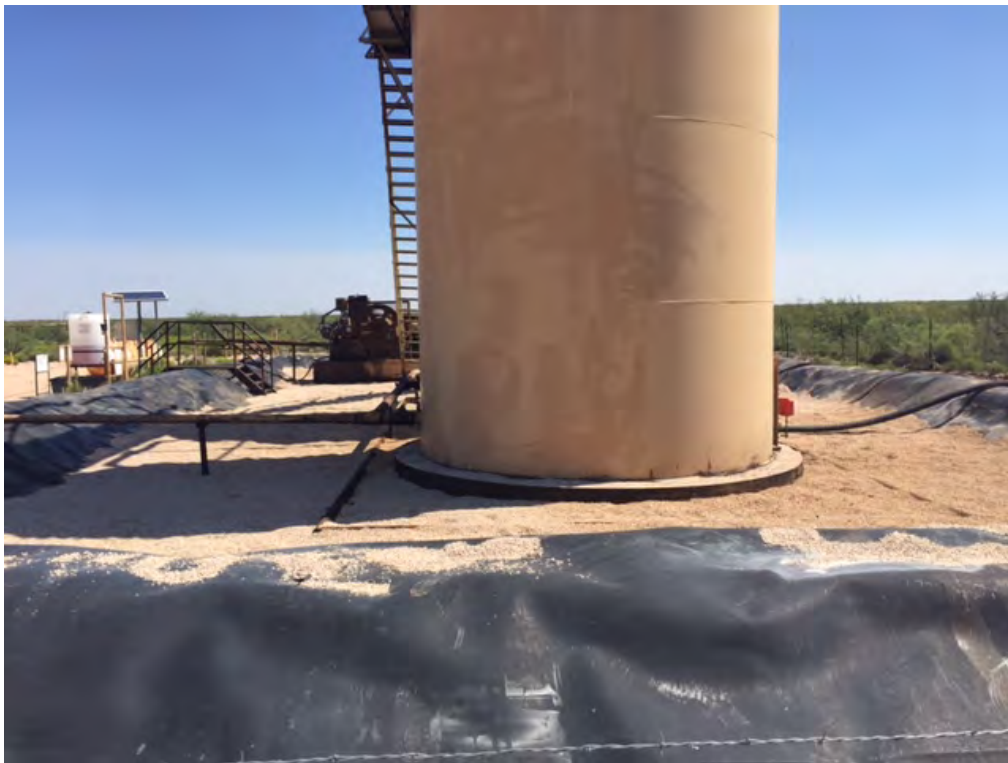
Corral Draw 2 SWD – Post-Remediation (Looking Northeast)

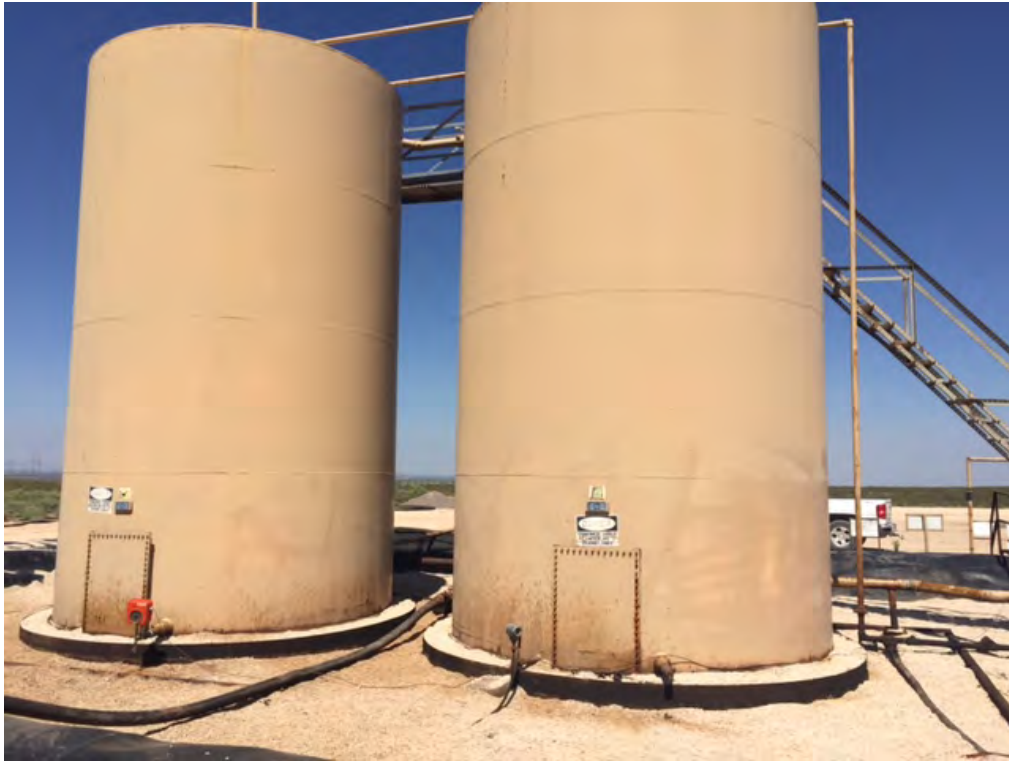
Corral Draw 2 SWD – Post-Remediation (Looking Northwest)

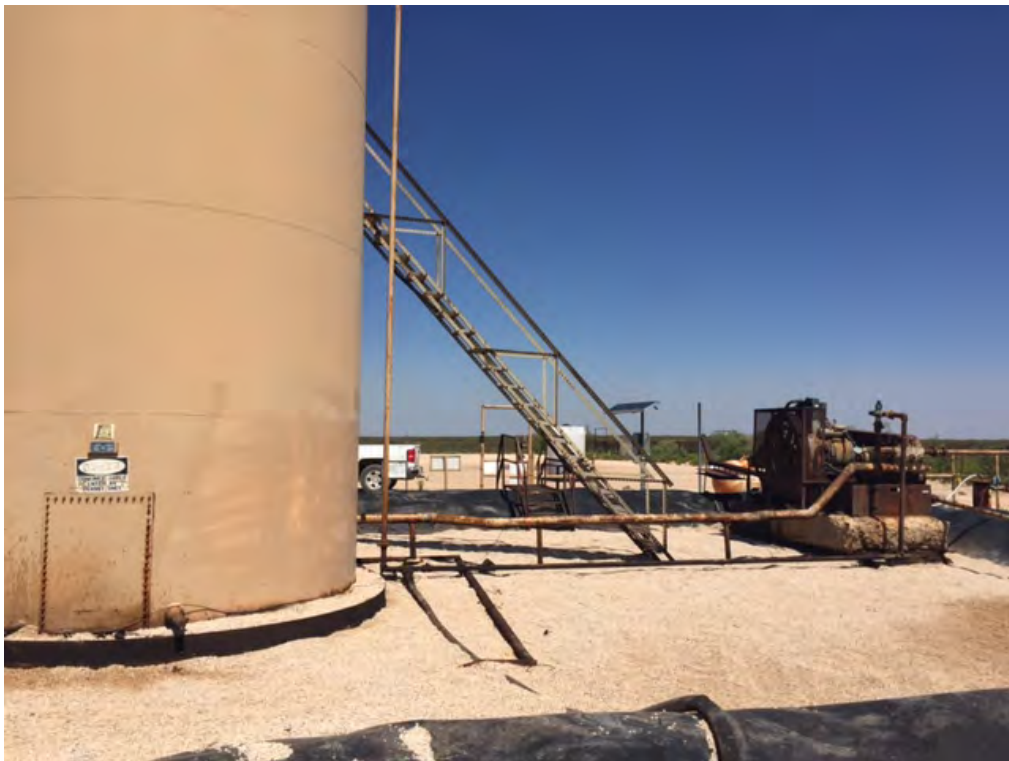
Corral Draw 2 SWD – Post-Remediation (Looking North)
