EOG Y Resources, Inc.

Characterization Plan

Kleeman PD & Platt Battery

2RP-4422

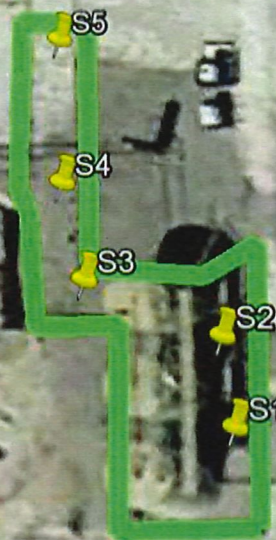
Figure 2

Vertical Sample Points

- Release Outline
- Vertical Sample Points

Vertical delineation samples will be collected at 5 sample points (S1-S5) within the release area. Samples will be collected at 1', 2', 3', and 4' below grade surface (bgs). Due to the nature of the release (produced water), the first set of vertical delineation hole soil samples (1' and 2' bgs) will be analyzed for Benzene, BTEX, TPH extended, and chlorides. If these samples are below RRALs for Benzene, BTEX, and TPH extended, no further sampling for these constituents will occur, only chloride will be analyzed with any further soil sampling if the initial sample analyses warrant further delineation. All samples will be sent to a NMOCD approved laboratory for analysis. Based on those results, additional vertical samples may be collected at the same sample points until the RRAL for a site ranking 0 has been met.

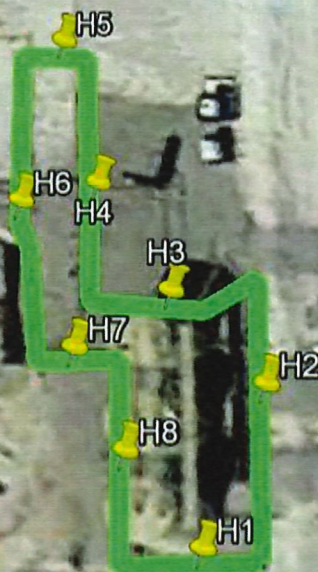
Figure 3

Horizontal Sample Points

- Horizontal Sample Points
- Release Outline

Horizontal delineation samples will be collected at 8 sample points (H1-H8) at what is believed to be the outer edge of the release area. Samples will be collected at 1' bgs and analysis will be run for the identified constituents determined from vertical delineation sampling to have caused impaction to the soil at the site. If a sample point is determined to be impacted by the release, a new sample will be collected moving out further until an area without impaction is located. Once located, samples will be taken to collaborate the impaction path to the next sample point in the sequence.

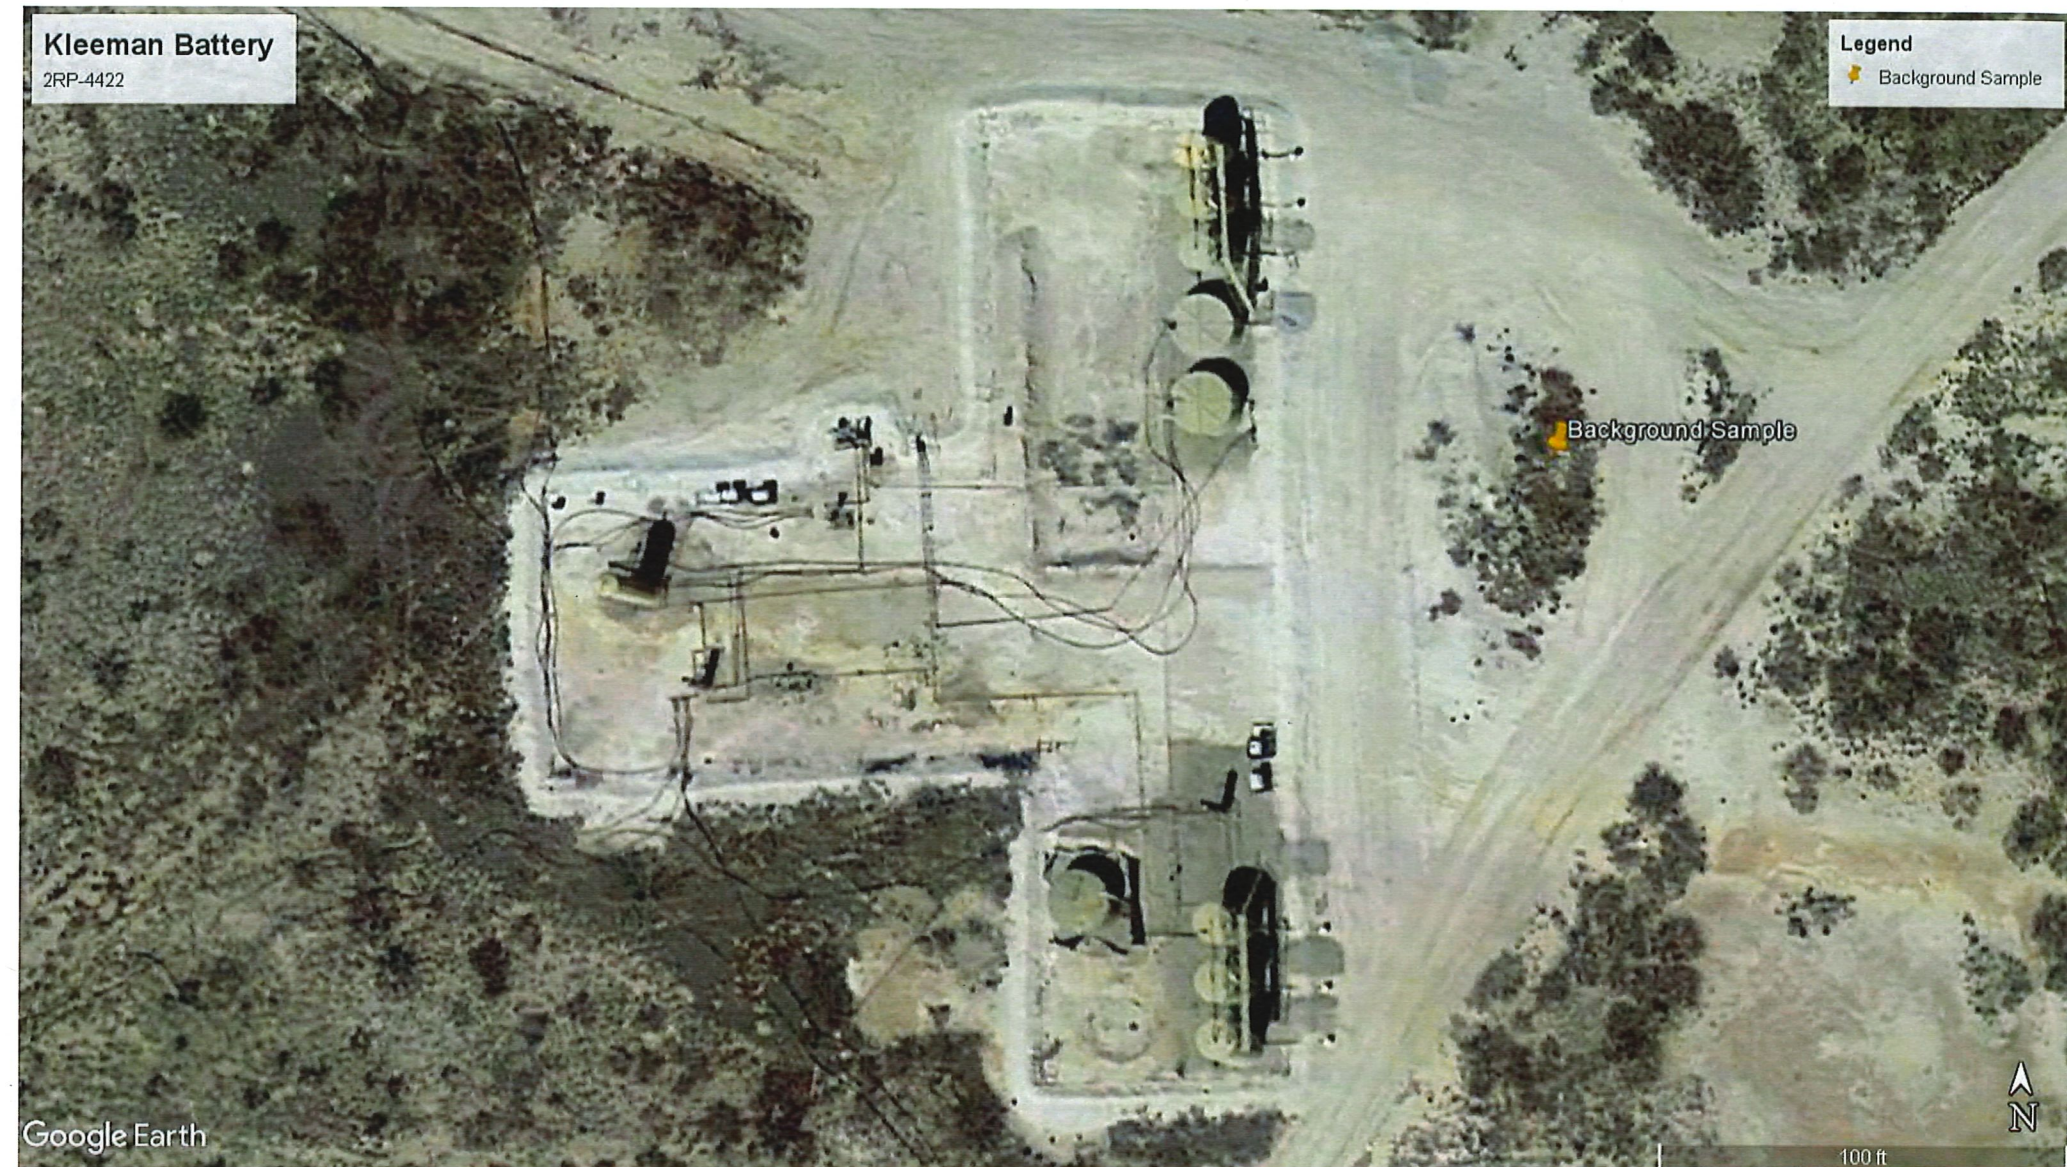
Figure 4

Background Sample Point

Background Sample

As a baseline for all sampling analytical data, background samples will be collected from a point northeast of release which remains on the production pad in an area that has no known release impaction. This creates less damage to the landowner's private surface by keeping the activities on the production pad and reduces the vegetative damage that would otherwise be created by moving off of location to collect background samples in the adjoining pasture.
