R. T. HICKS CONSULTANTS, LTD.

RE: Chi Operating – Benson Delaware Unit #6 Battery (32.67997, -103.93143)
Request for Reconsideration of Denial of Remediation Plan **2RP-4251**

Geology and the Karst Potential Map

Description of Area Geology

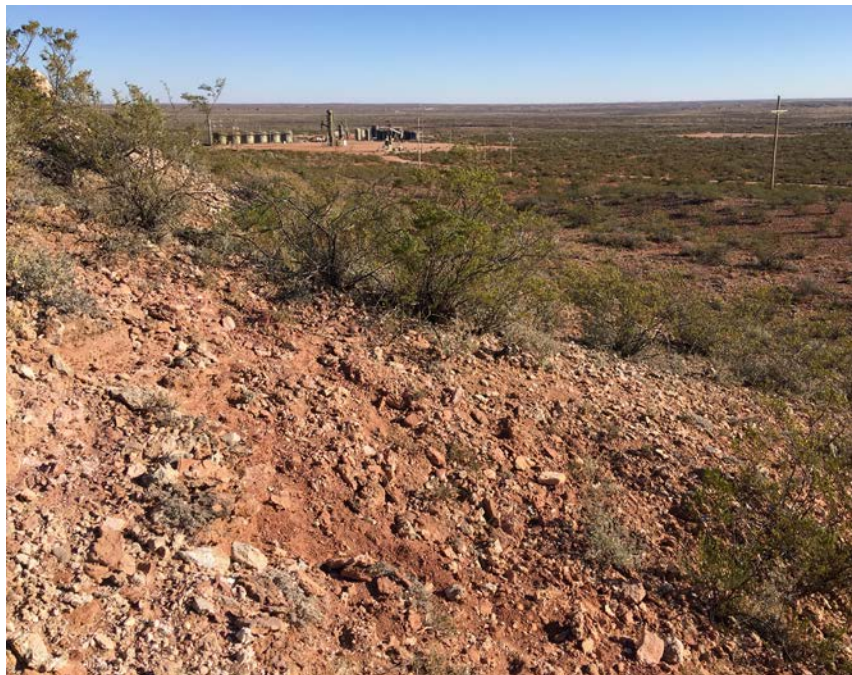
Image 1

This southeast facing image was taken in the area of the northeastern circle in Plate 3 where the character of the Quartermaster is best displayed. The BDU #6 tank battery is behind the battery in the foreground. The images below provide more detail relating to the character of the Quartermaster.

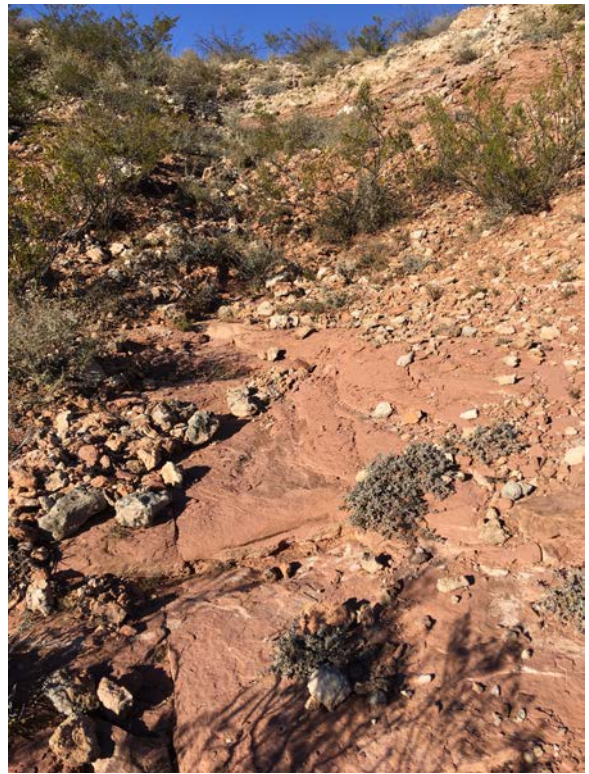
Image 2

This image shows the nature of the Quartermaster exposed on the south-facing slope that is north of BDU #6. Although the rock units in these images have been removed by erosion at the BDU #6, the nature of the Quartermaster in general is well displayed in this outcrop.

All of the red rock in the foreground is a silty sandstone. The ridge is capped by a white sandstone shown at the top of the image and in the image below.

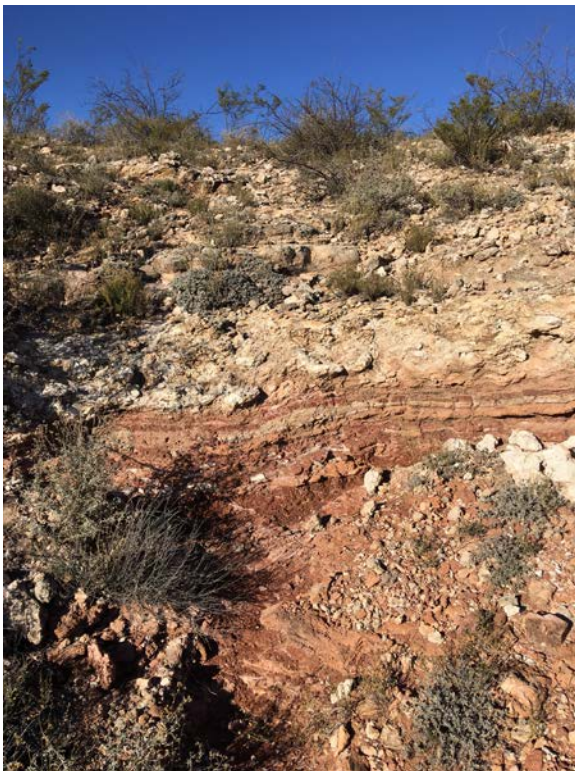
Image 3

The red silty sandstone in the bottom 1/3 of the image is overlain by thin horizons of red mudstone and silty sandstone that are overlain by the white sandstone.

Note that the thin mudstone and sandstone units bend in the central portion of the image. The “bend” does not occur in the sandstone beds above. This “bend” is not a fault movement but is contemporaneous with deposition of the sandstone.

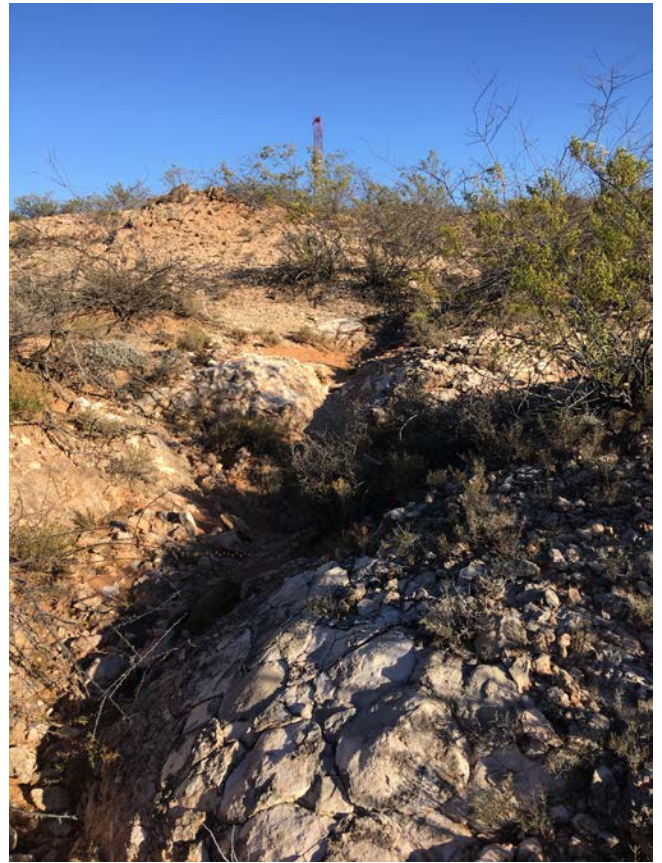
Image 4

This image and the three below are taken from the west-facing slope of exposed Quartermaster Formation that is shown in the circle due west of BDU #6 in Plate 3.

Red siltstone is in the foreground and white sandstone beds are in the center of the image. The rig is a workover at the well site west-southwest of BDU #6.

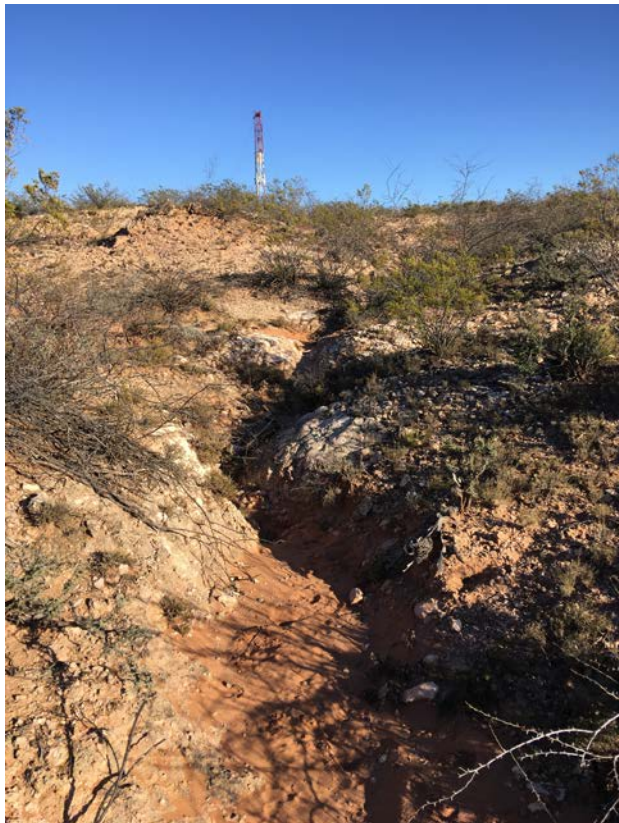
Image 5

This image is a closer view of the sandstone beds shown in the image above. In this portion of the section, the sandstones are inter-bedded with thin red siltstone.

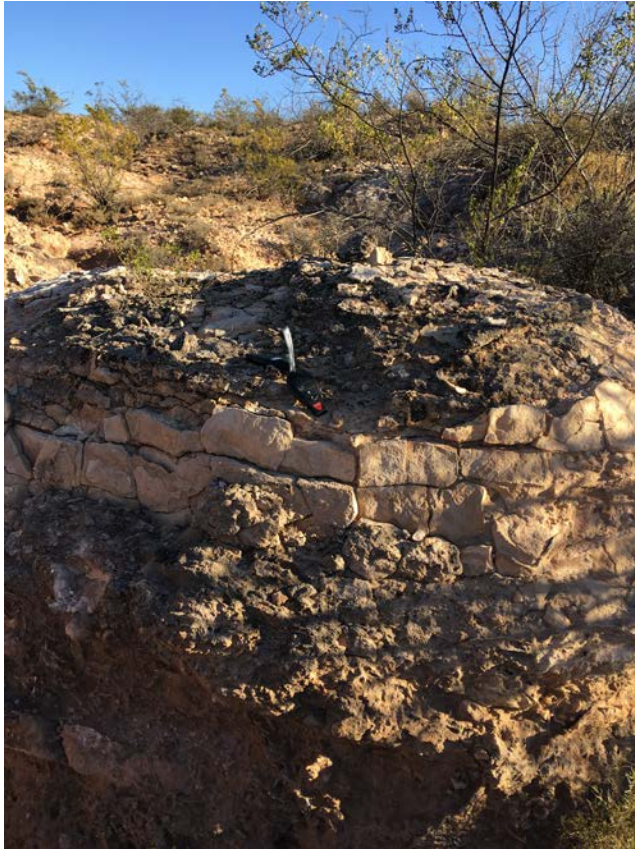
Image 6

The uppermost prominent sandstone bed in the images above is shown to the left. Note that above and below the white sandstone horizon are gray rock units that appear quite different. This weathering may be due to evaporitic cement in the sandstone as described in #3 on page 2.

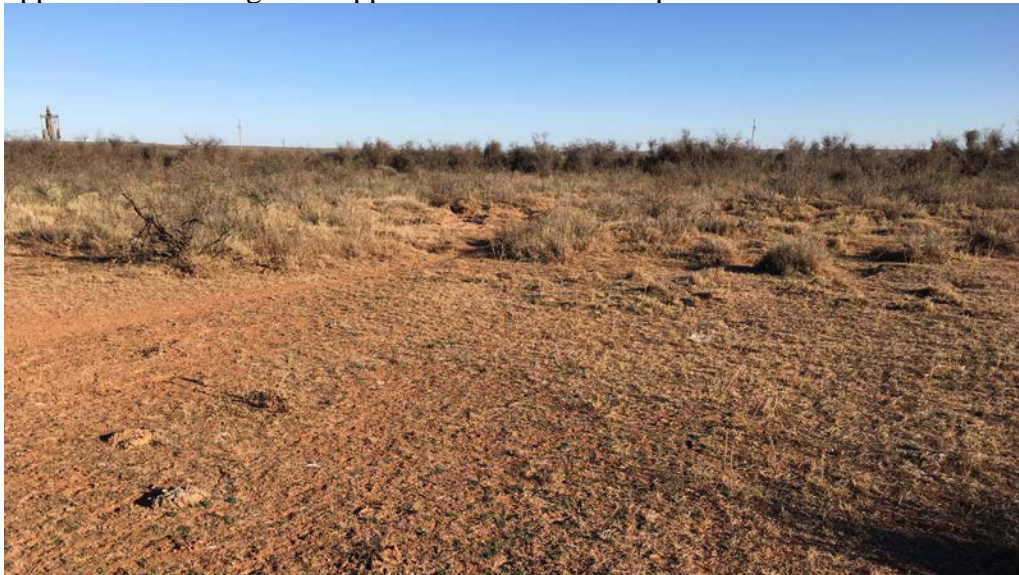
Image 7

The image below is looking east from near the center of the closed depression that is south-southeast of BDU #6. The foreground is an area mapped as high karst potential and the upper ½ of the image is mapped as moderate karst potential.

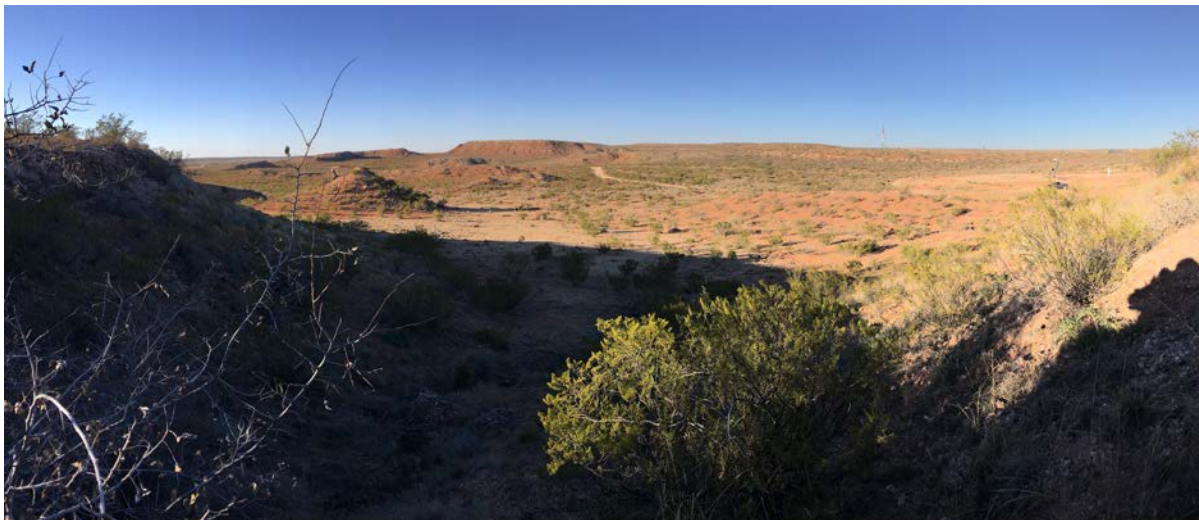
Image 8

The panorama presented below is a north facing view taken from the south-western circled area in Plate 3 and the red lines on Plate 3 show the area of view. In this image, the mesa in the center of the image, on the horizon, is composed of the Quartermaster Formation and it slopes (dips) gently to the southeast (right). The Quartermaster mesa to the left dips (slopes) to the west. The geologic map shows no faults in this area and we believe that solution of the underlying Rustler Formation may have caused slumping of the surface and these apparent diverging slopes (dips).

The image also shows the workover rig mast on the right (east) side. The conical hill in the left center of the image above is essentially the same section of Quartermaster observed in Images 4, 5 and 6.
