## REMEDIATION WORK PLAN

**Concho Operating, LLC.  
Birdseye 32 State #001H  
Eddy County, New Mexico  
Unit Letter "O", Section 32, Township 19 South, Range 31 East  
Latitude 32.61882, Longitude -103.87544  
2RP-4189**

November 2017

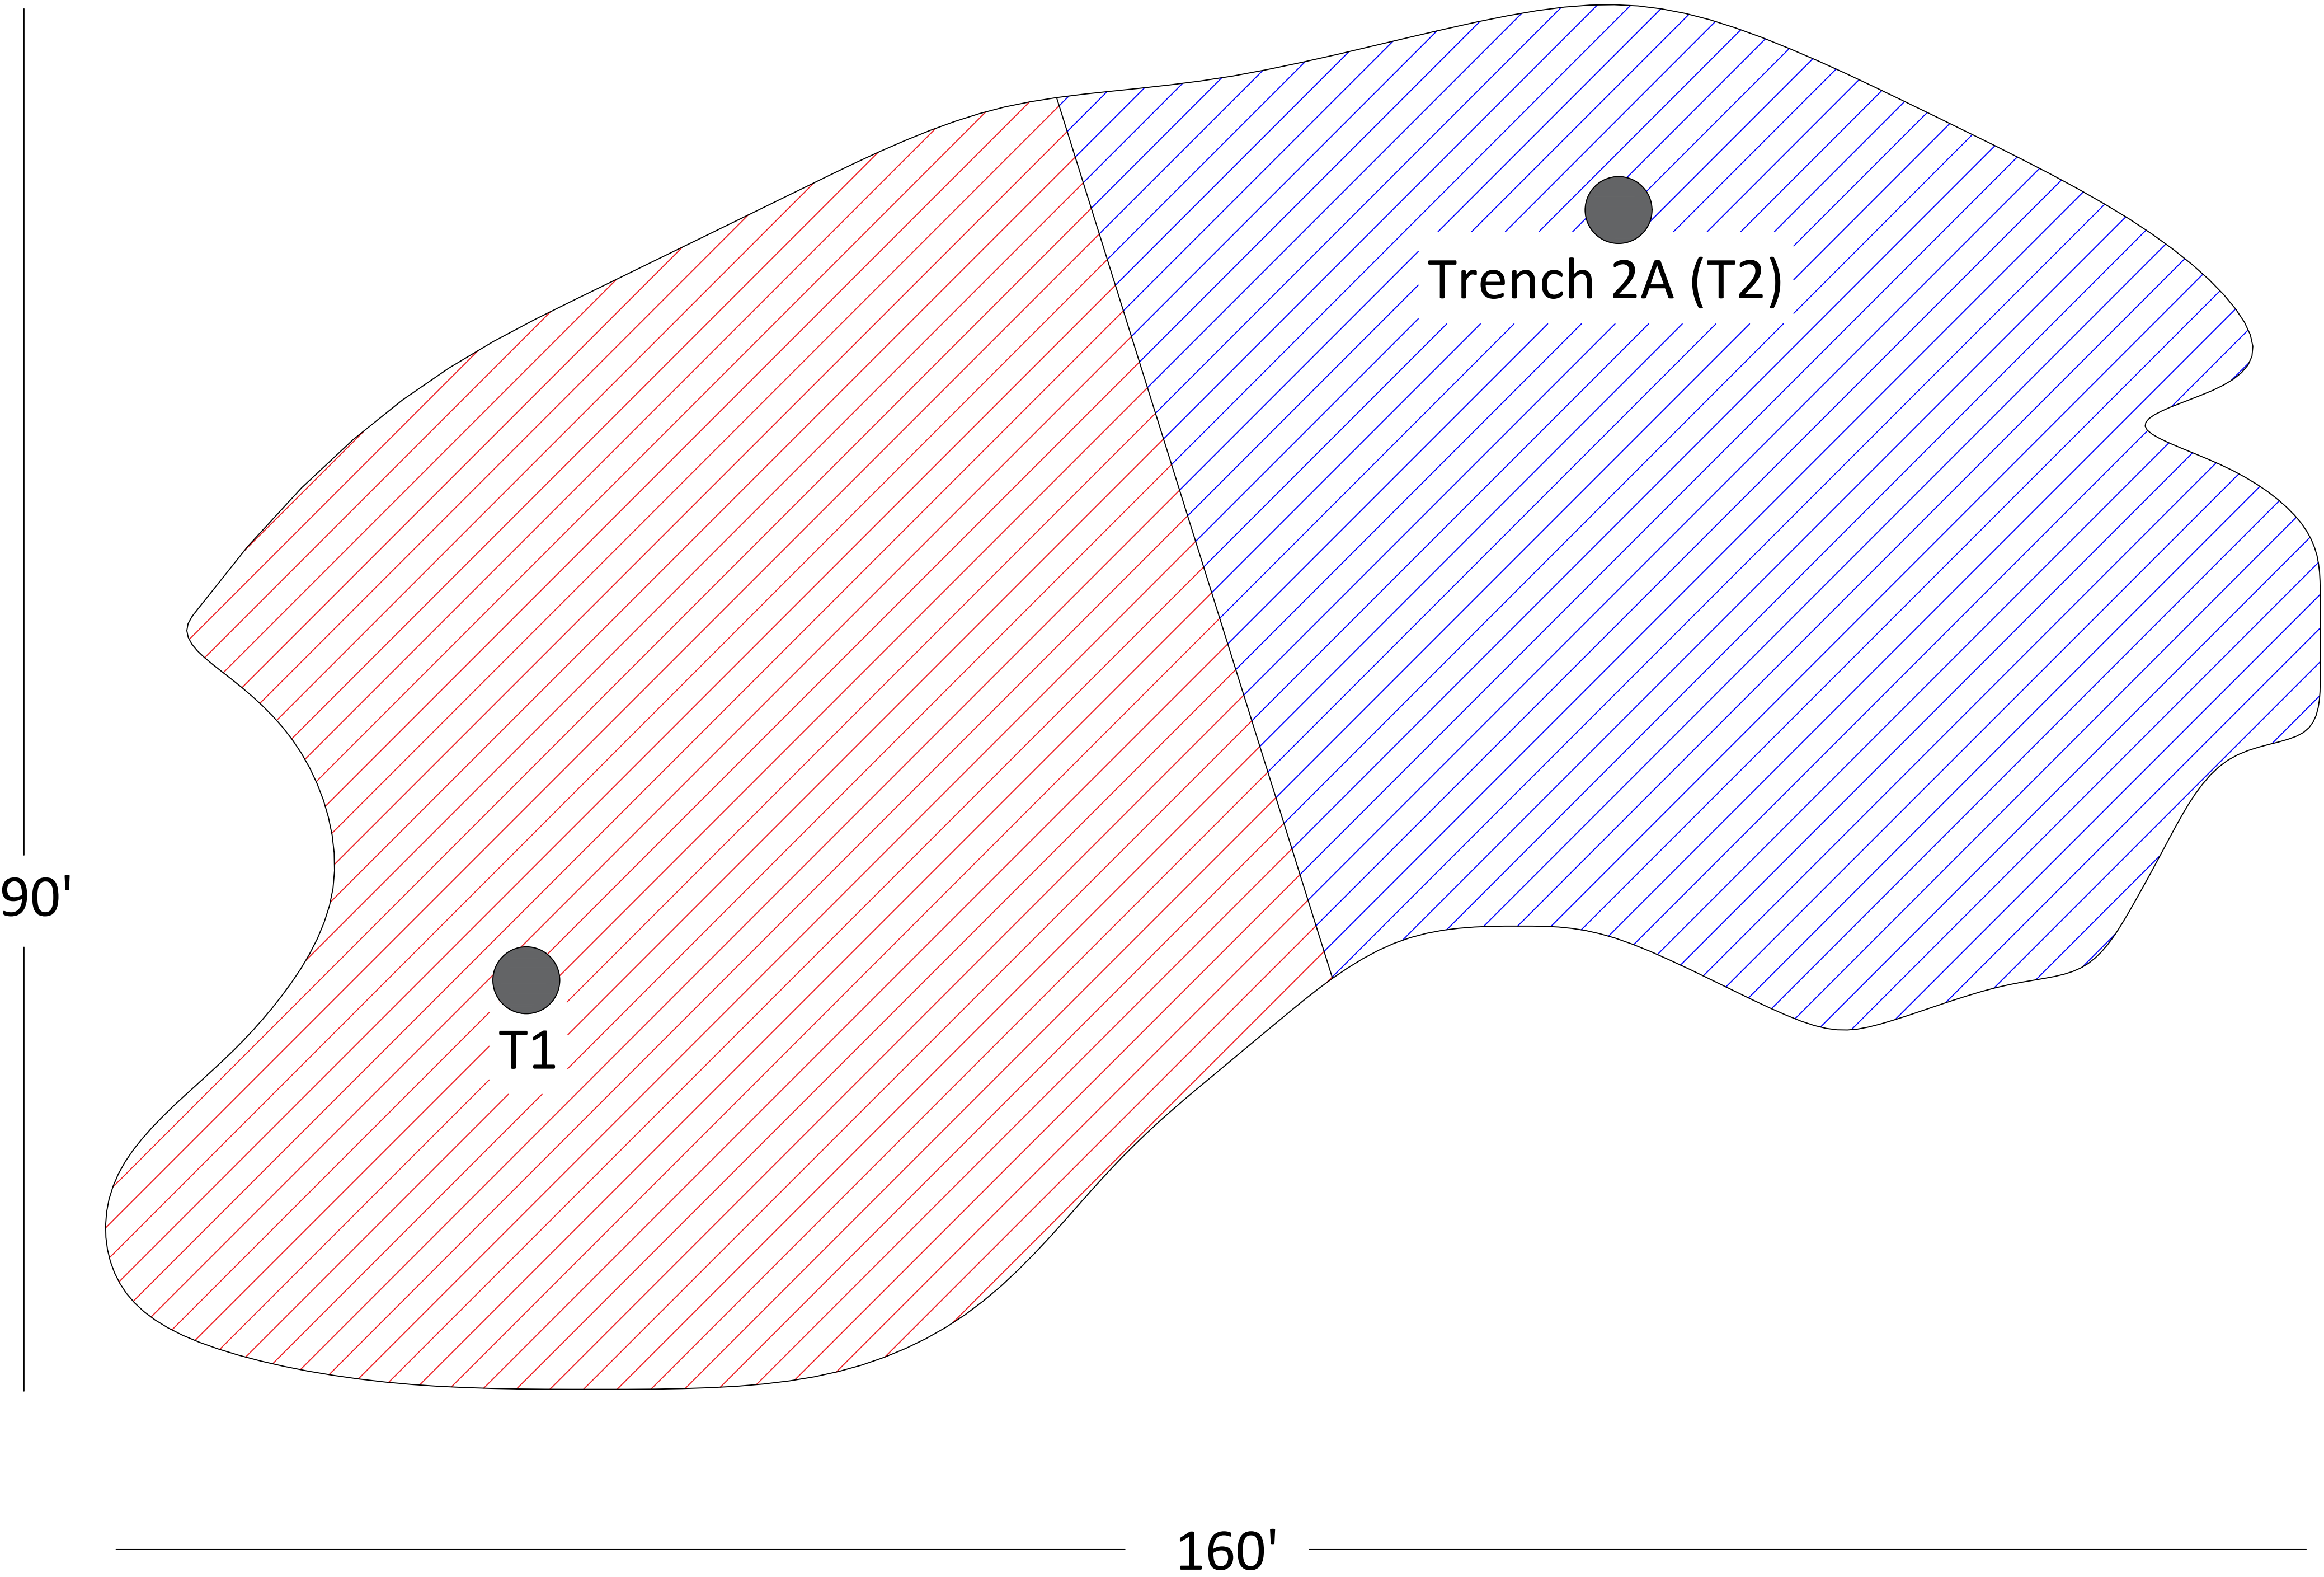
**FIGURE 4**  
**Proposed Excavation**  
**Depths**

— 4' with liner
-

— 2'
-

— Sample Point

Two (2) test trenches (i.e., T1 and T2), were advanced to delineate Chloride at depth. Trench locations are shown on Figure 4. Discrete samples were collected from T1 at the following depths: Surface, 1', 2', 3', 4', 6', 8', 10', 12', 14', 16', and 18', below ground surface (bgs). At T2 discrete samples were collected at the following depths: Surface, 1', 2', 3', 4' and 9' bgs. Soil was field screened for Chloride utilizing electro conductivity during trenching operations.

Figure 4 shows the approximate location of the sampling (i.e., Trench) locations and dimensions of the proposed excavation area in relation to pertinent land features and general Site boundaries, which is included in Appendix A.

Based on the analytical data presented in Table 1, COG and ASSI propose to complete a removal action of the impacted material. The area adjacent to and around T1 will be excavated to a depth of approximately four (4) feet bgs and have a 20 mil liner installed at the bottom of the excavated area. The area adjacent to and around Trench 2 (T2) will be excavated to a depth of approximately two (2) feet bgs (Figure 4). All material will be removed by mechanical means, be temporarily stockpiled onsite and subsequently removed (hauled away) offsite to a proper disposal facility under appropriate manifest. The excavated areas will be backfilled to grade with clean imported material and the surface grade contoured to the surrounding landscape.
