RE: Corrective Action Plan
XTO Energy
JRU 29 SWD
UL/K SEC. 36 T22S R30E
32.346432, -103.835934
2RP-2726; 2RP-3082; 2RP-3302; 2RP-3726 and 2RP-4040

XTO
JRU 29 SWD
2RP-2766, 2RP-3082, 2RP-3302,
2RP-3726 & 2RP-4040

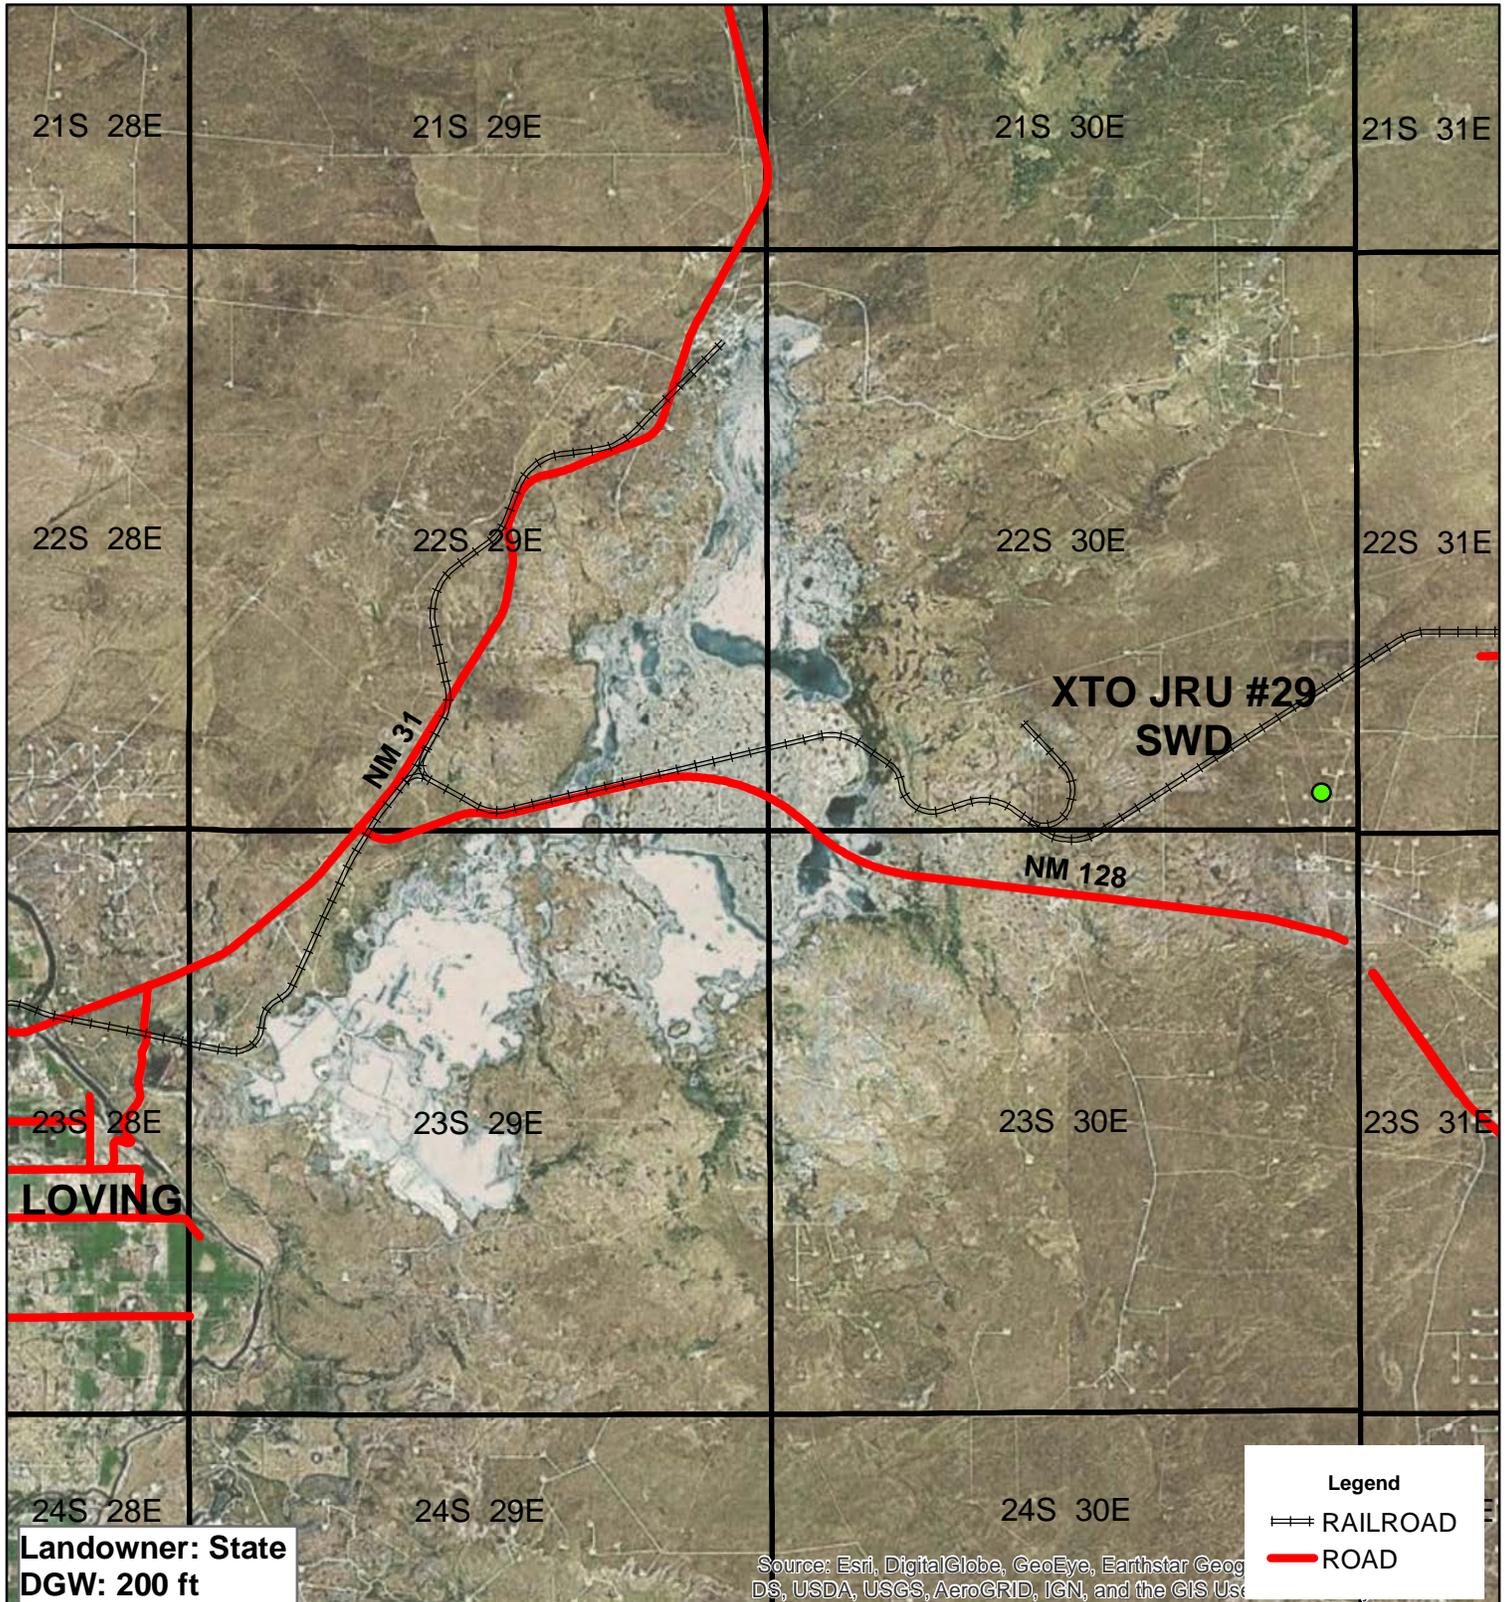
GPS: 32.319360 -103.931548
Figure 1
0 1 2
Miles
Drawing date: 10/10/17
Drafted by: T. Grieco

UL K SECTION 36
T-22-S R-30-E
EDDY COUNTY, NM

Figure 1 – Site Location Map

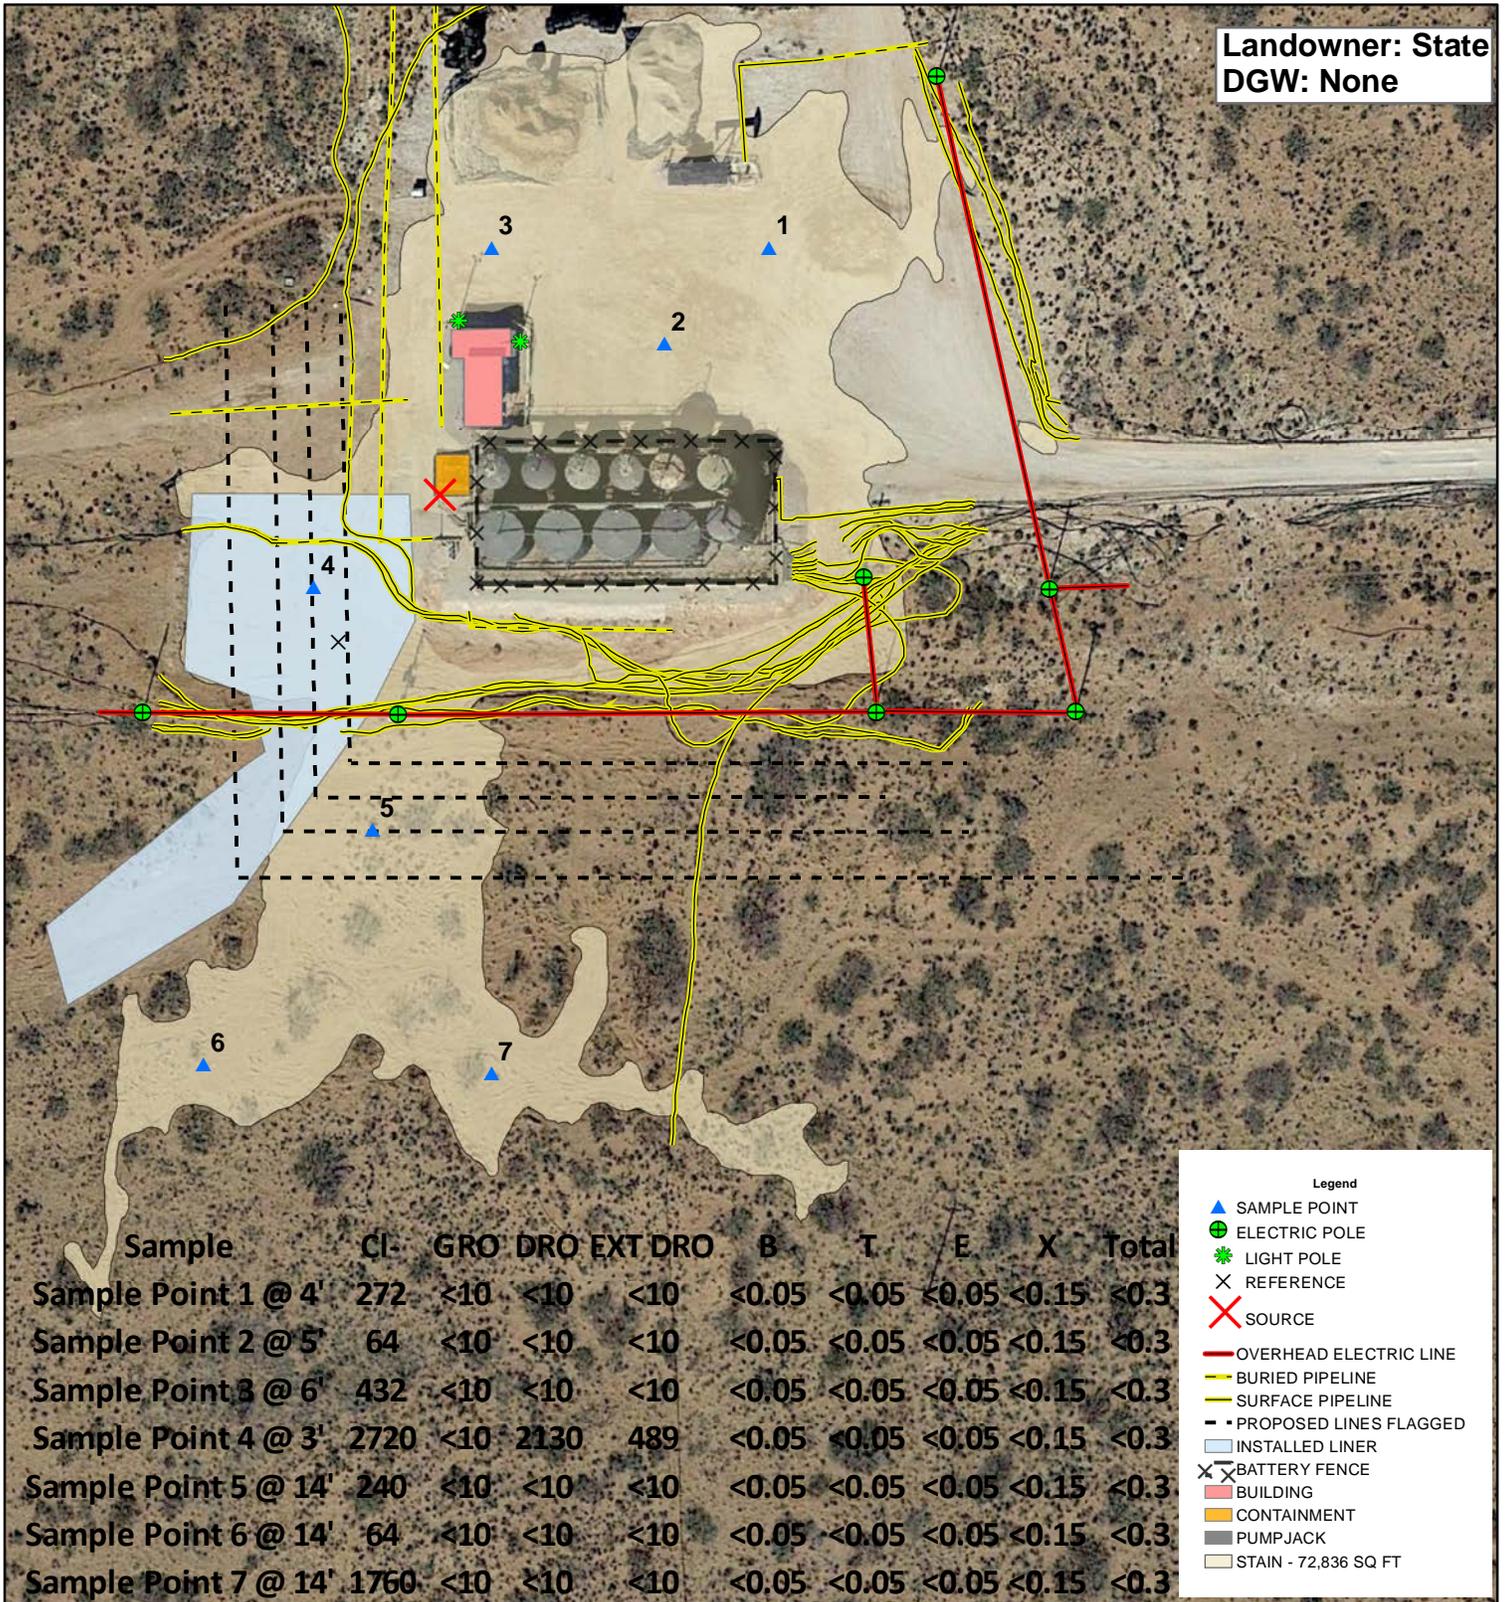
Initial Sampling

**XTO
JRU 29**

**Underground facilities are
spatially projected
and need to be field verified.**

NMOCD approved and certified laboratory. Results of field and laboratory testing are provided in Table 1. Select laboratory data is provided on the sample points location map (Figure 2).

A liner from a prior remediation effort will be removed. Location of the previously existing liner is shown in Figure 2. At sample locations SP-4 and SP-7 (reference Figure 2) excavation equipment will be utilized to collect deeper delineation samples for testing with field methods. Excavation and sampling will continue until results of field testing show chlorides are at or below the NMOCD target of 600 mg/kg. If a satisfactory delineation at or below the NMOCD target is obtained, the sample trenches will be backfilled and the soil material will be compacted.

Figure 2 – Sample Locations and Select Analytical Sampling Data
