**RE: Termination Request Report
XTO Energy Inc. – Hasta La Vista 1 DI Federal Com 001 H
UL/B sec. 5 T20S R31E
UL/0 sec. 32 T19S R31E
API No. 30-015-42533
2RP-3725**

XTO Energy Inc. (XTO) has retained Basin Environmental Service Technologies (Basin) to address potential environmental concerns at the above-referenced site.

Background and Previous Work

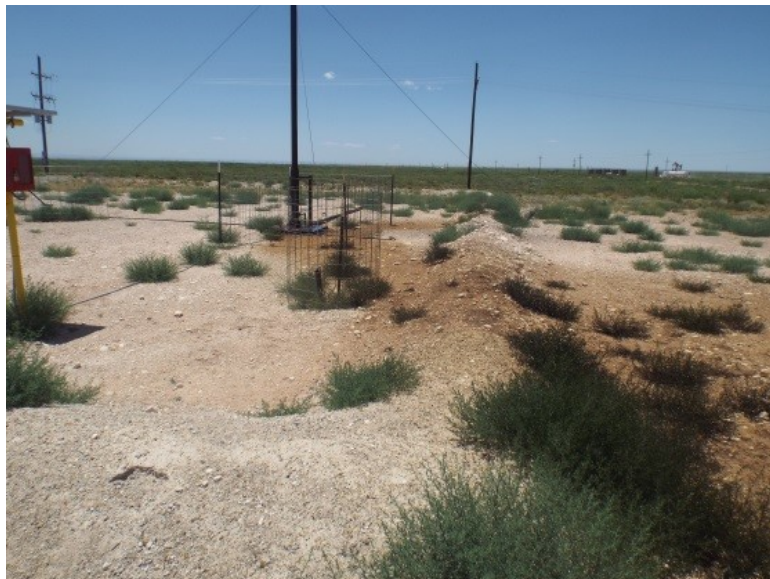
5/26/16

On May 26th, 2016, XTO discovered a release of approximately nine (9) barrels (bbls) of crude oil from an exit flare. None of the product was recovered. The release impacted an estimated thirty-four thousand six-hundred (34,600) square feet (ft²) of pasture. The New Mexico Oil Conservation Division (NMOCD) was notified of the release on June 8th, 2016, and an initial Release Notification and Corrective Action form (C-141) was submitted to NMOCD June 8th, 2016, for approval (Appendix A).

Describe Cause of Problem and Remedial Action Taken.*
Flare scrubber loaded up causing fluid to exit flare.

Flare release

Describe Area Affected and Cleanup Action Taken.*
Leak affected 34,600 sq. ft. of pasture to the east of the flare due to high winds. Area was washed down with microblaze on morning of 5/27/2016.

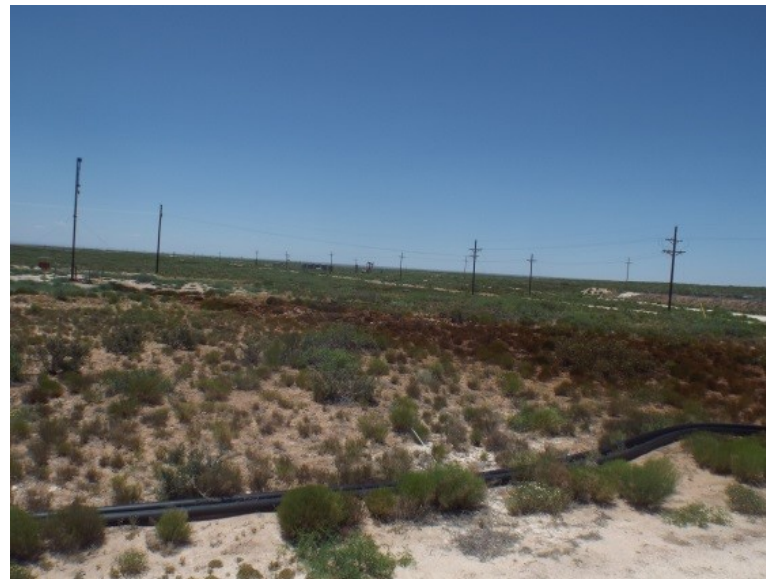
5/26/16

Flare release

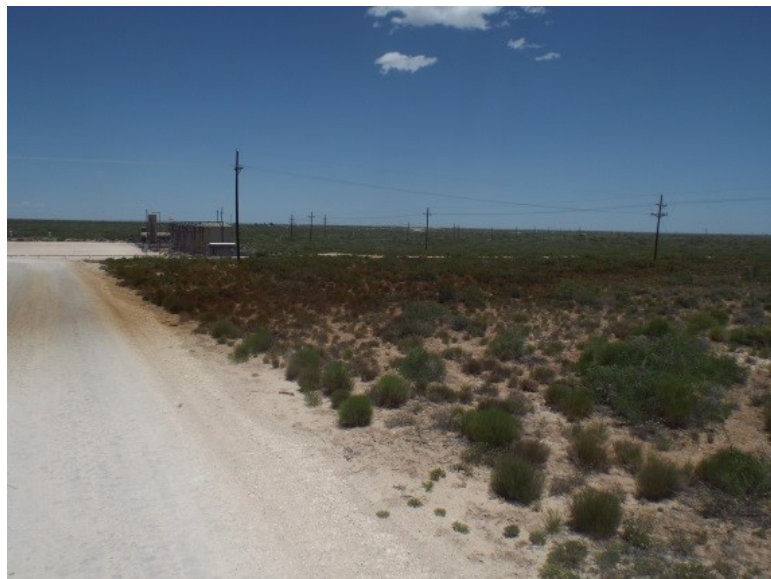
5/26/16

Flare release

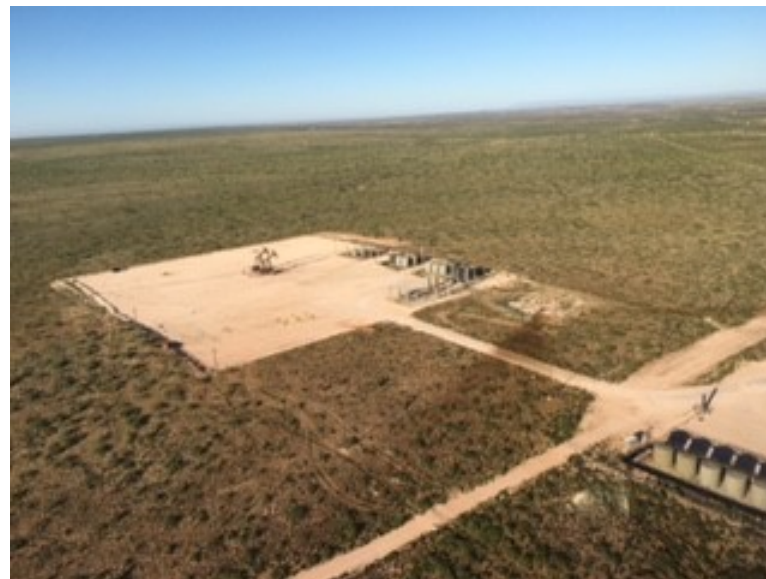
5/26/16

Aerial view of flare release
