## R. T. HICKS CONSULTANTS, LTD.

RE: Corrective Action Modification #3 - 2RP-3333 Remnant Oil Company NSLU #3: Unit J, Sec 19, T16S R31E, Eddy County, NM

## **Proposed Corrective Action**

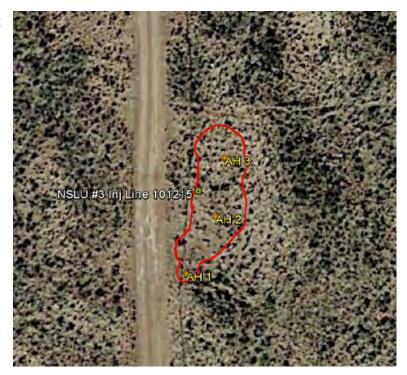
- S1 is located near AH 3.
- S2 is located near AH 1.
- S3 is located near AH2.

Image #1 – Location of eTech sampling points of October 2015 (from eTech Corrective Action Plan of November 2015).

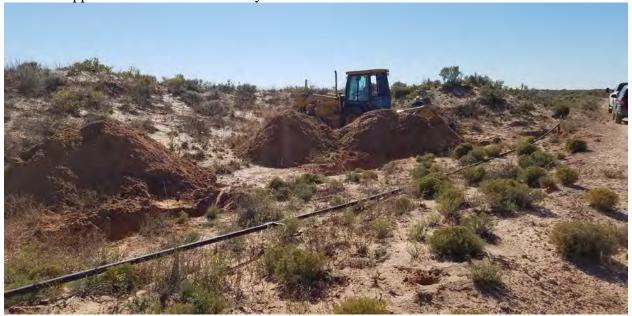
Image #2 – November 2017 sampling within the footprint of the October 2015 release. Sample locations approximate those obtained by eTech in 2015

November 2017 sample locations are

S-1 32.90292, -103.89378

S-2 32.90292, -103.89383

S-3 32.90292, -103.89378

Therefore, we propose that Remnant reseed the site with a mix acceptable to the BLM. Upon the satisfactory inspection of re-vegetation by BLM, we propose closure of the regulatory file with both agencies.
