**Re: Remediation Work Plan Request
Devon Energy – Blackjack 1 Federal #2
UL/J, S01, T24S, R30E
API No. – 30-015-33383**

Blackjack 1 Federal #2 – Site & Delineation Photos

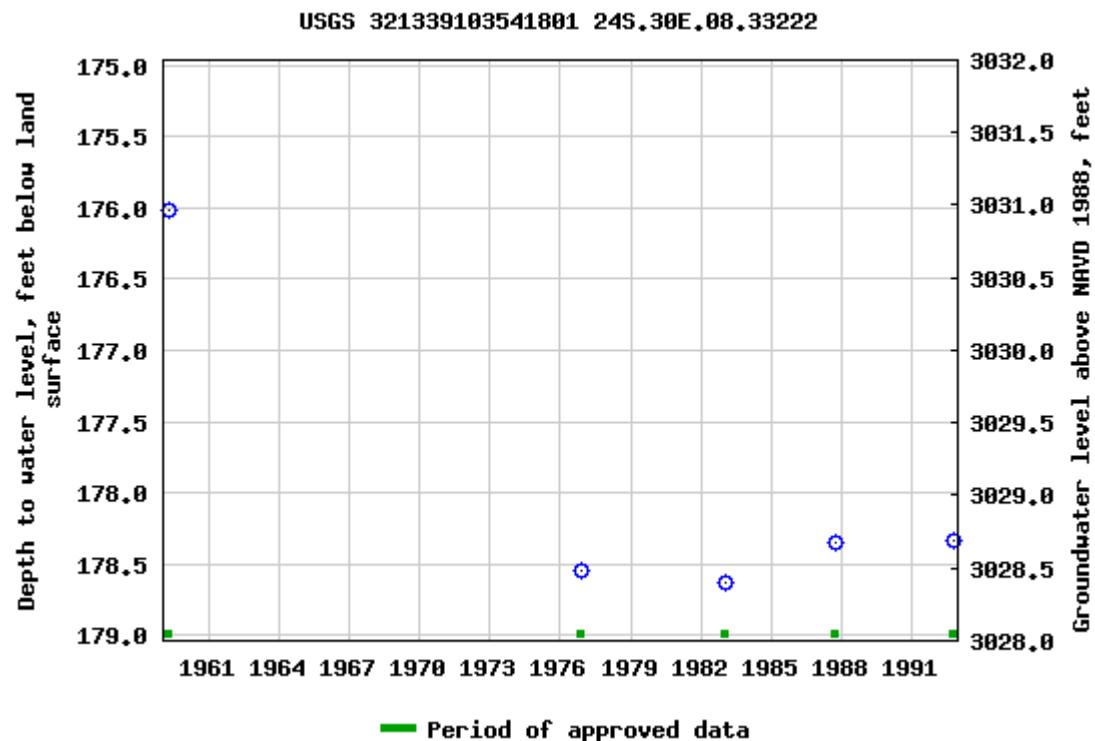
The depth of the well is 192 feet below land surface.

This well is completed in the Rustler Formation (312RSLR) local aquifer.

Breaks in the plot represent a gap of at least one year between field measurements.

WBE has also conducted a groundwater study of the area and has determined that according to the New Mexico Office of the State Engineer there is one verifiable record of groundwater in the immediate vicinity to the site mentioned above. The depth to groundwater in this area was last reported in 1991 to be at a depth of 192' below land surface. This well is completed in the Rustler Formation (312RSLR) local aquifer. The water well is located 4.34 miles (SSW) at 254.6 degree. Therefore, no eminent danger of groundwater impact.

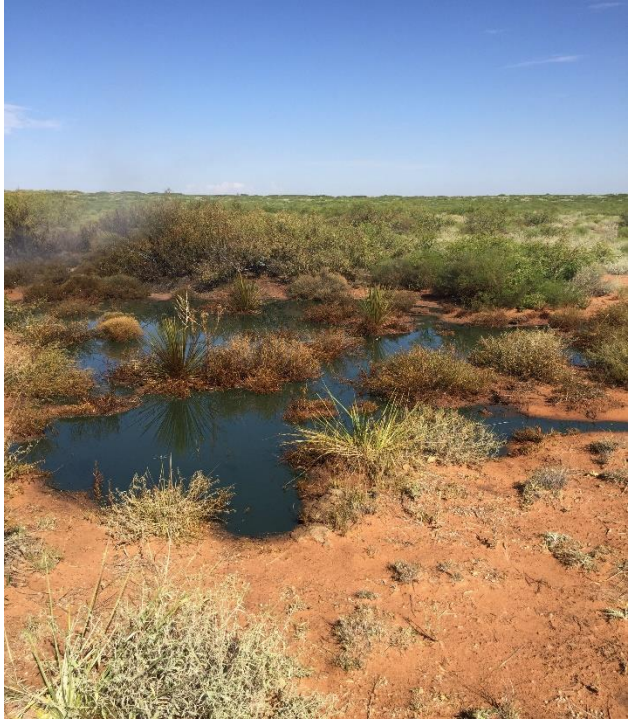
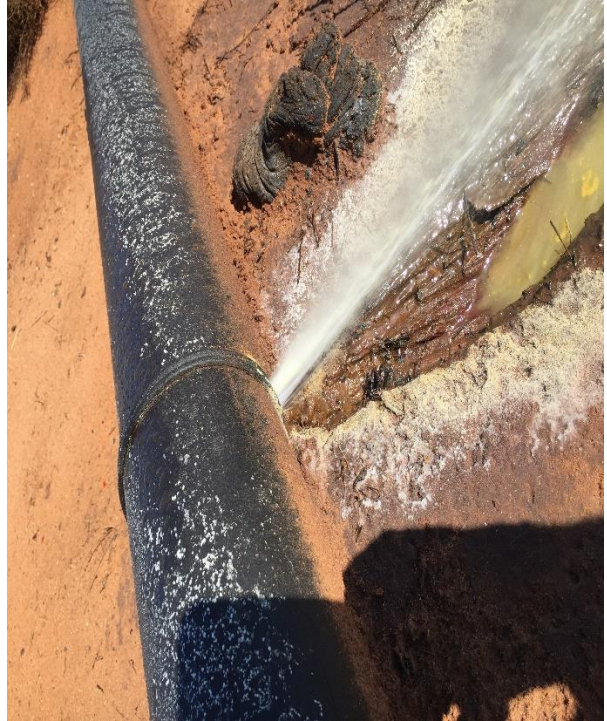
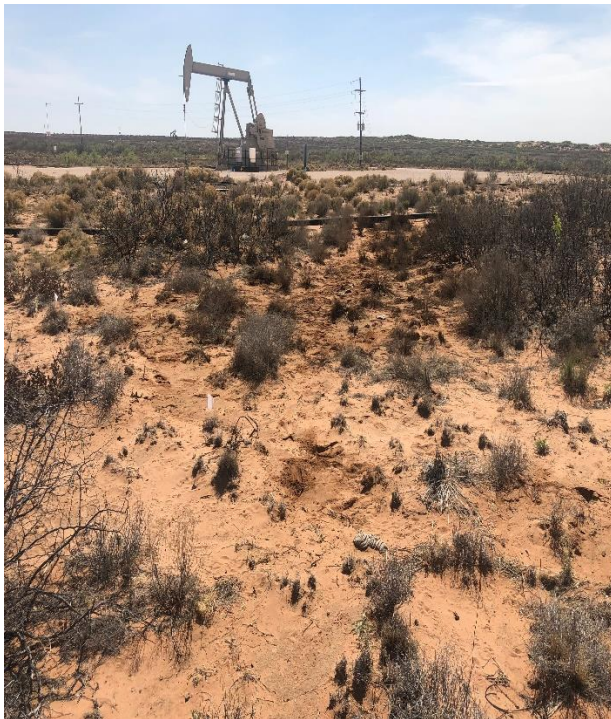
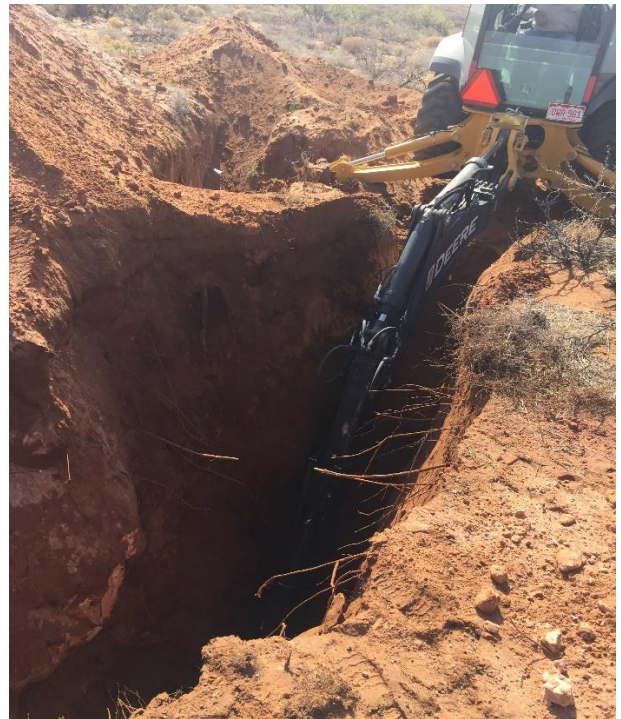
The site had an accidental discharge of fluids associated with the Blackjack 1 Federal #2. A poly line failed at a fused section of pipe causing a release of mixed fluids onto the pasture area north of the facility pad. It was estimated that a total of 8bbls of fluid was released consisting of 1bbl of oil and 7bbls of

Please note the flowline that caused this release is shown to go through the area dividing SP1-SP3 and SP4-SP6.

WBE is proposing to excavate to a total depth of 4'bgs, the contaminated soil will be removed and taken to an NMOCD approved facility which at that time we will install a 20-mil polyurethane liner and backfilled with topsoil. With the added area in the horizontal impact the proposed excavation is a total of 2493 sq. ft. The entire site excavation and disturbed area will then be contoured and seeded with a native mixture per BLM and NMOCD guidelines.

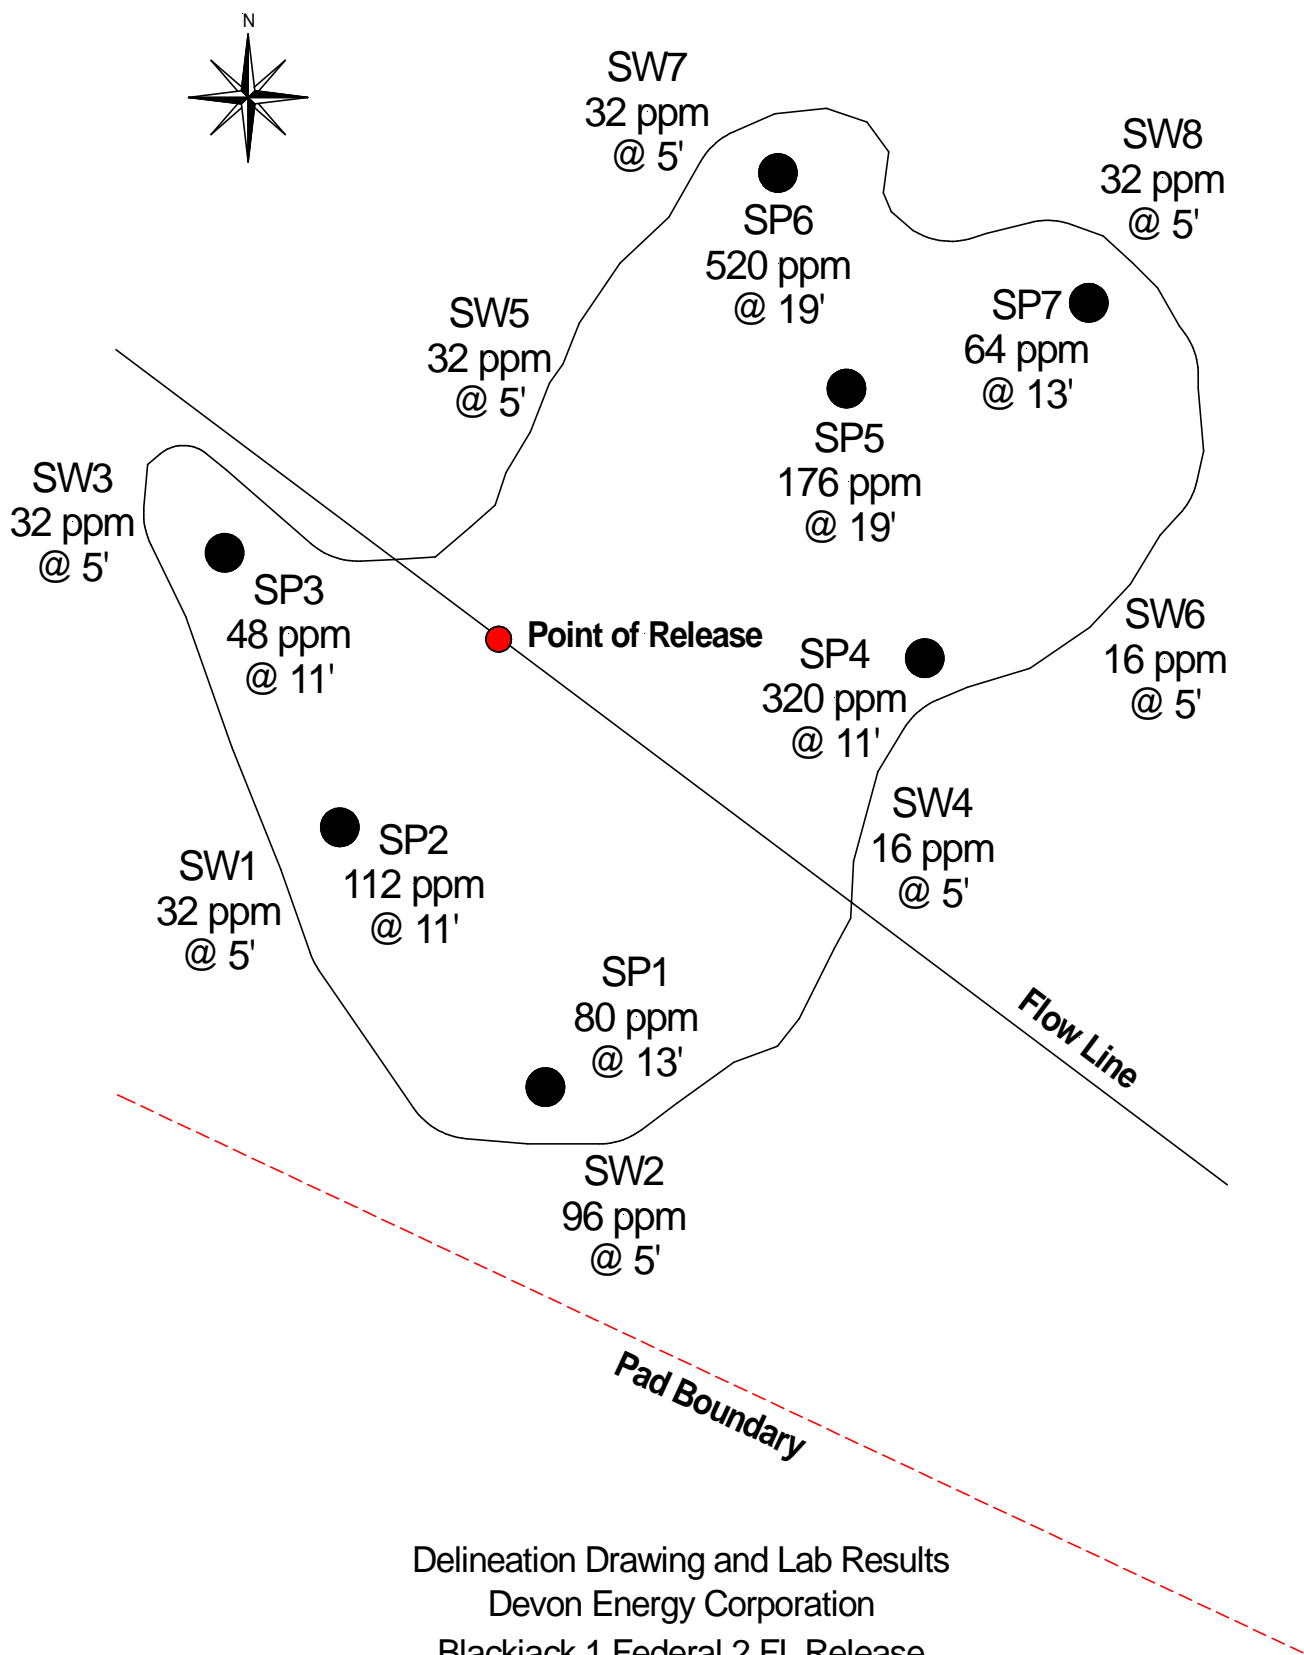
Devon Energy Corporation
Blackjack 1 Federal #2

SW1 was delineated from the southeast side of SP2
SW2 was delineated from the south side of SP1
SW3 was delineated from the west side of SP3
SW4 was delineated from outside the visual impacted area
SW5 was delineated from the west of SP6
SW6 was delineated between the SP4 & SP7 visual impacted area
SW7 was delineated from the north side of SP6
SW8 was delineated from the north side of SP7

FT	SP1	FT	SP2	FT	SP3	FT	SP4	FT	SP5	FT	SP6	FT	SP7
SFC	2800	SFC	250	SFC	250	SFC	6858	SFC	4260	SFC	12554	SFC	4658
1'	952	1'	1140	1'	2589	1'	4260	1'	1042	1'	4260	1'	2384
2'	1876	2'	784	2'	1524	2'	4260	2'	708	2'	3904	2'	2032
3'	3904	3'	952	3'	855	3'	3038	3'	1470	3'	4260	3'	3288
5'	11850	5'	1500	5'	190	5'	12554	5'	1352	5'	2552	5'	3817
7'	910	7'	910	7'	510	7'	6858	7'	260	7'	1519	7'	798
9'	689	9'	910	9'	240	9'	866	9'	120	9'	4273	9'	280
11'	465	11'	410	11'	540	11'	340	11'	680	11'	2329	11'	546
13'	190	11'	112	11'	48	11'	320	13'	1440	13'	<600	13'	420
13'	80							15'	1280	15'	1016	13'	64
								17'	60	17'	200		
								19'	540	19'	520		
								19'	176				
FT	SW1	FT	SW2	FT	SW3	FT	SW4	FT	SW5	FT	SW6	FT	SW7
1'	900	1'	320	1'	460	1'	640	1'	600	1'	580	1'	980
3'	300	3'	280	3'	180	3'	320	3'	600	3'	580	3'	522
5'	60	5'	240	5'	80	5'	60	5'	120	5'	180	5'	200
5'	32	5'	96	5'	32	5'	16	5'	32	5'	16	5'	32
FT	SW8												
1'	1012
