**Report Type: Work Plan      2RP-4154**

Site:	White Oak State #1					
Company:	COG Operating LLC					
Section, Township and Range	Unit P	Sec. 23	T 27S	R 28E		
Lease Number:	API No. 30-015-29749					
County:	Eddy County					
GPS:	32.8147278° N			104.1394958° W		
Surface Owner:	Private					
Mineral Owner:						
Directions:	From the intersection of Lovington Hwy and Turkey Tract Rd, travel north on Turkey Tract Rd for approximately 1.10 mi, turn east onto lease road and continue for 0.50 mi, turn south for 0.10 mi to location.

**Re: Work Plan for the COG Operating LLC., White Oak State #1, Unit P, Section 23, Township 17 South, Ranch 28 East, Eddy County, New Mexico. 2RP-4154.**

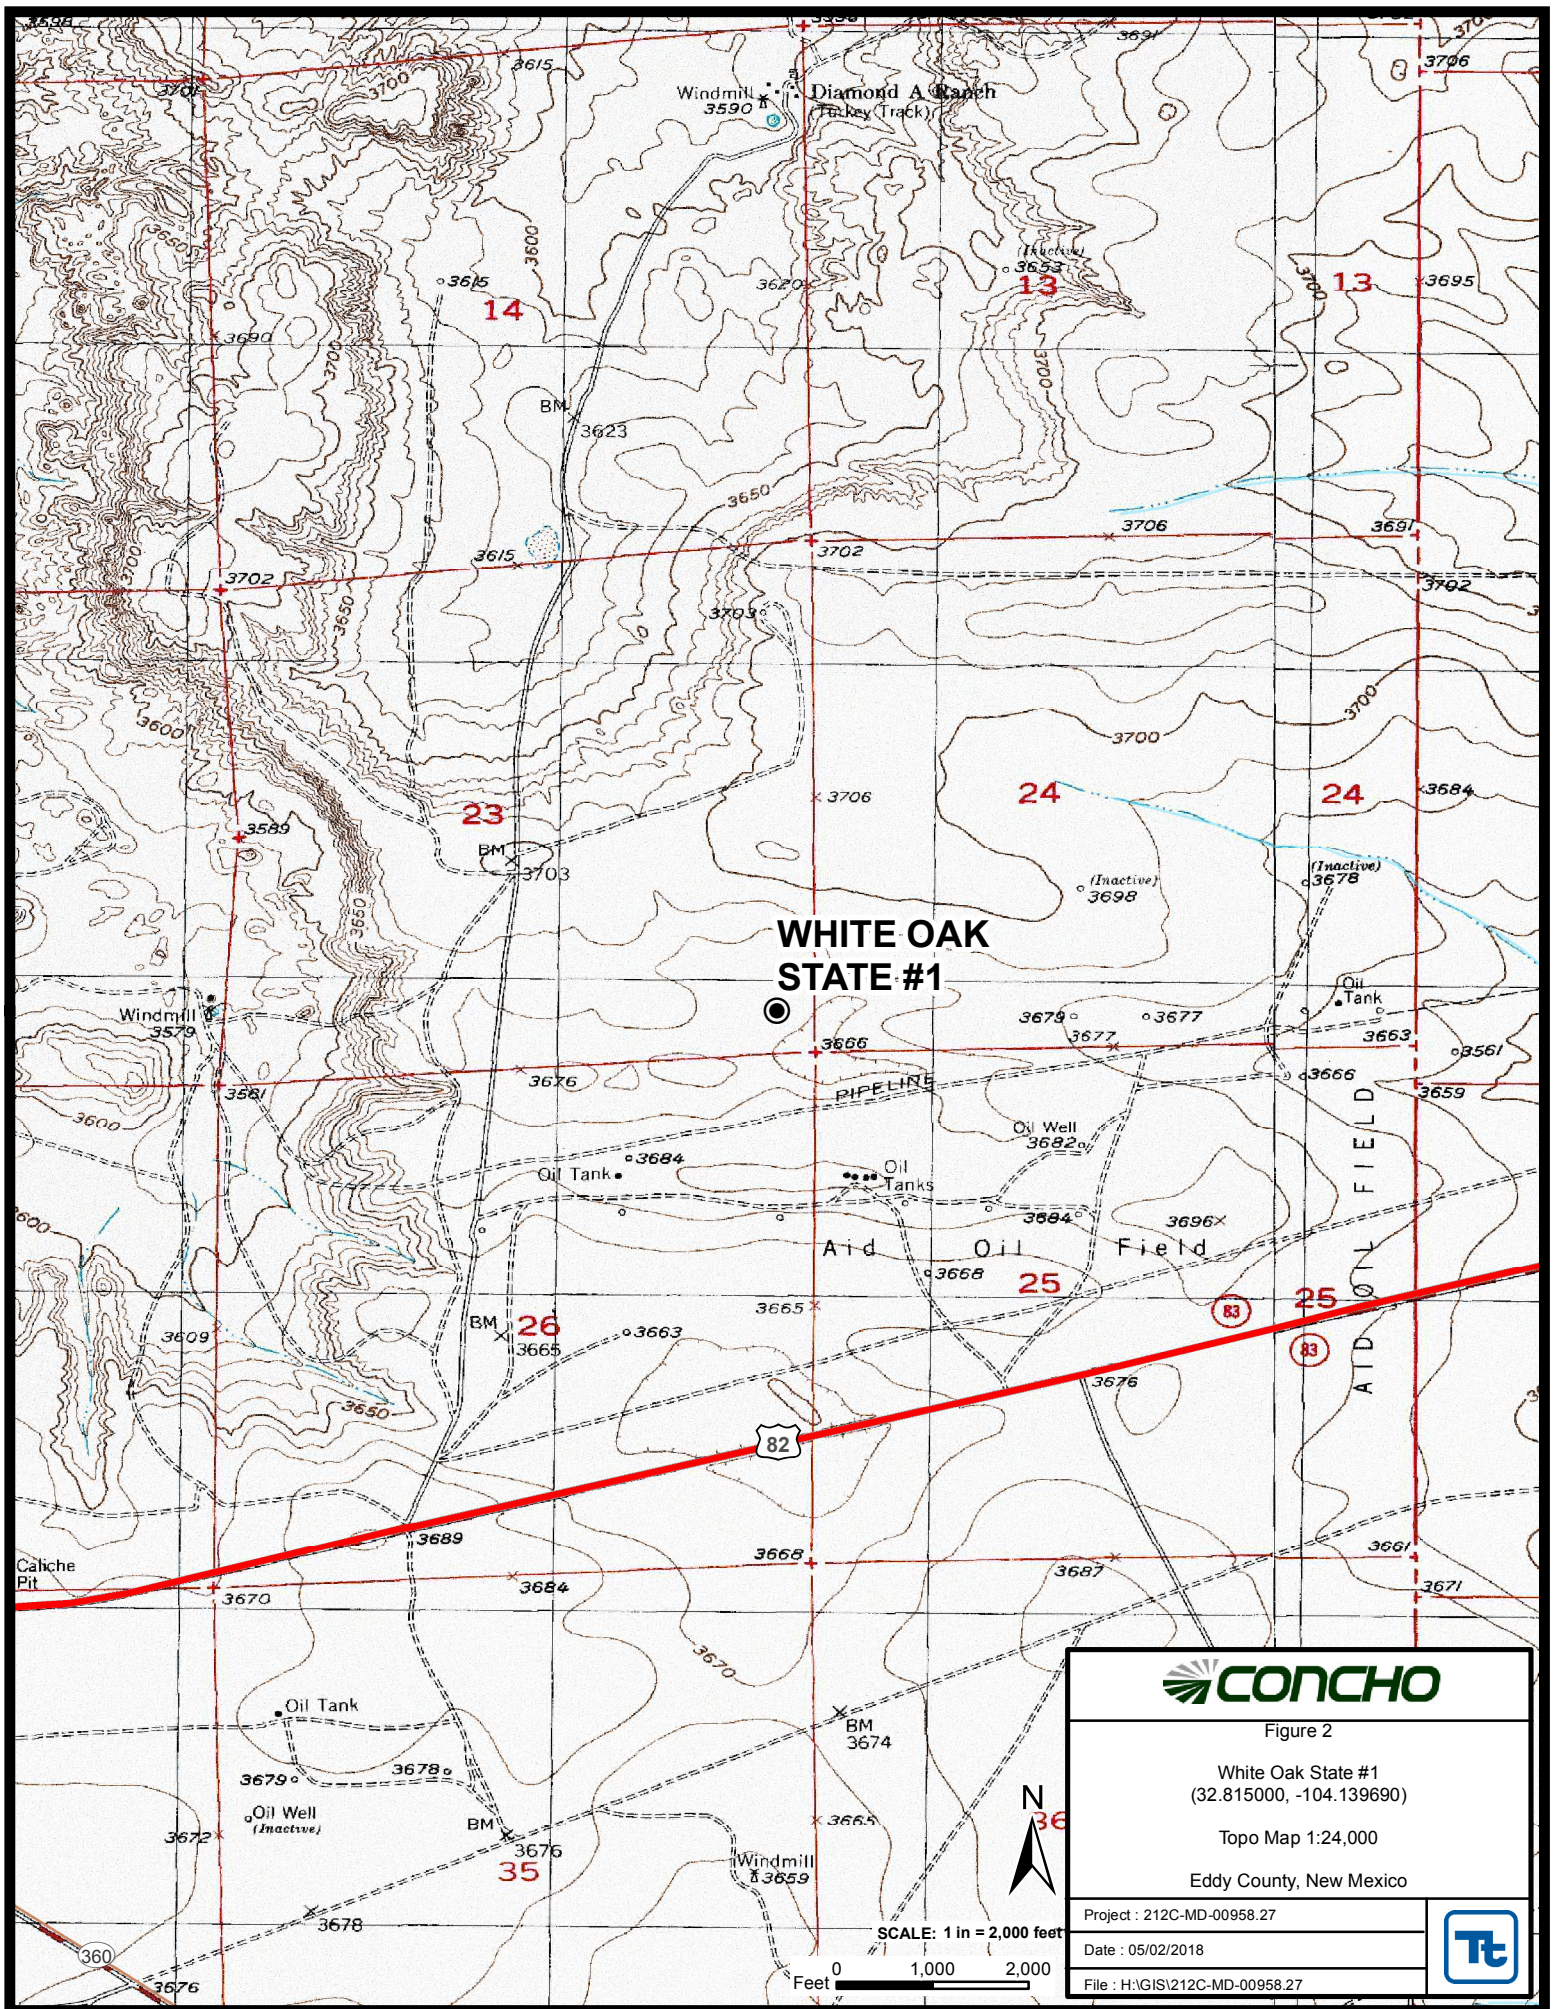
Tetra Tech, Inc. (Tetra Tech) was contacted by COG Operating LLC., (COG) to evaluate and assess a release that occurred at the White Oak State #1, Unit P, Section 23, Township 17 South, Ranch 28 East, Eddy County, New Mexico (Site). The spill site coordinates are N 32.8147278°, W 104.1394958°. The site location is shown on Figures 1 and 2.

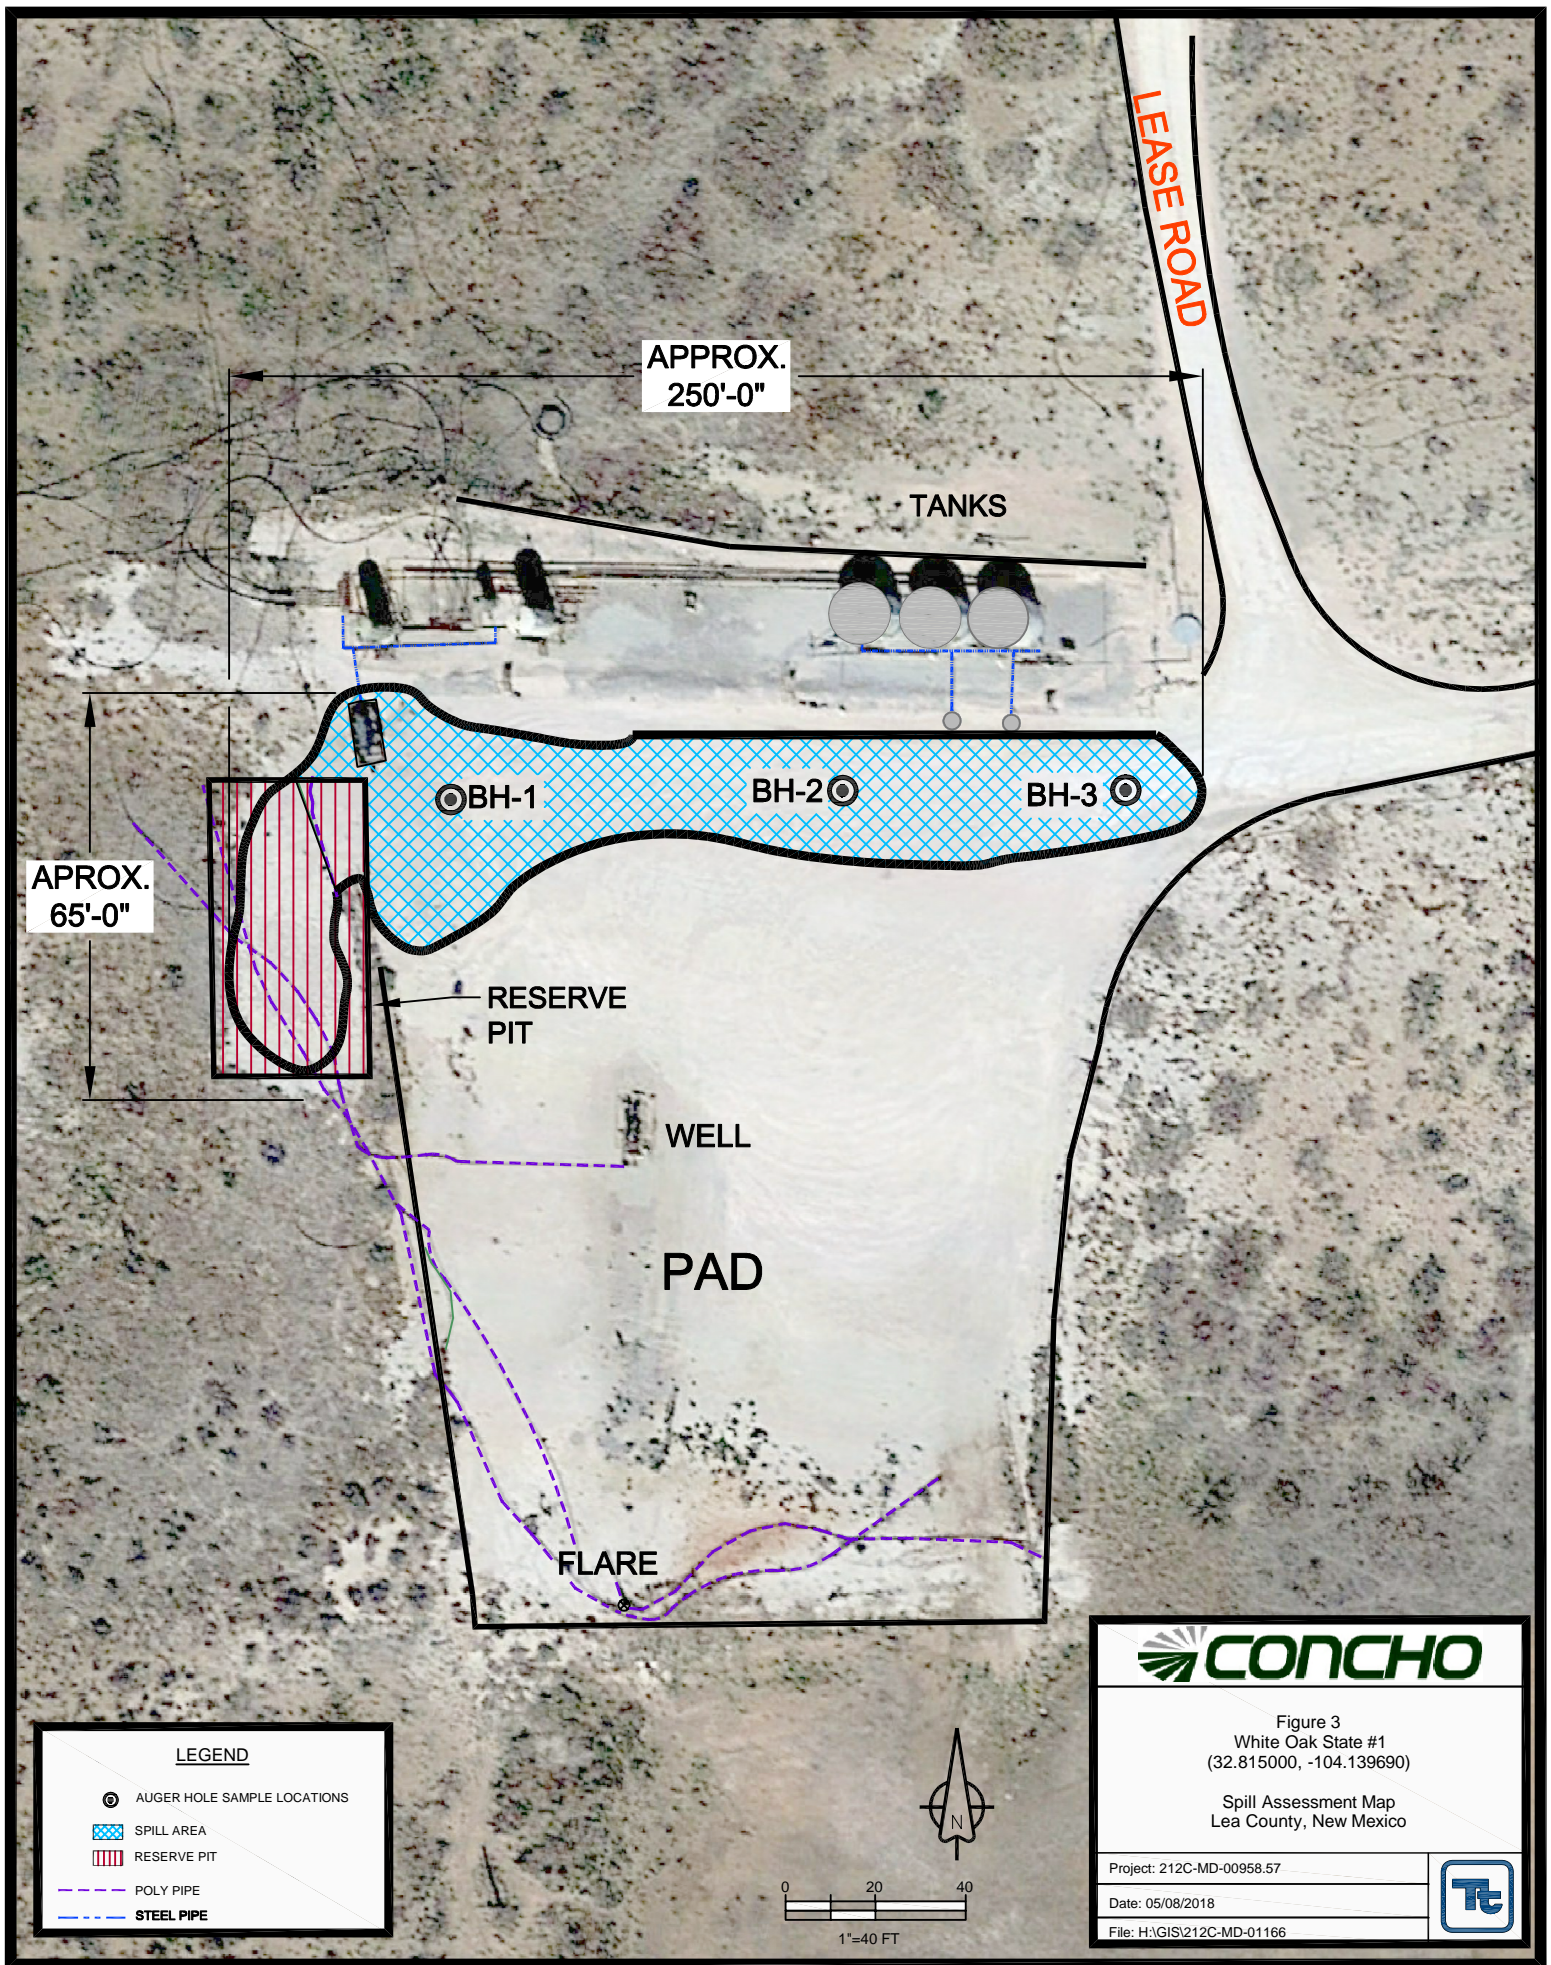
On April 23, 2018, Tetra Tech personnel were onsite to evaluate and sample the release area. Three (3) boreholes (BH-1, BH-2, and BH-3) were installed in the release footprint in order to evaluate the soils. Selected samples were analyzed for TPH analysis by EPA method 8015 modified, BTEX by EPA Method 8021B and chloride by EPA method 300.0. Copies of laboratory analysis and chain-of-custody documentation are included in Appendix C. The sampling results are summarized in Table 1. The borehole locations are shown on Figure 3.

However, a shallow chloride impact was detected in all areas. The area of borehole (BH-1) showed a chloride high of 30,900 mg/kg at 2-3', which declined with depth to 644 mg/kg at 9-10' and 244 mg/kg at 14'-15' below surface. The area of borehole (BH-2) showed a chloride concentration of 11,200 mg/kg at 0-1', which declined with depth to 306 mg/kg at 4-5' and 182 mg/kg at 6-7' below surface. The area of borehole (BH-3) showed a chloride high of 3,170 mg/kg at 0-1' which then declined to below the 600 mg/kg threshold at 2-3' below surface.

COG proposes to remove the chloride concentrations that were identified in the shallow soils in the areas of boreholes (BH-1, BH-2 and BH-3). The areas of borehole (BH-2) will be excavated to approximately 2.0' to 3.0' and the area of borehole (BH-3) will be excavated to approximately 1.0' below surface. The area of borehole (BH-1) will be excavated to approximately 3.0' to 4.0' below surface and capped with a 20-mil liner to prevent vertical migration of the deeper impact. Once the areas are excavated to the appropriate depth, the excavation will be backfilled with clean material to surface grade. All of the excavated material will be transported offsite for proper disposal.

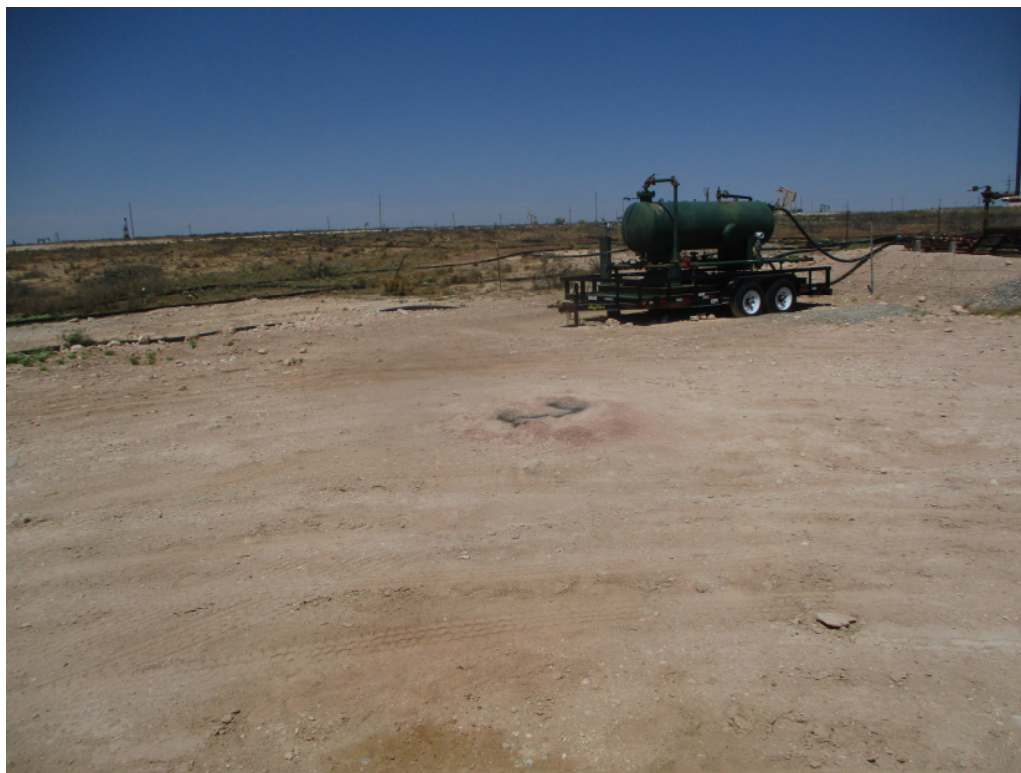
View West – Area of BH-1

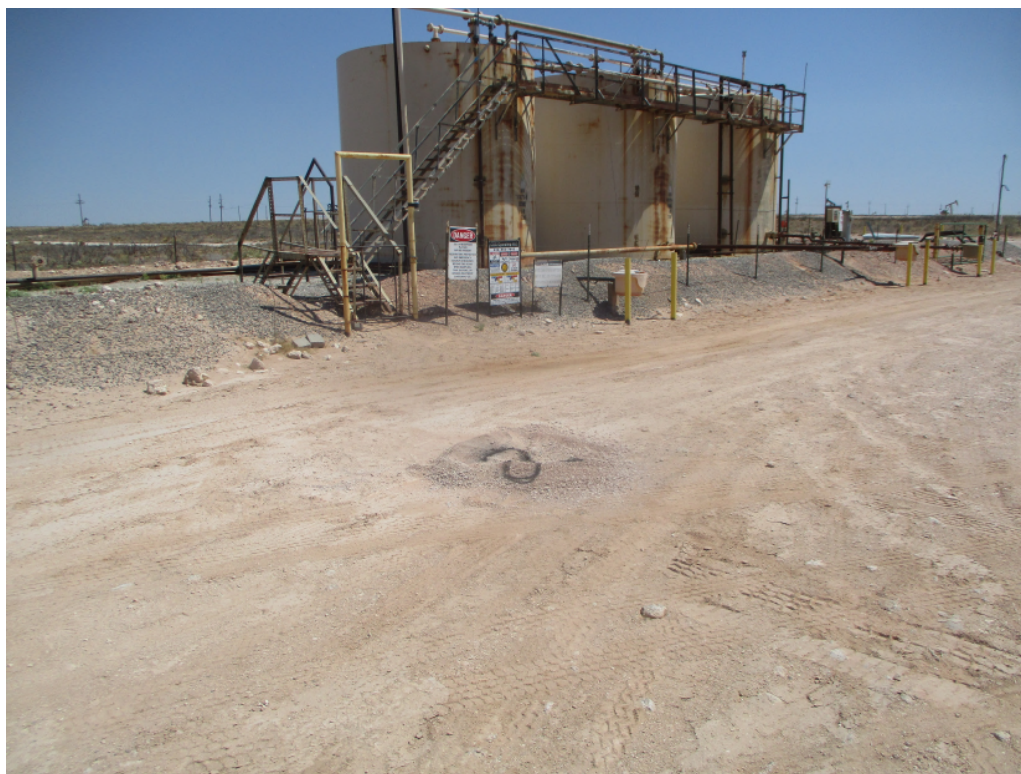
View Northeast – Area of BH-2

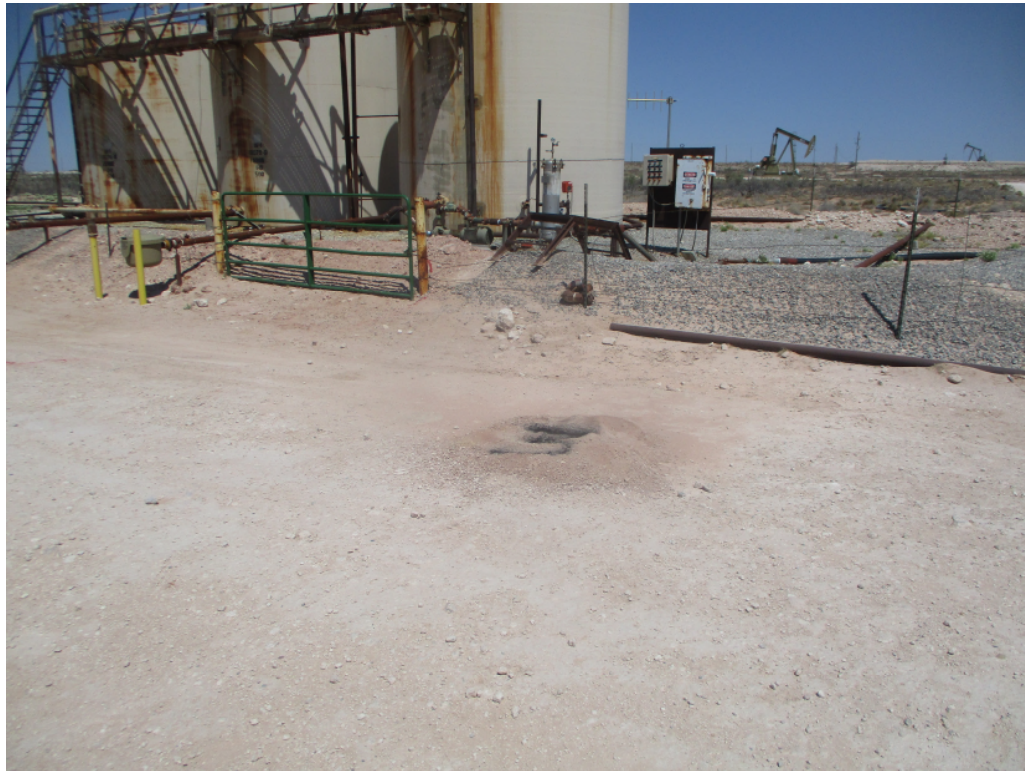
View North – Area of BH-3

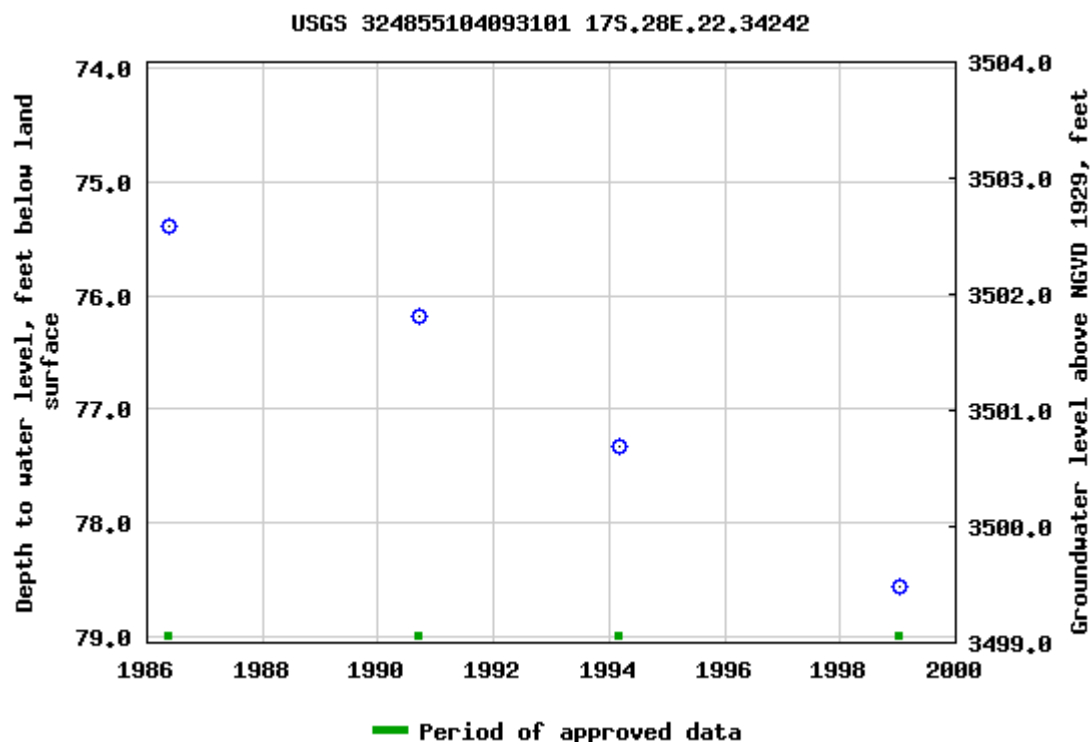
## USGS 324855104093101 17S.28E.22.34242

The depth of the well is 95.00 feet below land surface.

Breaks in the plot represent a gap of at least one year between field measurements.
