SUBJECT: SOIL REMEDIATION WORK PLAN FOR INCIDENT 2RP-755, State D SWD #001, UNIT N SECTION 16-T20S-R24E NMPM, API# 30-015-21572, EDDY COUNTY, NEW MEXICO

# SOIL REMEDIATION WORK PLAN FOR INCIDENTS 2RP-755 AND NMLB0610137549 (NO RP #) EOG Y RESOURCES, INC.

STATE D SWD #001  
UL N, SECTION 16, T20S R24E, NMPM  
API #30-015-21572  
EDDY COUNTY, NM

March 20, 2017  
SMA Reference  
5E25868 BG3

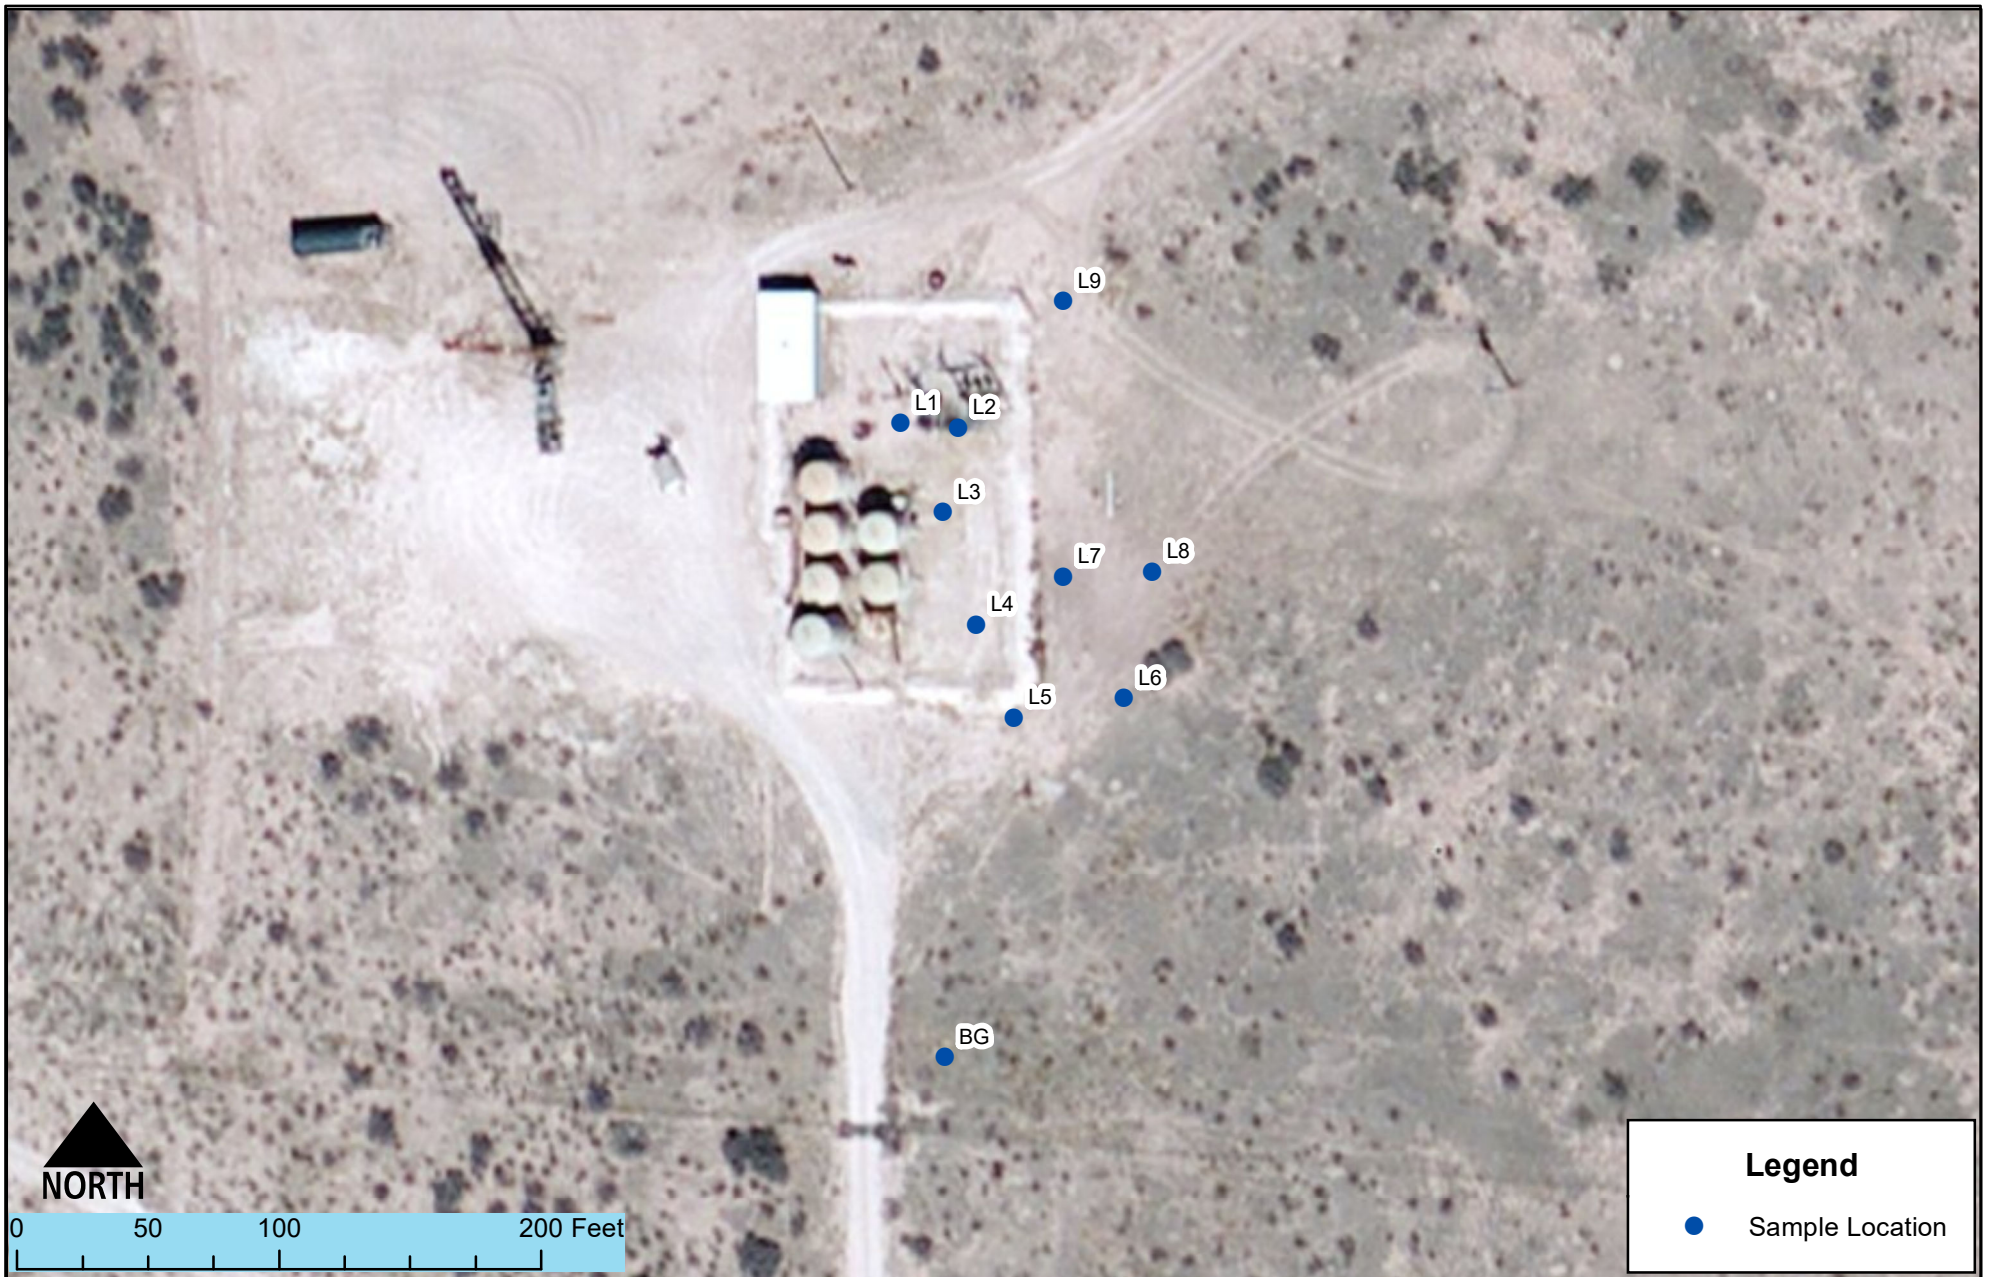
**FIGURE 2**

**DETAILED SITE AND SAMPLE  
LOCATION MAP**

Detailed Site and Sample Map  
 State D SWD #001 ~ EOG  
 Eddy County, New Mexico

Soil contaminant concentrations found during the initial delineation are illustrated in Figure 2. A summary of the laboratory analyses is included in Table 3. Laboratory reports are included in Appendix A.

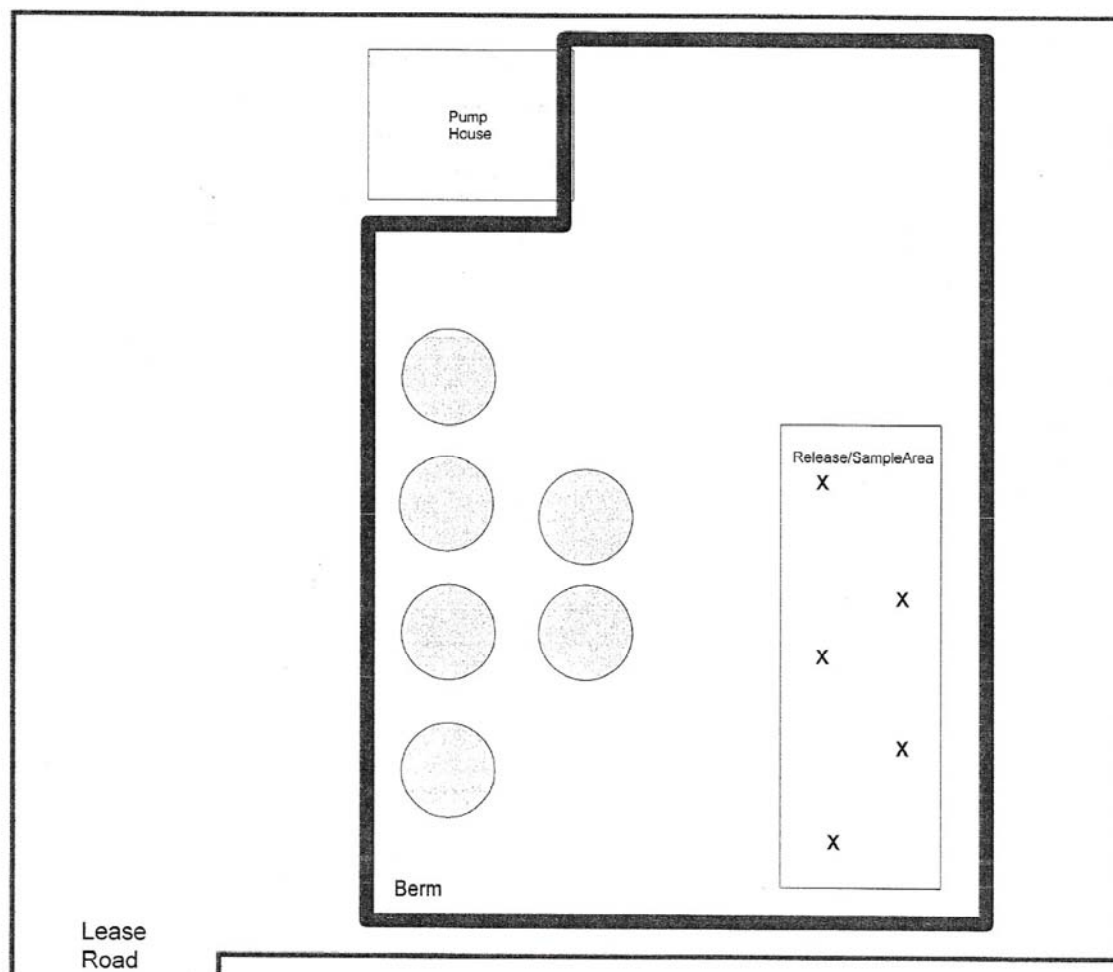
Sample ID	Sample Area	Sample Date	Sample Type	Depth	BTEX	GRO	DRO	TOTAL	Chlorides
GS/Comp-Surface	Battery Area	8/11/2009	Grab/Auger	4"	ND	ND	887	887	2910
GS/Comp-001	Battery Area	8/11/2009	Grab/Auger	12"	2.077	147	1130	1277	515
GS/Comp-002	Battery Area	8/11/2009	Grab/Auger	24"	2.319	182	787	969	299
Sample ID	Sample Area	Sample Date	Sample Type	Depth	BTEX	GRO	DRO	TOTAL	Chlorides
GS/Comp-Surface	Battery Area	2/17/2010	Grab/Auger	4"	0.2294	37.2	109	146.2	1970
GS/Comp-001	Battery Area	2/17/2010	Grab/Auger	12"	39.28	709	910	1619	682
GS/Comp-002	Battery Area	2/17/2010	Grab/Auger	24"	25.67	1820	3290	5110	397

Site Ranking is Zero (0). Depth to Ground Water >100' (approx. 350').

All results are ppm. Chloride results are for documentation. X - Sample Points

**SAMPLE DIAGRAM (Not to Scale)**  
Xenco Laboratories: #340666  
Report Date: 8/18/2009  
Xenco Laboratories: #362835 & 362836  
Report Date: 2/24/2010  
Prepared by Robert Asher  
Environmental Regulatory Agent
