Report Type: Work Plan 2RP-4128

Site:	Barn Owl Federal #2H				
Company:	COG Operating LLC				
Section, Township and Range	Unit B	Sec. 19	T 26S	R 27E	
Lease Number:	API No. 30-015-42472				
County:	Eddy County				
GPS:	32.0336952° N			104.2253418° W	
Surface Owner:	Federal				
Mineral Owner:					
Directions:	From intersection of HWY 285 & Whites City Rd, travel west on Whites City Rd for approx 7.80 mi, turn south onto lease rd for 1.90 mi, turn west onto lease rd for 1.25 mi, turn south onto lease rd for 400' to location.

Re: Work Plan for the COG Operating LLC., Barn Owl Federal #2H, Unit B, Section 19, Township 26 South, Range 27 East, Eddy County, New Mexico. 2RP-4128.

Spill Assessment Map

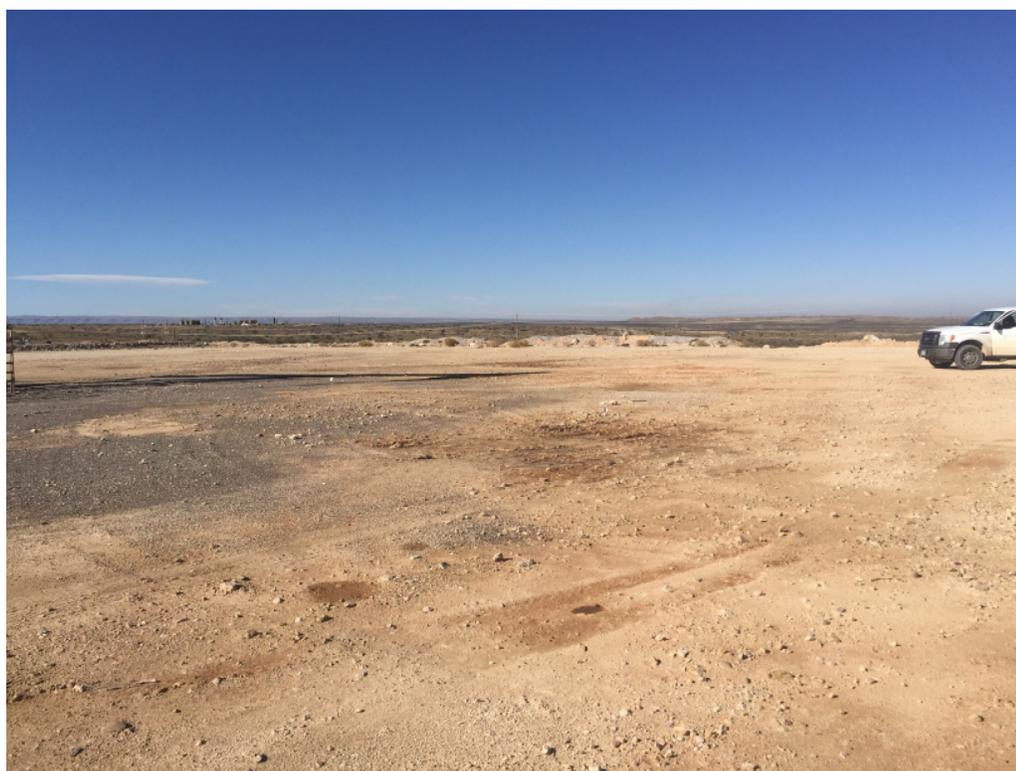
View North – Area of BH-1

Referring to Table 1, the samples showed shallow impact to the area. The area of borehole (BH-1) showed a chloride high of 9,920 mg/kg at 0-1' and declined with depth to 714 mg/kg at 6.0'-7.0'. The bottom hole sample at 29'-30' showed a chloride concentration of 85.7 mg/kg. Additionally, the sample collected at 9-10' showed TPH, benzene, and total BTEX concentrations below the laboratory reporting limits.

Based on the laboratory results, COG proposes to remove the chloride impacted soils as shown on Figure 4 and highlighted (green) on Table 1. The area of trench (T-1) will be excavated to approximately 4.0' below surface to remove the chloride impacted soils. The excavation will then be backfilled with clean material to surface grade. All of the excavated material will be transported offsite for proper disposal.

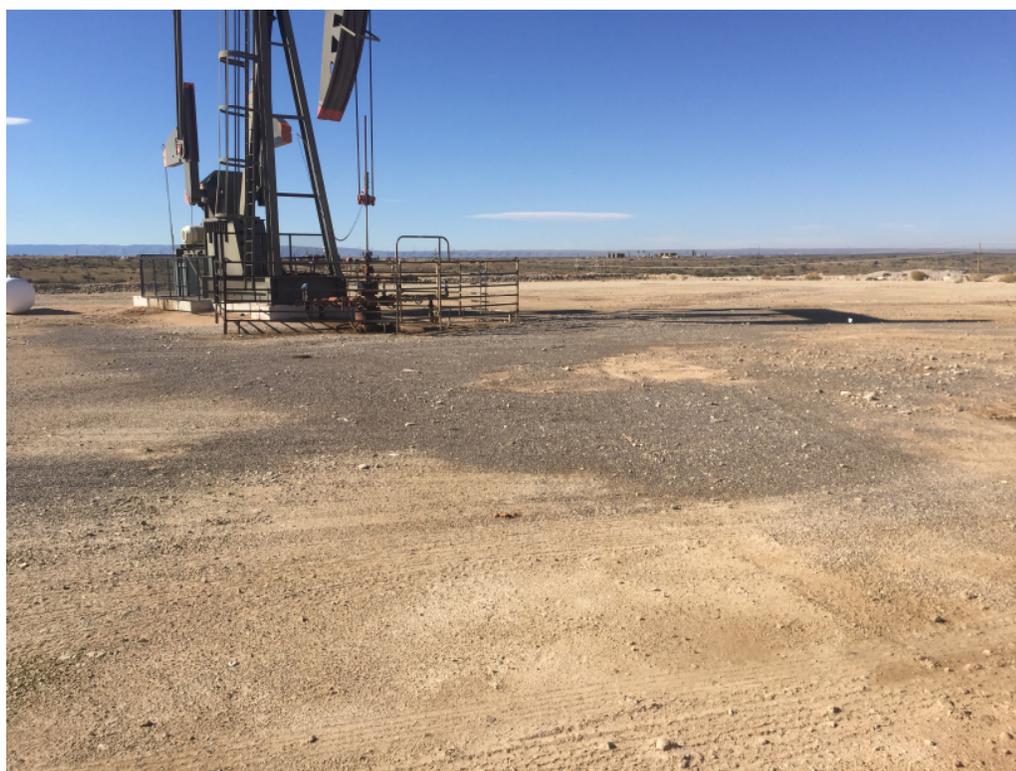
View West – Area of BH-1
