**Figure 3**  
 Site Details & Confirmation  
 Soil Sample Locations Map  
 SRO STATE COM #064H  
 COG Operating, LLC.  
 Eddy County, NM

Scale: 1" = 66'	
CAD By: JH	Checked By: NG
November 30, 2017	
LAT. N 32.0576019 , Long. W 104.0815811	
SW 1/4 NW 1/4 SEC 10 T26S R28E	
TRC Proj. NO.: 279785

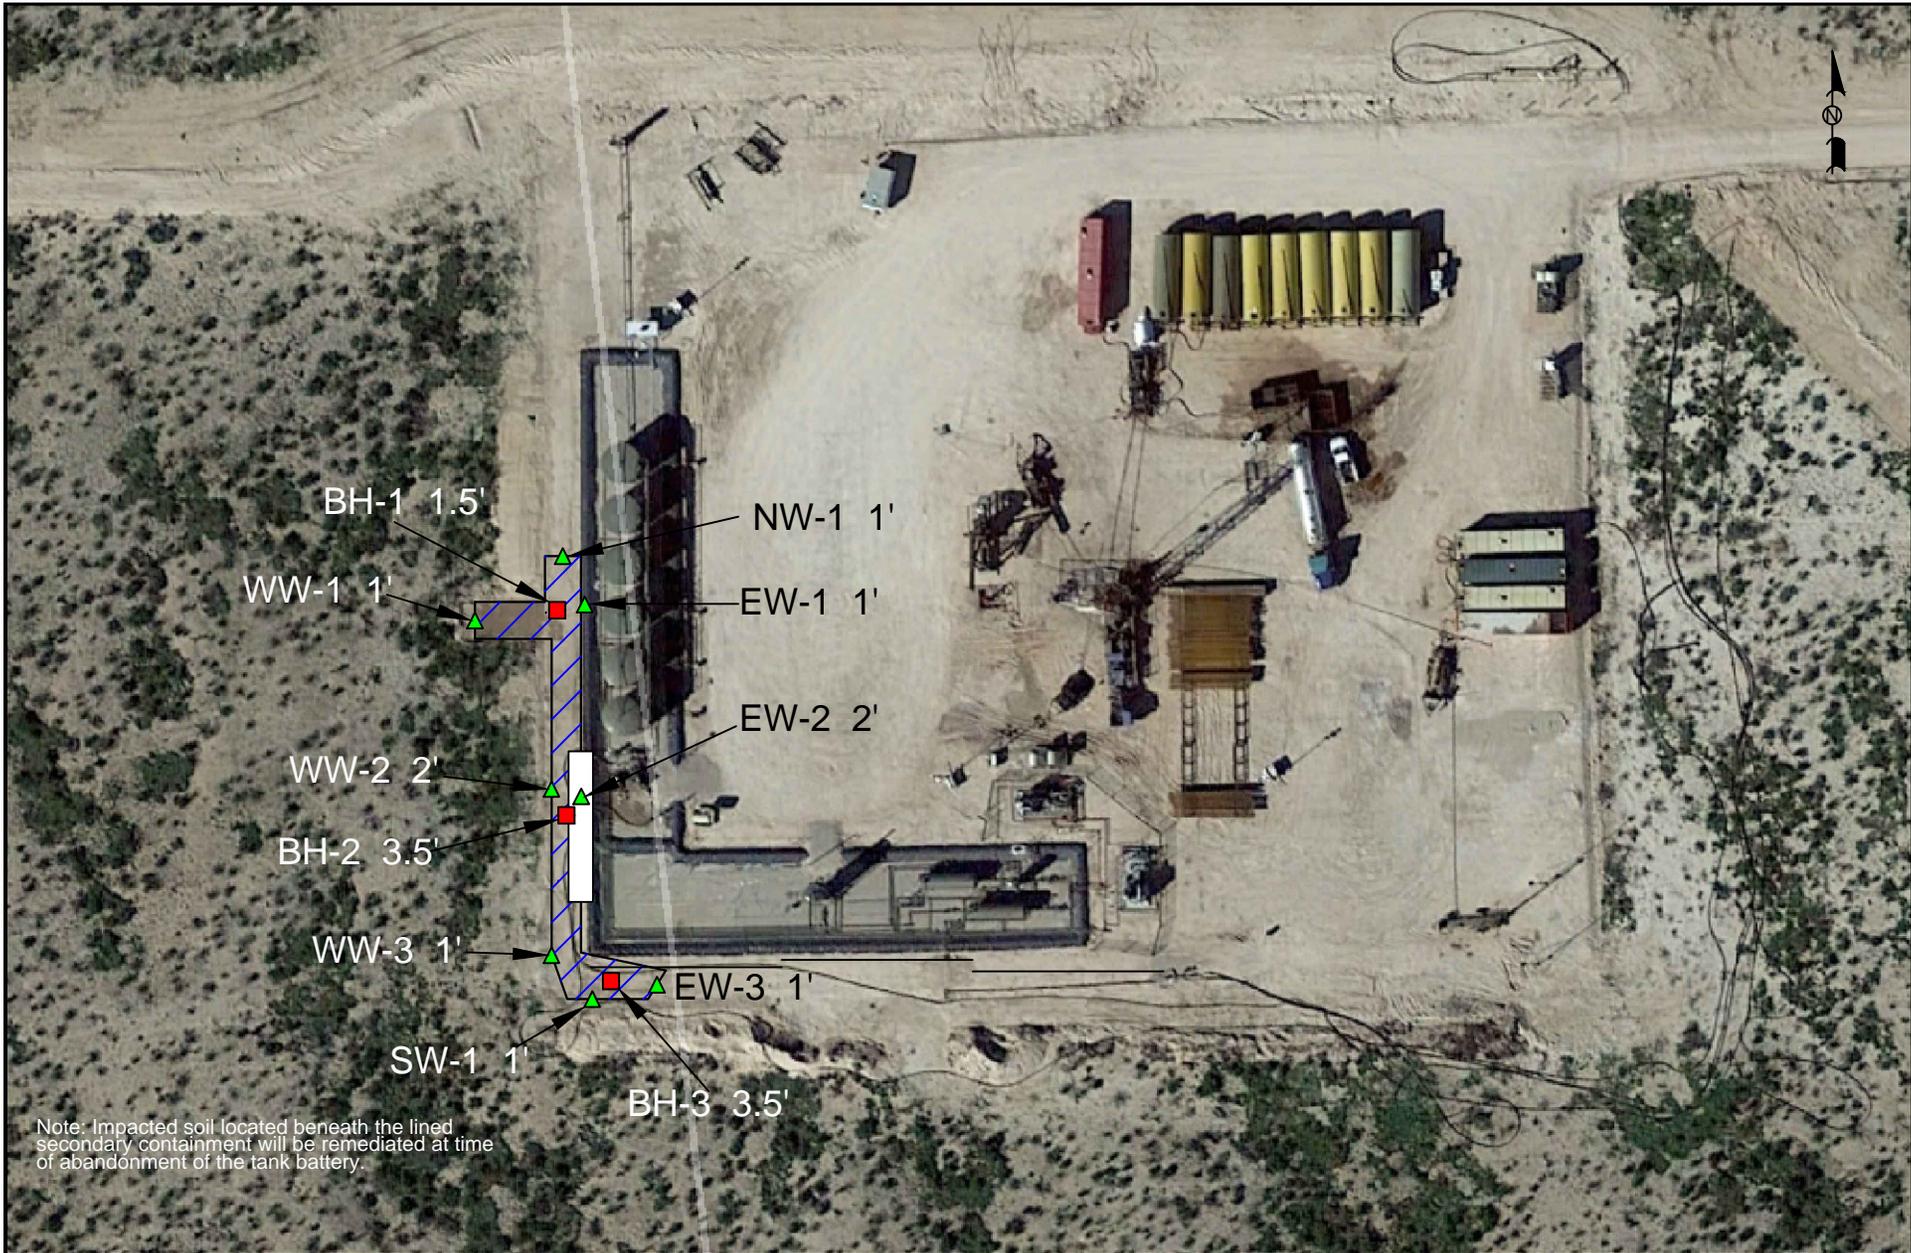
Note: Impacted soil located beneath the lined secondary containment will be remediated at time of abandonment of the tank battery.
