Closure Report

Site Name:	Cedar Canyon 23 Federal #33H
Company:	Oxy USA Inc.
Legal Description:	U/L I, Section 22, T24E, T29E
County:	Eddy County, NM
GPS Coordinates:	N 32.20205° W-103.96723°

Date of Release:	08/10/2017
Type of Release:	Produced water
Source of Release:	Compromised poly line
Volume of Release:	12 bbls
Volume Recovered:	9 bbls

Remediation Parameters:	Excavated the areas around SP1-SP5 to a depth of 2 feet. Excavated the areas around SP6 and SP7 to a depth of 1 foot. Backfilled the site with clean soil.	
Remediation Activities:	08/06/2018 to 08/14/2018	
Plan Sent to OCD:	11/25/2017	Email from Cliff Brunson to Mike Bratcher
OCD Approval of Plan:	03/05/2018	Email from Mike Bratcher to Cliff Brunson
Plan Sent to BLM:	11/25/2017	Email from Cliff Brunson to Shelly Tucker
BLM Approval of Plan:	12/26/2017	Email from Shelly Tucker to Cliff Brunson

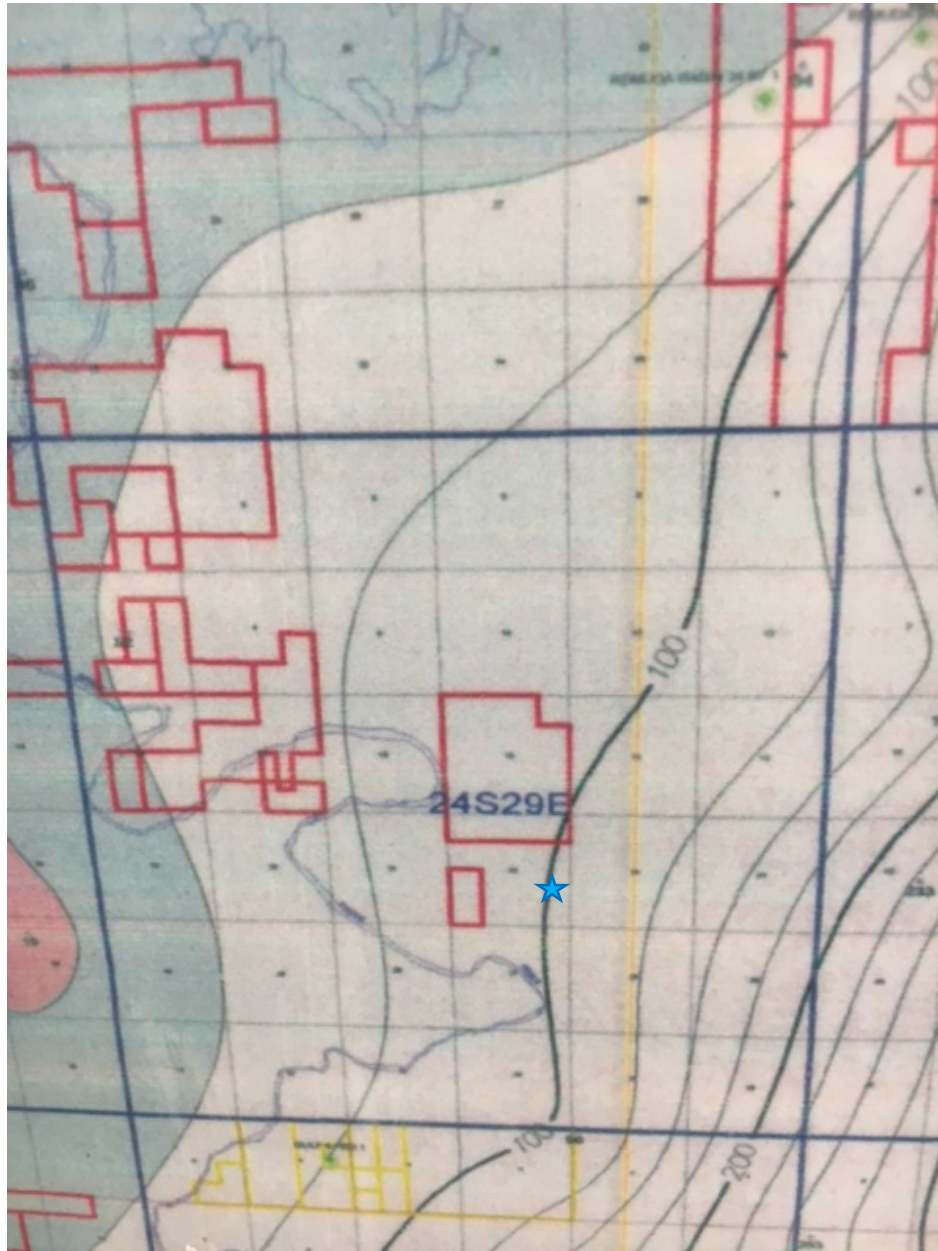
Oxy, Cedar Canyon 23 Federal #33H

U/L I, Section 22, T24S, R29E

Groundwater: 100'
