Re: Remediation Summary and Closure Report
NG Phillips St #037
API No. 30-015-24848
GPS: 32.80305, -104.15940
UL "P", Sec. 27, T17S, R32E
Eddy Co, NM
NMOCD Ref. No. 2RP-4195

TRC Environmental Corporation (TRC), on behalf of COG Operating, LLC (COG), has prepared this *Remediation Summary and Closure Report* for the release site known as the NG Phillips St. #037. Details of the release are summarized below:

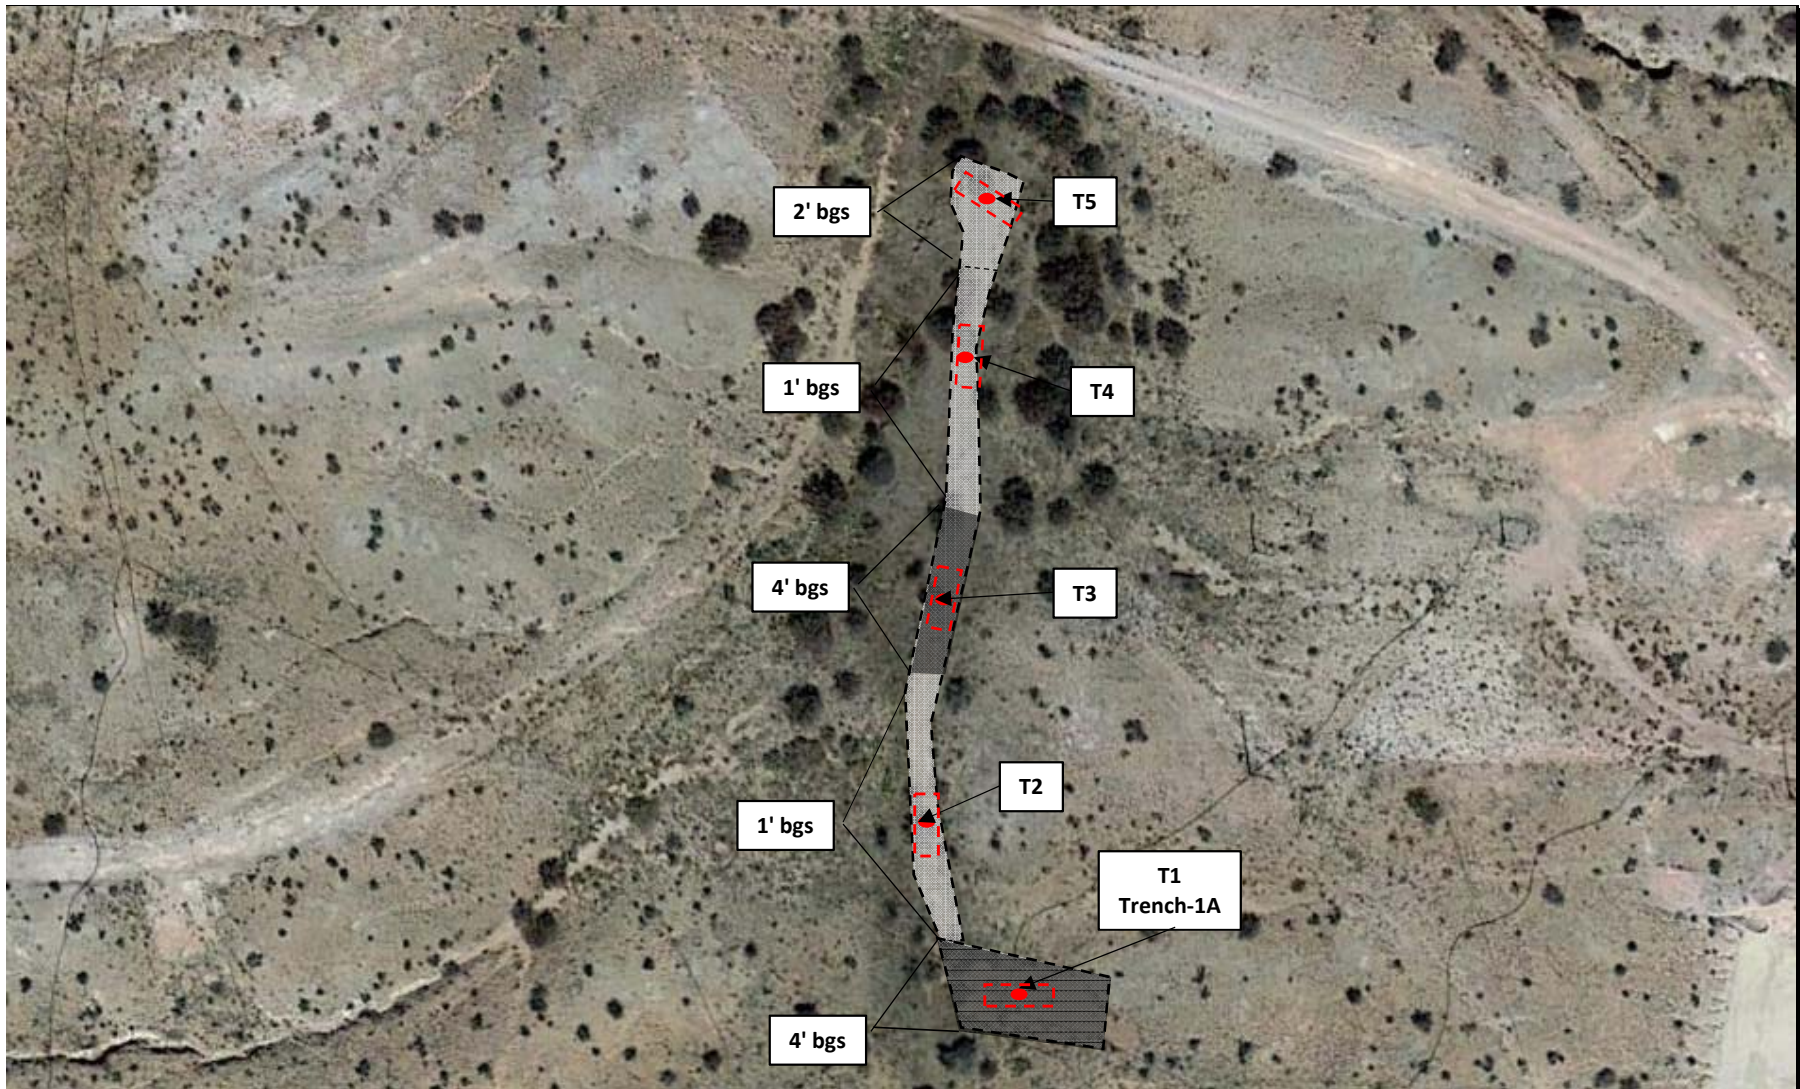
Test Trench	Figure 2 Site & Sample Location Map COG Operating, LLC NG Phillips St #037 Eddy Co, NM	Scale 1" = 50'

Laboratory analytical reports are provided as Attachment #4. A "Site & Sample Location Map" is provided as Attachment #2.

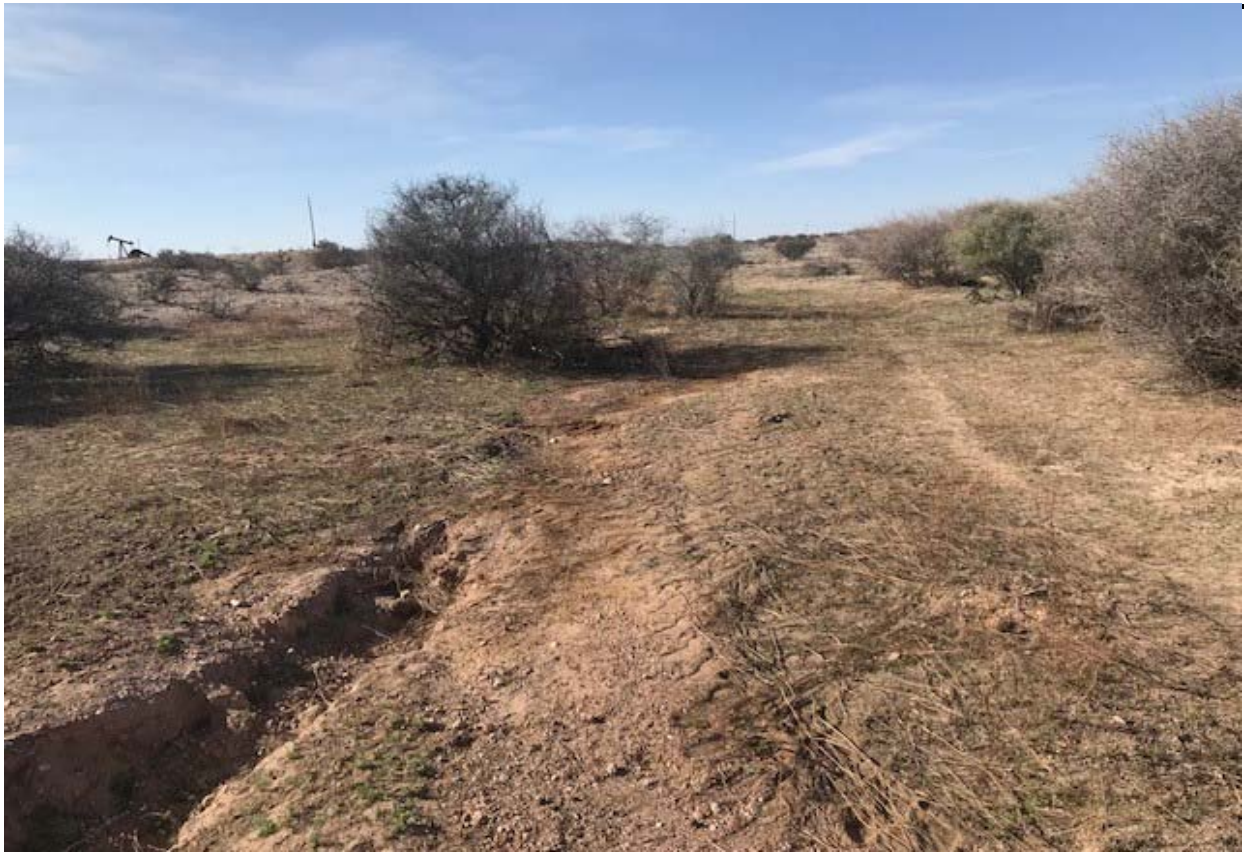
Figure 1 - View of surface staining from the initial release.

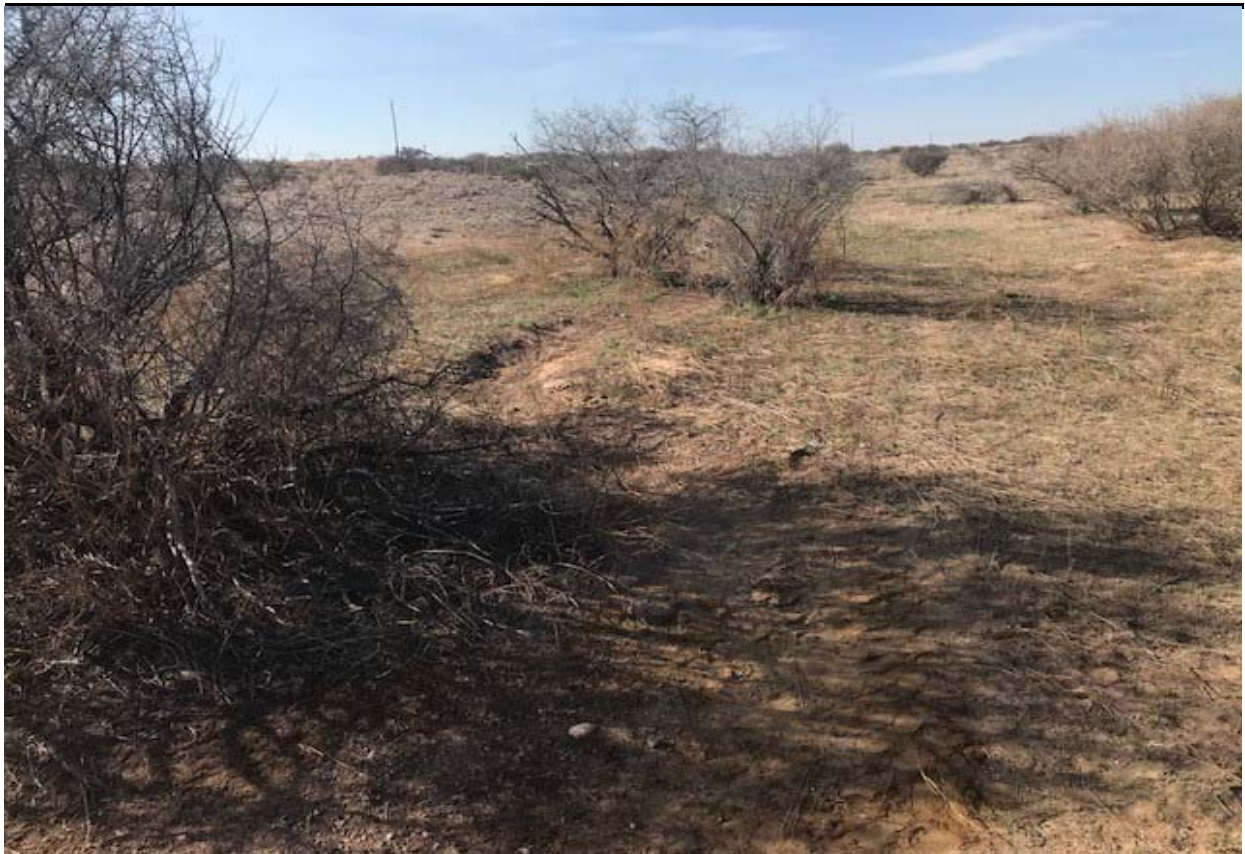
Figure 2 - View of surface staining from the initial release.

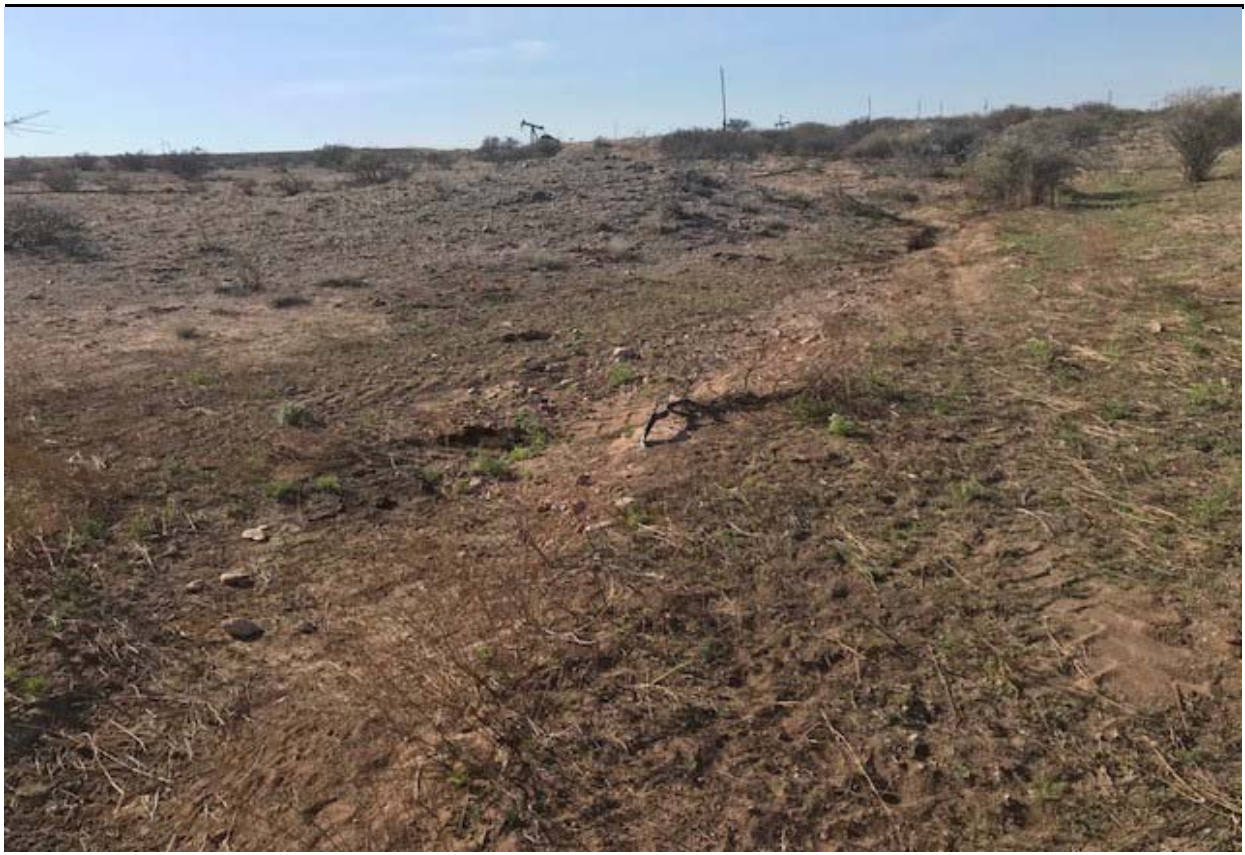
Figure 3 - View of surface staining from the initial release.

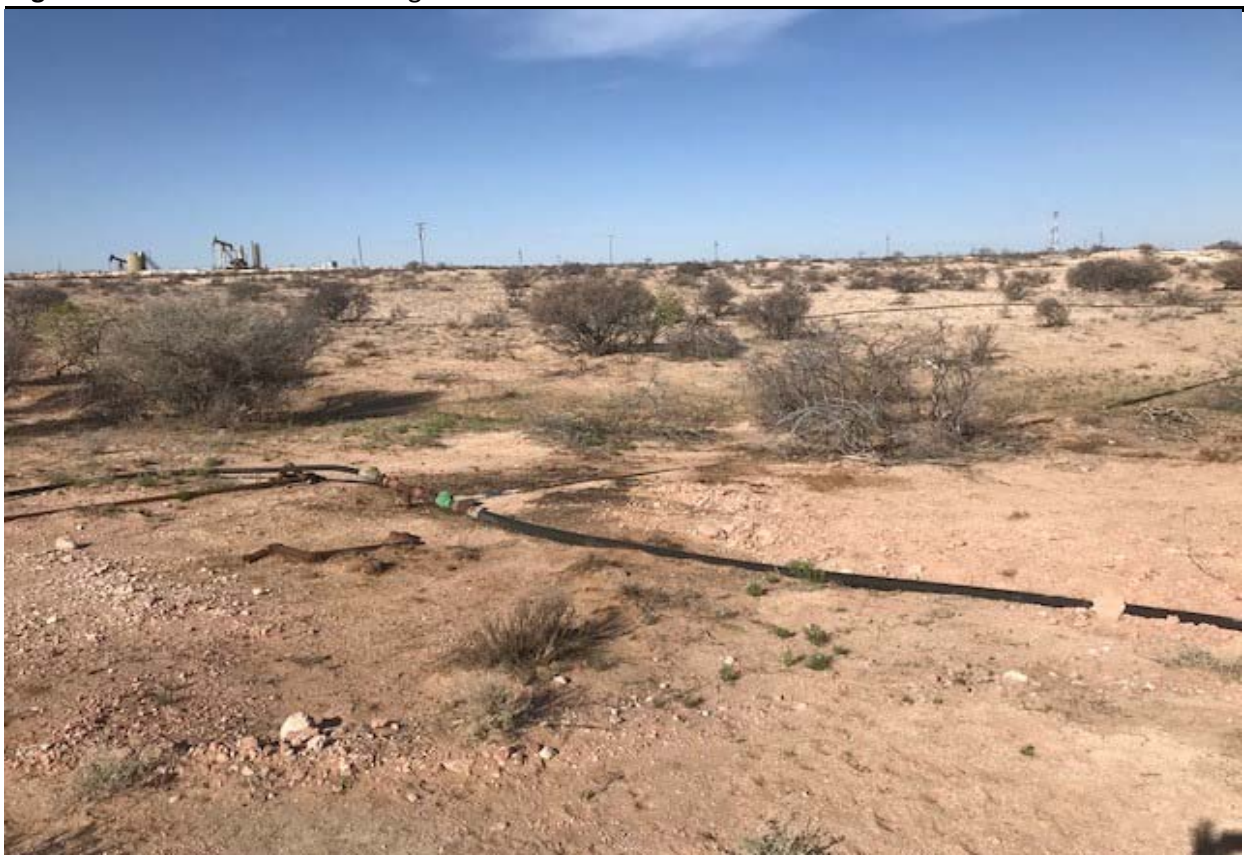
Figure 4 - View of surface staining from the initial release.

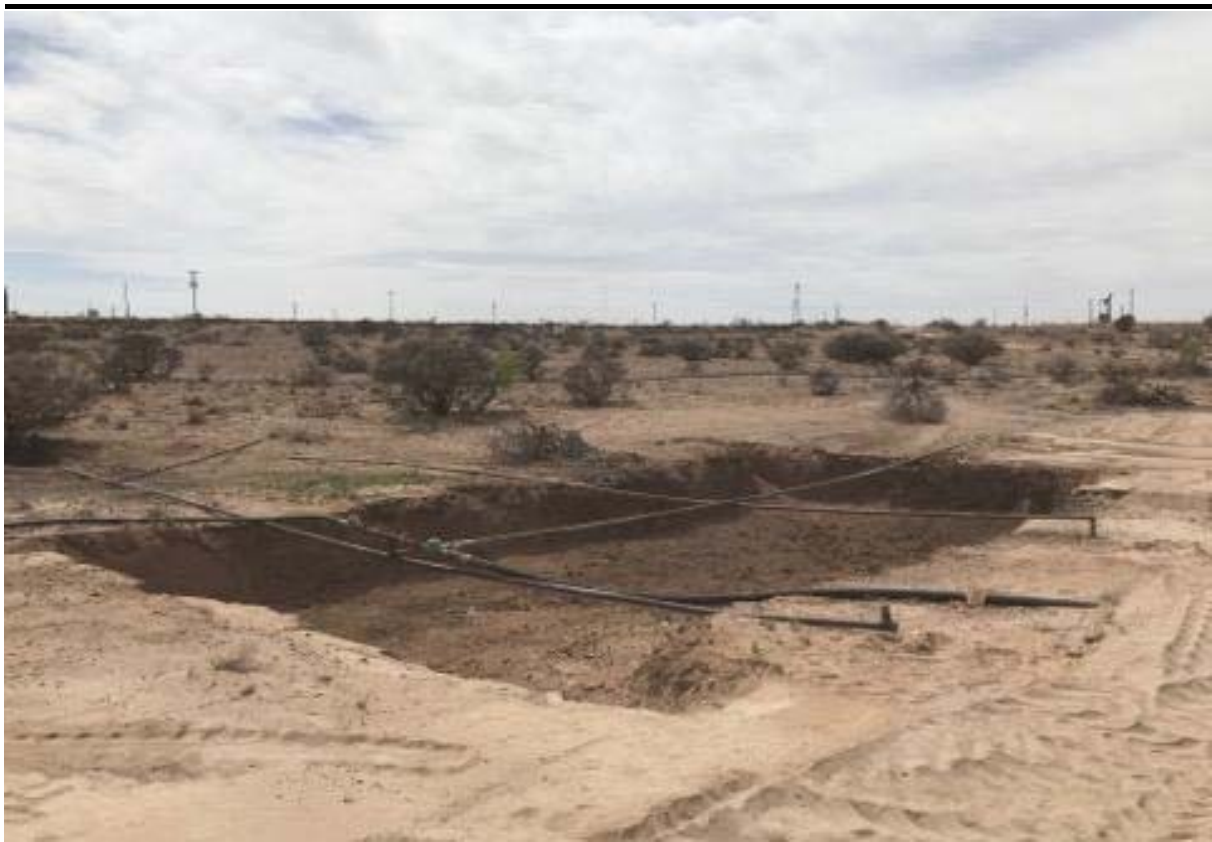
Figure 5 - View of portion of the excavated area.

As per the approved *Workplan*, impacted soil in the areas represented by test trenches T1 and T3 were excavated to a depth of approximately four (4) feet bgs and 20-millimeter polyurethane liners were installed in the bottom of the excavations. This engineering control is designed to inhibit the vertical migration of contaminants left in-situ. Impacted soil in the areas represented by test trenches T2 and T4 were excavated to a depth of approximately one (1) foot bgs. Impacted soil in the area represented by test trench T5 was excavated to a depth of approximately two (2) feet bgs. In accordance with the stipulation of the approved *Workplan*, an additional sample (T-3b@14') was taken from the area represented by test trench T3 and was submitted to the laboratory for analysis of TPH. Excavated soil was transported to an NMOCD-approved disposal facility and the excavations were backfilled with locally sourced, non-impacted "like" material. A table summarizing laboratory analytical results from confirmation soil samples is provided below:

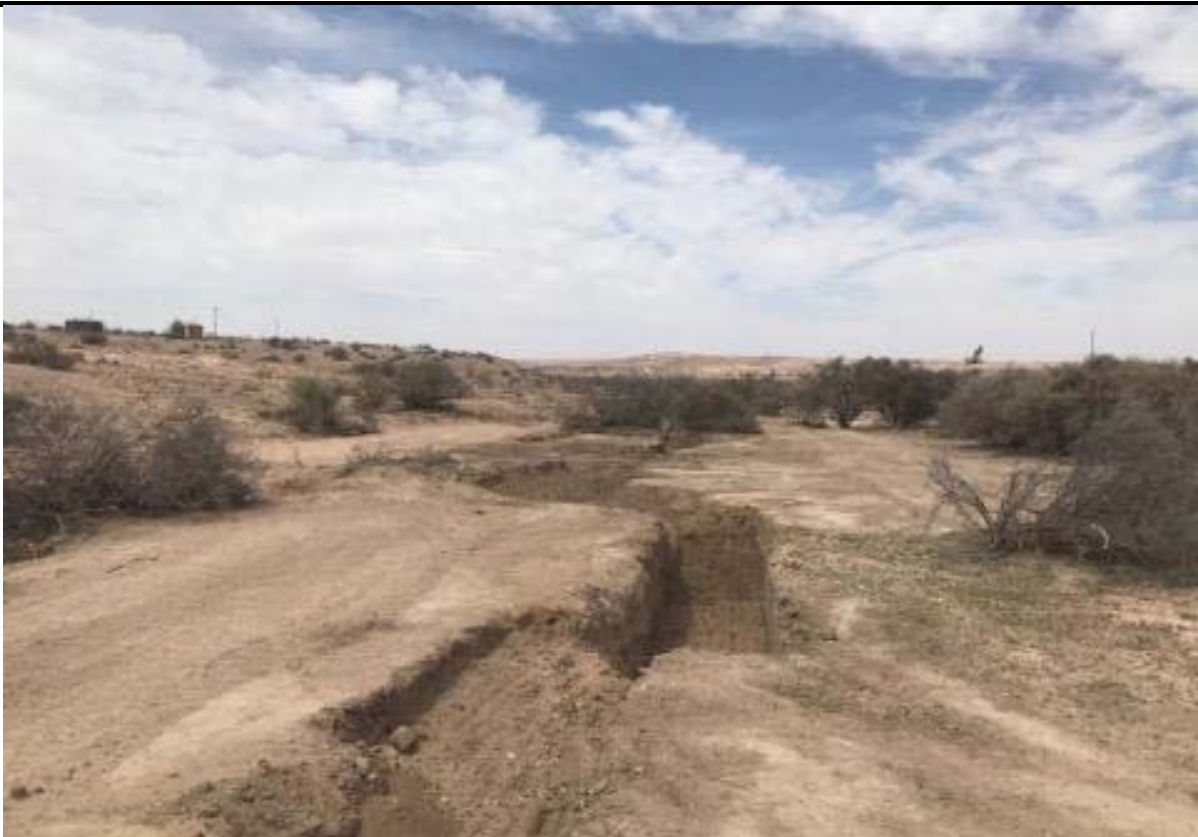
Figure 6 - View of portion of the excavated area.

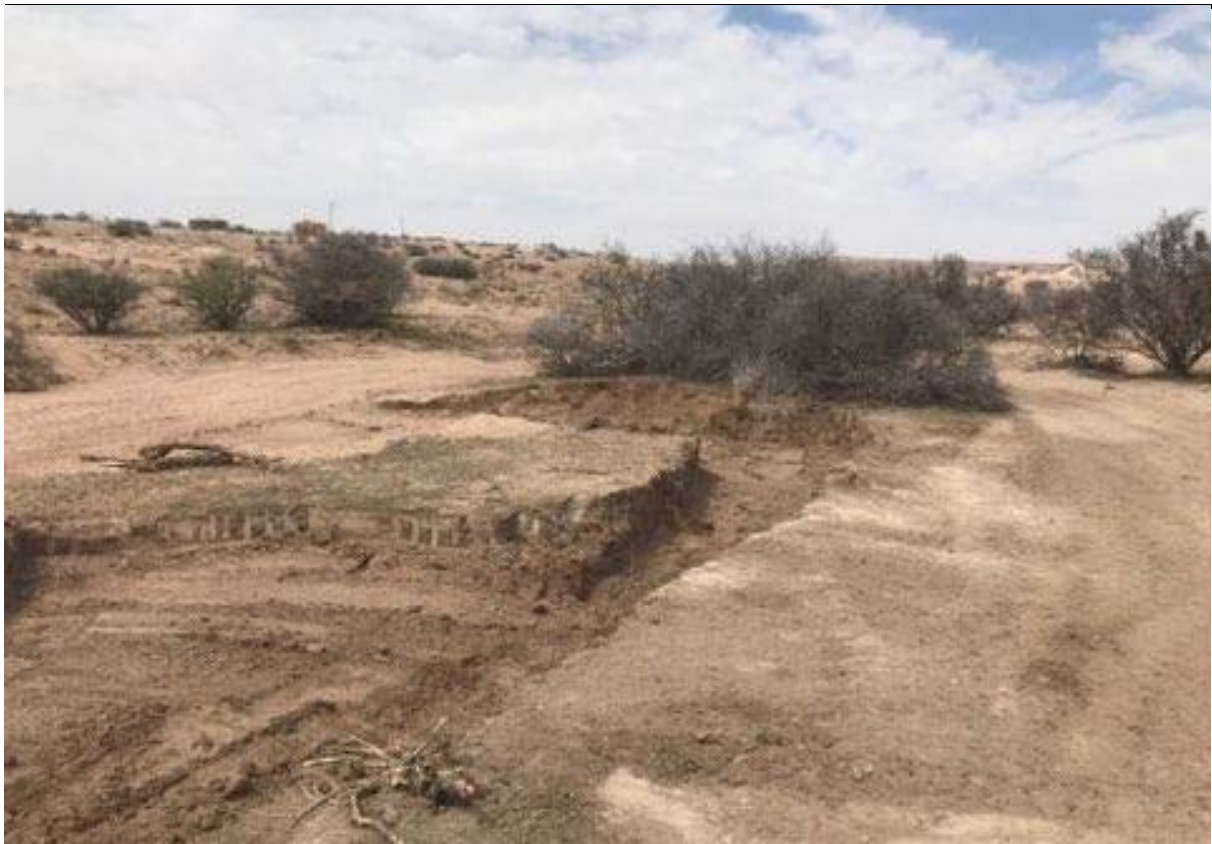
Figure 7 - View of portion of the excavated area.

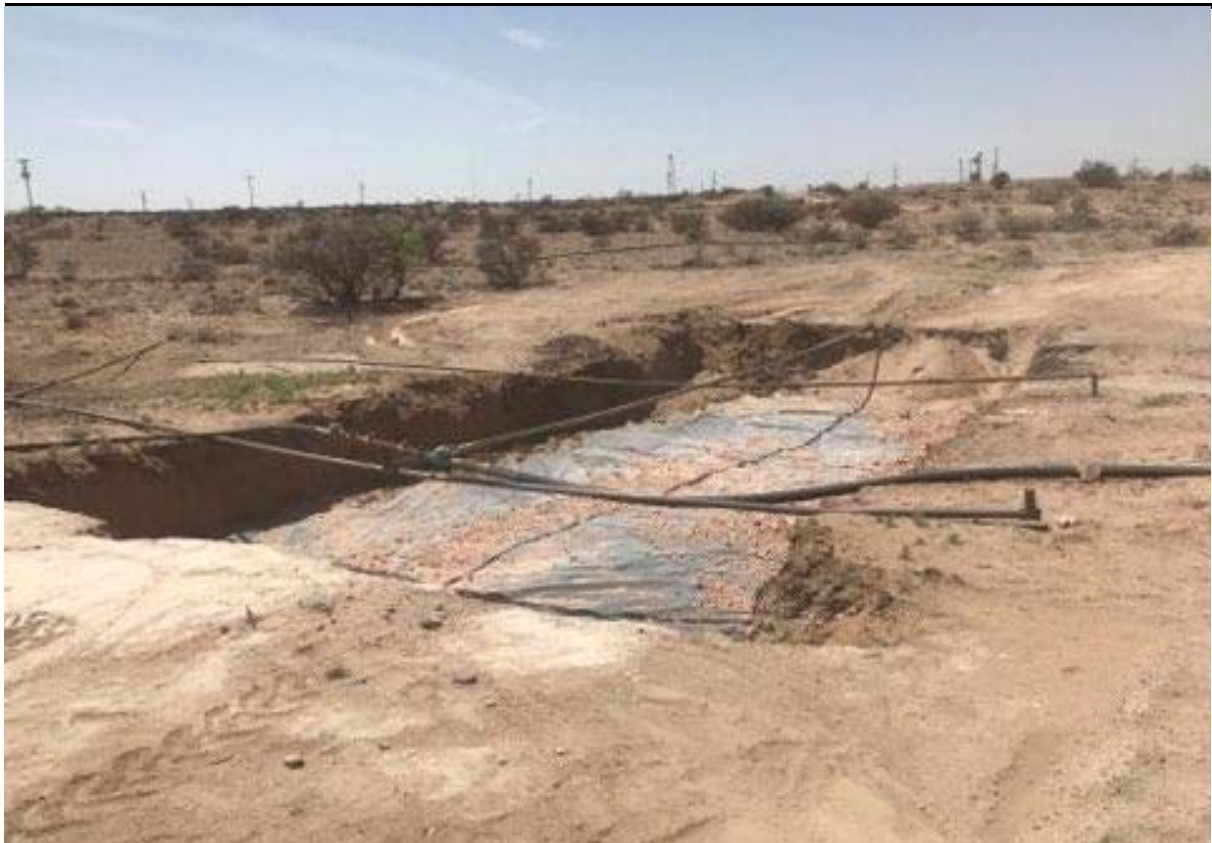
Figure 8 - View of portion of the excavated area and liner installation.

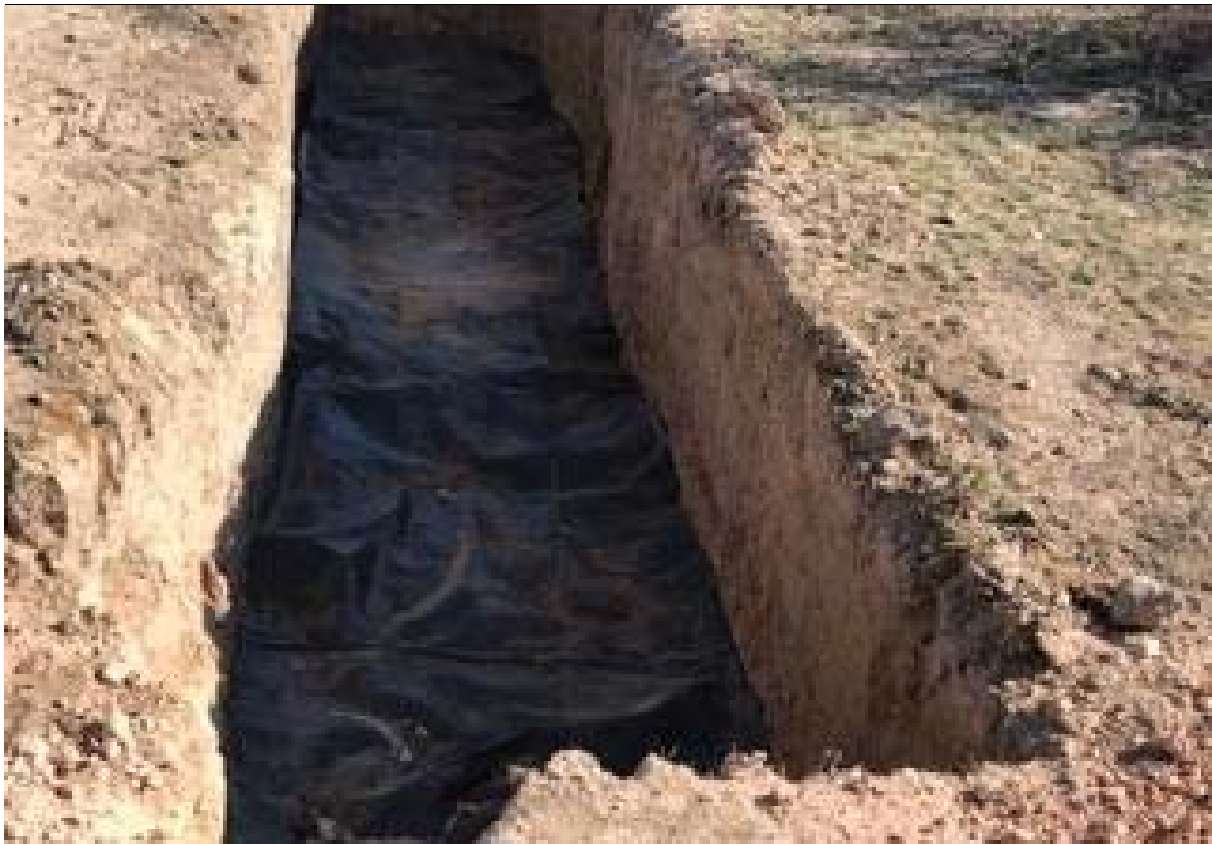
Figure 9 - View of portion of the excavated area and liner installation.

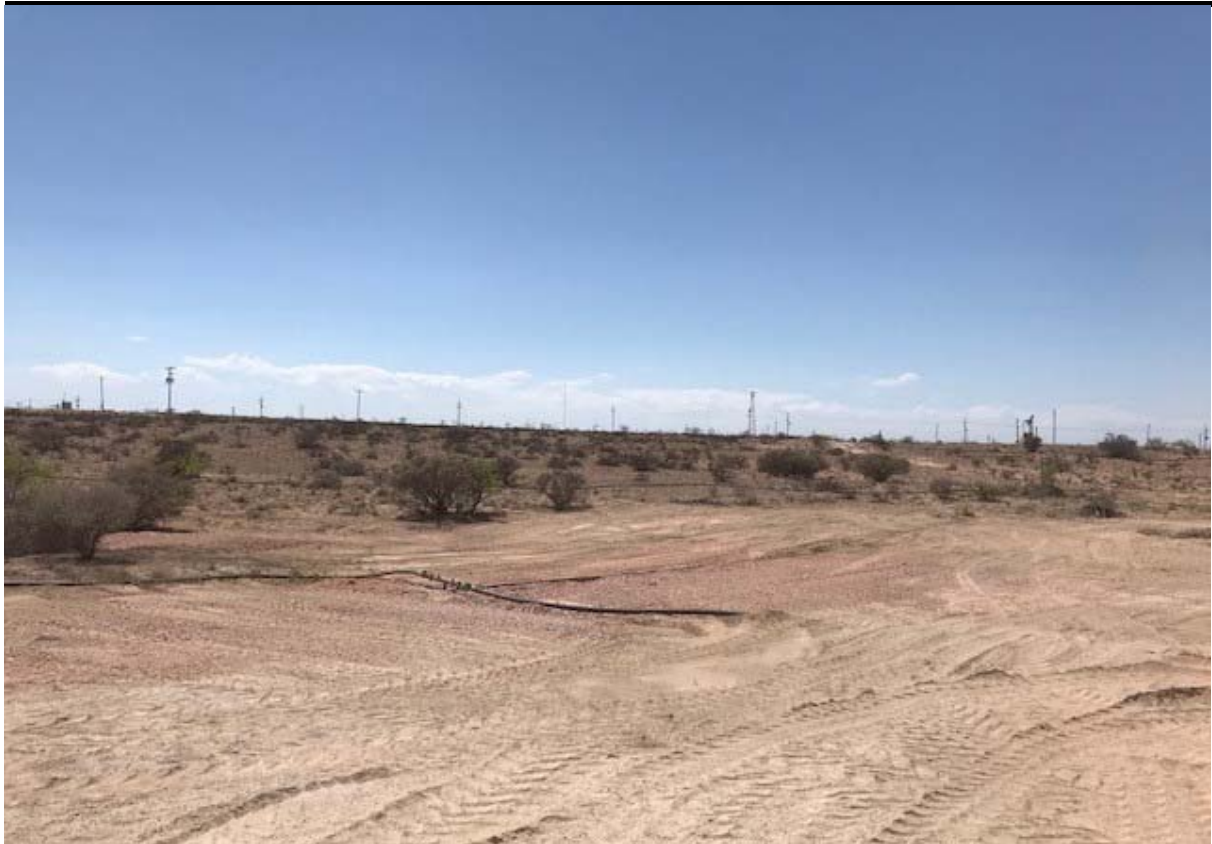
Figure 10 - View of affected area after remediation activities.

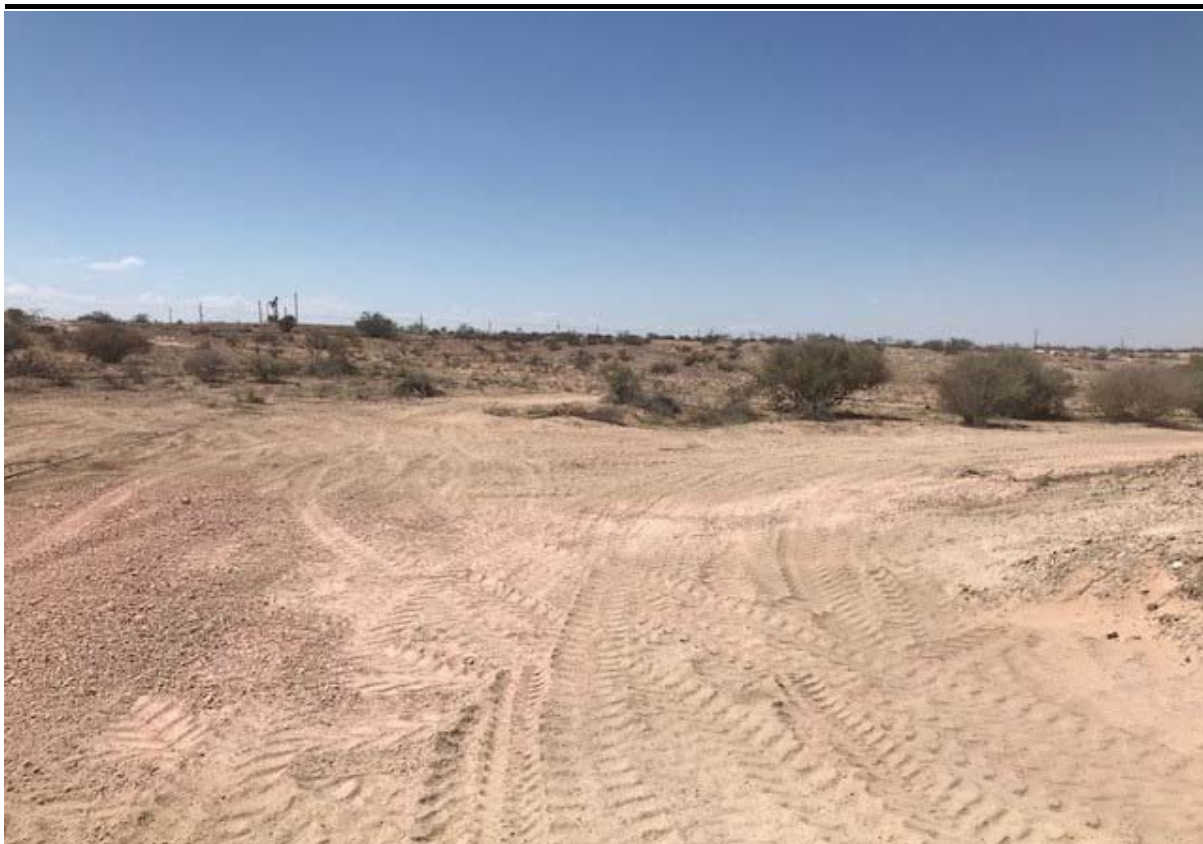
Figure 11 - View of affected area after remediation activities.

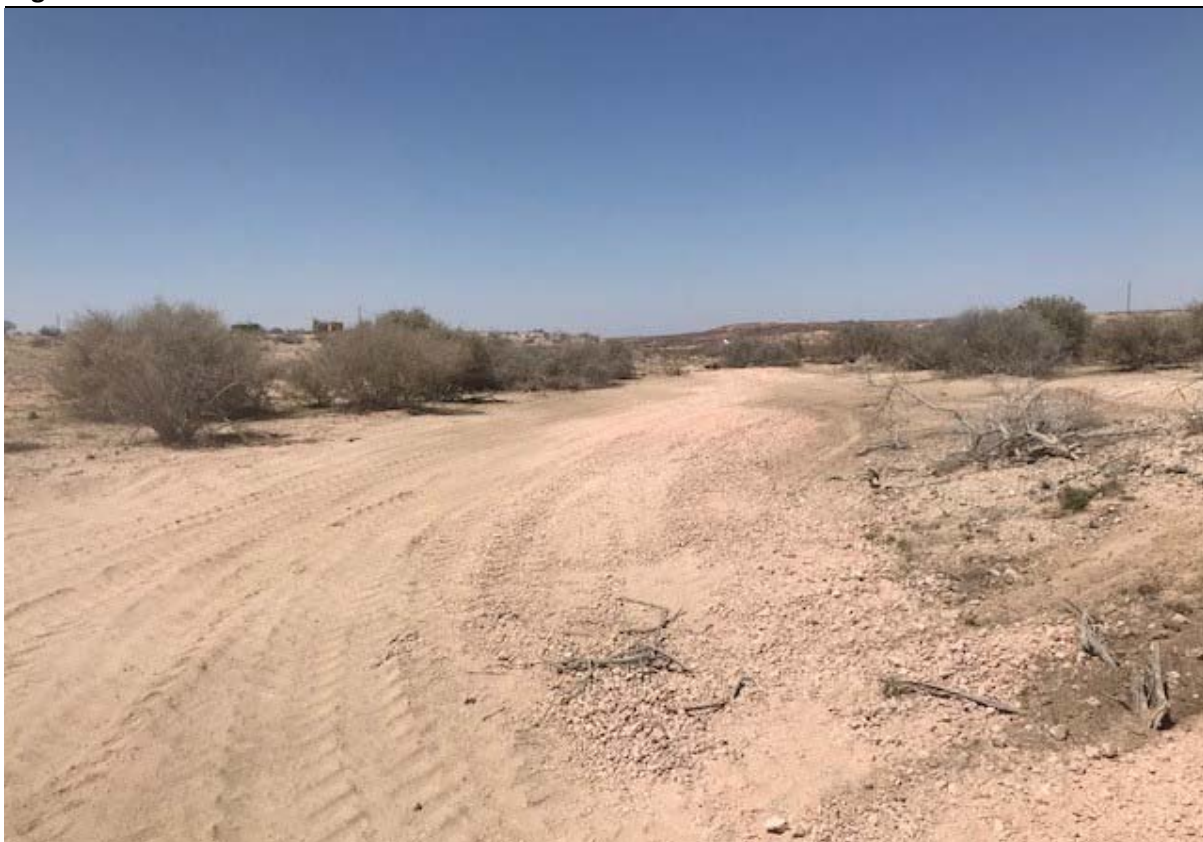
Figure 12 - View of affected area after remediation activities.

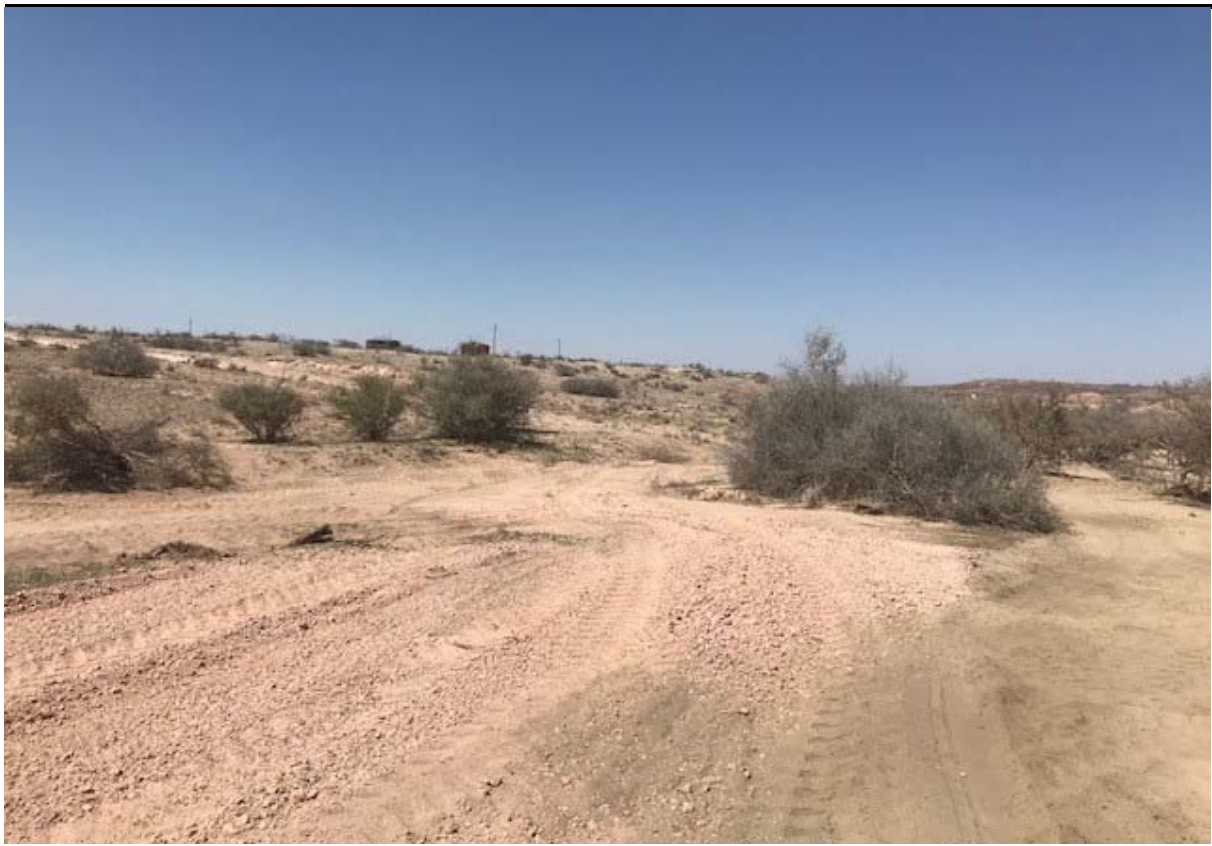
Figure 13 - View of affected area after remediation activities.
