Re: Kleeman PB Battery  
30-015-00253  
Section 26, T18S-R26E  
Eddy County, New Mexico  
2RP-4422

EOG Y Resources, Inc. is submitting the enclosed remediation work plan for the above referenced site. The plan is being submitted accompanying the C-141 report dated on September 28, 2017

**Kleeman PB Battery  
Remediation Work Plan  
Section 26, T18S-R26E  
Eddy County, New Mexico  
August 21, 2018  
2RP-4422**

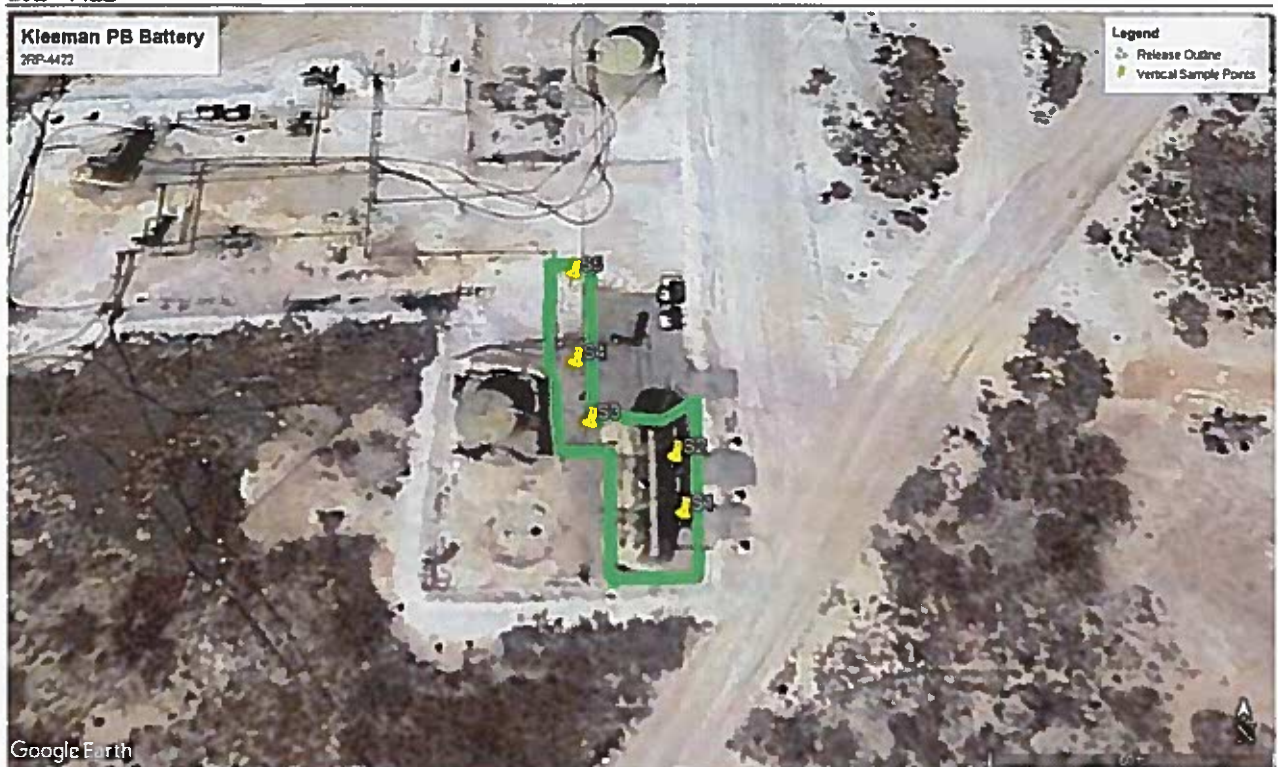
# Figure 1

## Site Map with Vertical Sample Points

Figure 1: Site Map with Vertical Sample Points

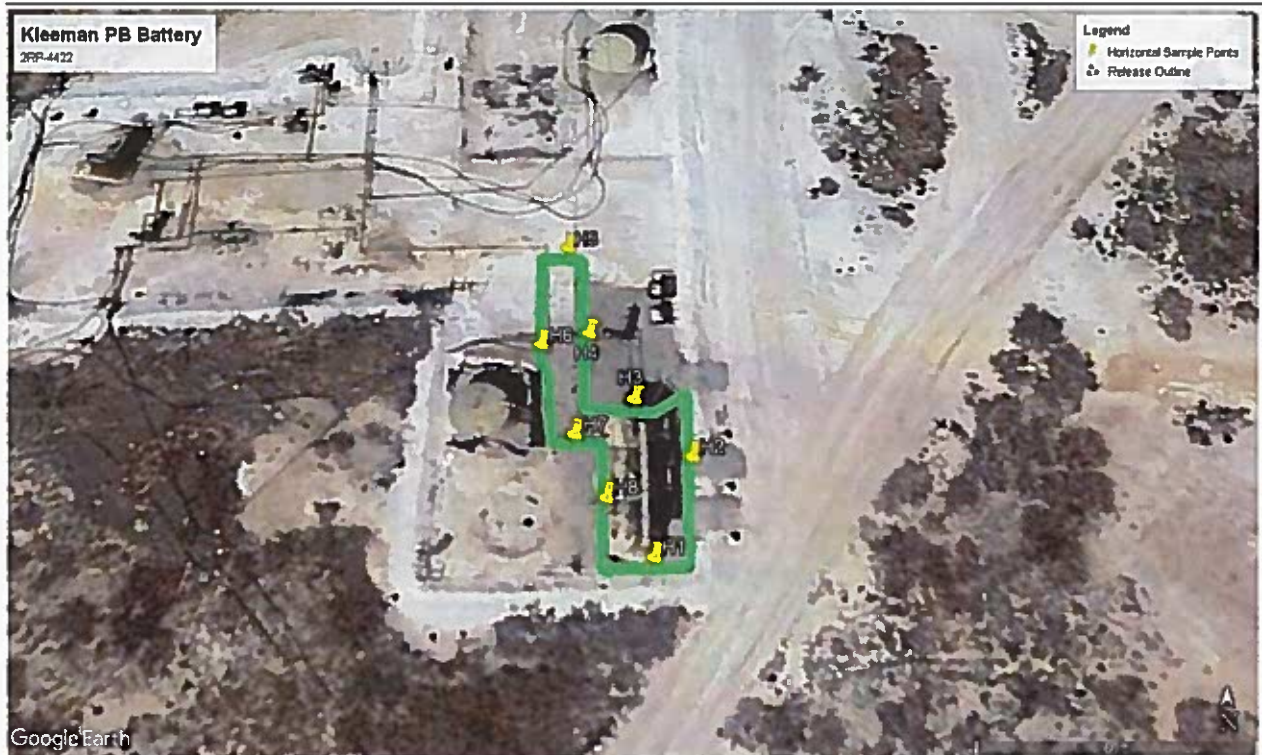
# Figure 2

## Site Map with Horizontal Sample Points

Figure 2: Site Map with Horizontal Sample Points
