SUBJECT: Remediation Closure Report for the Red Light State Com 23 26 27 WA 15H Release (2RP-4764), Eddy County, New Mexico

Vicinity and Well Head Protection Map  
 Red Light State Com 23 26 27 WA 15H - Marathon  
 S 27-T23S-R26E, New Mexico

Site and Sample Location Map  
 Red Light State Com 23 26 27 WA 15H - Marathon  
 S 27-T23S-R26E, New Mexico

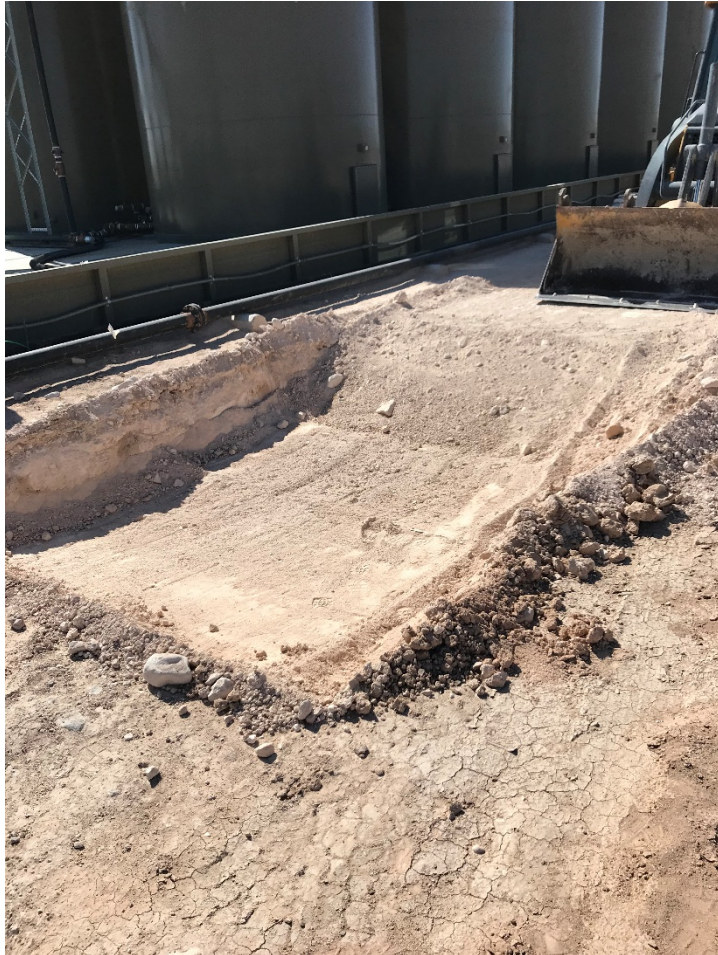
Photo Taken August 29, 2018

Facing Southeast

32.281755, -104.275553

Contaminated soils were removed and replaced with clean backfill material to return the surface to previous contours. The contaminated soil was transported and disposed of at R360 near Hobbs, NM, an NMOCD permitted disposal facility.

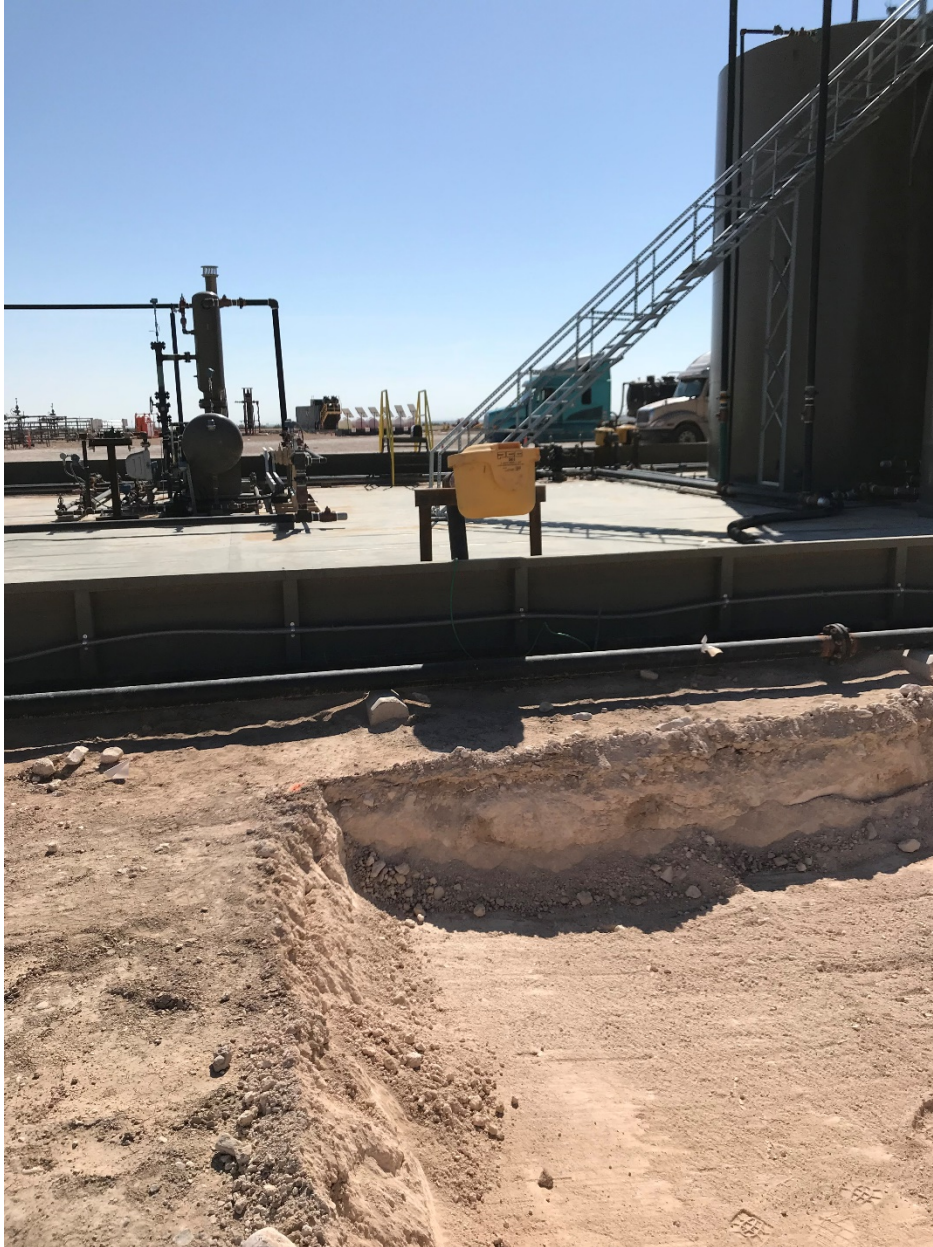
Photo Taken August 29, 2018

Facing East

32.281772, -104.275571
