Holly Energy Partners

Pump Colgate Osage Lease

Work Plan

2RP-4947

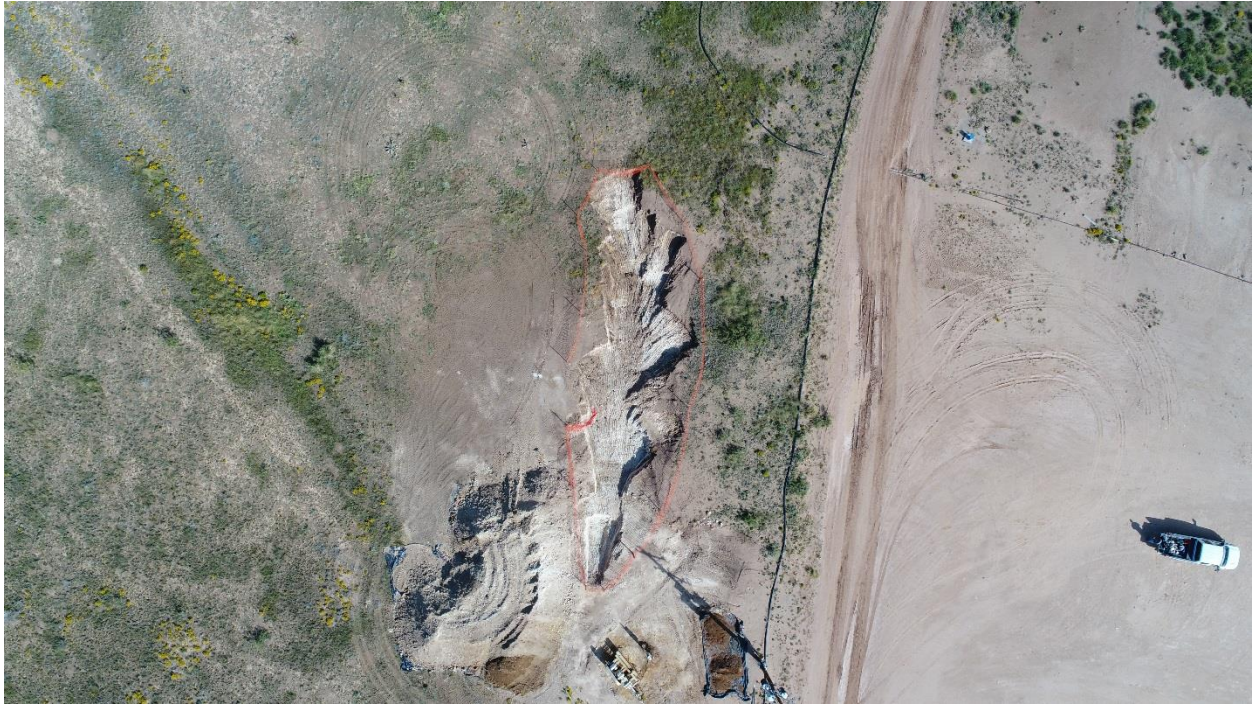
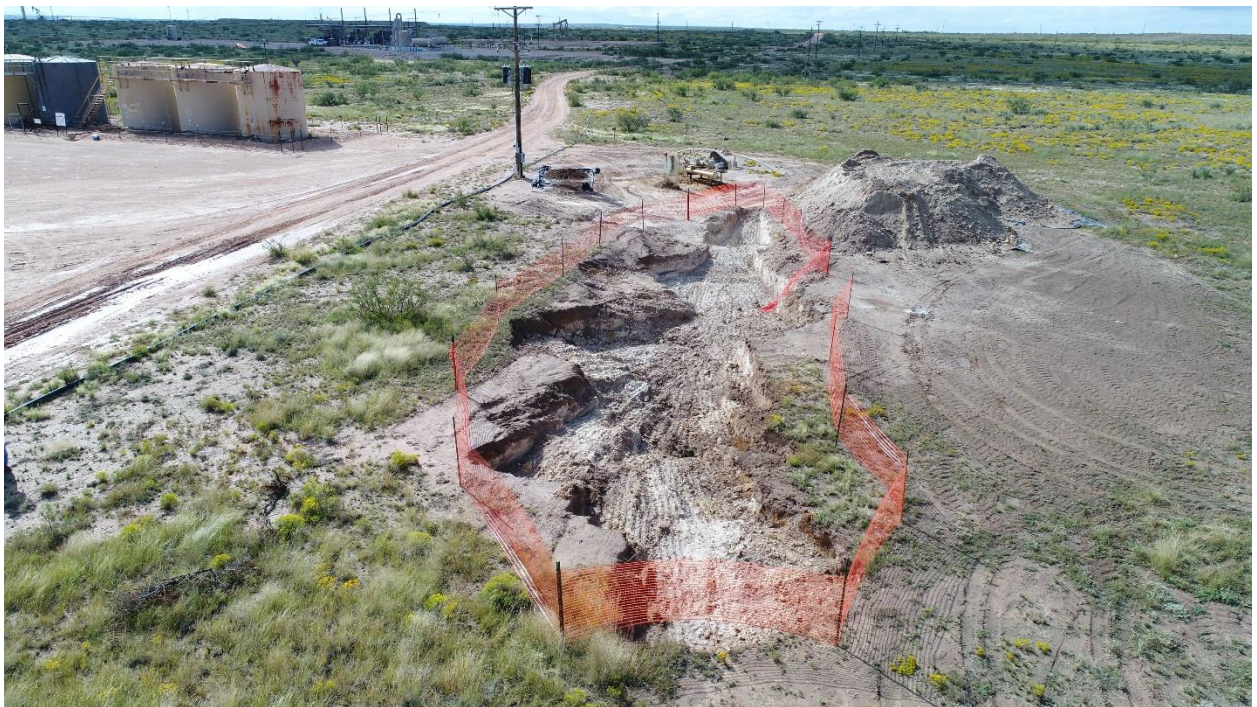
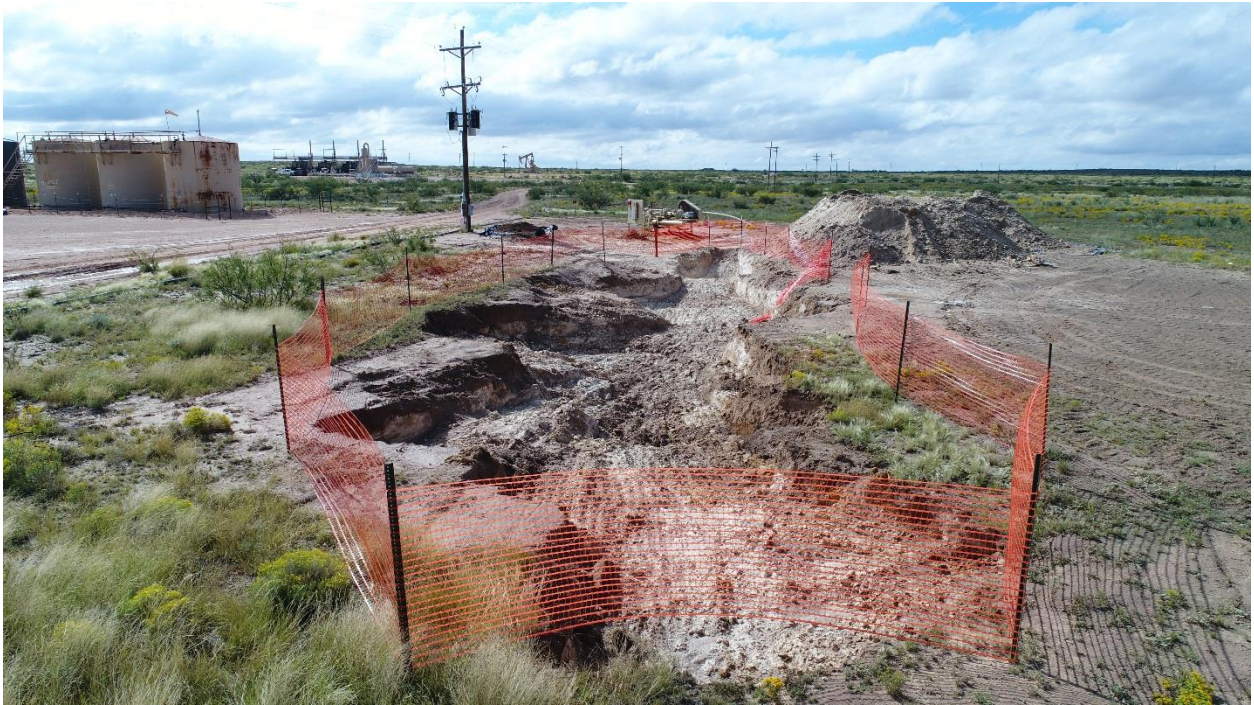
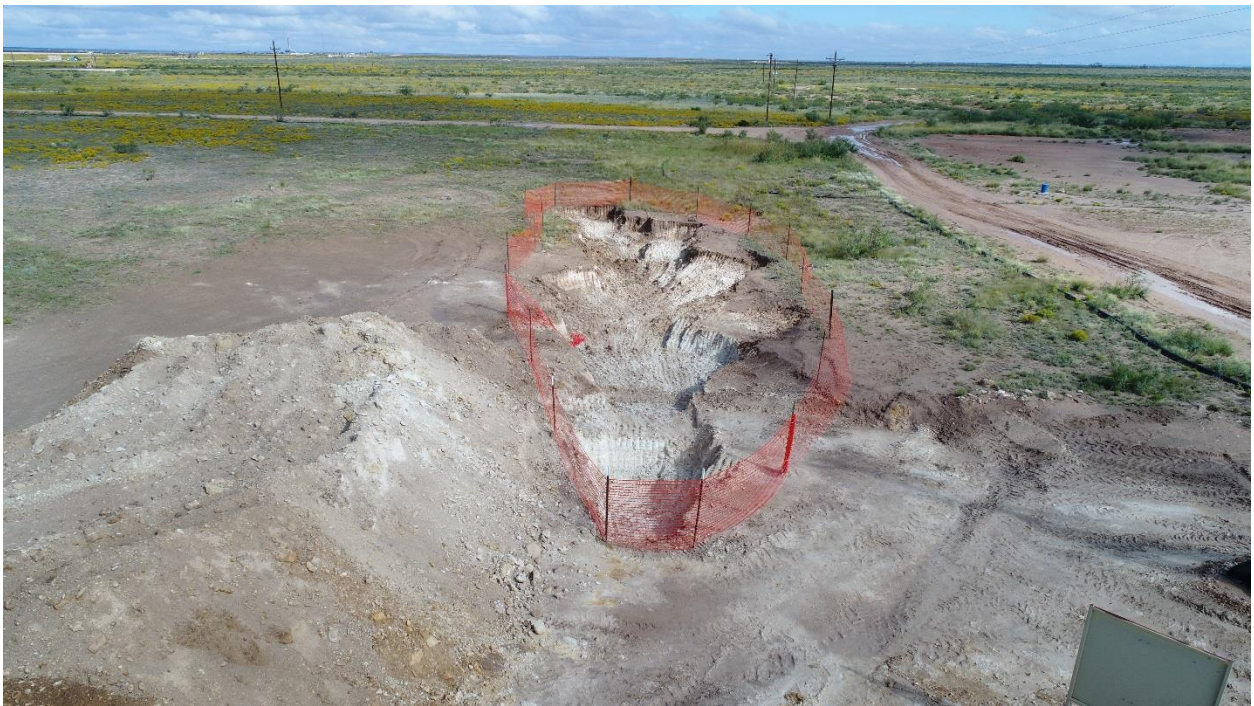
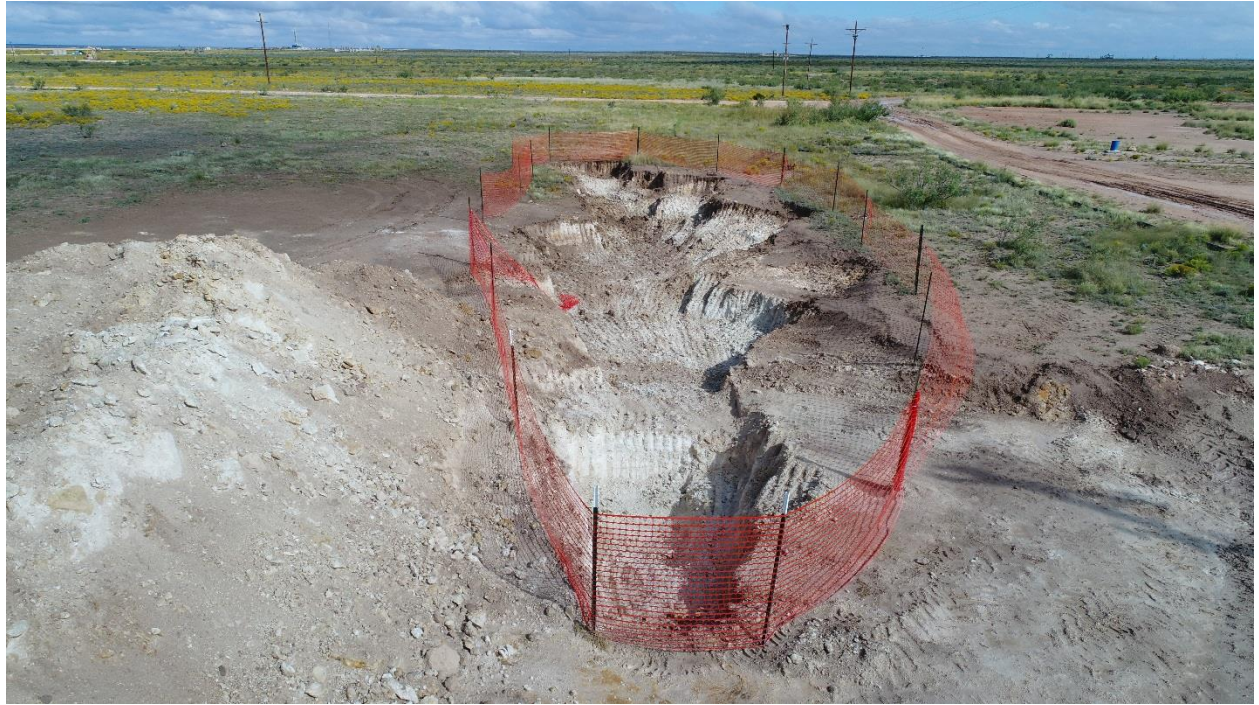
Site Photos

Holly Energy Partners
Pump Colgate Osage Lease
Drone Photos-9/21/2018

On September 21, 2018, SESI personnel was onsite at the HEP Colgate Osage Lease release to obtain confirmation soil samples. HEP personnel had excavated contaminated soils to a depth of four feet in preparation of the confirmation sampling. SESI personnel obtained two bottom soil samples and one sample a piece from the North, South, East and West walls. The excavation and sample points were mapped using the Juno 3B. Site photos were taken of the excavation along with aerial photos using the drone. The sample points were mapped using the Juno 3B. The samples were properly packaged, preserved and transported to Cardinal Laboratories of Hobbs, NM by chain of custody, and analyzed for TPH(total petroleum hydrocarbons)(Method 8015M), BTEX, and Chlorides(Method 4500). The results are presented in the table below:
