Holly Energy Partners

Pump Colgate Osage Lease

Closure

2RP-4947

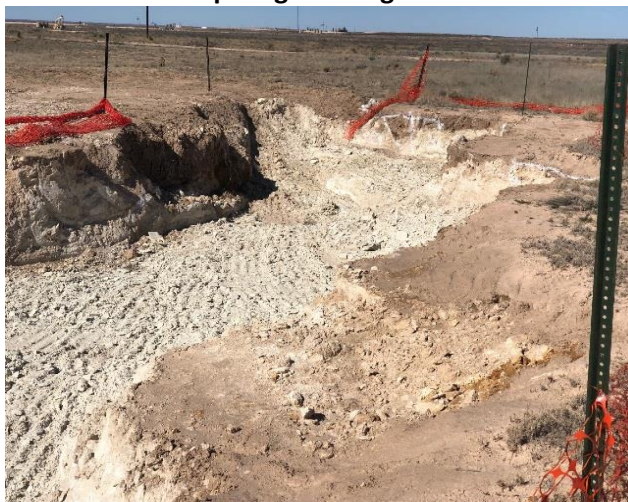
Additional excavation N. Wall 1-28-19

On January 28, and 29, 2019, SESI personnel together with equipment and operator from B & B Construction revisited the site to further delineate and excavate as per the NMOCD conditions for closure (photo documentation).

The Bottom of the previously excavated area was excavated an additional 1' bgs., and field tested. Further excavation and delineation of the North wall was also conducted until field results for TPH were at or below 100 mg/kg. All soil samples were properly packaged, preserved and transported to Cardinal Laboratories of Hobbs, NM by chain of custody, and analyzed for TPH(total petroleum hydrocarbons)(Method 8015M). The results are recapped in the table below:

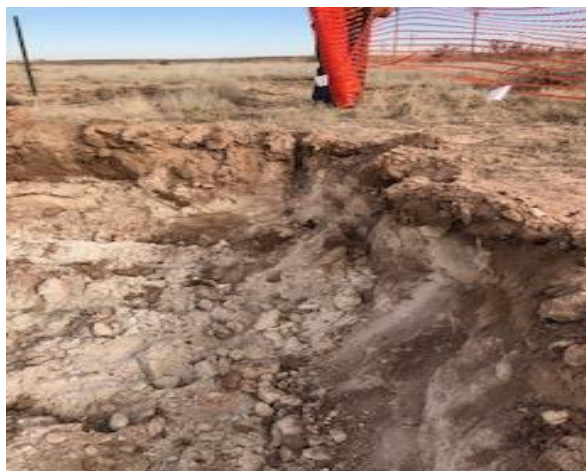
Additional Excavation W. Wall 1-29-19

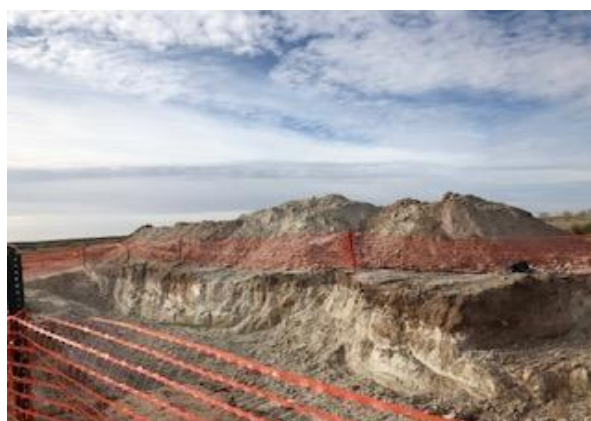
Stockpile 1-29-19

Due to all sampling results indicating that the excavation removed all impacted soil in excess of 100 ppm, HEP requests that upon closure approval the excavation be backfilled with similar material, returned to grade, and reseeded in the spring of 2019. All Stockpiled soil will be disposed of at an NMOCD approved facility.
