#5E26784-BG14

SUBJECT: SOIL REMEDIATION CLOSURE REPORT FOR THE POKER LAKE UNIT PLU #041  
RELEASE (2RP-5052), EDDY COUNTY, NEW MEXICO

**Site Photographs**  
**PLU #041 Site Excavation and Remediation**

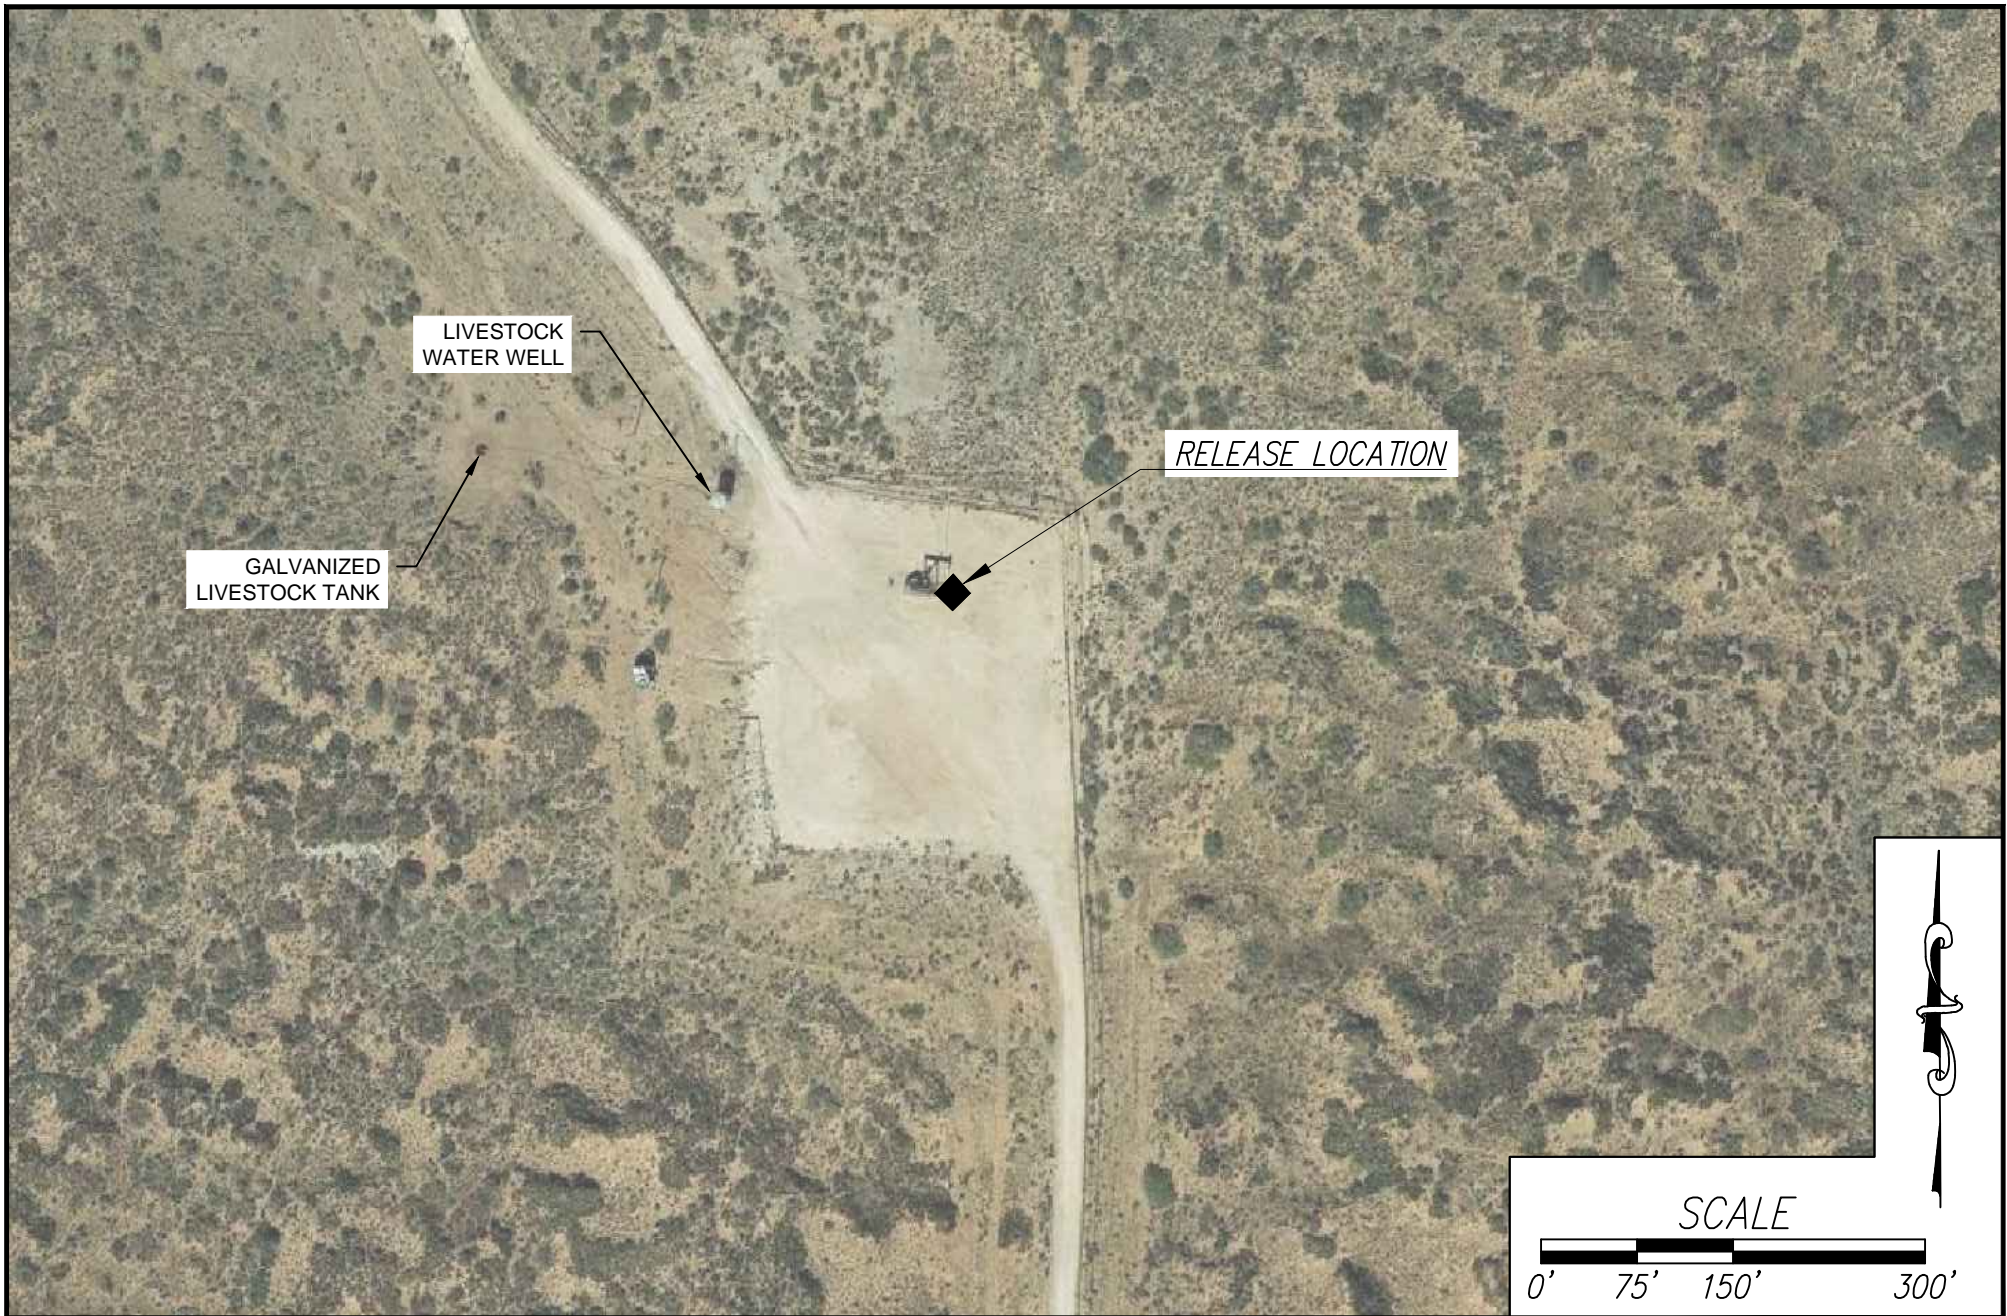
**FIGURE 2**  
**SITE MAP**

The nearest known water source within ½-mile of the location is a livestock watering well (C-03960-POD1), according to the NMOSE online water well database. The livestock watering well pumps water to a nearby stock tank. These features are shown on Figure 2.

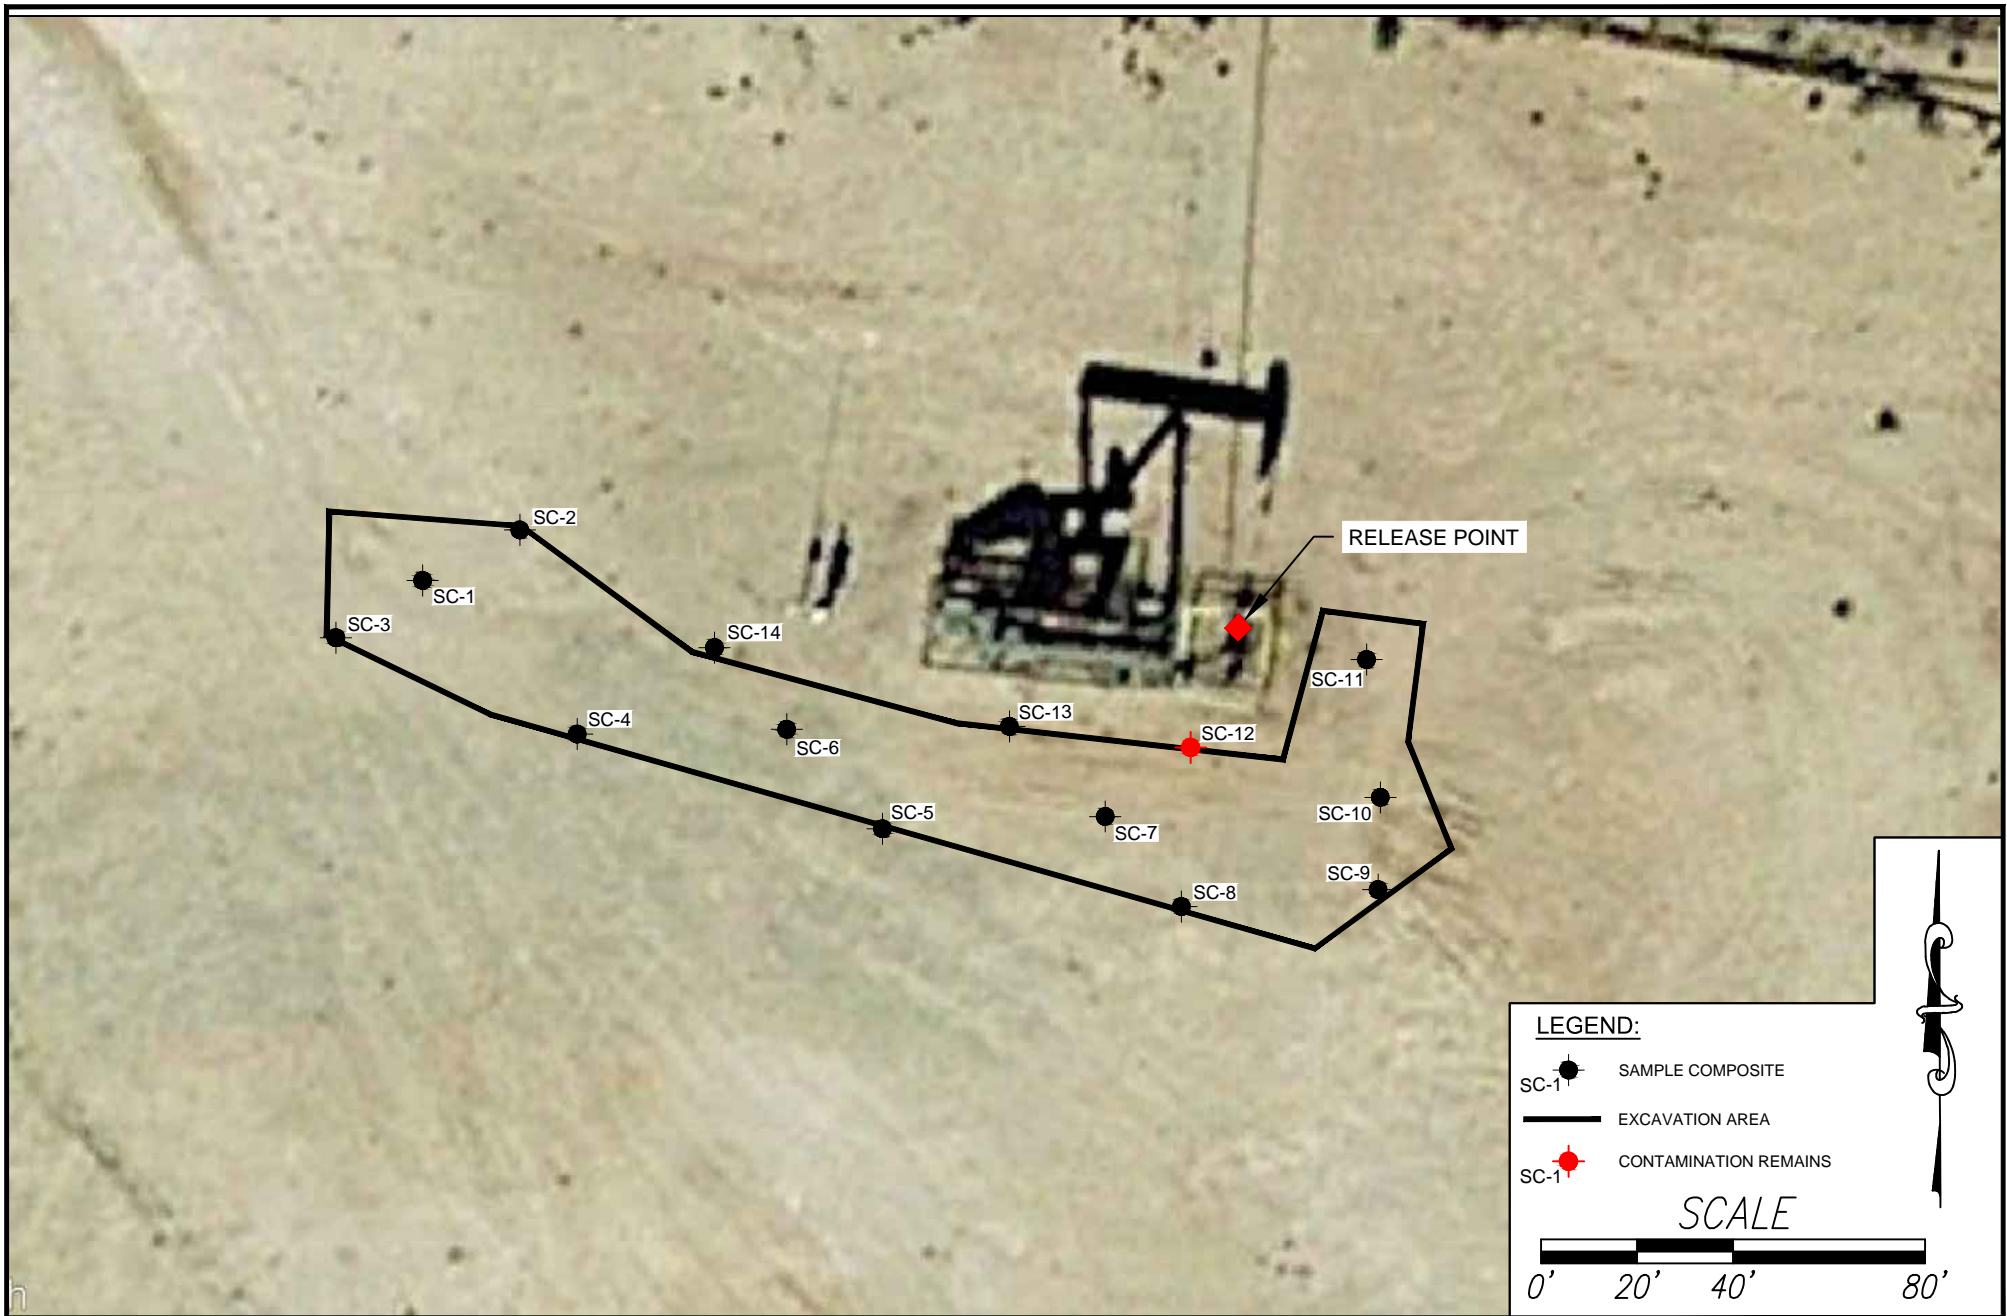
**FIGURE 3**  
**SAMPLE LOCATION MAP**

Laboratory results confirm that contamination was removed from all locations, with the exception of SC-12, which remains above the closure level for chlorides at 1,100 mg/Kg. However, further excavation could not be completed at SC-12 due to its proximity to the pumpjack unit. SMA recommends deferring the area of SC-12 until site plugging and abandonment.

Locations for samples SC-1 through SC-14 are depicted on Figure 3, and a summary of the laboratory results is displayed in Table 3. Laboratory reports are included in Appendix E.

- ☒ Contamination must be in areas immediately under or around production equipment where remediation could cause a major facility deconstruction.  
☒ Extents of contamination must be fully delineated.  
☒ Contamination does not cause an imminent risk to human health, the environment, or groundwater.
- Deferral for sample area SC-12 (Figure 3 of Closure Report).

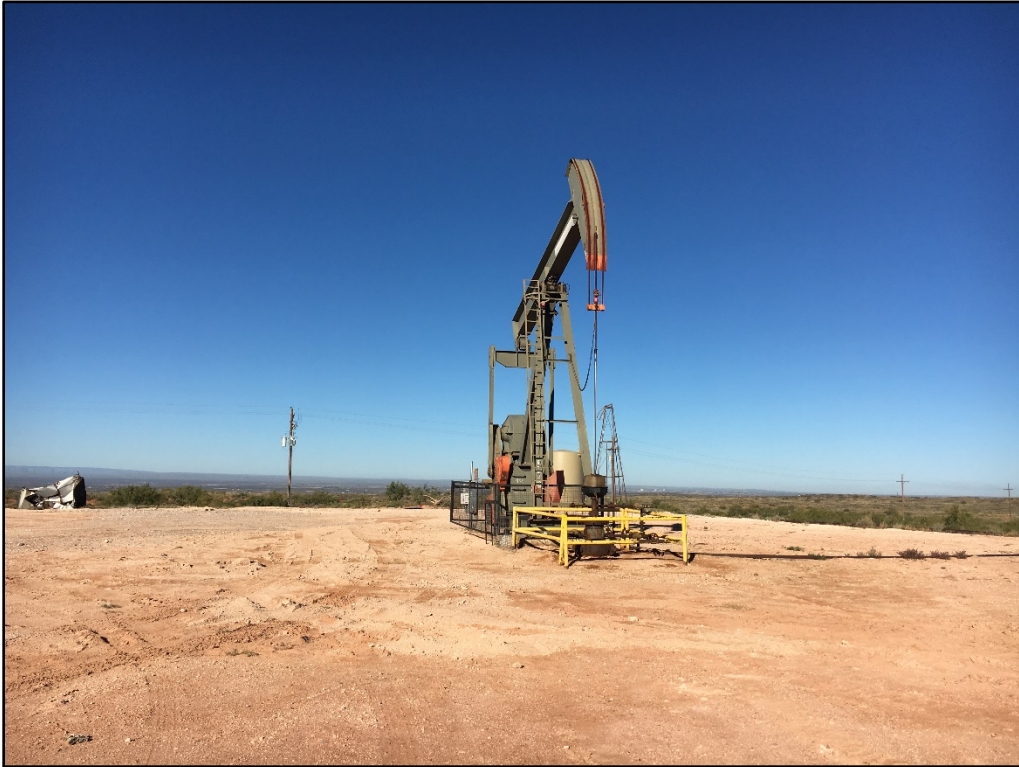
*Photo 1. Pumpjack unit. Impacted soils located left of pumpjack and extending in direction of powerline.*

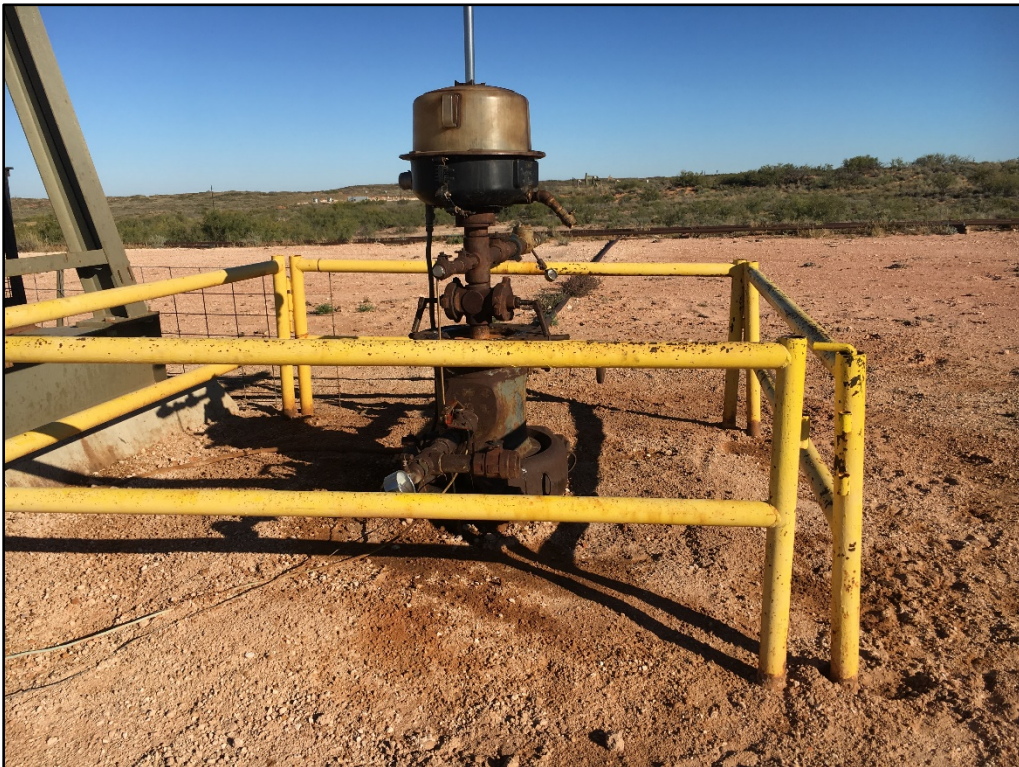
Fluids were released from the well head due to a stuffing box packing failure. A vacuum truck recovered free standing fluids. The packing was replaced and the well was returned to production.

*Photo 2. Source of release.*

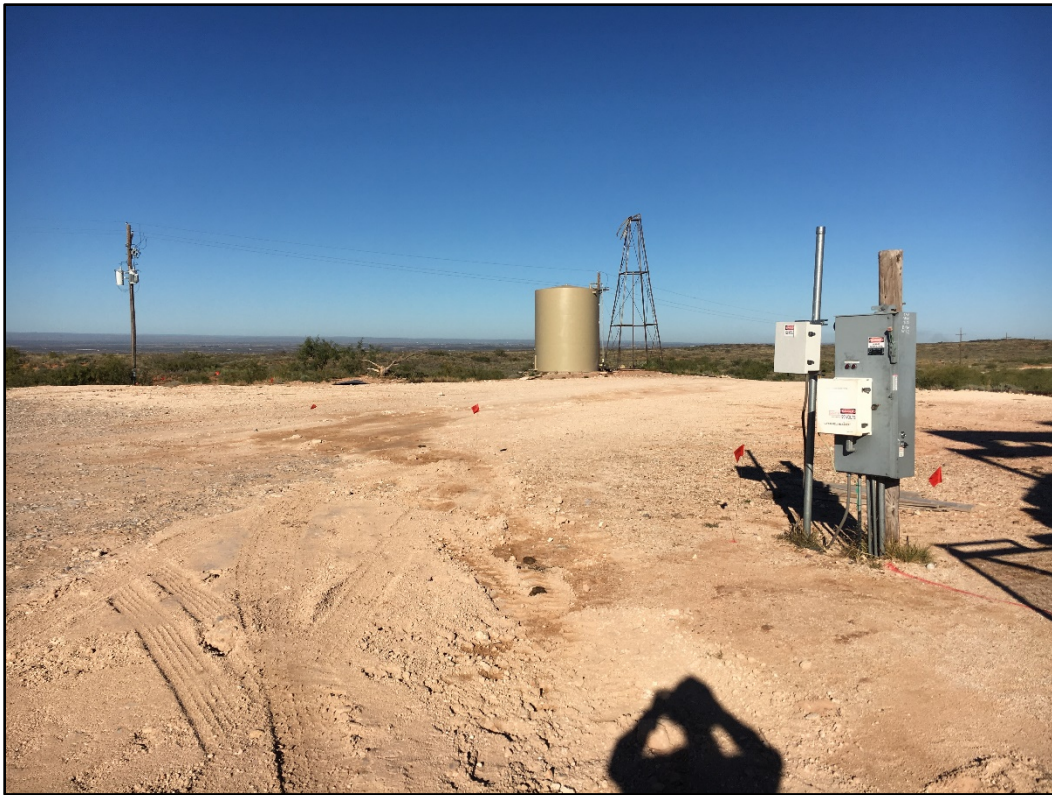
*Photo 3. Impacted soils extending northwest from pumpjack.*

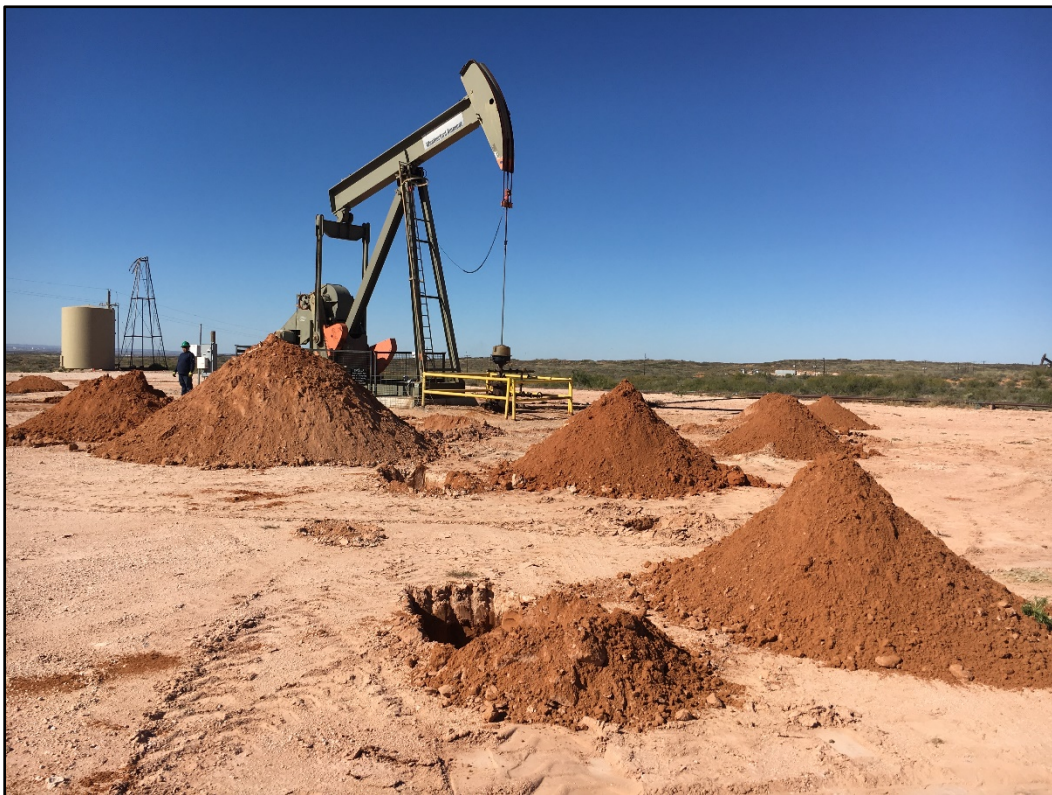
*Photo 4. Delineation activities showing pothole locations.*

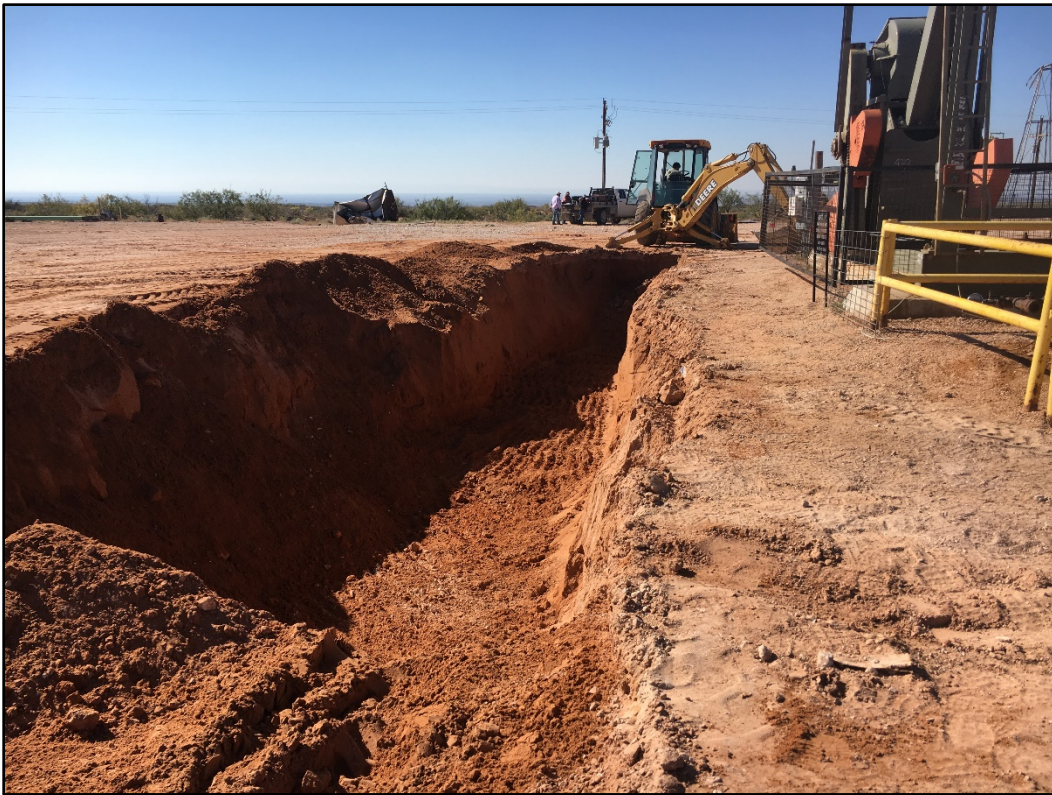
*Photo 5. Beginning excavation adjacent to pumpjack.*

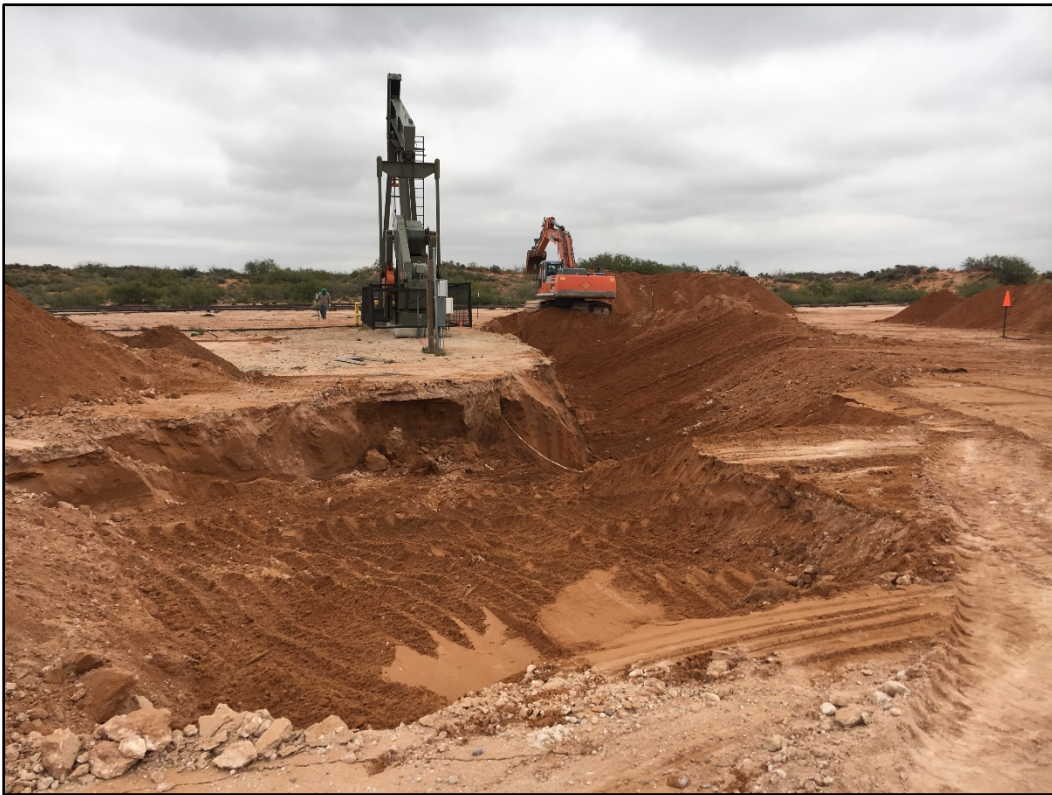
*Photo 6. Excavation activities. Note exposed electrical line in center of photo.*

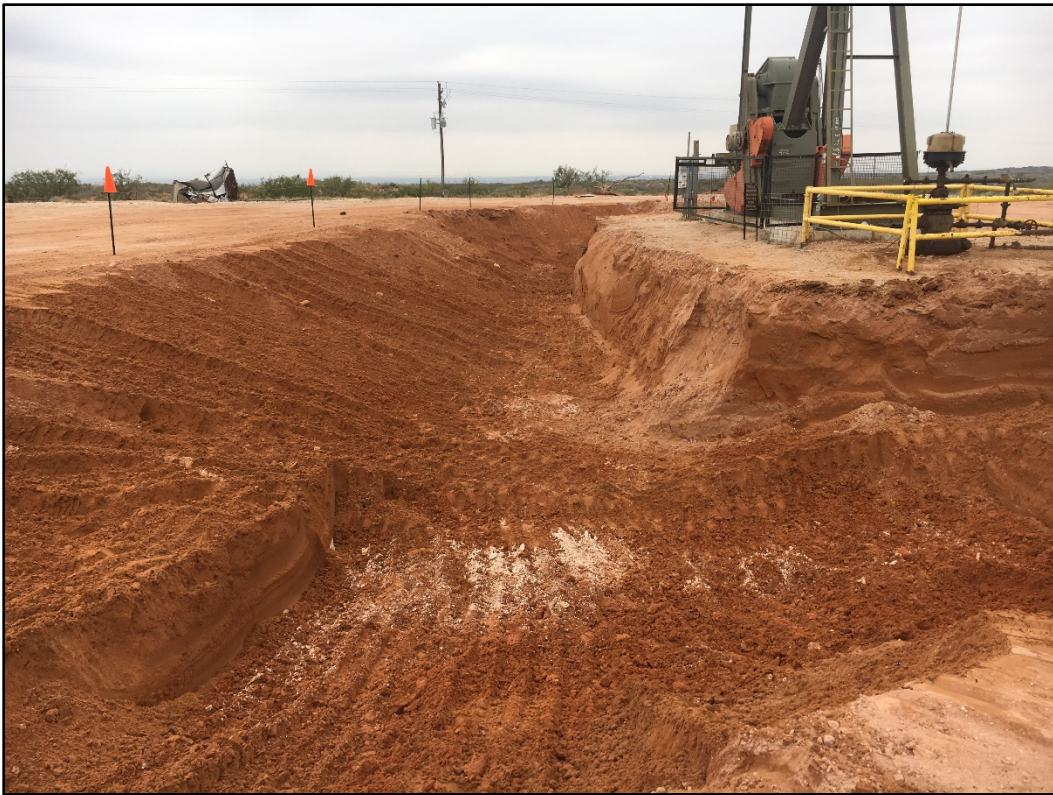
*Photo 7. Excavation area.*

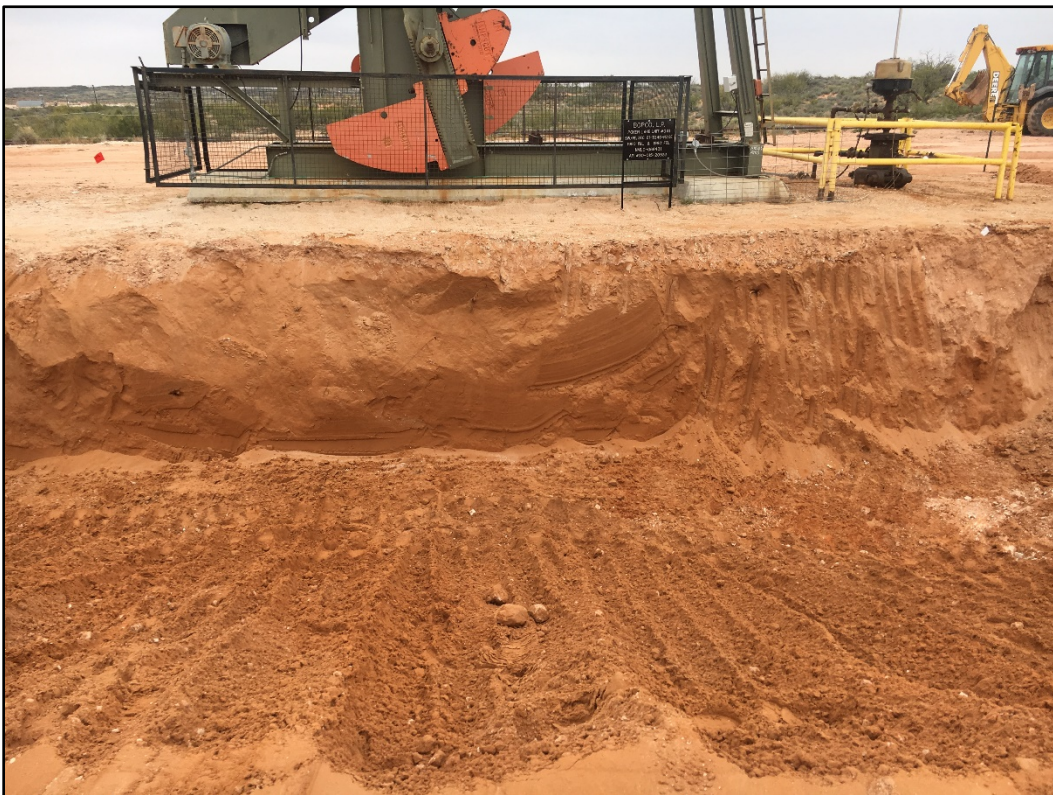
*Photo 8. Scraping the walls for samples SC-12 and SC-13.*

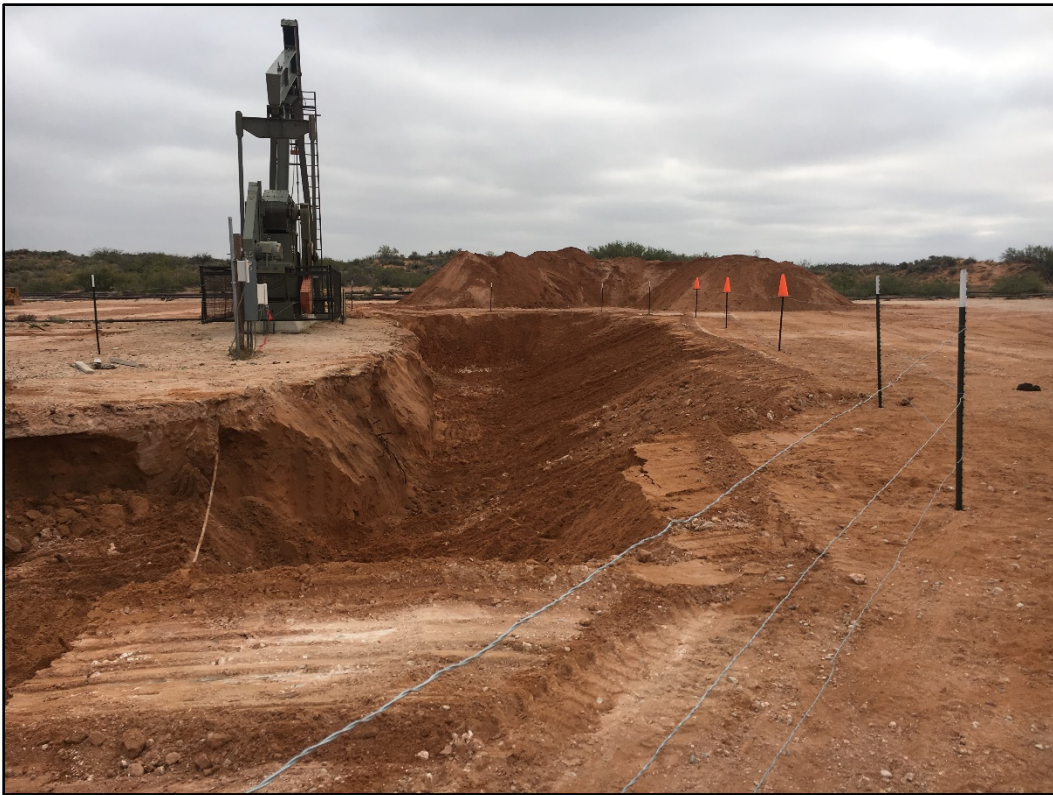
*Photo 9. Excavation secured using 3-wire fencing.*

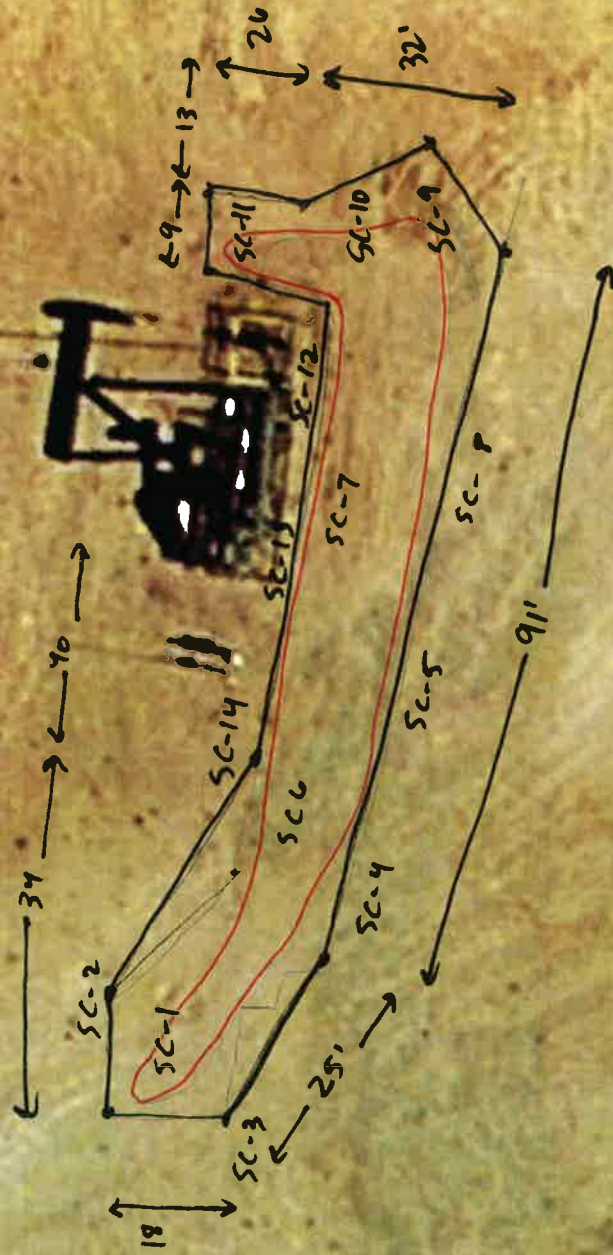
— surface staining  
— excavation area
