Re: Remediation Summary and Permission to Backfill Request COG Patron 23 Federal No. 004H (2RP-4665) GPS: N 32.1217981° W 103.9478047° Unit Letter "A", Section 23, Township 25 South, Range 29 East Eddy County, New Mexico

Introduction

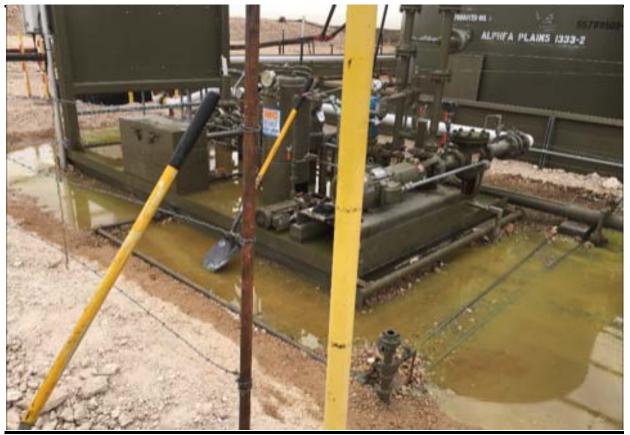
On March 9, 2018, a crude oil release occurred on the LACT unit at the COG Patron 23 Federal No. 004H. The release was attributed to operator error while routine maintenance was being conducted. The initial Release Notification and Corrective Action (Form C-141) indicated approximately five (5) barrels (bbls) of crude oil were released within the earthen containment. During initial response activities, the release site was secured and a vacuum truck was utilized to recover approximately four (4) bbls of free standing crude oil. Upon discovering the release, the NMOCD and (BLM) were notified. Please reference the attached Release Notification and Corrective Action (Form C-141) for additional details.

Figure 1 - View of the initial release, facing Southeast.

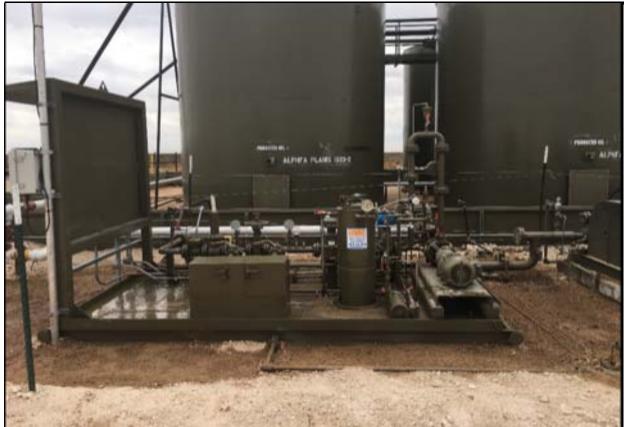
Figure 2 - View of surface staining from the initial release, facing South.

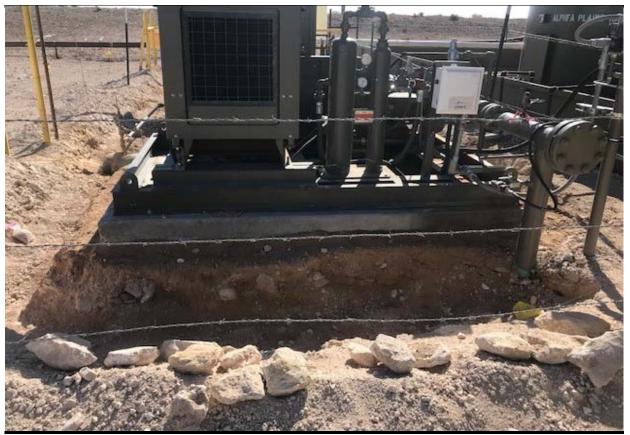
Figure 3 - View of portion of the excavated area, facing East.

Impacted soil in the floor of the excavated area adjacent to the LACT unit affected above the NMOCD RRAL for TPH will be further investigated and/or remediated at time of abandonment (TOA). Plains maintains additional excavation of the hard rock layer poses a risk to human health and safety and may result in equipment damage.

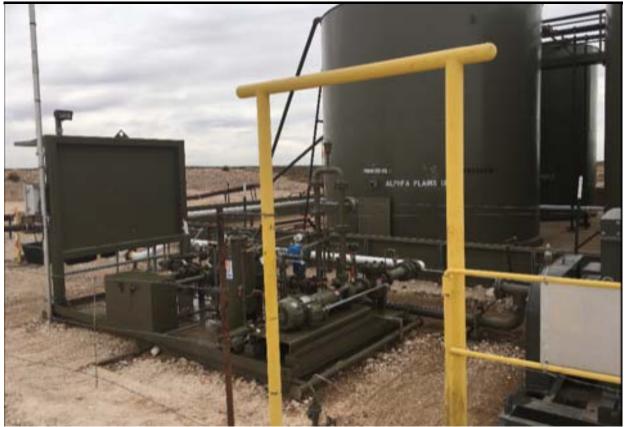
Figure 4 - View of portion of the excavated area, facing Southeast.

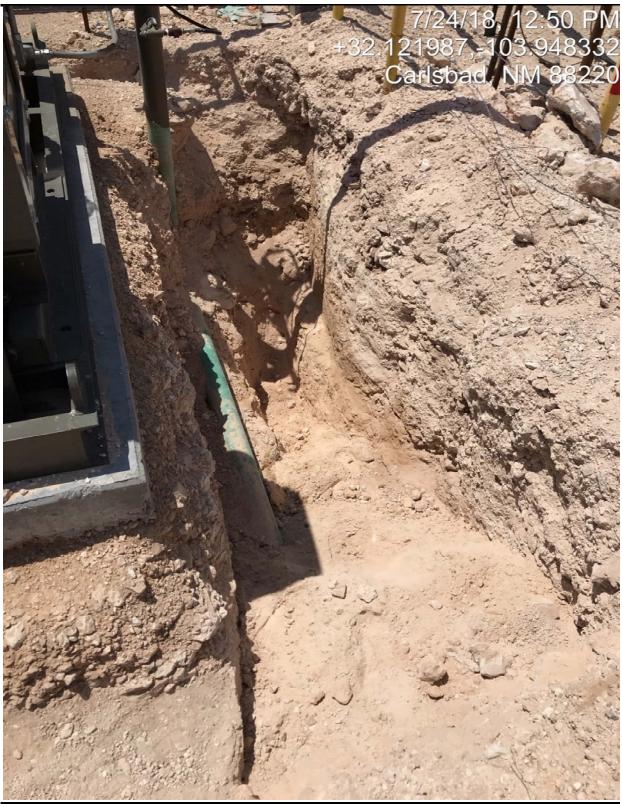
Figure 5 - View of portion of the excavated area, facing South.
