**Report Type: Closure Report**

**2RP-5013**

**Re: Closure Report for the COG Operating, LLC, Big Papi Federal Com #12H, Unit B, Section 04, Township 26 South, Range 29 East, Eddy County, New Mexico. 2RP-5013**

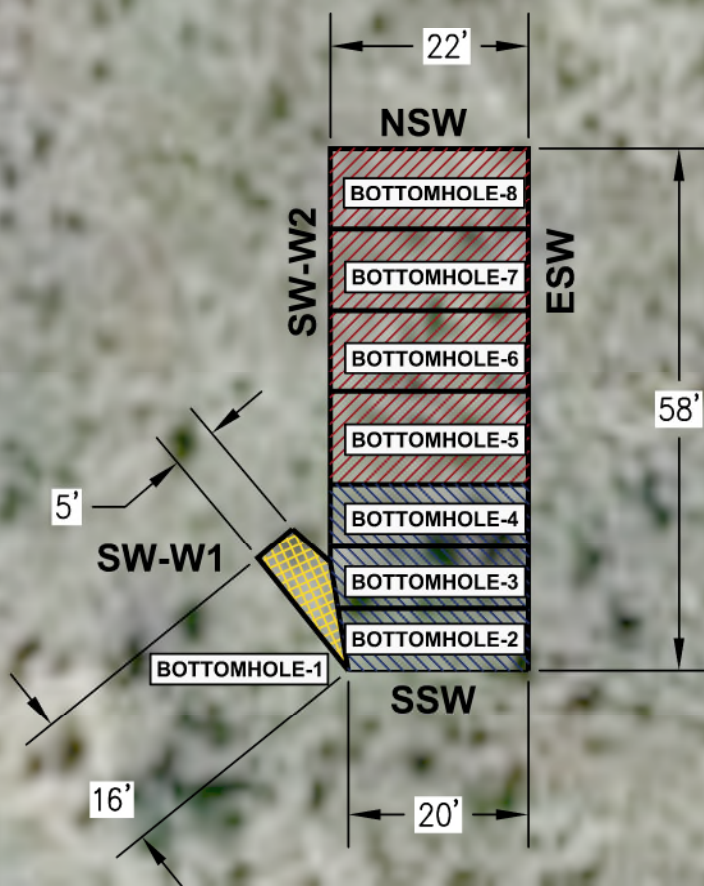
FIGURE 3

EXCAVATION AREA & DEPTH MAP  
EDDY COUNTY, NEW MEXICO

- 5.0' EXCAVATED AREA
- 4.0' EXCAVATED AREA
- 3.0' EXCAVATED AREA
- EQUIPMENT

Based on the confirmation sampling results, the release area was excavated to total depths ranging from 3.0' and 5.0' below surface. Soil samples were collected and submitted to the laboratory for TPH analysis by EPA method 8015 modified, BTEX by EPA Method 8021B, and chloride by EPA method 300.0. Copies of laboratory analysis and chain-of-custody documentation are included in Appendix D. The results of the sampling are summarized in Table 1. The excavation areas and depths are shown on Figure 3.

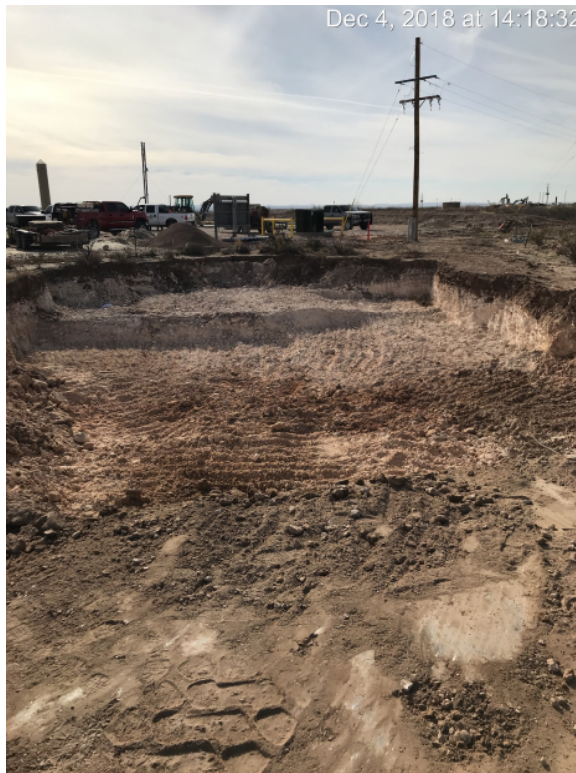
View South – Excavated Area

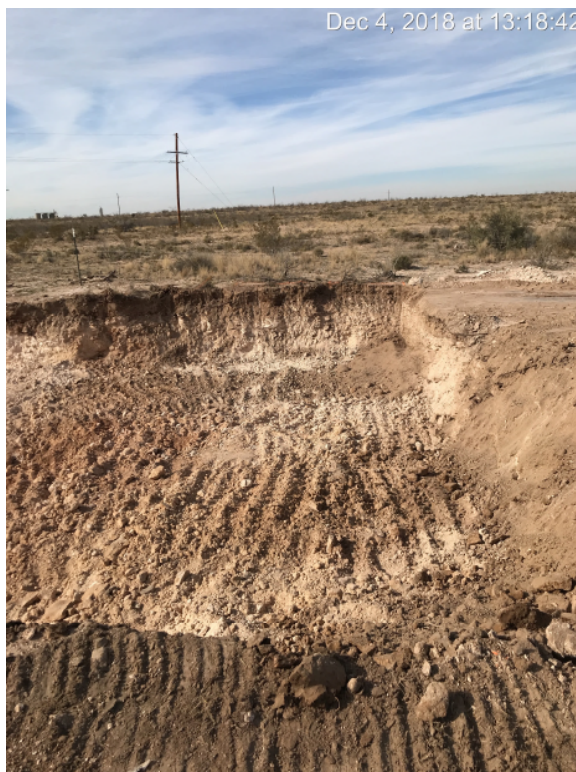
View West – Excavated Area

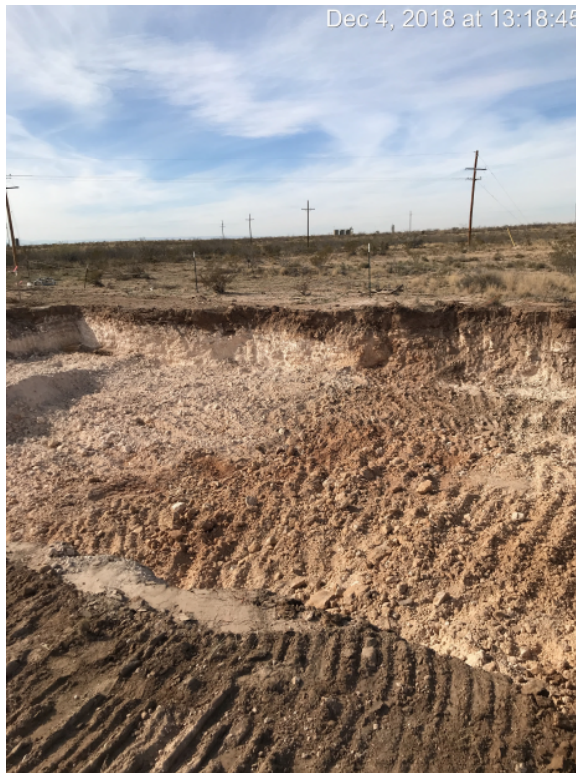
View West – Excavated Area
