## **DELINEATION WORKPLAN**

### **COG – COPPERHEAD 31 FED COM #001H (Leak Date: 5/27/18)**

#### **RP # 2RP-4796**

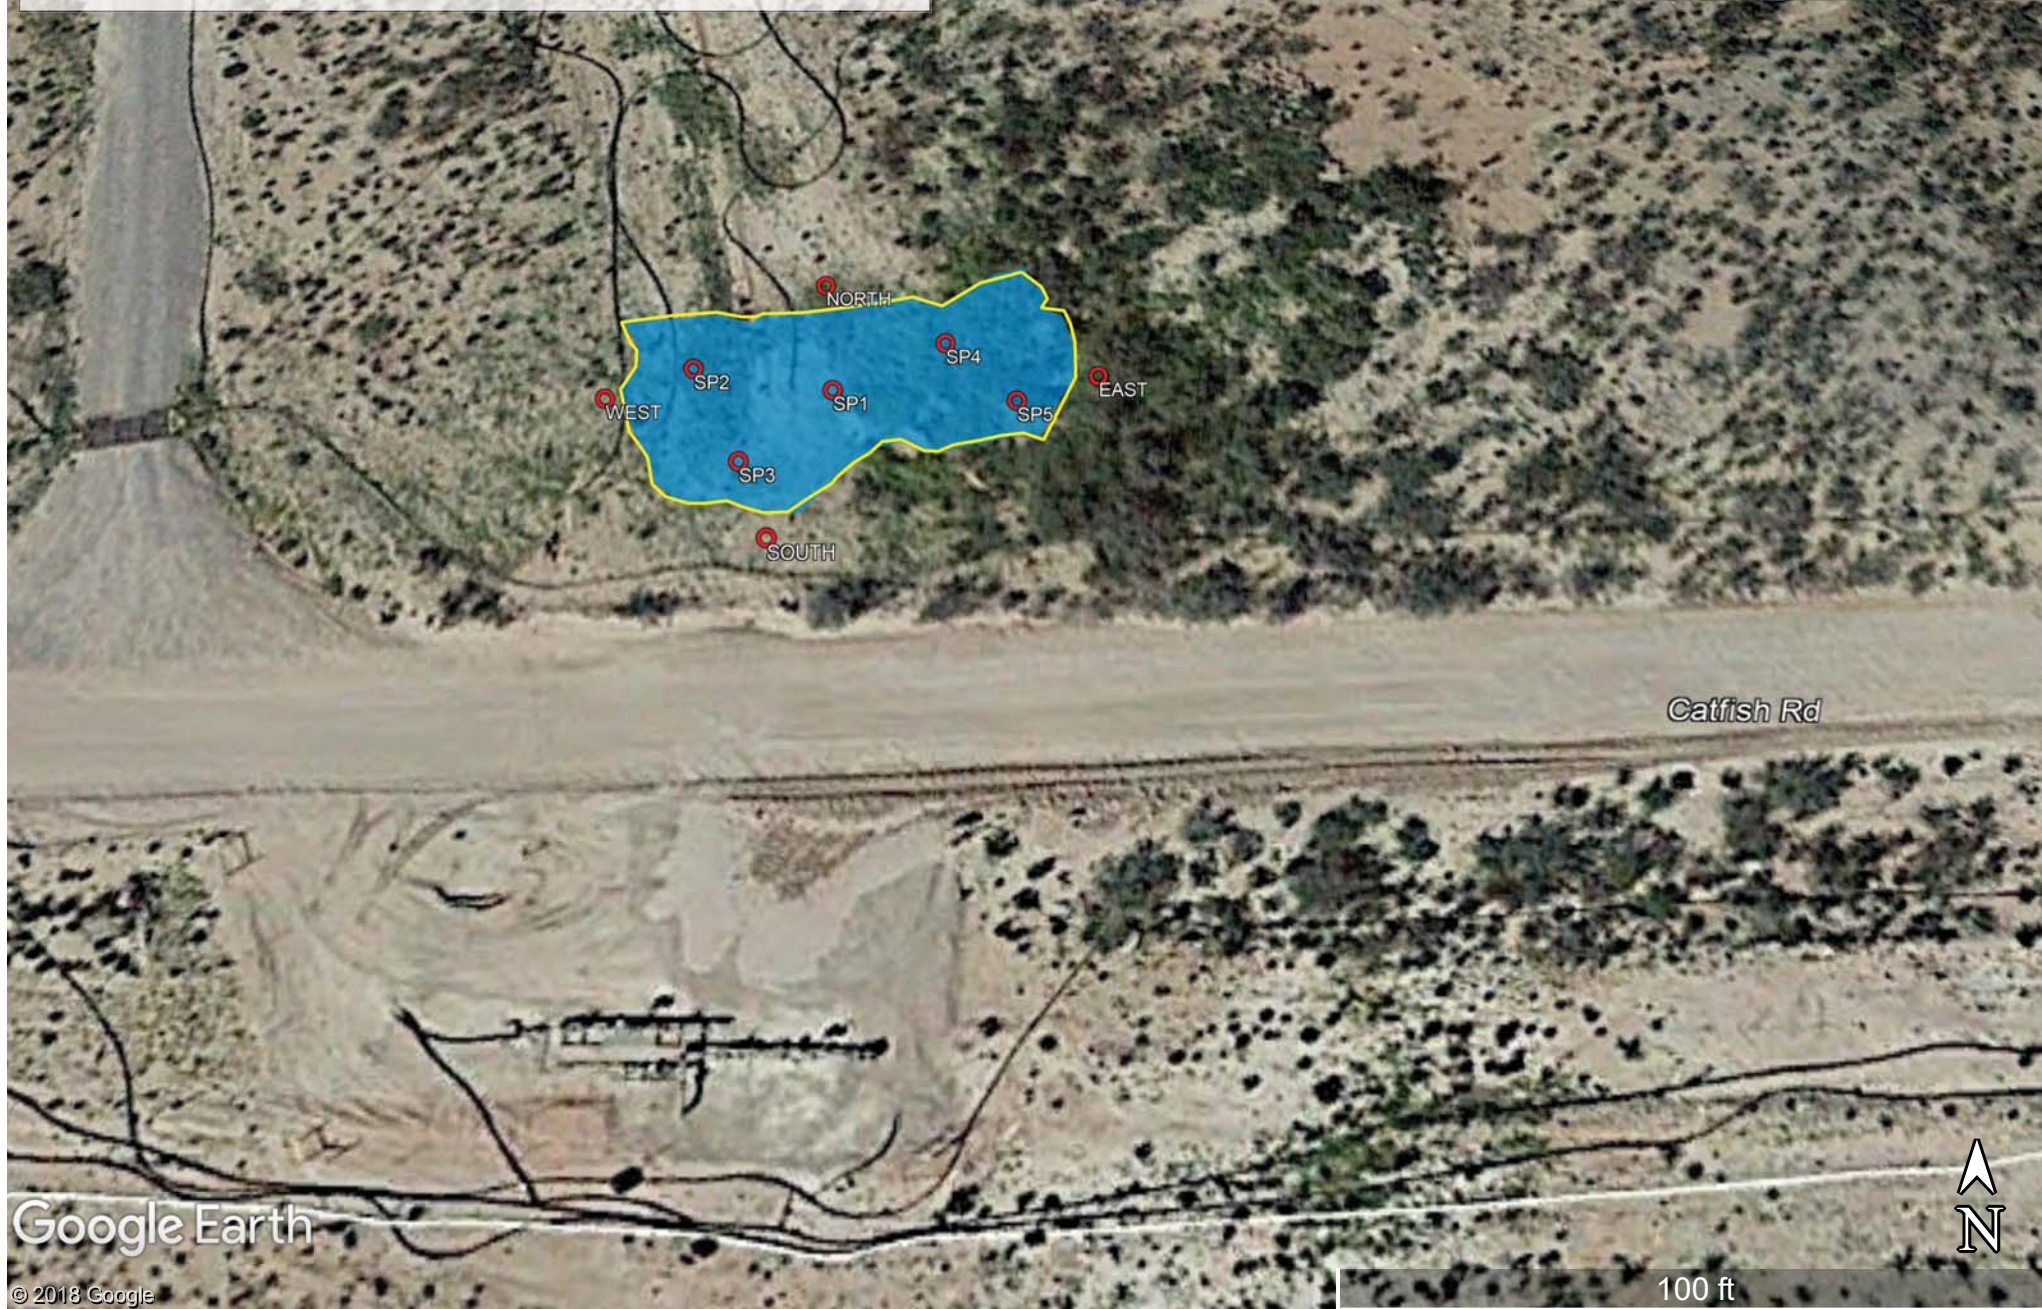
# COG, Copperhead 31 Fed Com #001H

Leak date: 05/27/2018  
Eddy County, NM  
SPI# 30-015-38532  
2RP-4796

-

4 ft excavation with liner
-

Sample points
-

Leak area

***COG will excavate the spill area as depicted on the following site diagram. The entire leak area will be excavated to a depth of 4 feet with an impermeable liner placed in the bottom of the excavation.***

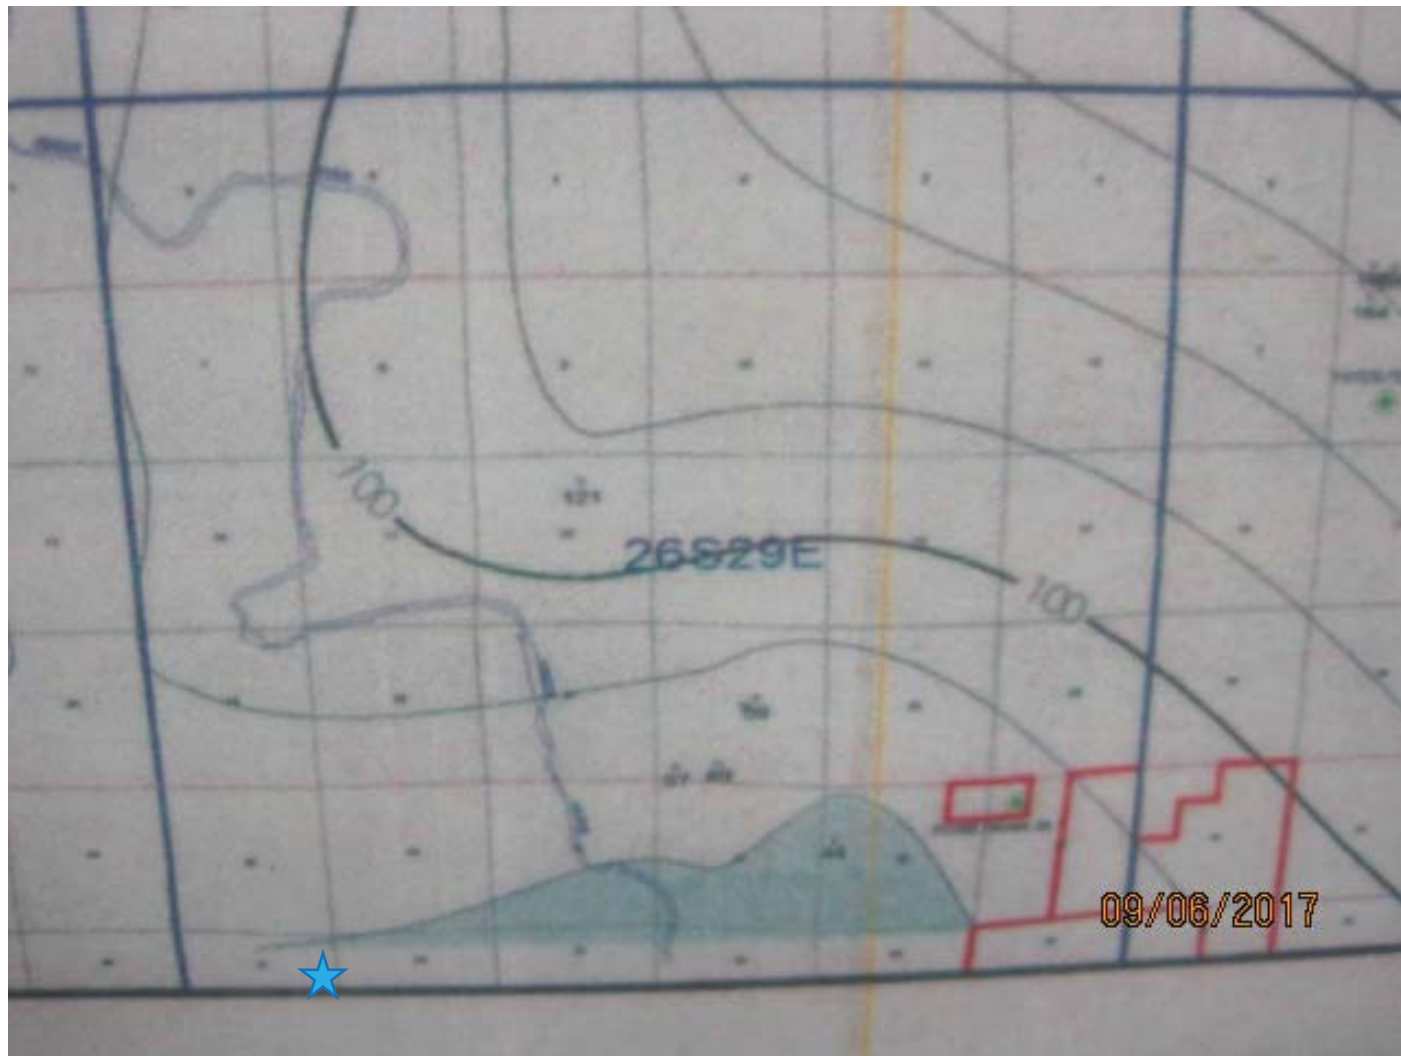
COG, Copperhead 31 Fed Com #001H

Sample points

SP1, N 32.00031 W-104.01629

SP2, N 32.00032 W-104.01637

SP3, N 32.00027 W-104.01634

SP4, N 32.00034 W-104.01622

SP5, N 32.00031 W-104.01618

NORTH, N 32.00037 W-104.01629

SOUTH, N 32.00023 W-104.01632

EAST, N 32.00032 W-104.01613

WEST, N 32.00031 W-104.01641
