**Re: Closure Request
James Ranch Compressor Station (2RP-4679)
ETC Texas Pipeline, Ltd
Site Location: Unit E, Sec. 16, T 23-S, R 31-E
(Lat 32.30538N°, Long -103.78808W°)
Eddy County, New Mexico**

On behalf of ETC Texas Pipeline, Ltd. (formerly ETC Field Services LLC), GHD Services, Inc. is requesting that no further action status be granted for the James Ranch Compressor Station (hereafter referred to as the "Site").

**Re: Site Assessment Summary and Remediation Work Plan
James Ranch Compressor Station
2RP-4679
ETC Field Services LLC
Site Location: Unit E, Sec. 16, T 23-S, R 31-E
(Lat 32.30538N°, Long -103.78808W°)
Eddy County, New Mexico**

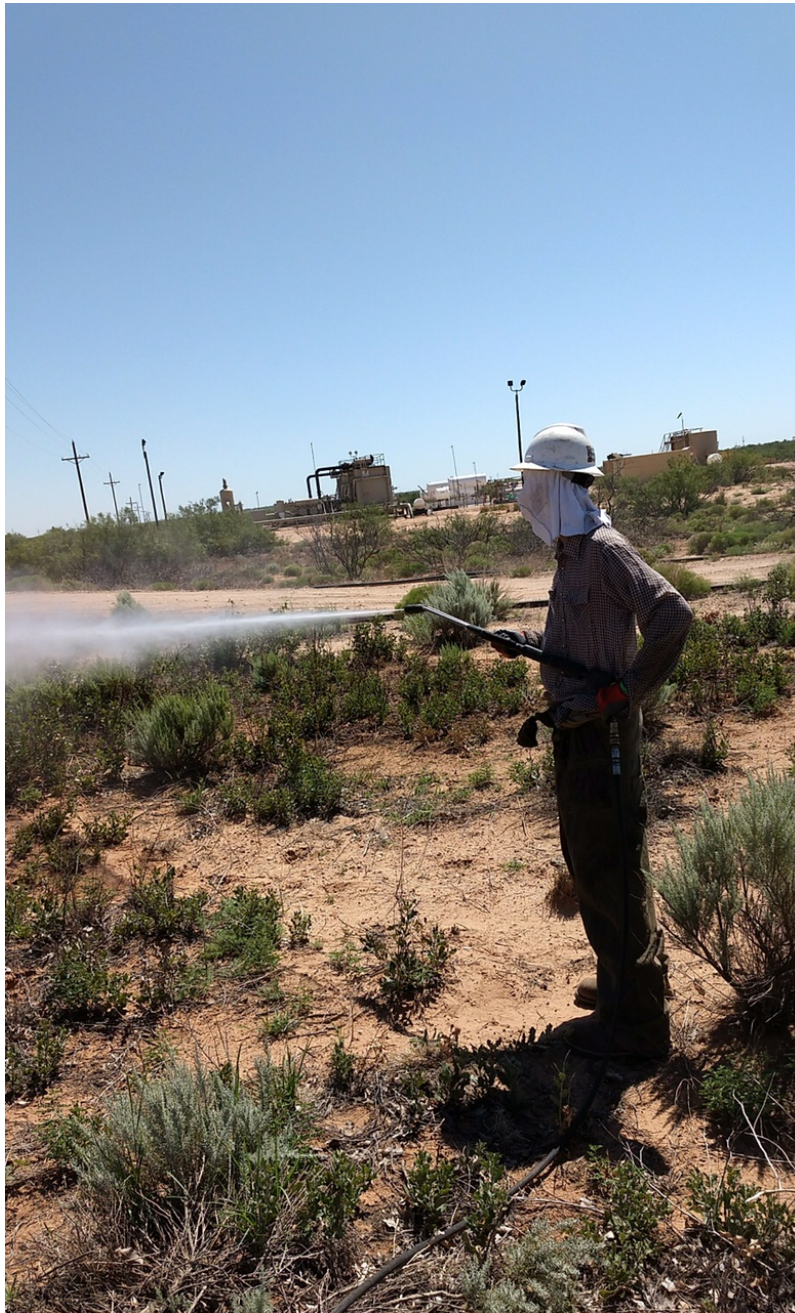
Photo 1 - Micro-Blaze® application

The work scope was approved by Mr. Bratcher with the New Mexico Oil Conservation Division and Mr. Mann of the New Mexico State Land Office on March 27, 2018. The application of Micro-Blaze® was completed on August 23, 2018 and is documented in the attached completion photos and final C-141 for the Site; therefore, No Further Action status is being requested for the Site.

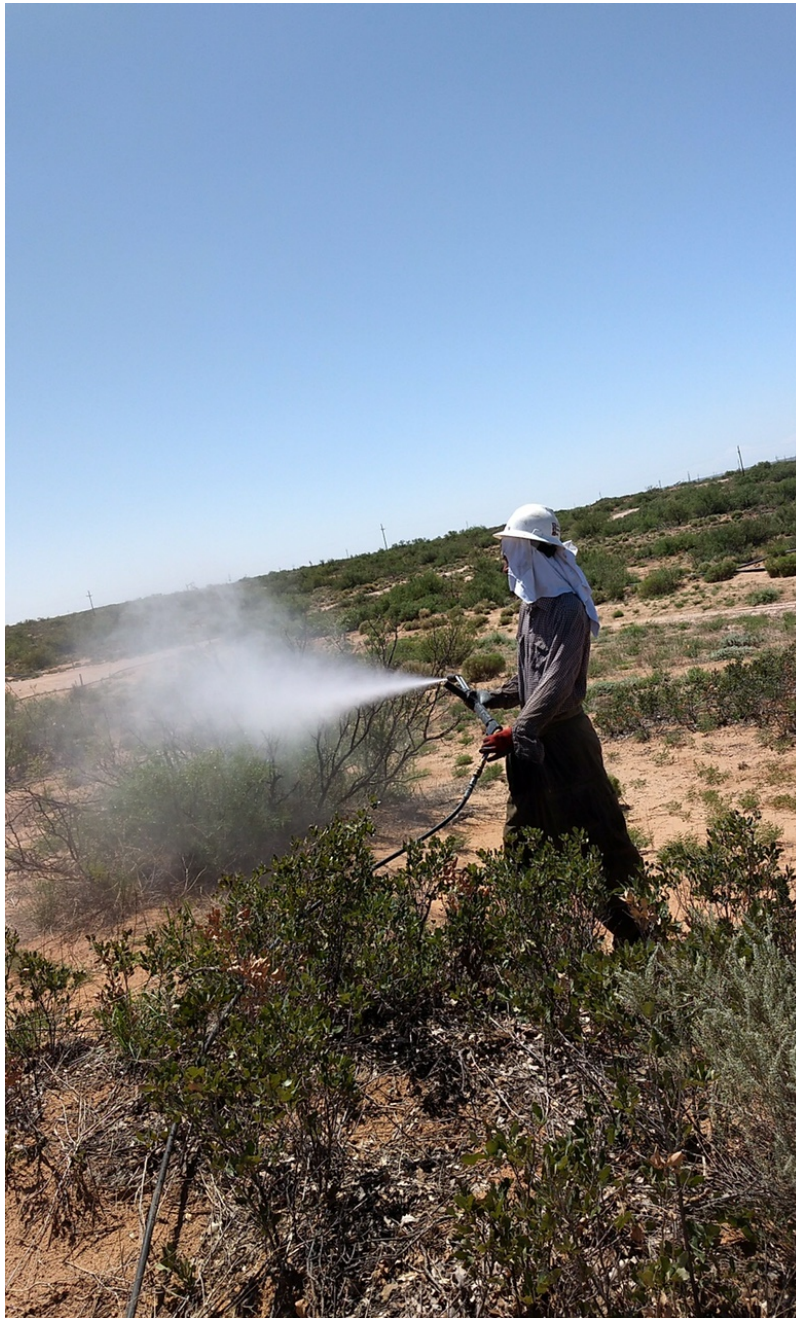
Photo 2 - Micro-Blaze® application

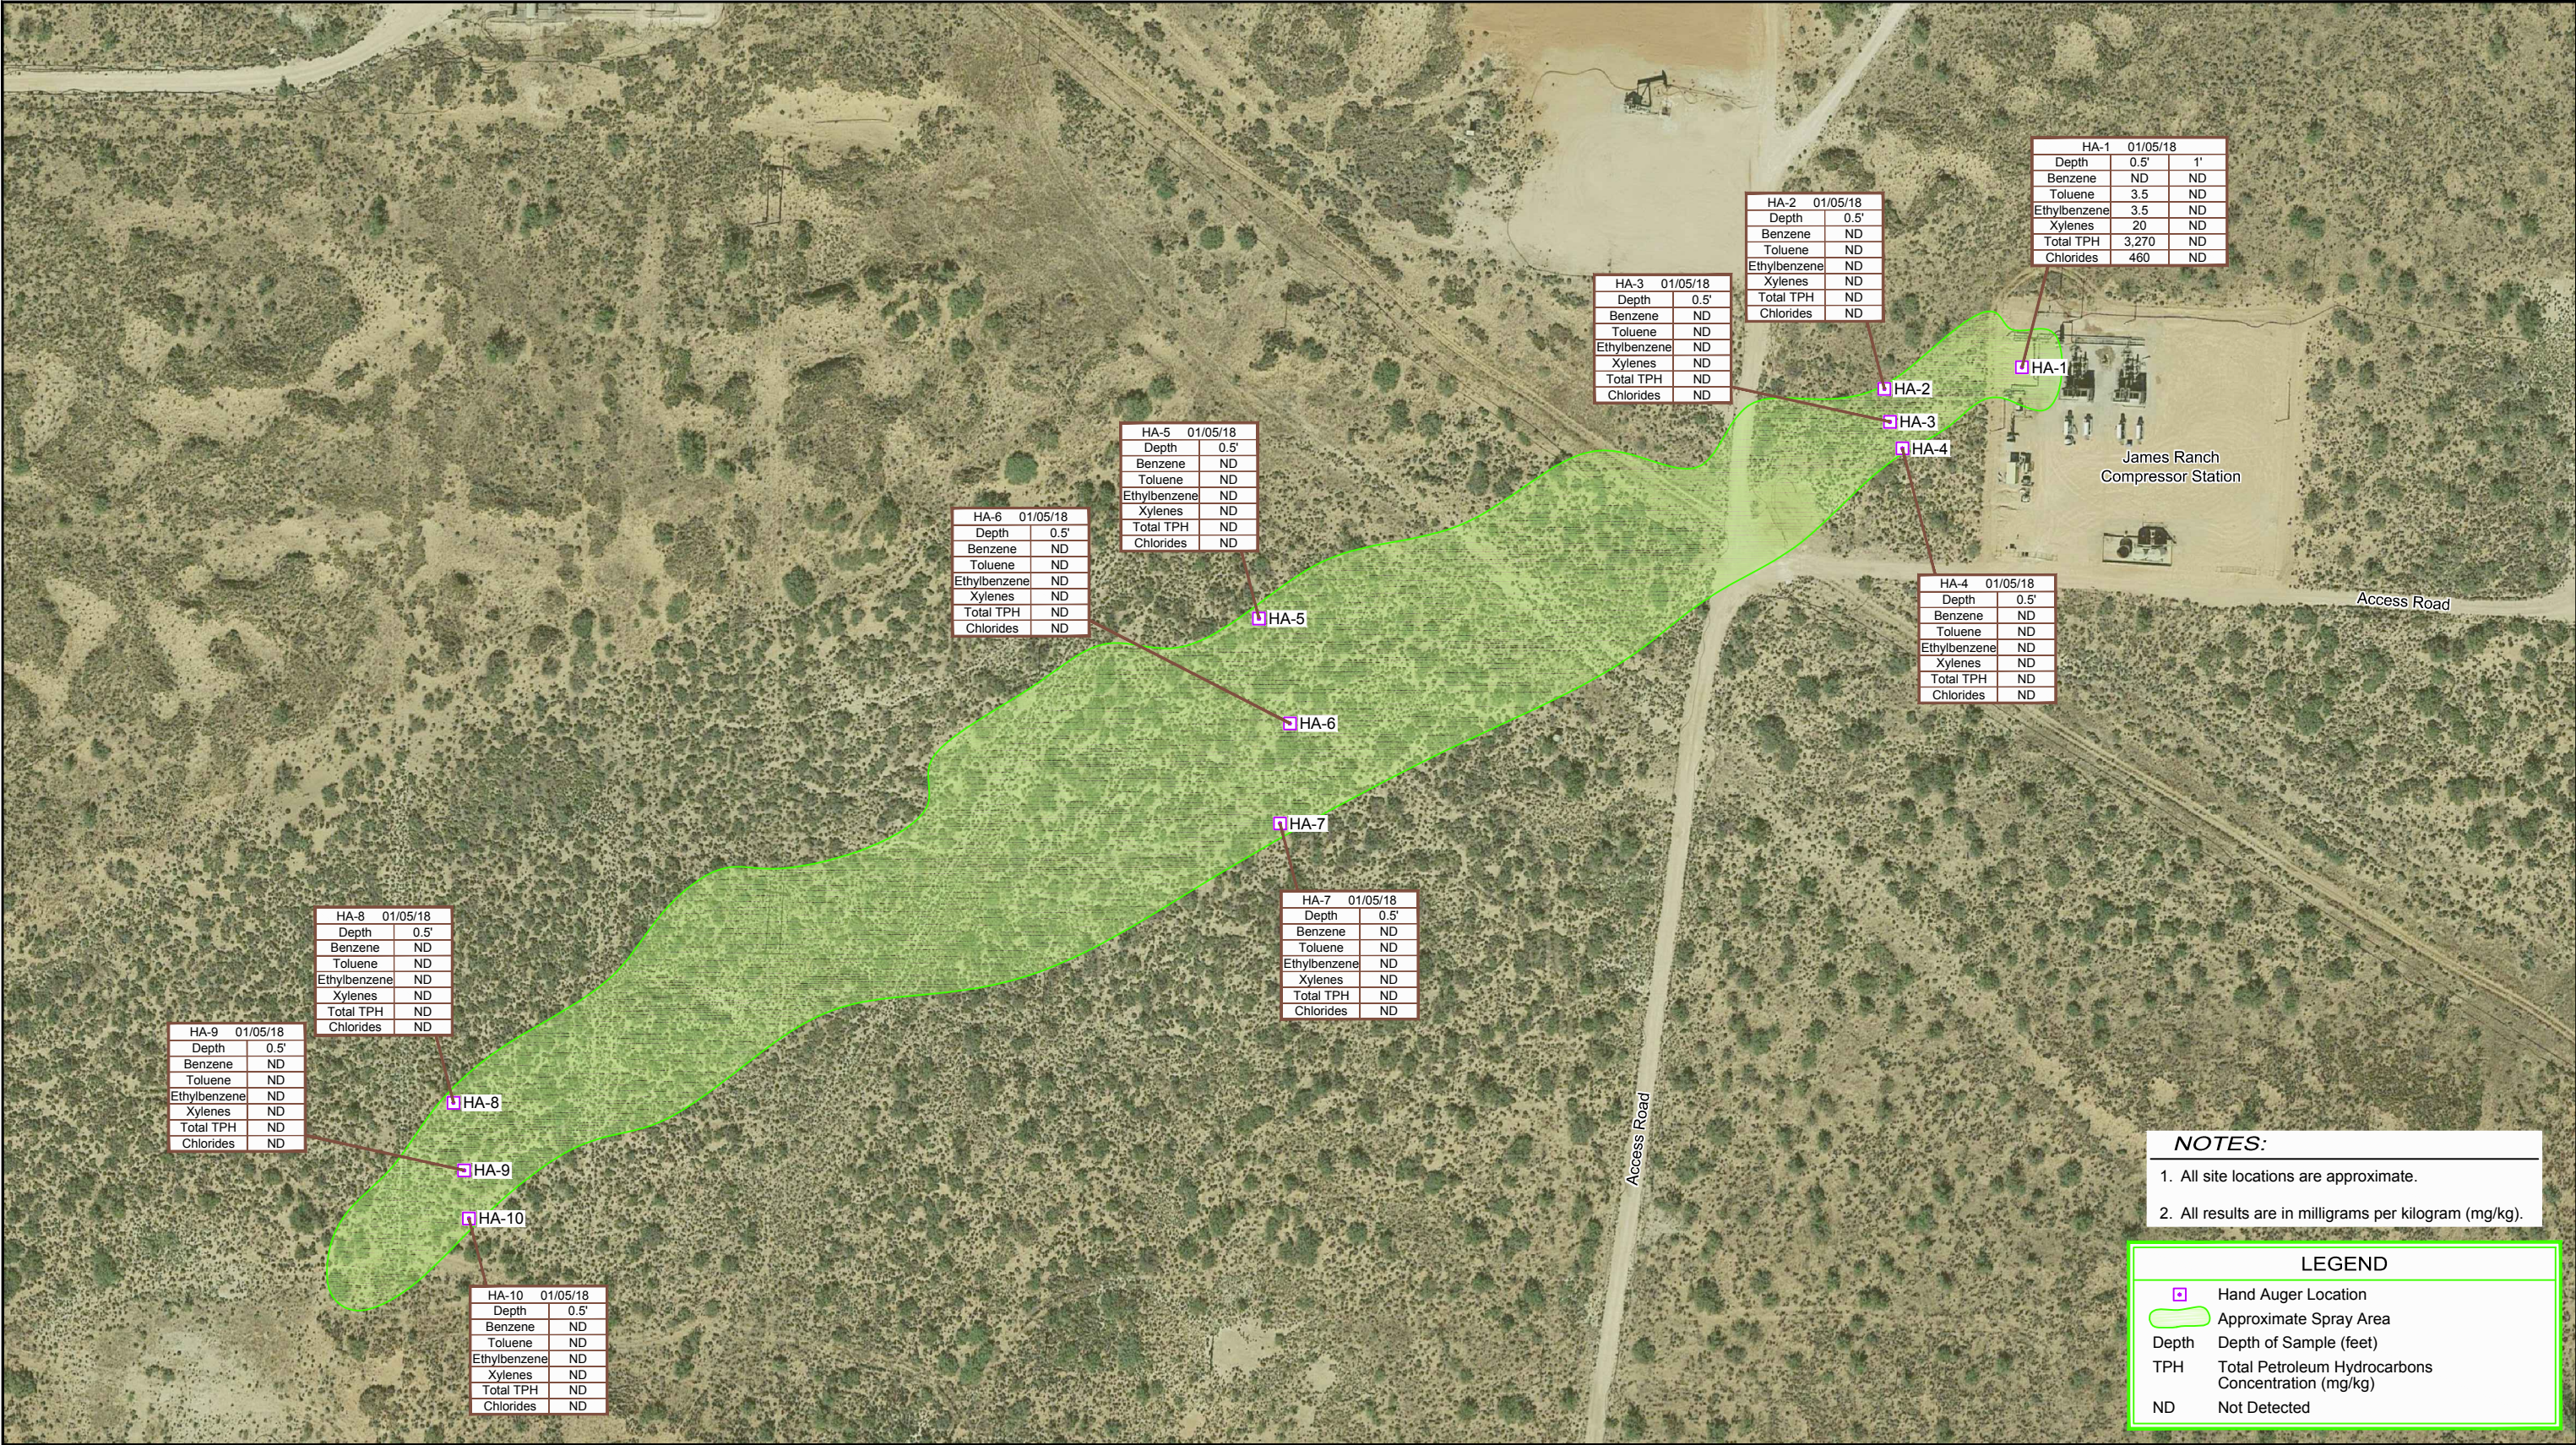
FIGURE 2

Toluene and ethylbenzene were detected in sample HA-1 6" at a concentration of 3.5 milligrams per kilogram (mg/kg) and xylenes were detected in this sample at a concentration of 20 mg/kg. BTEX constituents were not detected above the laboratory reporting limits (LRLs) in the remainder of the samples. Total TPH concentrations ranged from below LRLs to 3,270 mg/kg, and chloride concentrations ranged from below the LRL to 460 mg/kg. The laboratory report is included in Appendix B and the results are summarized on Figure 2 and in Table 1.

Soil samples were collected from the release area within the pad and from the adjoining pasture (see Figure 2) and submitted for laboratory analyses. Based on the laboratory results, the vertical and horizontal extent of petroleum hydrocarbons and chloride impacted soil has been assessed to below the RRALs in both areas.

SOIL SAMPLE LOCATION
