Subject: El Paso Natural Gas Company, L.L.C., Florida Compressor Station Release OCD 2RP-5168

EPNG is submitting the Site Assessment/ Characterization in accordance with 19.15.29.10 NMAC for the facility referenced above.

EI PASO NATURAL GAS
COMPANY
FLORIDA CS

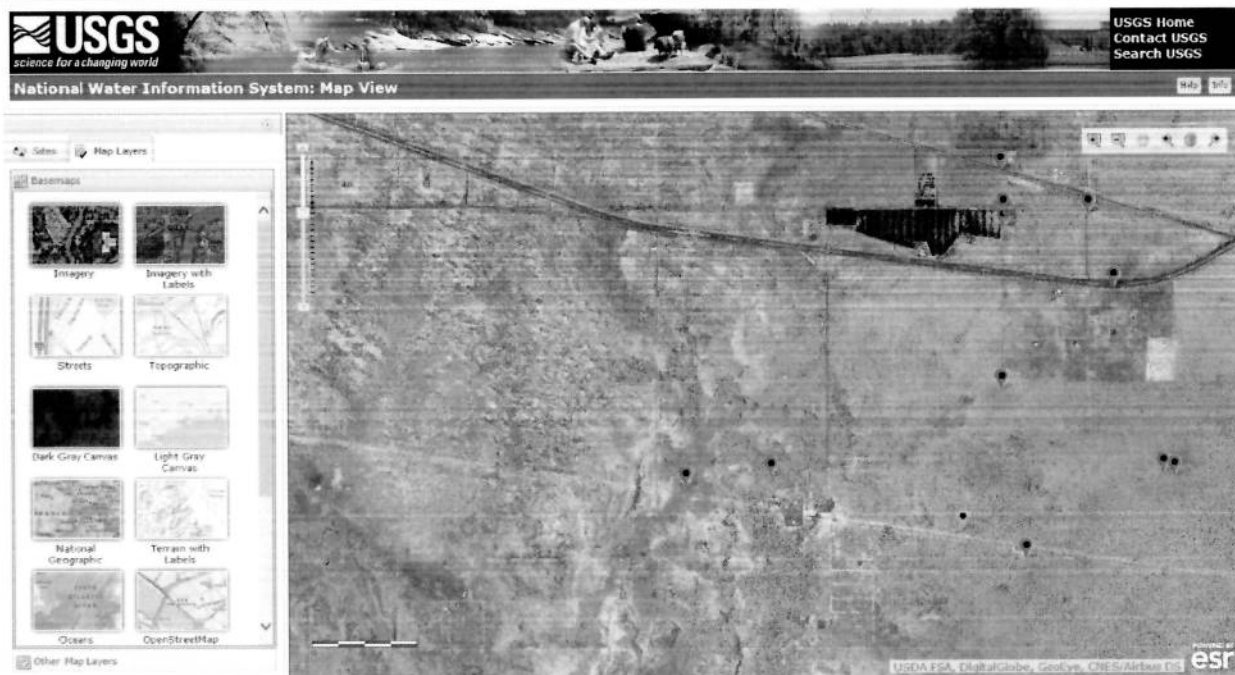
USGS 321259107241601 24S.06W.13.400

Luna County, New Mexico
Latitude 32°12'59", Longitude 107°24'16" NAD27
Land-surface elevation 4,130.00 feet above NGVD29
The depth of the hole is 233 feet below land surface.

Date	Time	Water-level date-time accuracy	Water level, feet below land surface	Water level, feet above specific vertical datum	Referenced vertical datum	Water-level accuracy	Status	Method of measurement	Measuring agency	Source of measurement	Water-level approval status
1942-09-19			D	65.90		2		U		U	A

Depth to water based on USGS last reading on nearest wells (Appendix C) is between 60 and 90 ft. approximately.

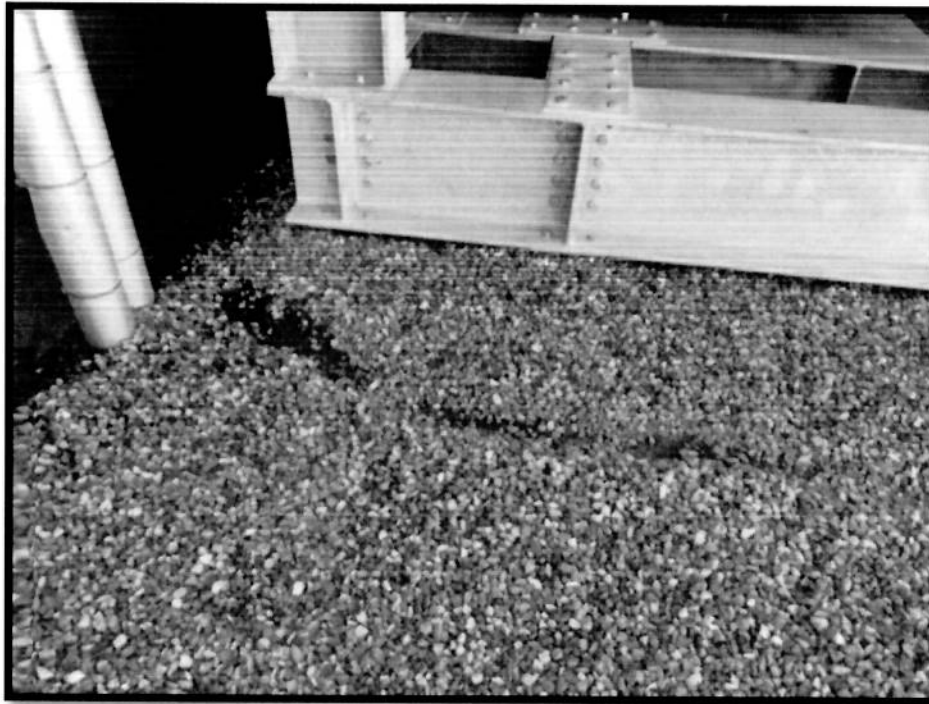
As described Release Notification form C-141 submitted to your department on November 6, 2018 (Appendix A), Mechanical hydraulic oil pump seal failed on Florida A-01 unit releasing approximately 1500 gallons. 1200 gallons were contained on the building basement and approximately 300 gallons of lube oil were released out of the building into the environment.

Florida Unit A-01 Oil Release 11/5/2018

Contractors were mobilized on November 6, 2018 to collect remaining liquids. Impacted soil was excavated and EPNG conducted sampling to determine the extent of the impacted area.

On December 17, EPNG mobilized contractors to continue excavating and collecting the impacted soil. Some areas are very close or below the exhaust pad making the excavation very difficult.

- Once the depth of the contamination has been established, EPNG will excavate and collect the contaminated soils for disposal.
- There are complicated areas to excavate due to Exhaust equipment (Appendix E- Pictures). EPNG will intent to collect as much as possible the contaminated soils immediately under or around the exhaust pad without compromising the equipment.

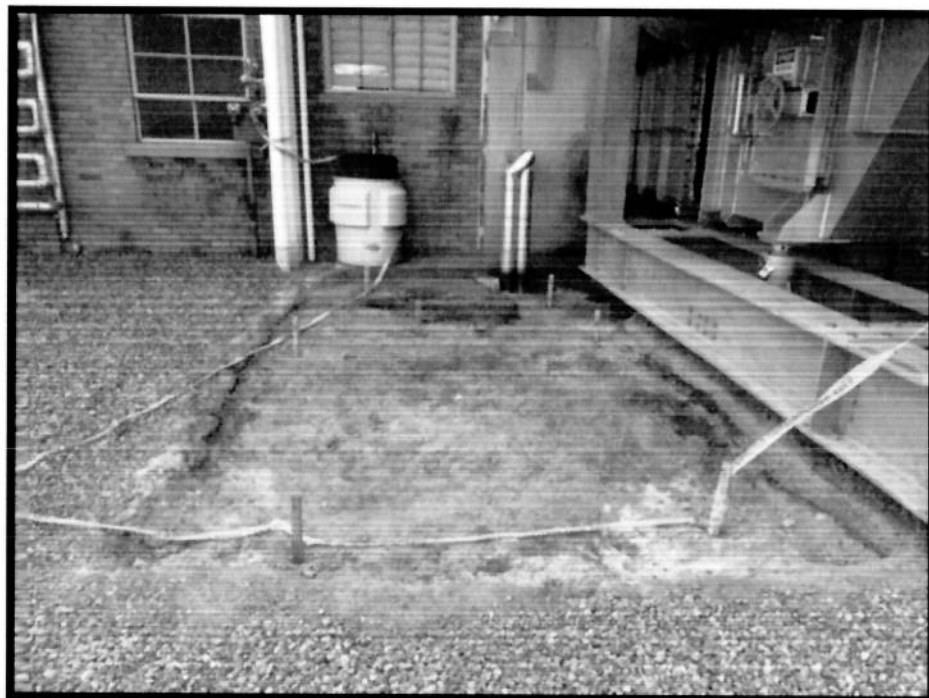
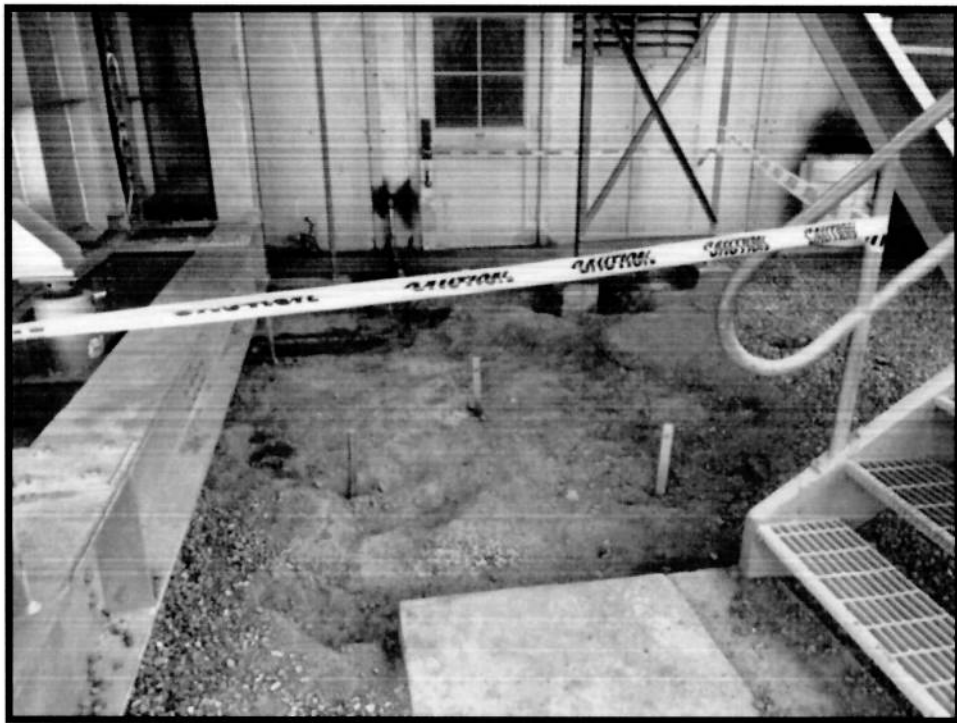
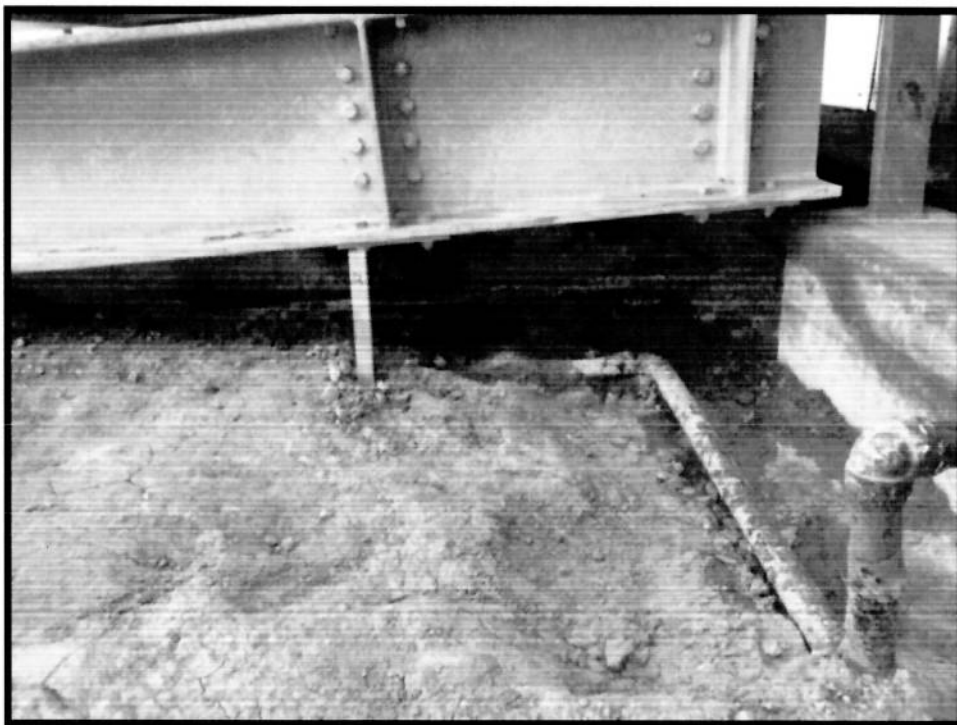
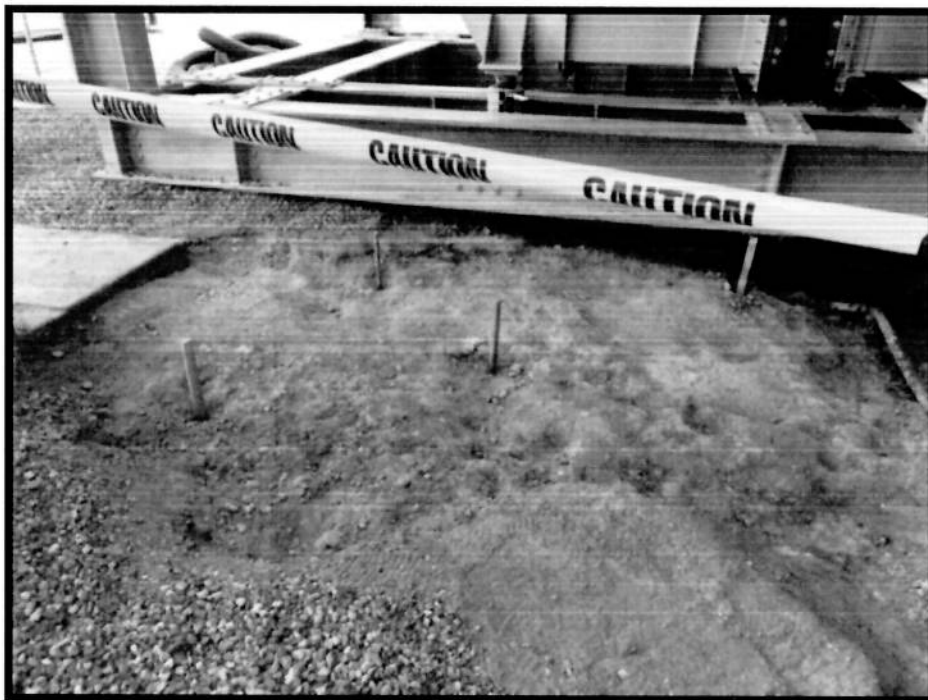
Sample Locations 1/11/2019

At this time, approximately 15 yards of contaminated soil have been collected and stored on a rolloff bin at the facility. After the remaining contaminated soils have been collected, they will be sent to disposal to an approved landfill. A third party laboratory conducted the final sampling on January 11, 2019. The report was received on January 28, 2019. A total of 16 grab samples were collected by the contractor and sent to a certified laboratory for analysis. Analyses were performed in accordance with Table I of 19.15.29.12 NMAC. Laboratory results are shown in Appendix G.

- EPNG will contract a company to perform bores and take samples at 1 foot and 2 feet depth at each location that shows contamination above the cleanup levels. Lateral extents of the contamination have already been determined as described on the Soil Waste Characteristic section above.

- A grab sample of each sample point shown on the sample location map (Appendix B) will be collected and sent to a certified laboratory for analysis in accordance with Table I of 19.15.29.12 NMAC.
