# **Breitburn Management**

**State 647-711**

**Work Plan**

**Section 27, Township 18S, Range 28E  
Eddy County, New Mexico**

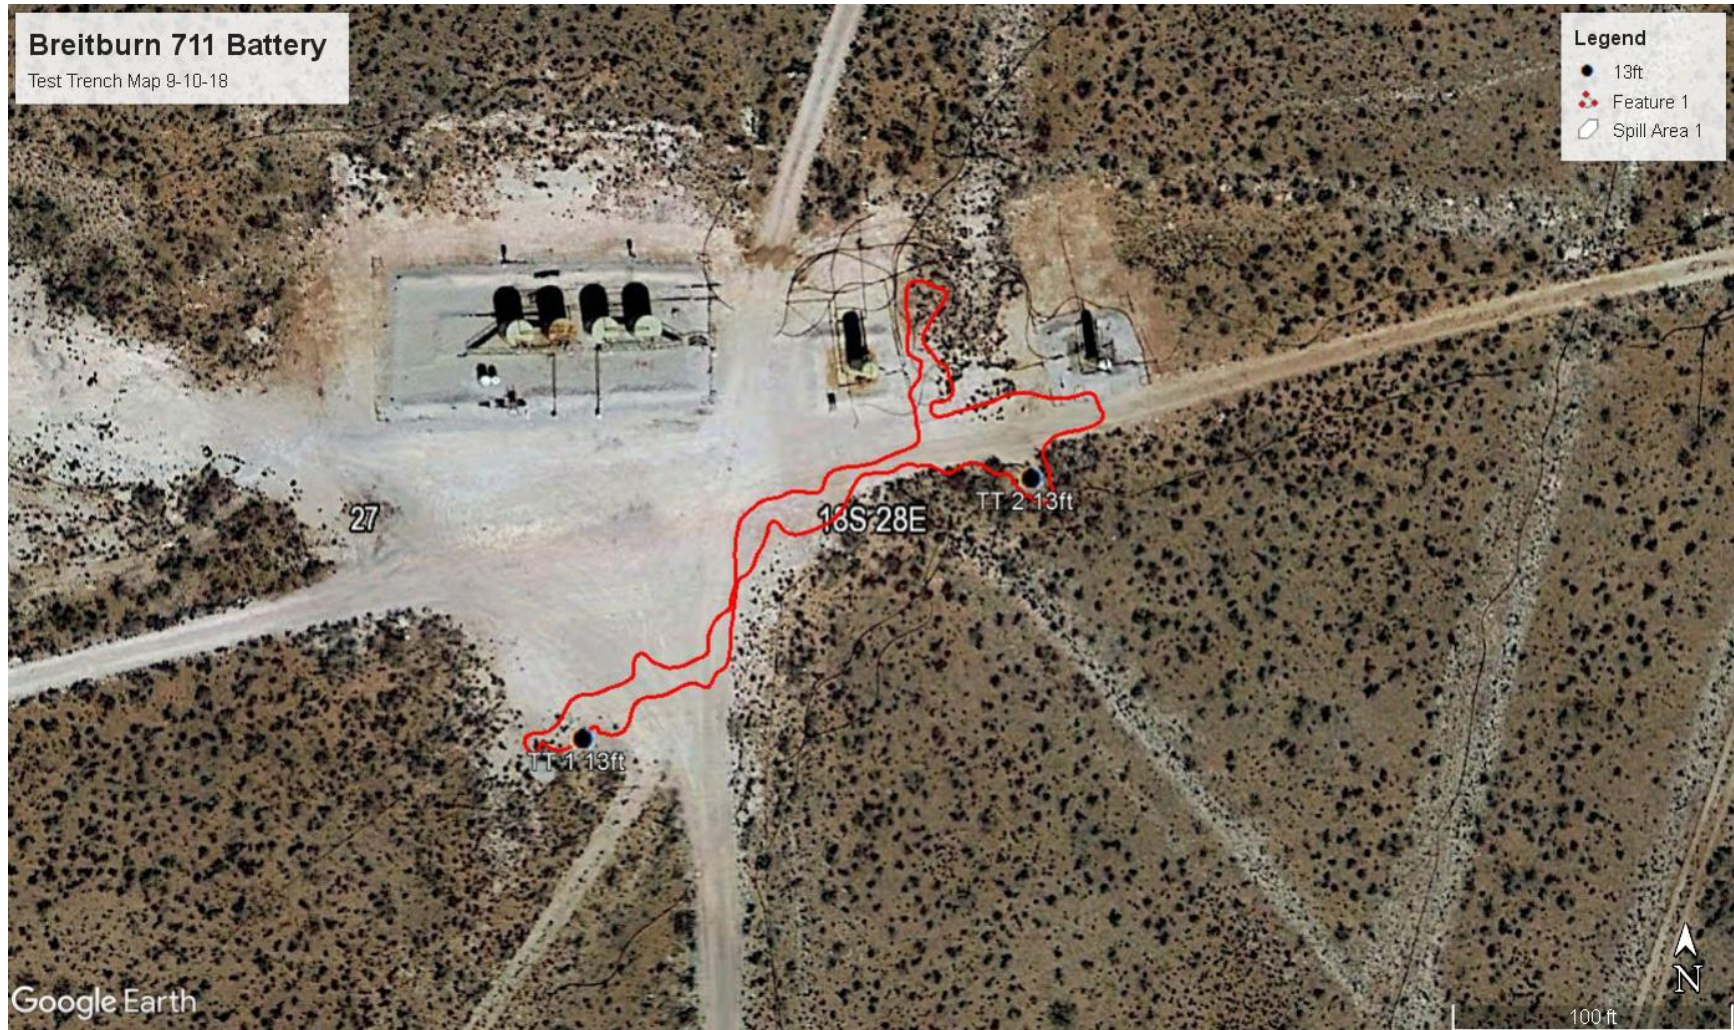
# **Figure 1**

## **Site Map**

Test Trench Map 9-10-18

Sample Point 2  
TT 2 13ft

TT 1 13ft Sample Point 3

On September 10, 2018, SESI personnel was onsite at the Breitbart State 647-711 with Breitbart personnel and JS Services Backhoe personnel to begin delineation of the release installing test trenches to determine vertical extent of contamination. The JS Services personnel hand excavated to the depth of one foot in the release area where several pipelines were located. Test trench one was installed to the max depth of thirteen feet with the backhoe. Soil samples were obtained and field tested for TPH and Chlorides. Test trench one was then backfilled, and test trench two was installed to the depth of thirteen feet, while soil samples were obtained and field tested. The location was pin flagged using white flags for the one call. The excavation was mapped using the Juno 3B and site photos were taken. Aerial photos of the location, release area, and excavation were also taken using the drone. All soil samples were properly packaged, preserved and transported to Cardinal Laboratories of Hobbs, NM by chain of custody, and analyzed for TPH (total petroleum hydrocarbons) (Method 8015M), BTEX, and Chlorides (Method SM4500CI-B). The lab results are recapped in the following table:

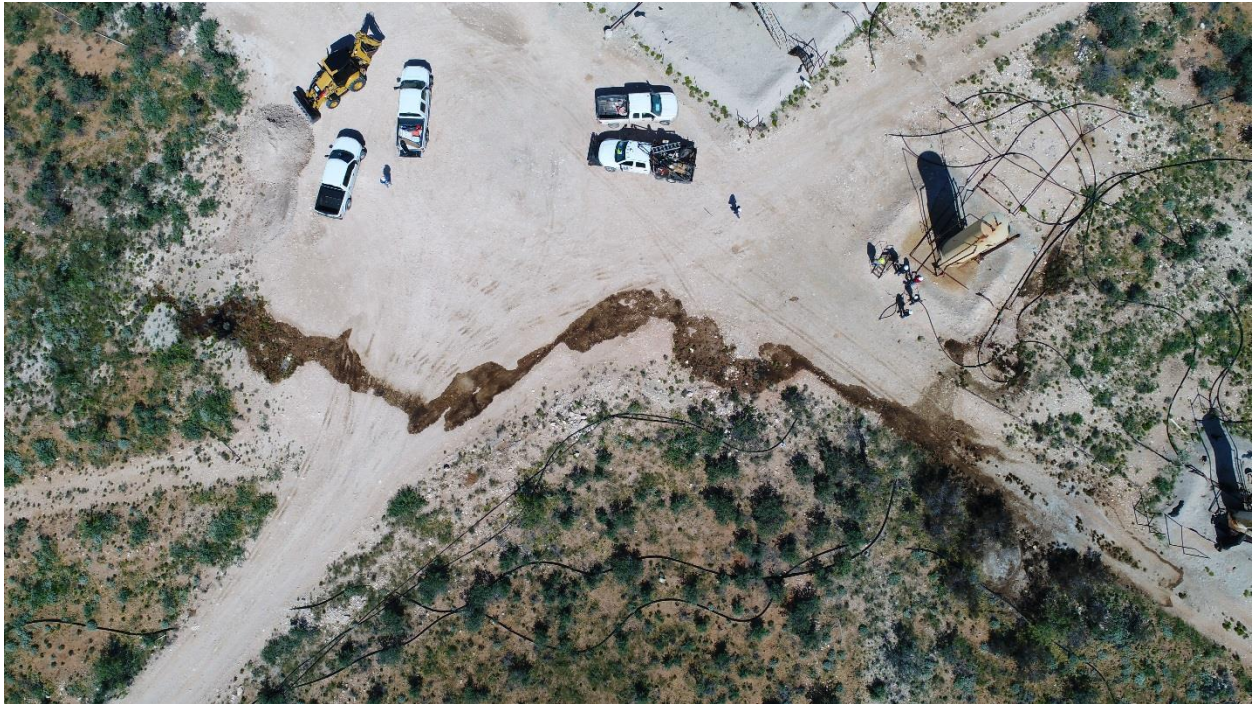
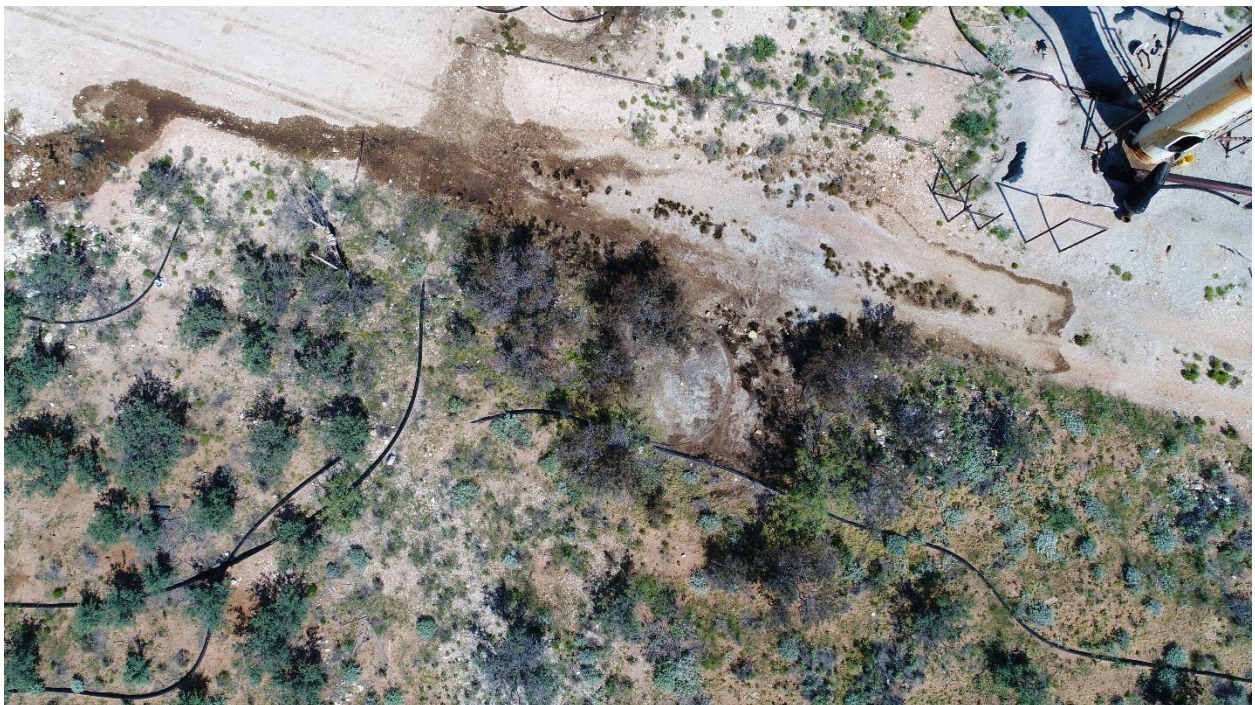
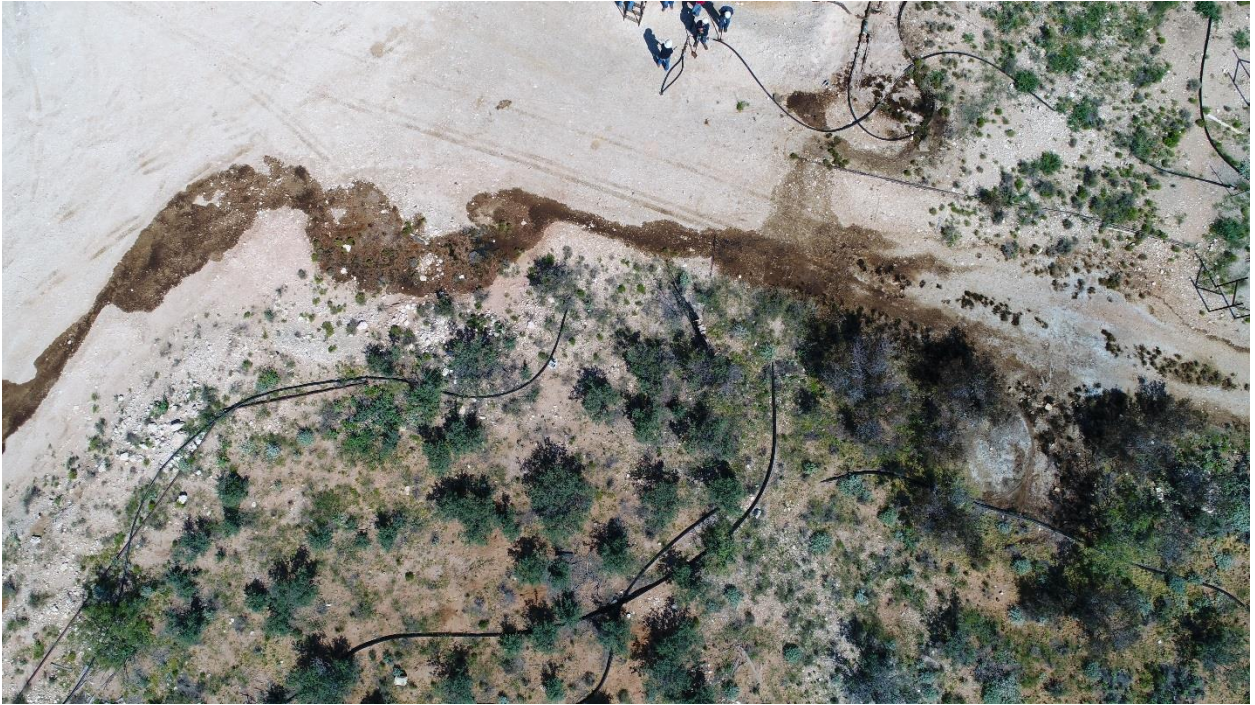
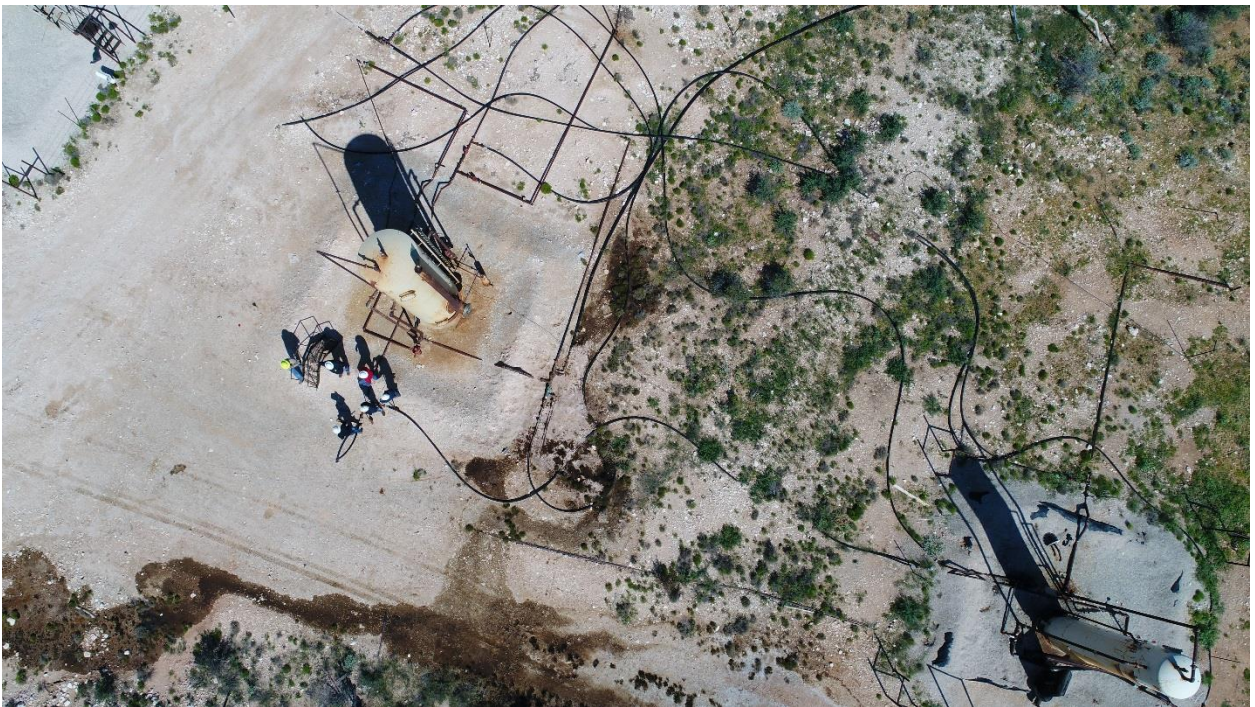
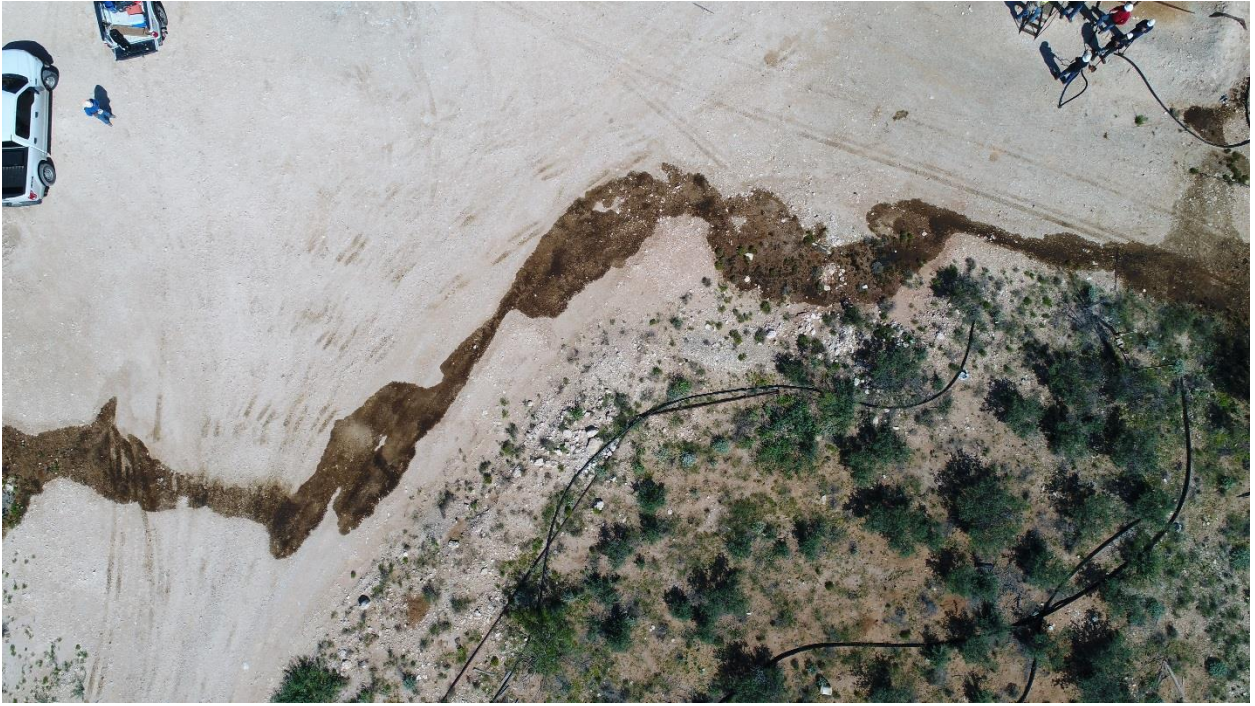
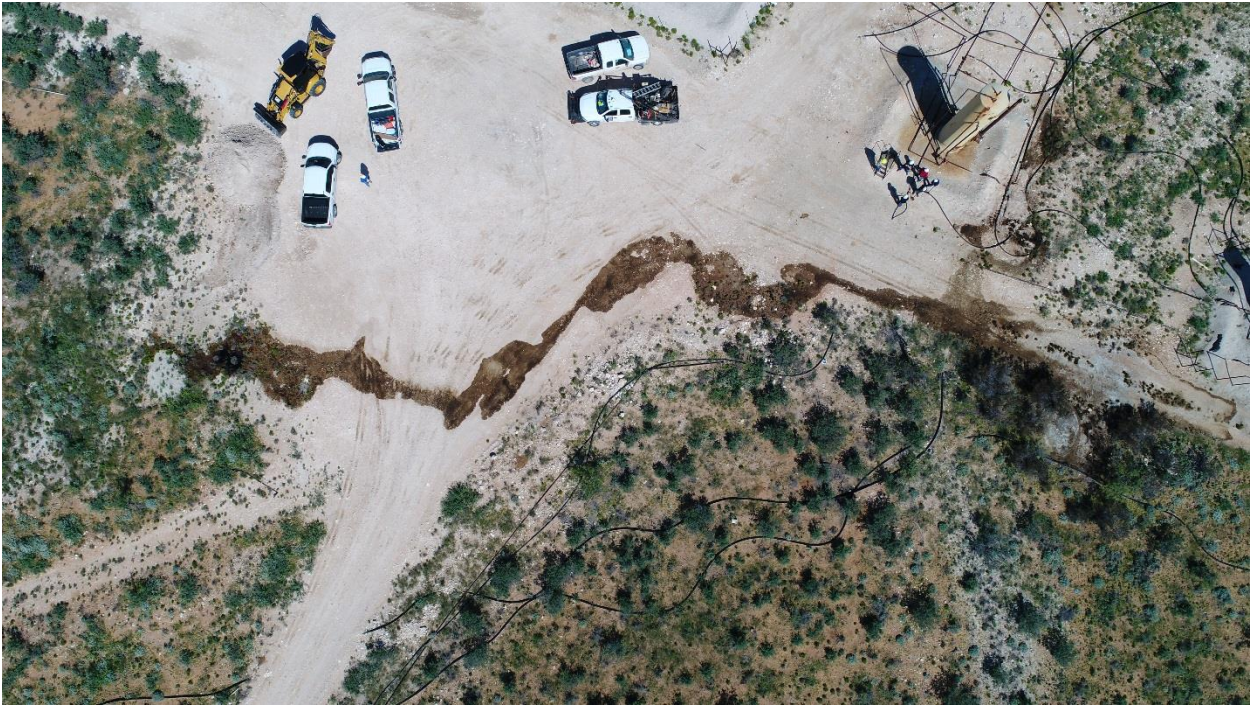
Drone Photos 9-10-18

## Breitburn 647-711 Battery
