## SITE INFORMATION

Report Type: Work Plan 2RP-5209

**Re: Work Plan for the COG Operating, LLC, SRO State Com #64, Unit E, Section 10, Township 26 South, Range 28 East, Eddy County, New Mexico. 2RP-5209**

Tetra Tech, Inc. (Tetra Tech) was contacted by COG Operating, LLC (COG) to assess a release that occurred at the SRO State Com #64, Unit E, Section 10, Township 26 South, Range 28 East, Eddy County, New Mexico (Site). The spill site coordinates are 32.057491°, -104.082026°. The site location is shown on Figures 1 and 2.

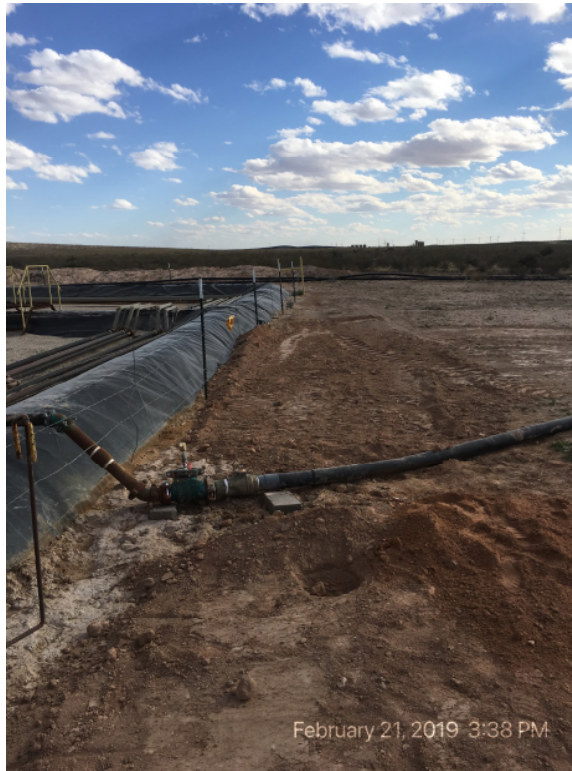
View South – Area of BH-1

area of borehole (BH-3) will be excavated to 2'-3' below surface. Additionally, the area of borehole (BH-1) will be excavated to 4'-5' below surface.

Per rule 19.15.29.14, COG requests a variance to install a 20-mil liner at 4.0' below surface in the areas of borehole (BH-1) to prevent vertical migration of the deeper chloride concentrations detected. Prior to the liner installation, composite sidewall samples will be collected every 200 square feet, to be representative of the release area, for documentation purposes.

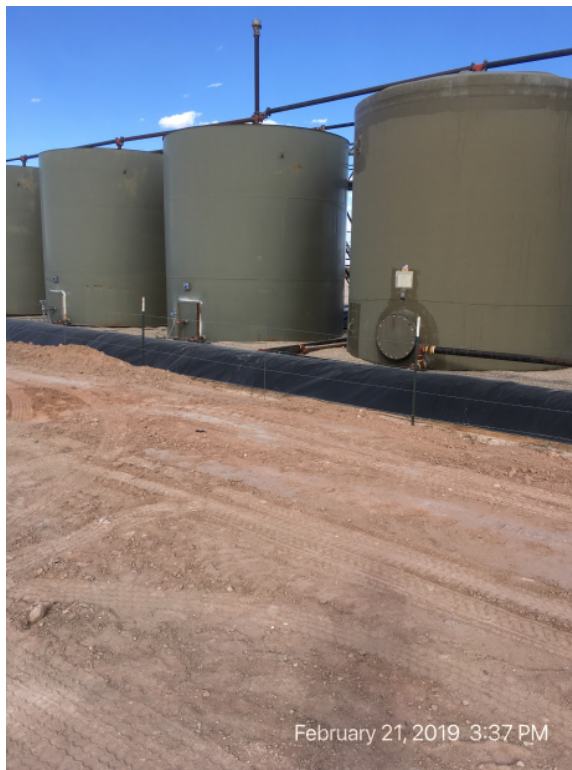
View West – Area of BH-2

Based on the laboratory results, COG proposes to remove the chloride impacted soils as shown on Figure 4 and highlighted (green) on Table 1. Due to access issues and safety concerns, the proposed excavation will be performed to remove the impacted soil to the maximum extent practicable. The areas of borehole (BH-2) will be excavated to 1'-2' and the

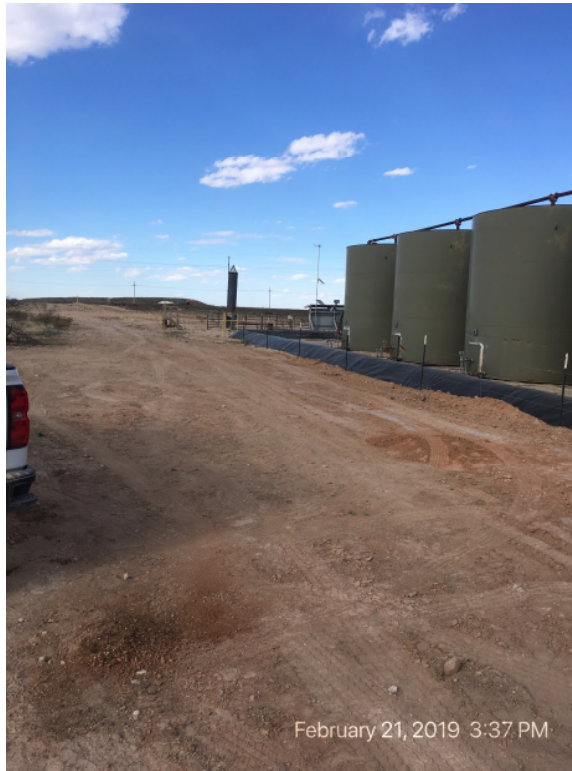
View Northwest – Area of BH-3
