**RE: Closure Request  
Remuda South 25 State #123H Well Pad/Remuda 100 Battery  
Remediation Permit Numbers 2RP-5277 and 2RP-5193  
Eddy County, New Mexico**

REMUDA SOUTH 25 STATE #123H WELL PAD/  
REMUDA 100 BATTERY

FIGURE 1  
SITE LOCATION MAP  
REMUDA SOUTH 25 STATE #123H WELL PAD/  
REMUDA 100 BATTERY  
UNIT E SEC 25 T23S R29E  
EDDY COUNTY, NEW MEXICO  
XTO ENERGY, INC.

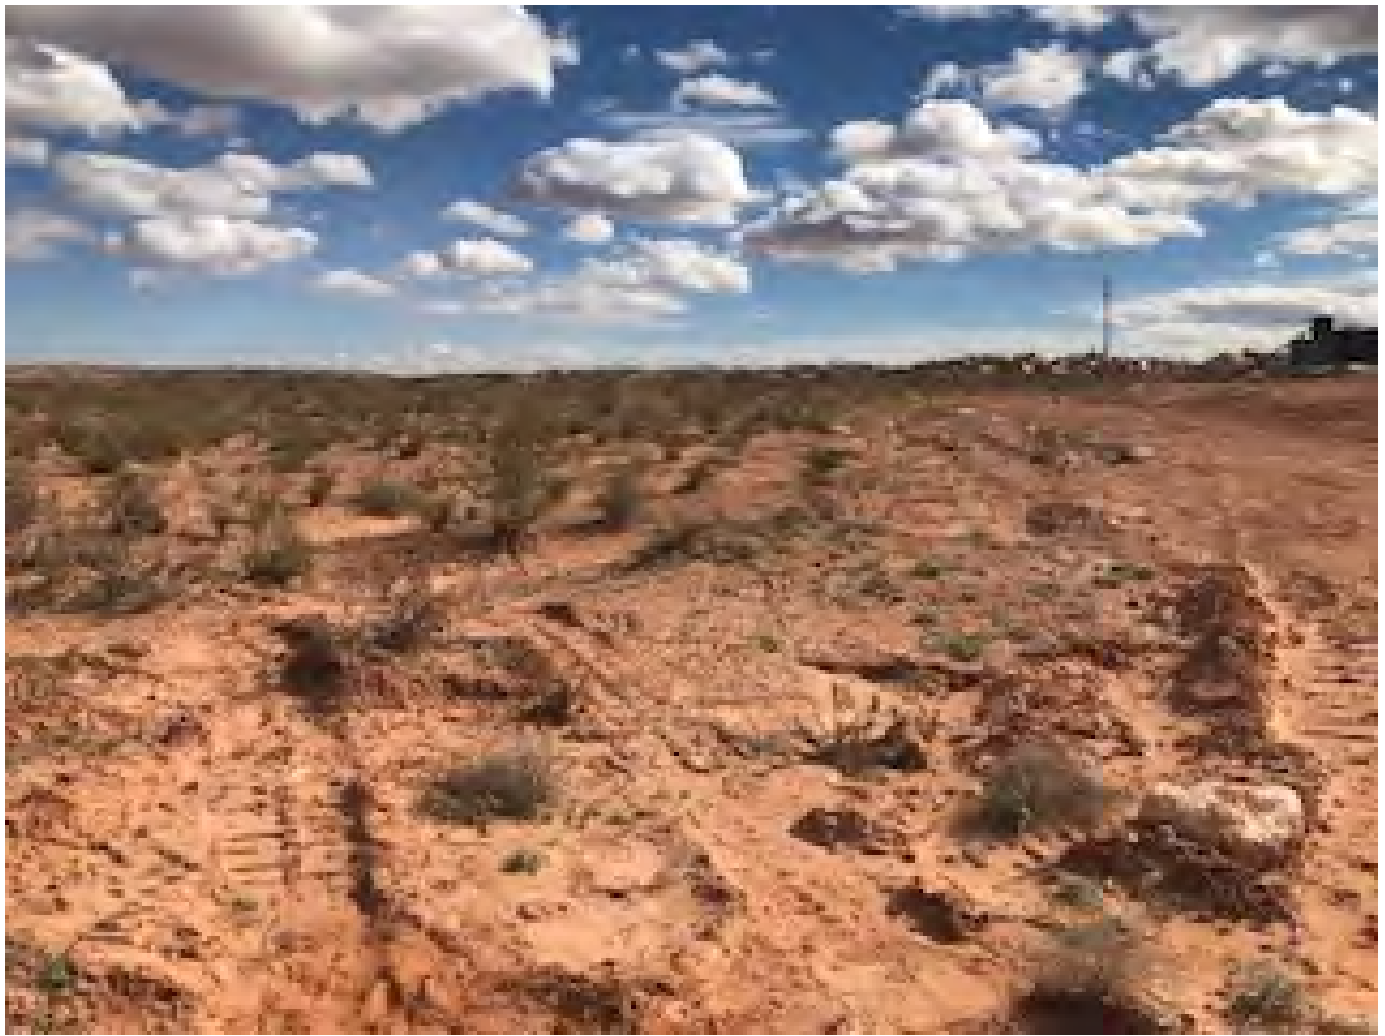
On January 10, 2019, LTE personnel inspected the Site to evaluate the release extent. Surface hydrocarbon staining was observed in the release area on the well pad and pasture area north of the pad. The release extent was mapped using a handheld Global Positioning System (GPS) unit and is depicted on Figure 2.

**East facing view of the release area on the well pad.**

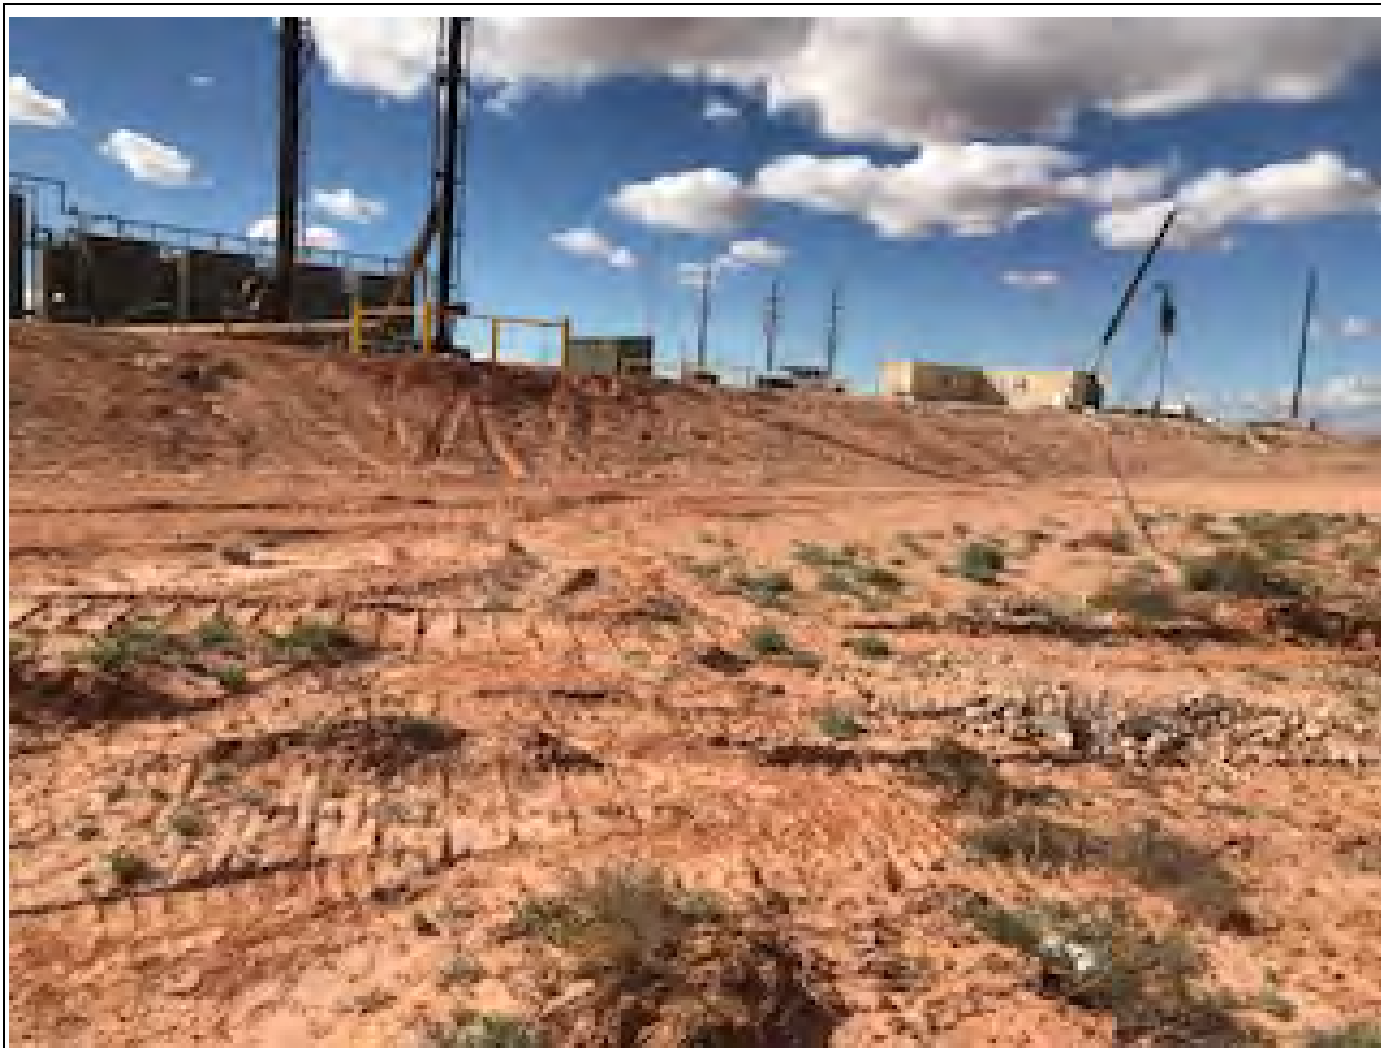
**South facing view of the release area north of the well pad.**
