Re: Remediation Summary and Closure Report
Myox 32 Fee #002H
API No. 30-015-41521
GPS: Latitude 32.093593 Longitude -104.110361
UL "N", Sec. 29, T25S, R28E
Eddy County, NM
NMOCD Ref. No. 2RP-4953

TRC Environmental Corporation (TRC), on behalf of COG Operating, LLC (COG), has prepared this Remediation Summary and Closure Report for the Release Site known as the **Myox 32 Fee #002H**. Details of the release are summarized below:

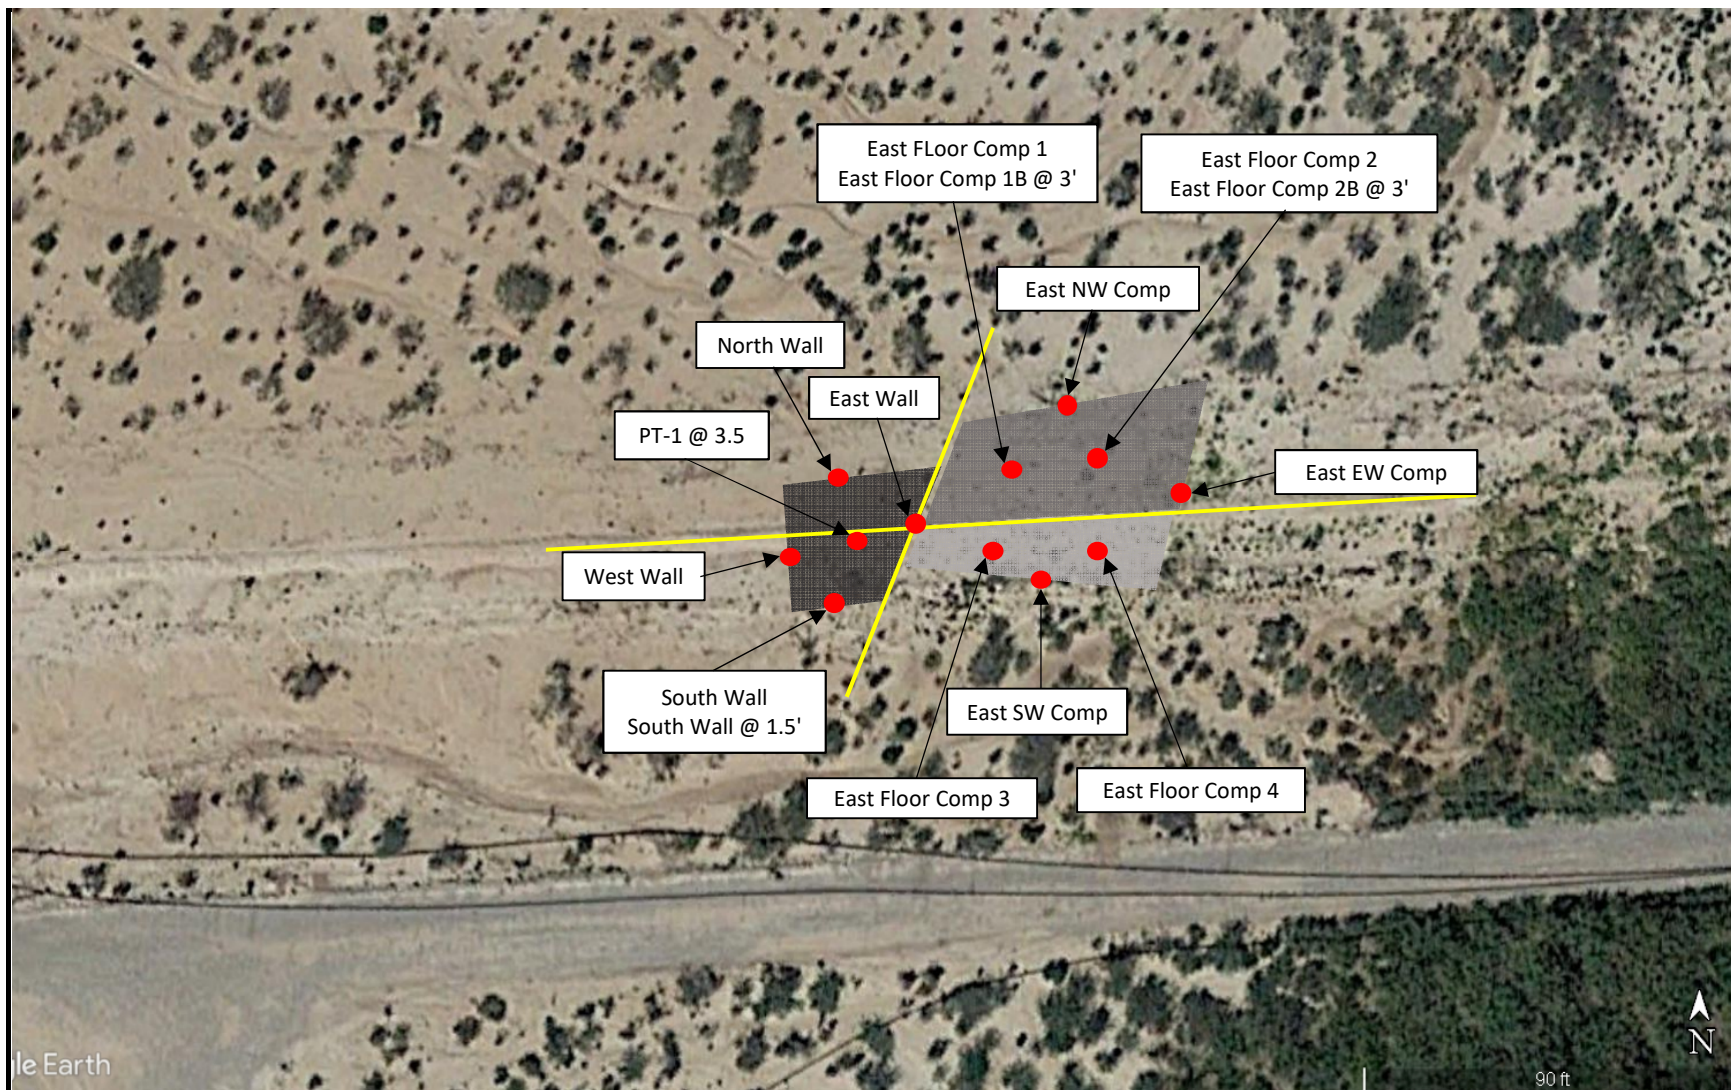
Excavated Area 3.5'
-

Excavated Area 3'
-

Excavated Area 2'
-

Site & Sample Location Map
 COG Operating, LLC
 Myox 32 Fee #002H
 Eddy County, NM

During the installation of a new underground flowline, a third-party contractor struck a COG underground trunk line resulting in the release of approximately fifty (50) barrels (bbls) of produce water. A vacuum truck was dispatched to the Release Site where it recovered forty-five (45) bbls of produced water. During initial response activities, a third party contractor repaired the damaged utility and conducted remediation activities, in an effort to advance the Site towards closure. TRC was later dispatched to the location and collected twelve (12) confirmation soil samples from the floor and sidewalls of the excavated area, each soil sample representing no more than 200 SqFt. The collected soil samples were submitted to the laboratory for analysis of Benzene, BTEX, TPH, and/or chloride concentrations. Upon receiving laboratory analytical data, sample areas exhibiting chloride concentrations above NMOCD Closure Criteria were advanced until visual and olfactory evidence suggested concentrations were below NMOCD Closure Criteria. An additional three (3) soil samples were collected from the floor and sidewalls of the excavated area representing no more than 200 SqFt. The collected samples were submitted to the laboratory for analysis of chloride concentrations. Upon receiving laboratory analytical results exhibiting concentrations below NMOCD Closure Criteria, the third-party contractor was dispatched to the Site and impacted soil was transported under manifest to a NMOCD-approved facility. The excavated area was backfilled with locally sourced, non-impacted "like" material. Figure 3 depicts the locations of confirmation soil samples. A table summarizing laboratory analytical results from confirmation soil samples is provided below:

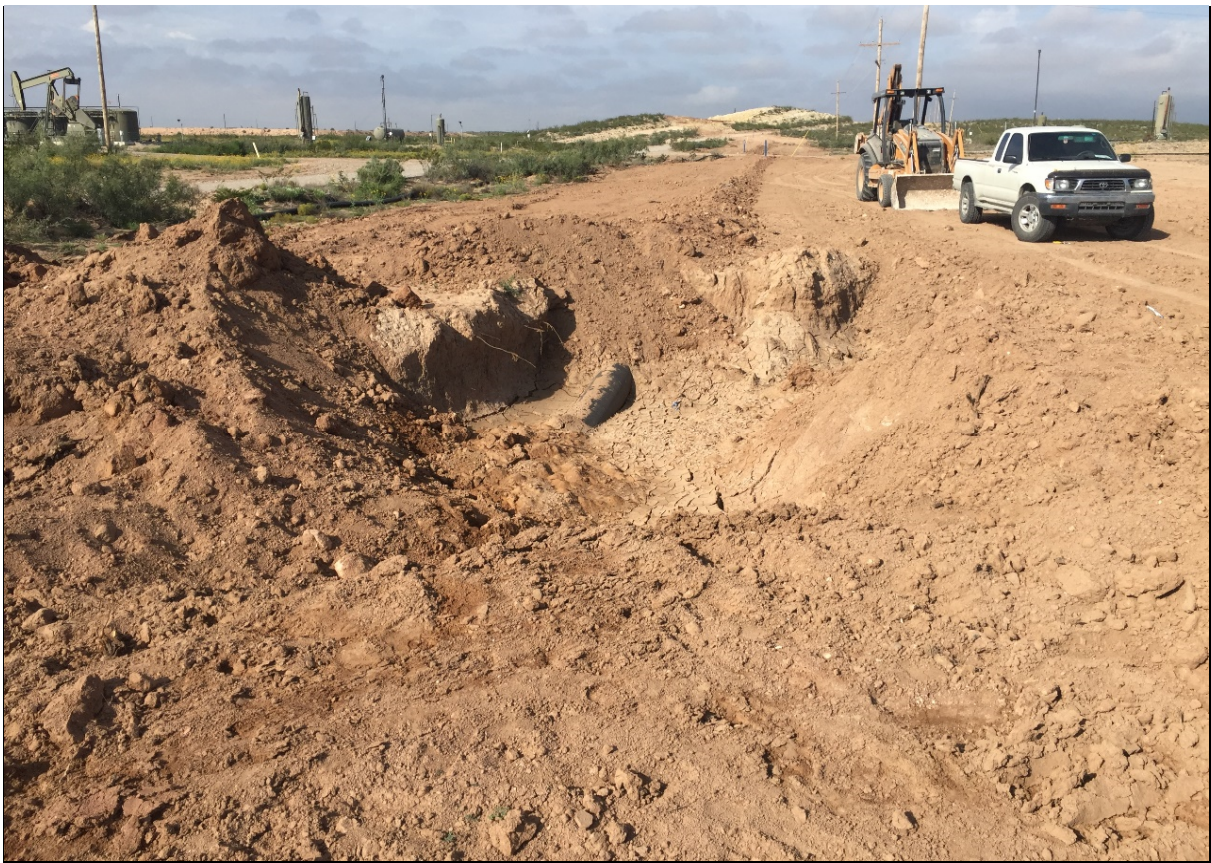
Photo 1 - View of affected area prior to remediation activities, facing West.

The release was caused by a 3rd party hitting our trunk line. The damaged line is being replaced. The release was in the pasture. A vacuum truck was dispatched to remove all freestanding fluids. Concho will evaluate the site to determine if we may commence remediation immediately or delineate any possible impact from the release and we will present a remediation work plan to the NMOCD for approval prior to any significant remediation activities

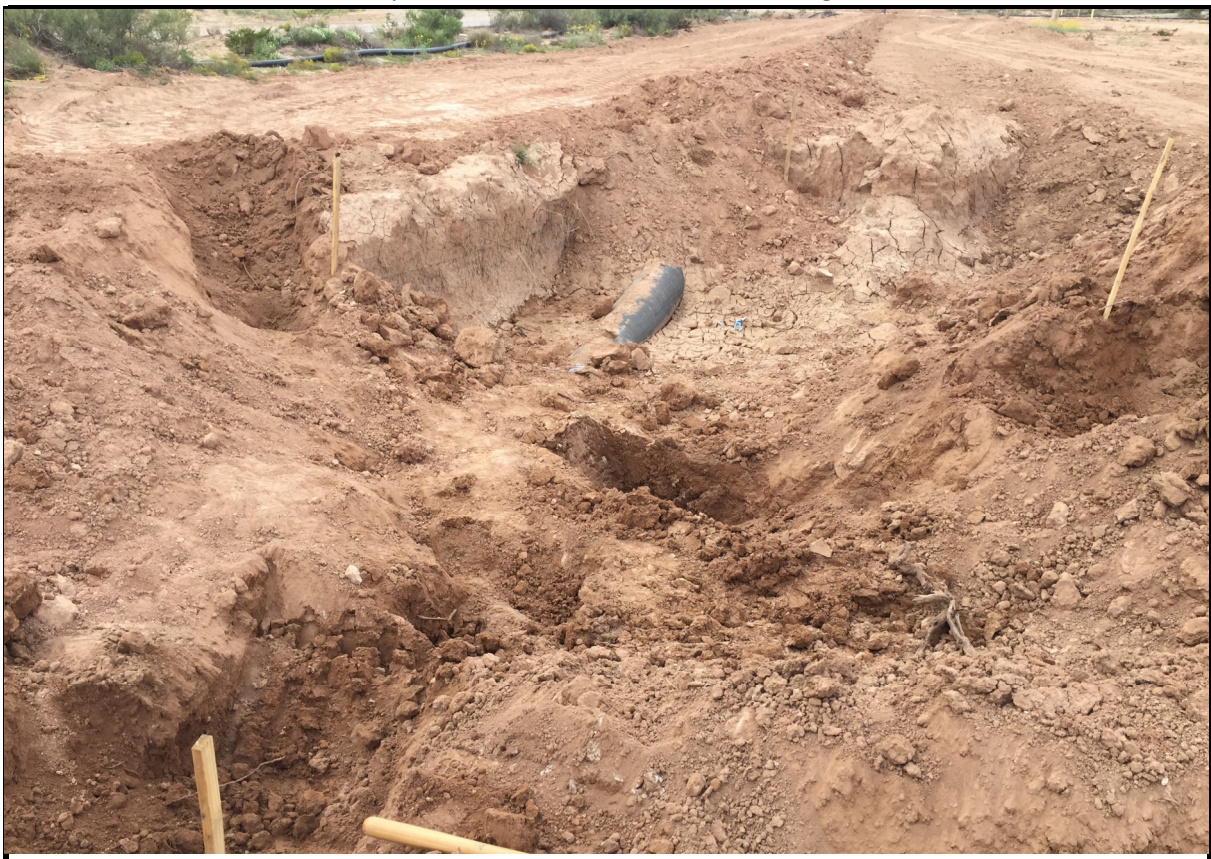
Photo 2 - View of affected area prior to remediation activities, facing East.

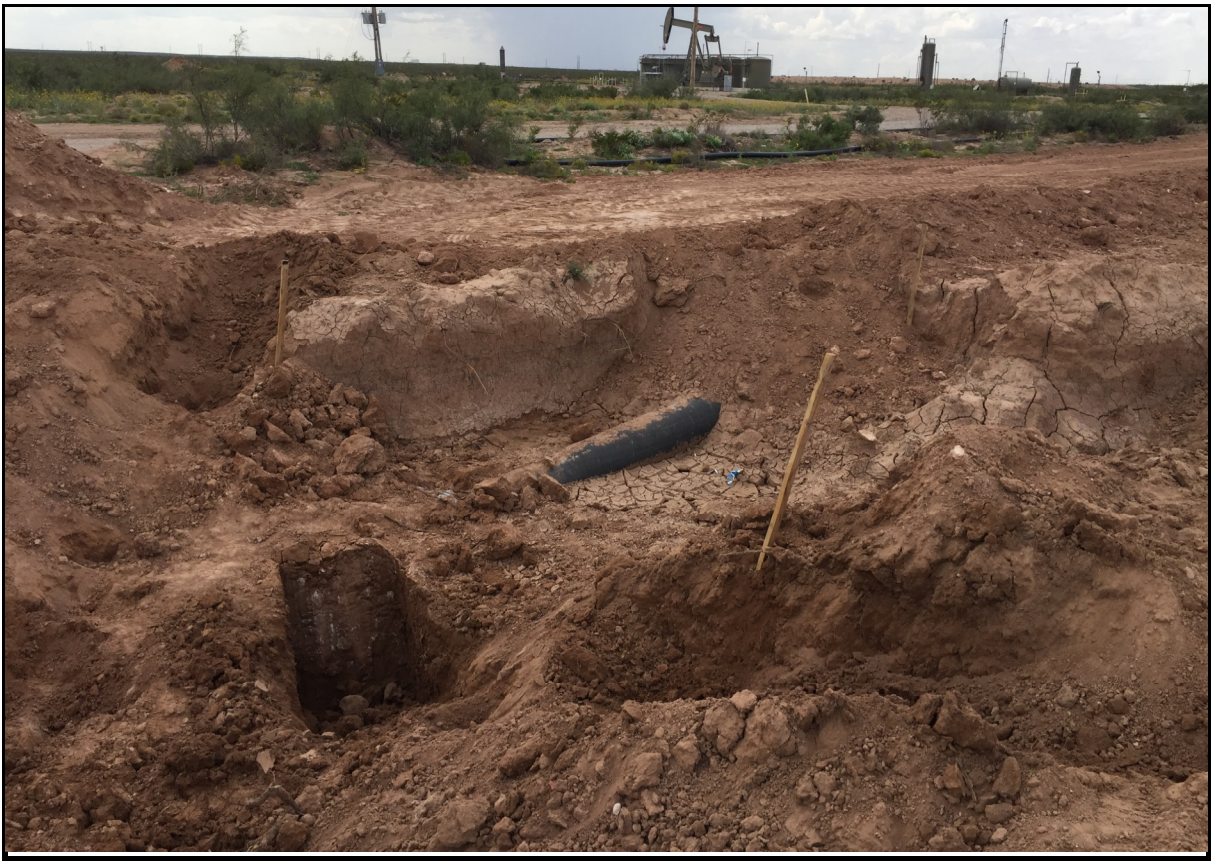
Photo 3 - View of affected area prior to remediation activities, facing South.
