**RE: Closure Request  
Poker Lake Unit #192Q  
Remediation Permit Number 2RP-5229  
Eddy County, New Mexico**

LT Environmental, Inc. (LTE), on behalf of XTO Energy, Inc. (XTO), presents the following report detailing excavation and soil sampling activities at the Poker Lake Unit #192Q (Site) in Unit H, Section 7, Township 24 South, Range 30 East, in Eddy County, New Mexico (Figure 1). The purpose of the soil sampling and excavation activities was to address impacts to soil after fluid was released from a flow line.

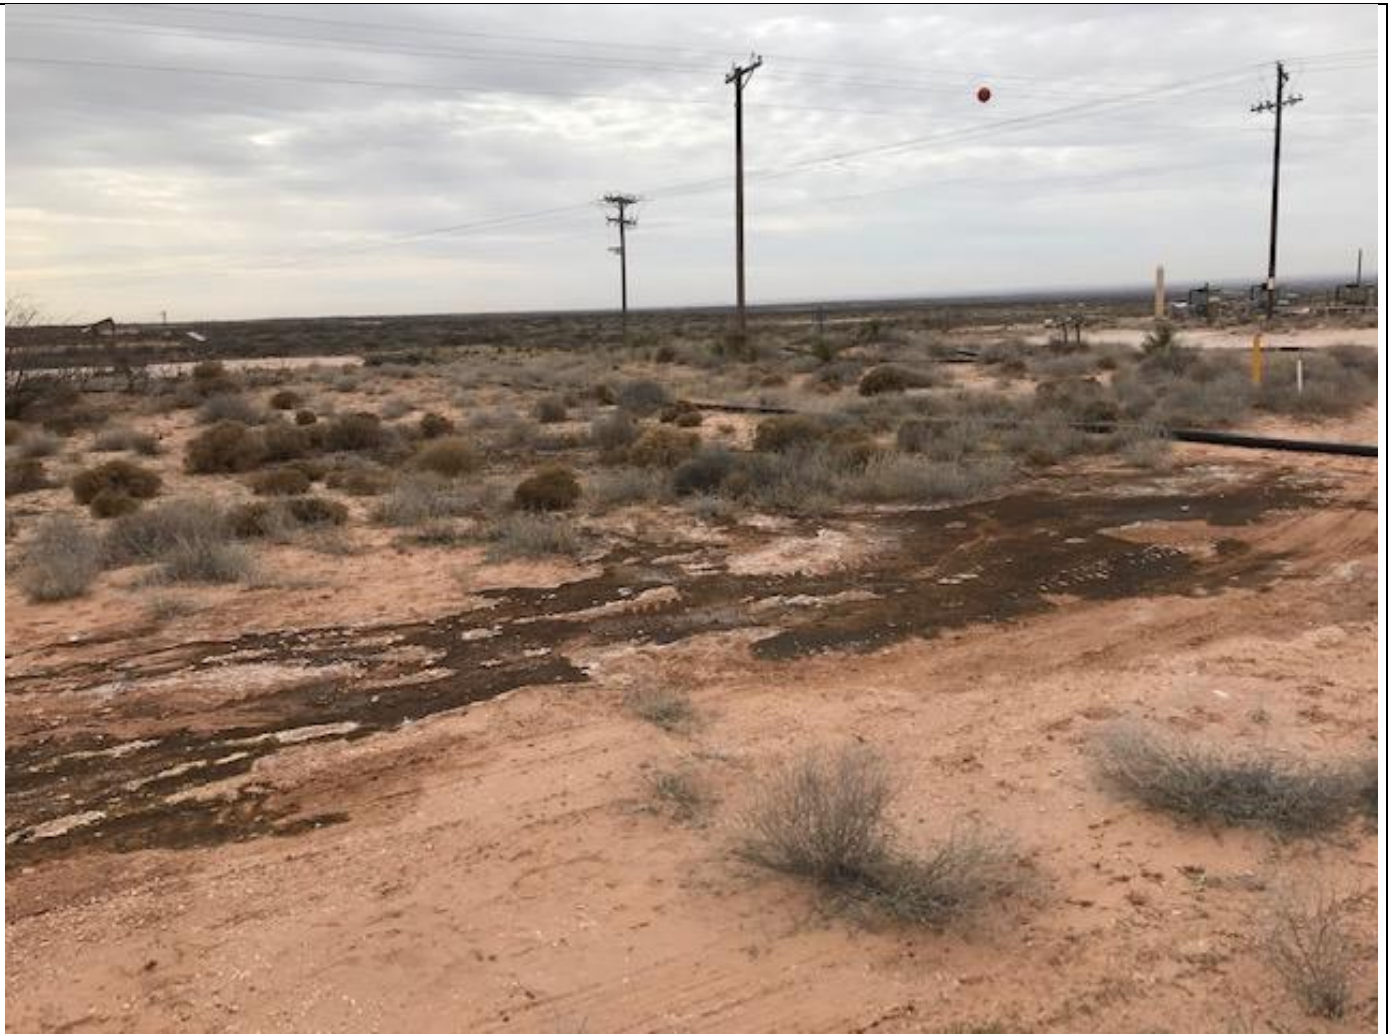
On January 29, 2019, LTE personnel inspected the Site to evaluate the release extent. Surface staining was observed in the release area within the process equipment berm. The release extent was mapped using a handheld Global Positioning System (GPS) unit and is depicted on Figure 2. LTE personnel collected five preliminary soil samples (SS01 through SS05) within the release area from a depth of 0.5 feet bgs to assess the lateral extent of impacted soil. The soil sample locations were selected based on field observations and information provided on the NMOCD Form C-141.

If you have any questions or comments, please do not hesitate to contact Ms. Adrian Baker at (432) 887-1255.
