**Report Type: Closure Report      2RP-5165**

Site:	Myox 8 State #004H					
Company:	COG Operating LLC					
Section, Township and Range	Unit D	Sec. 17	T 26S	R 28E		
Lease Number:	API No. 30-015-41924					
County:	Eddy County					
GPS:	32.04965			-104.11487		
Surface Owner:	State					
Directions:	From the intersestion of Hwy 285 and Whites City Rd., head west on Whites City Rd. for 3.1 miles, turn left (south) onto unnamed lease road and go 1.1 miles, turn left (east) and go 0.18 miles and arrive on location.

**Re: Closure Report for COG Operating, LLC, Myox 8 State #004H, Unit D, Section 17, Township 26 South, Range 28 East, Eddy County, New Mexico. 2RP-5165**

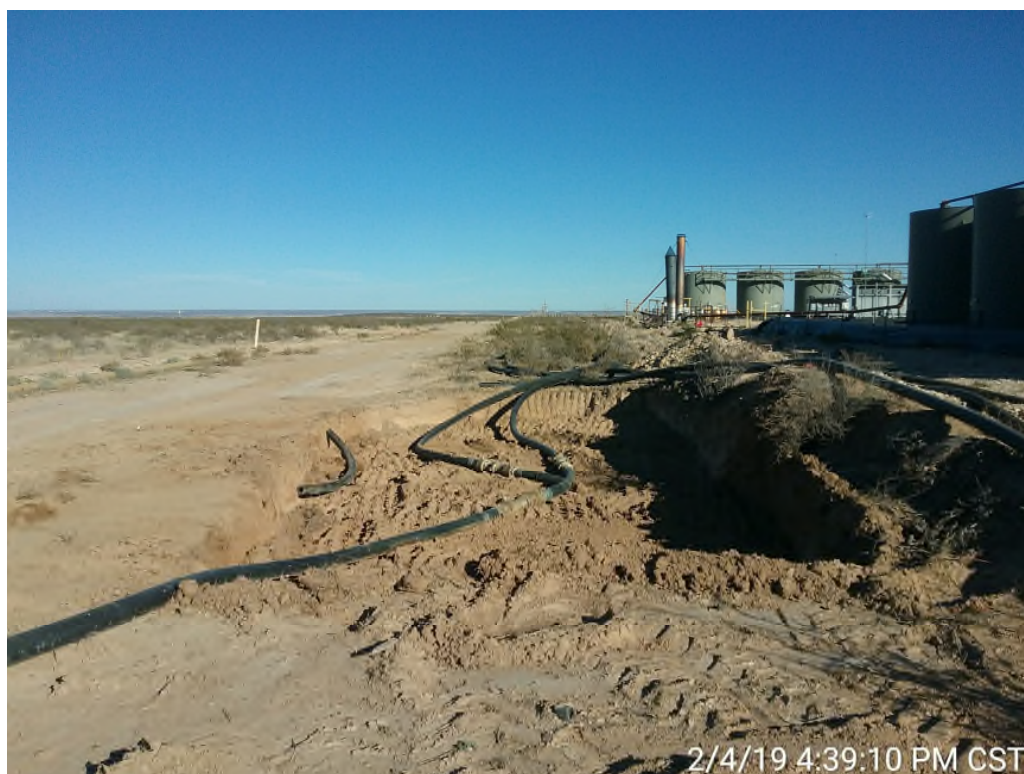
Area of Excavation – View to East

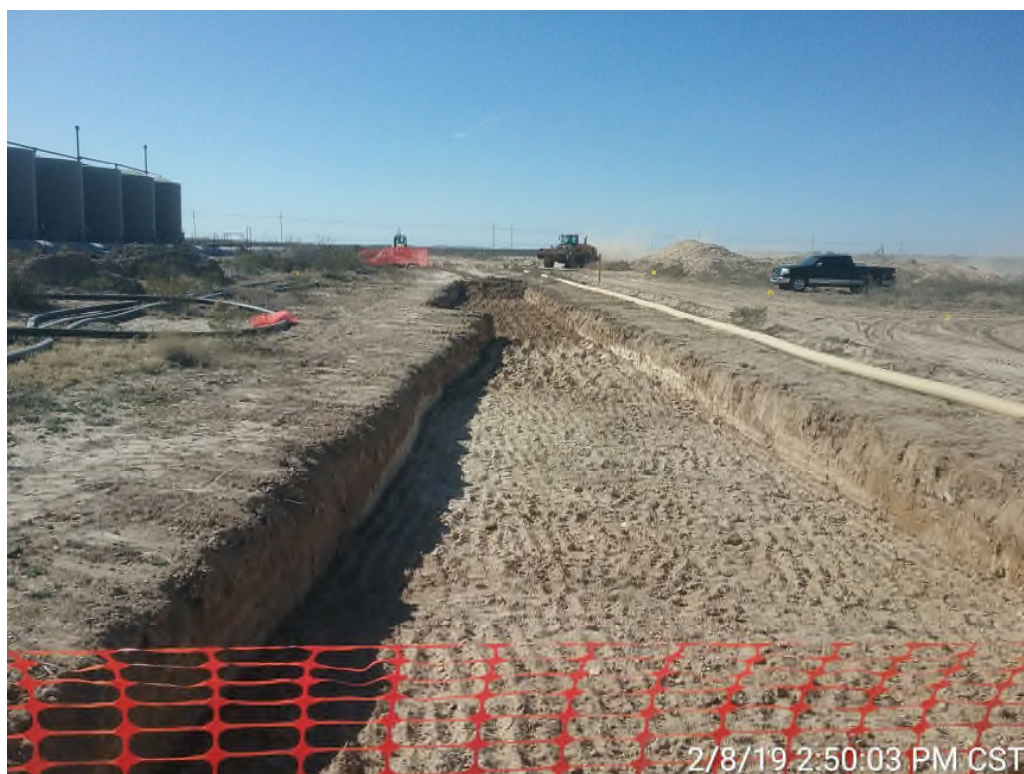
Area of Excavation – View to West

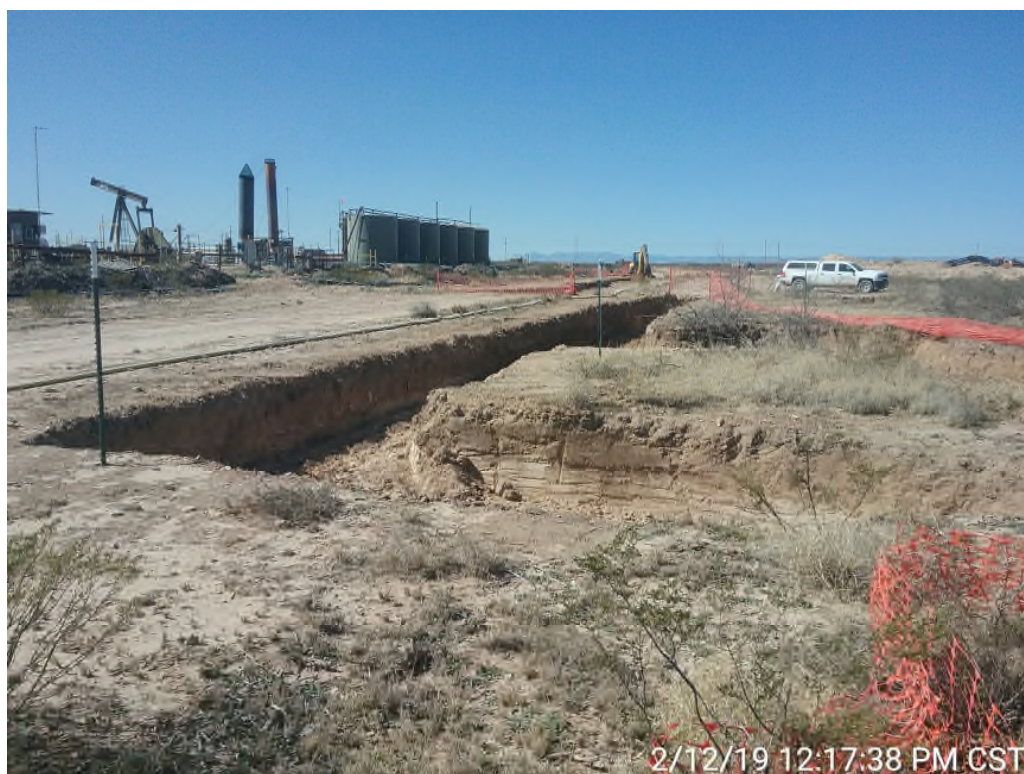
Area of Excavation – View to West-southwest
