**Report Type: Closure Report      2RP-5165**

Site:	Myox 8 State #004H					
Company:	COG Operating LLC					
Section, Township and Range	Unit D	Sec. 17	T 26S	R 28E		
Lease Number:	API No. 30-015-41924					
County:	Eddy County					
GPS:	32.04965			-104.11487		
Surface Owner:	State					
Directions:	From the intersestion of Hwy 285 and Whites City Rd., head west on Whites City Rd. for 3.1 miles, turn left (south) onto unnamed lease road and go 1.1 miles, turn left (east) and go 0.18 miles and arrive on location.

**Re: Revised Closure Report for COG Operating, LLC, Myox 8 State #004H, Unit D, Section 17, Township 26 South, Range 28 East, Eddy County, New Mexico. 2RP-5165**

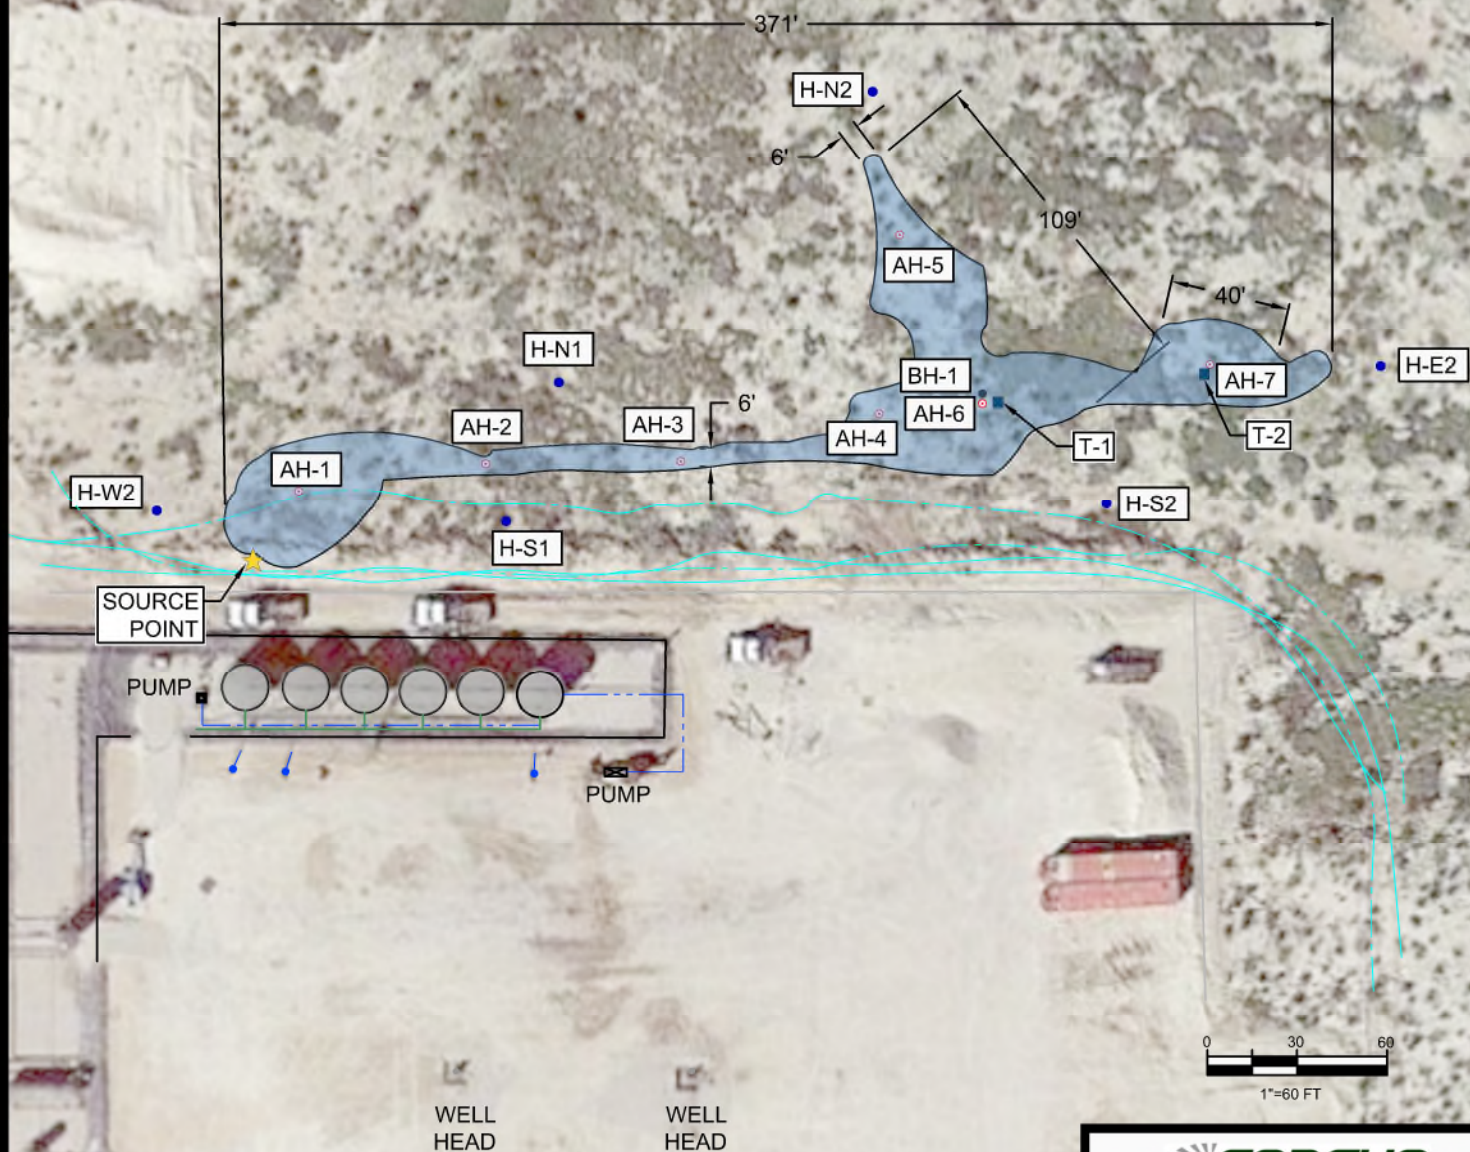
On January 16, 2019, Tetra Tech personnel were onsite to install auger holes in the release area. A total of seven (7) auger holes (AH-1, AH-2, AH-3, AH-4, AH-5, AH-6, and AH-7) were installed to total depths ranging from 1' to 2.5' below surface. Additionally, six (6) horizontal delineation samples (Horizontal North-1, Horizontal North-2, Horizontal East-1, Horizontal South-1, Horizontal South-2, and Horizontal West-1) were collected outside of the spill footprint. Soil samples were collected and submitted to the laboratory for TPH analysis by EPA method 8015 modified, BTEX by EPA Method 8021B, and chloride by EPA method 300.0. Copies of laboratory analysis and chain-of-custody documentation are included in Appendix C. The results of the sampling are summarized in Table 1. The sample locations are shown on Figure 3.

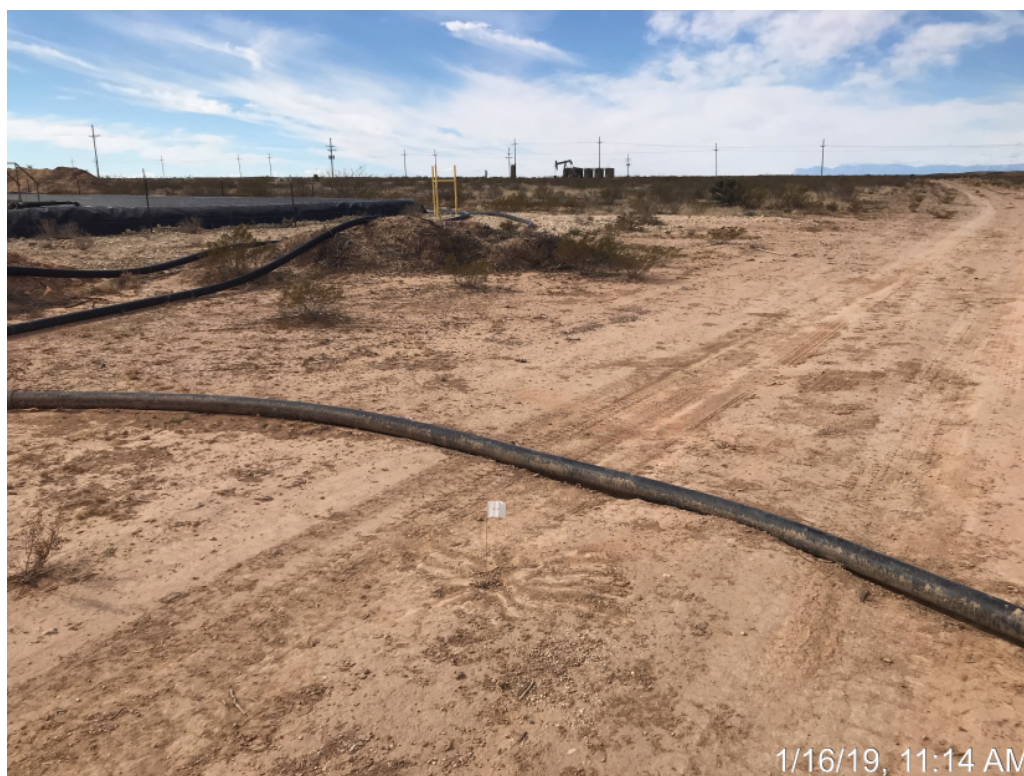
Area of H-W1 – View to West

Referring to Table 1, the horizontal delineation samples (Horizontal North-1, Horizontal North-2, Horizontal East-1, Horizontal South-1, Horizontal South-2, and Horizontal West-1) did not show any benzene, total BTEX, or total TPH above the laboratory reporting limits. Additionally, no samples showed chloride concentrations above the RRAL, with concentrations ranging from below the laboratory reporting limit to 91.7 mg/kg.

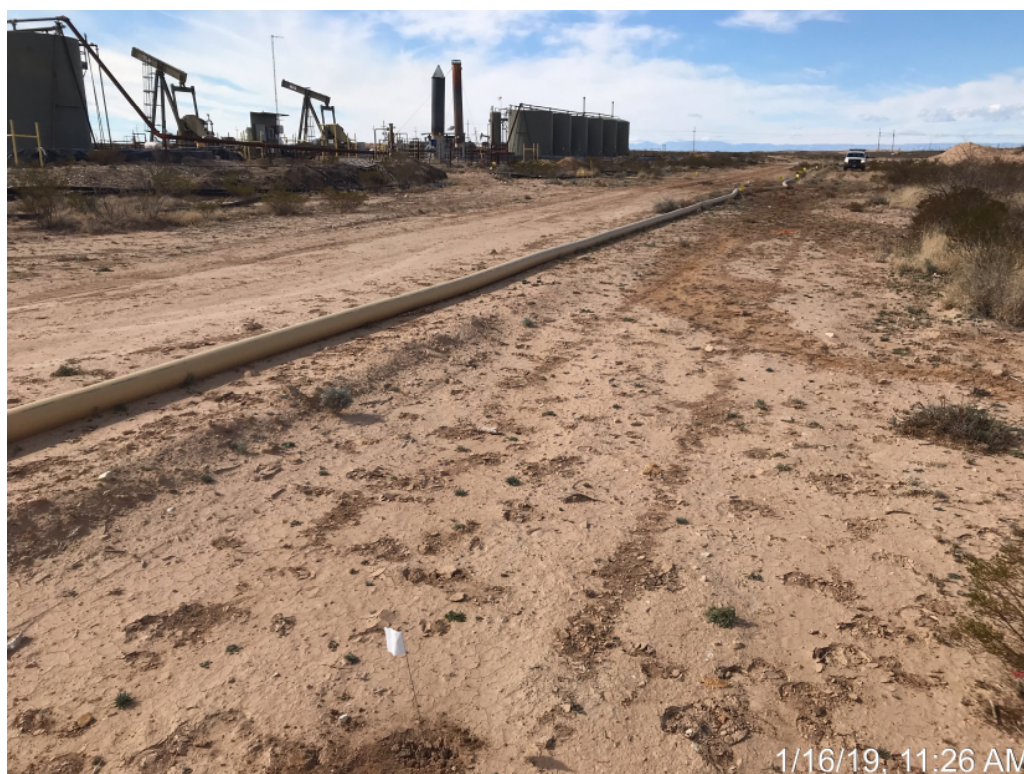
Area of H-E1 – View to West

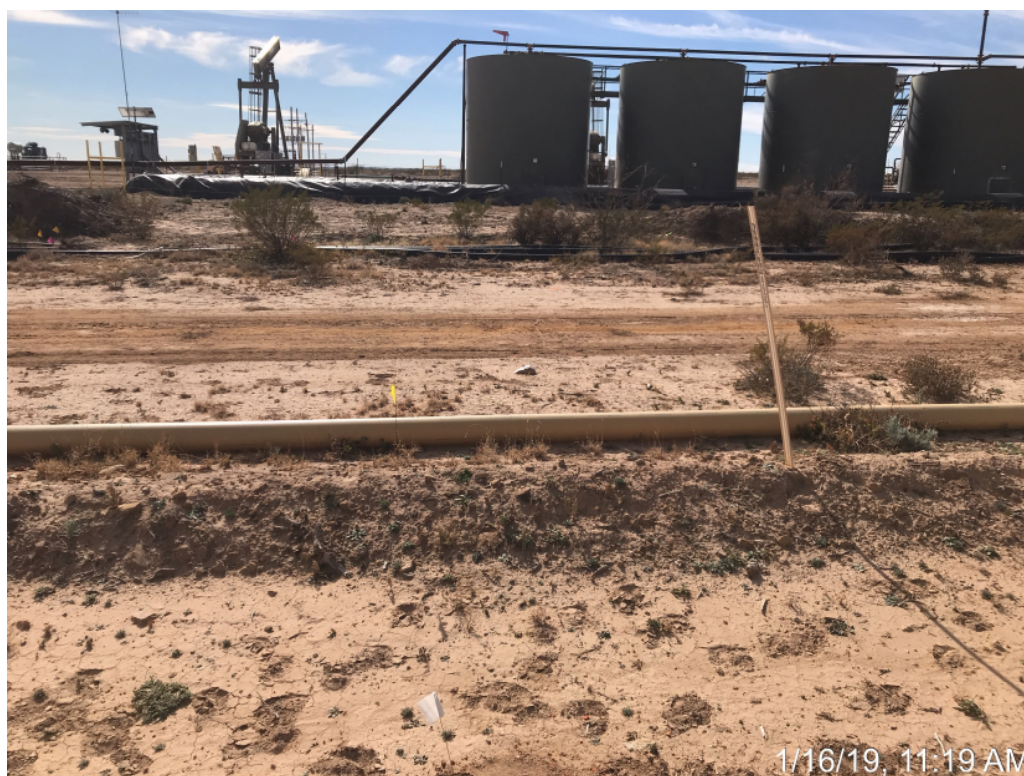
Area of H-N1 – View to South

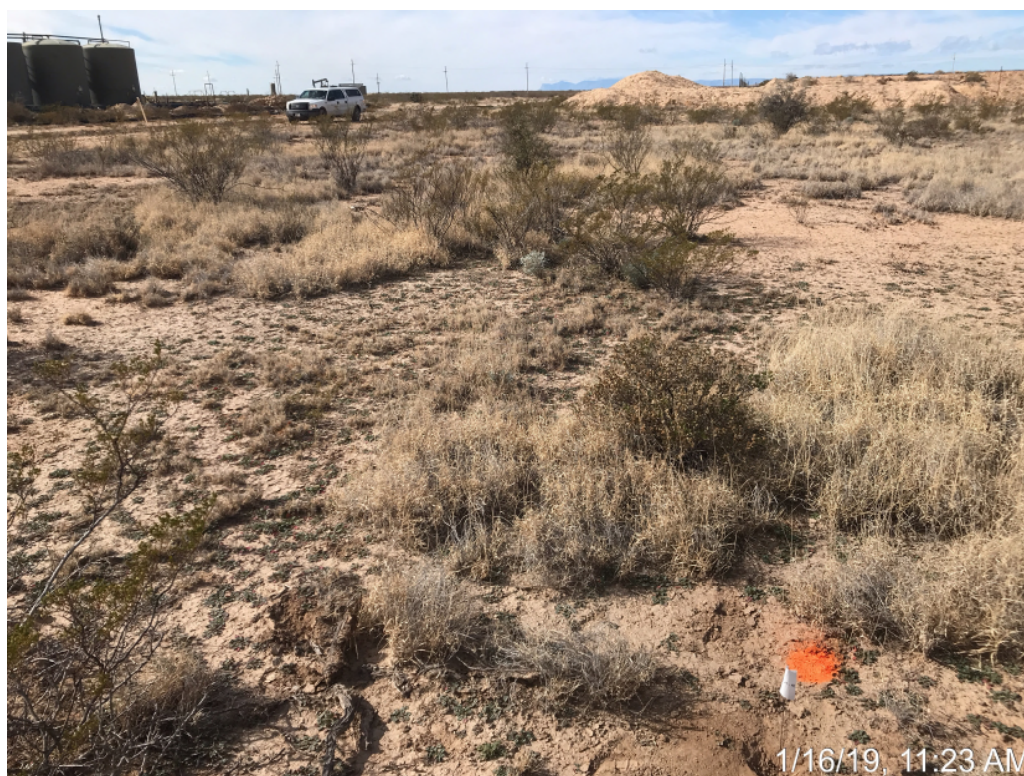
Area of H-N2 – View to West

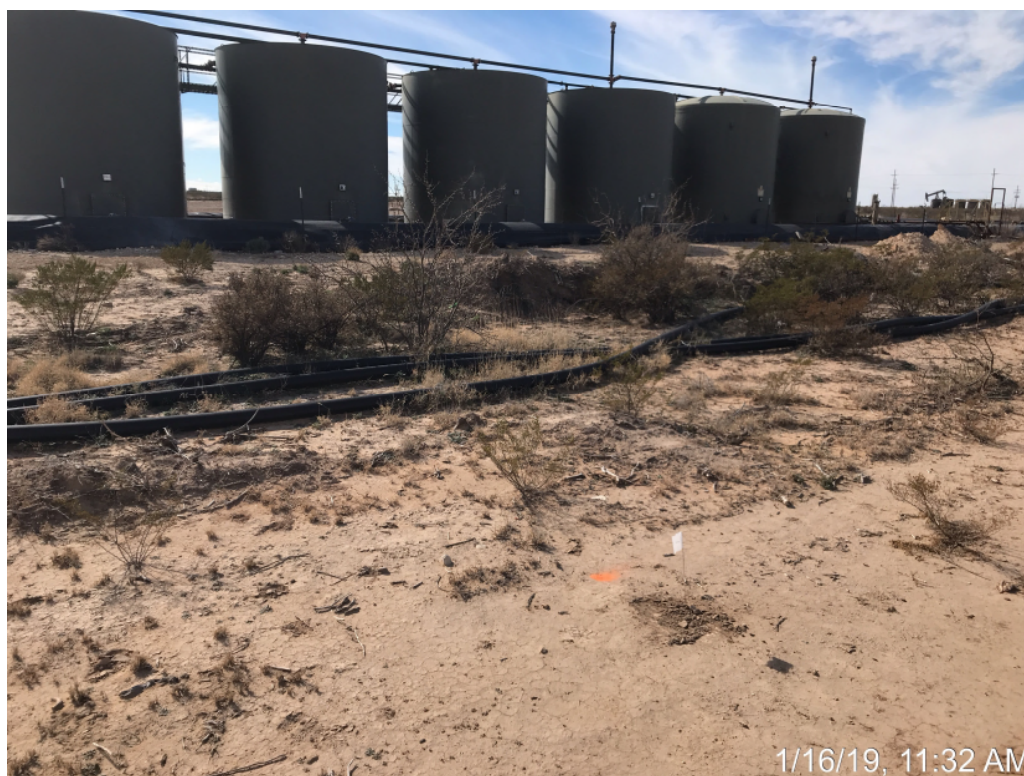
Area of H-S1 – View to Southwest

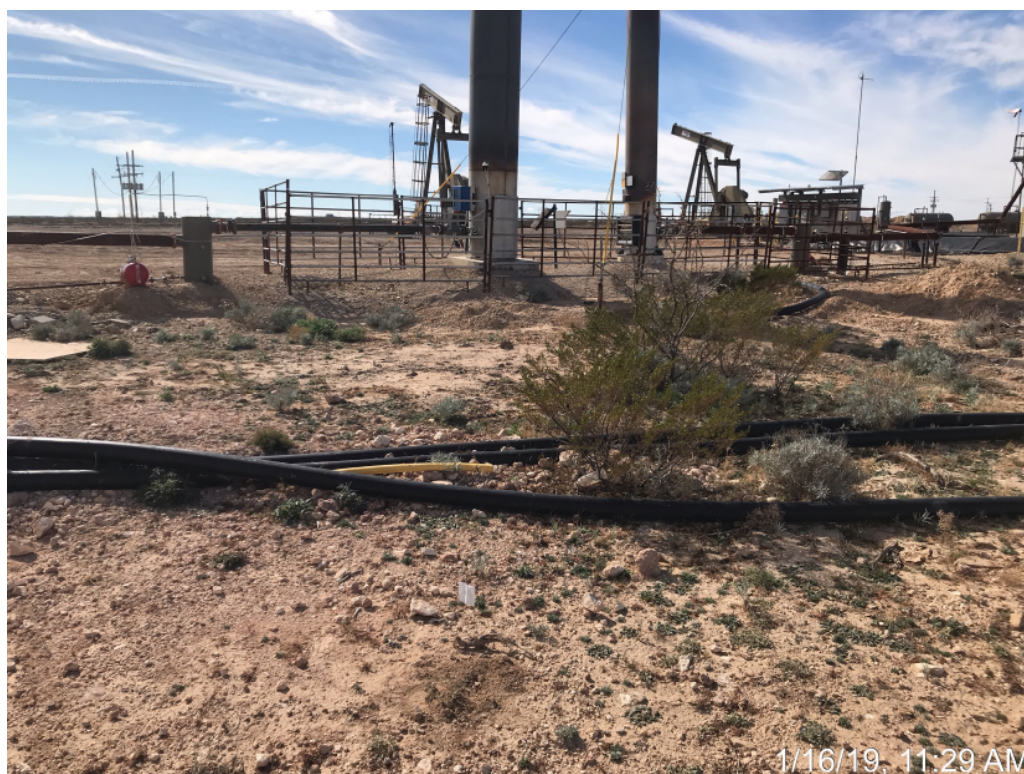
Area of H-S2 – View to South

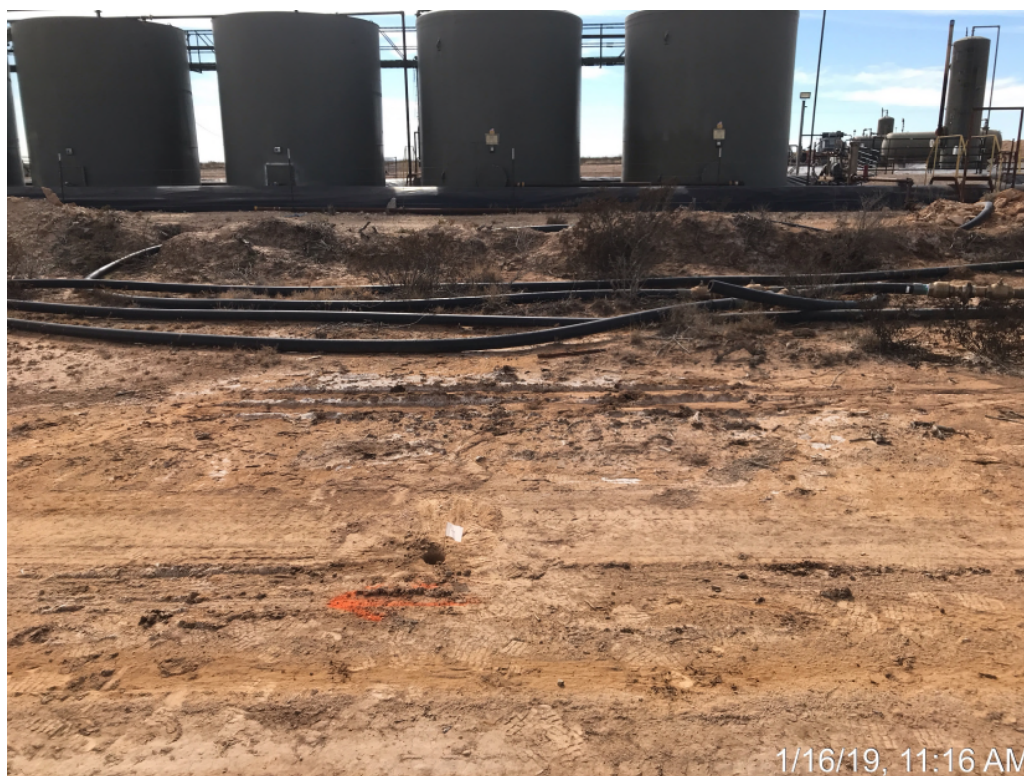
Area of AH-1 – View to South

Referring to Table 1, the areas of auger holes (AH-1, AH-2, AH-3, AH-4, AH-5, AH-6, and AH-7) did not show any benzene, total BTEX, or total TPH above the laboratory reporting limits. The areas of auger holes (AH-1, AH-2, AH-3, AH-4 and AH-5) showed chloride highs at 0-1' below surface of 8,340 mg/kg (AH-1), 4,880 mg/kg (AH-2), 8,570 mg/kg (AH-3), 935 mg/kg (AH-4), and 10,900 mg/kg (AH-5). Chloride concentrations decreased with depth to below the RRAL in auger holes (AH-1, AH-2, and AH-4) at 1-1.5' below surface and in auger holes (AH-3 and AH-5) at 2-2.5' below surface. The areas of auger holes (AH-6 and AH-7) were not vertically defined.

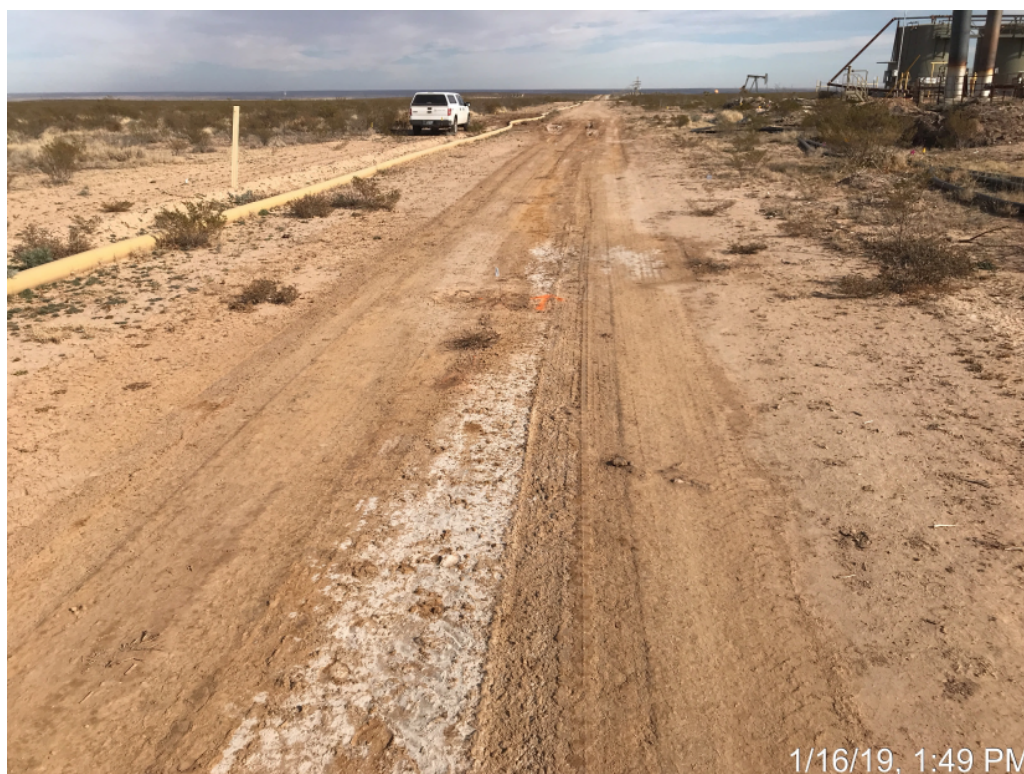
Area of AH-2 – View to East

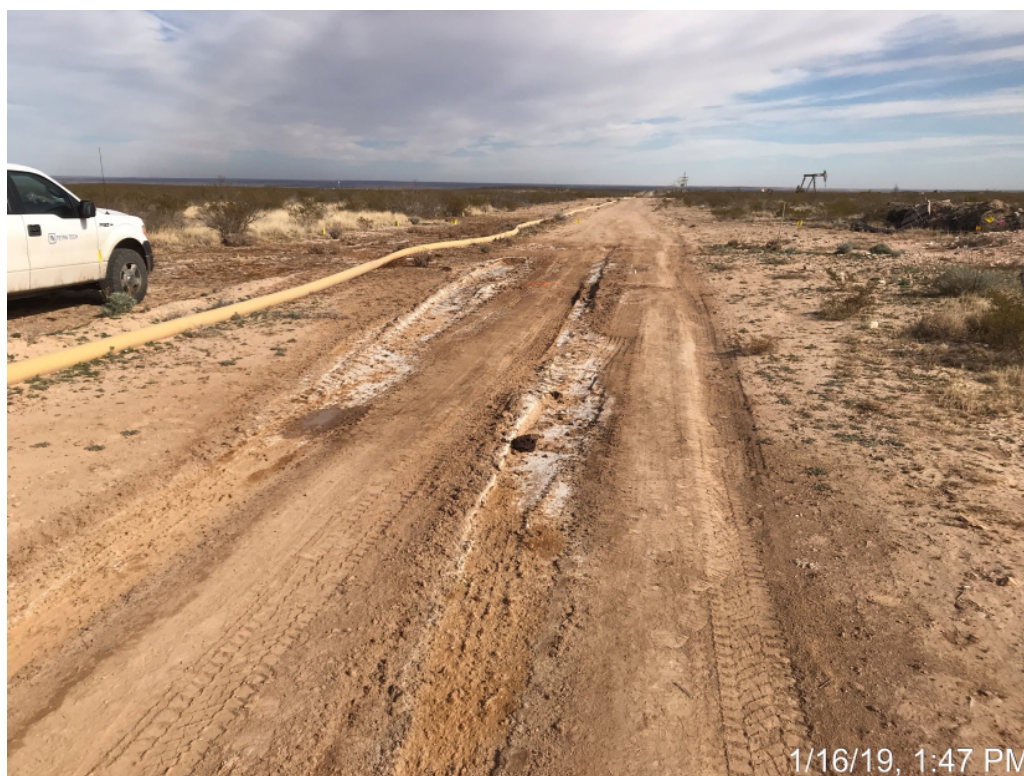
Area of AH-3 – View to East

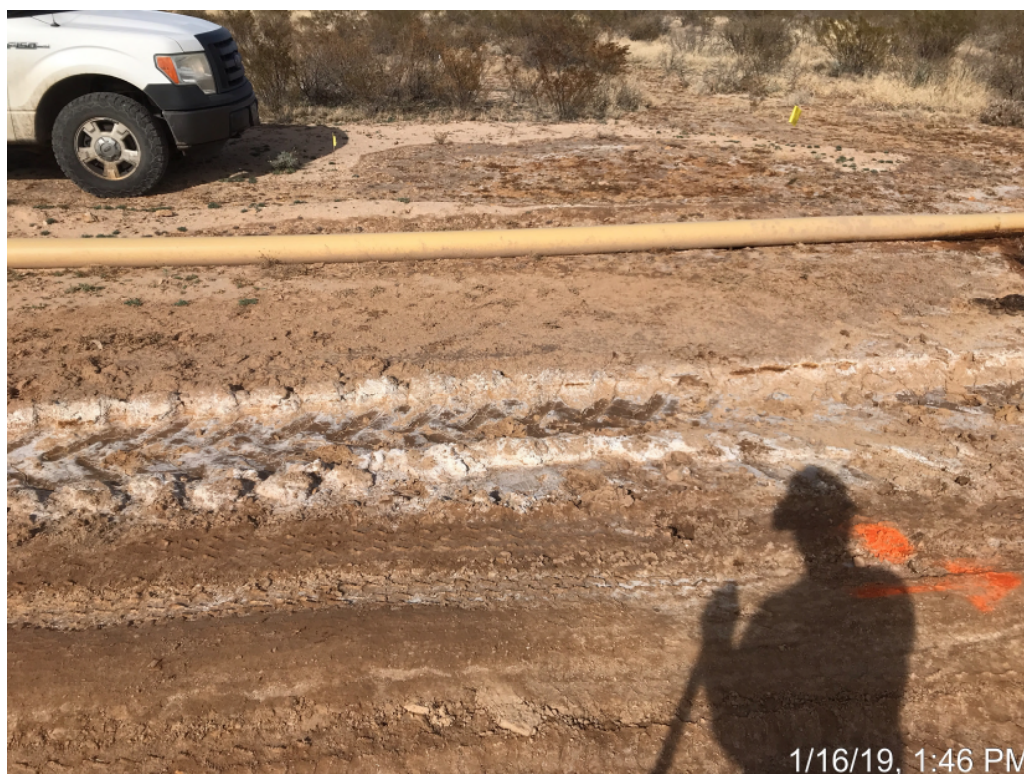
Area of AH-4 – View to North

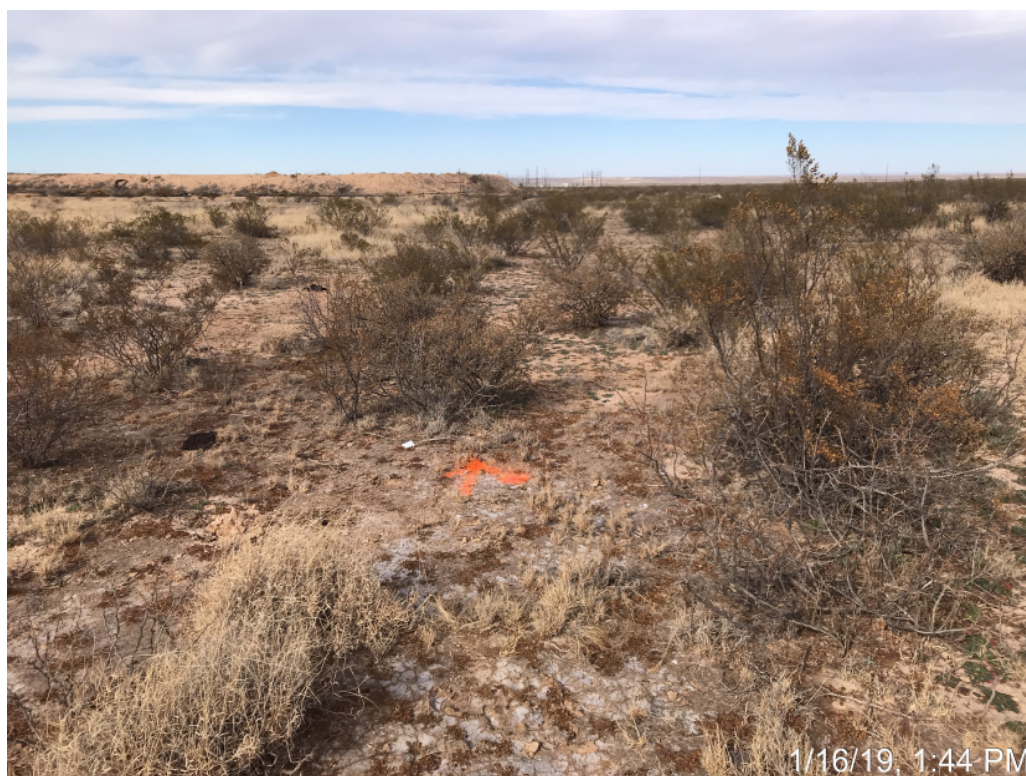
Area of AH-5 – View to North

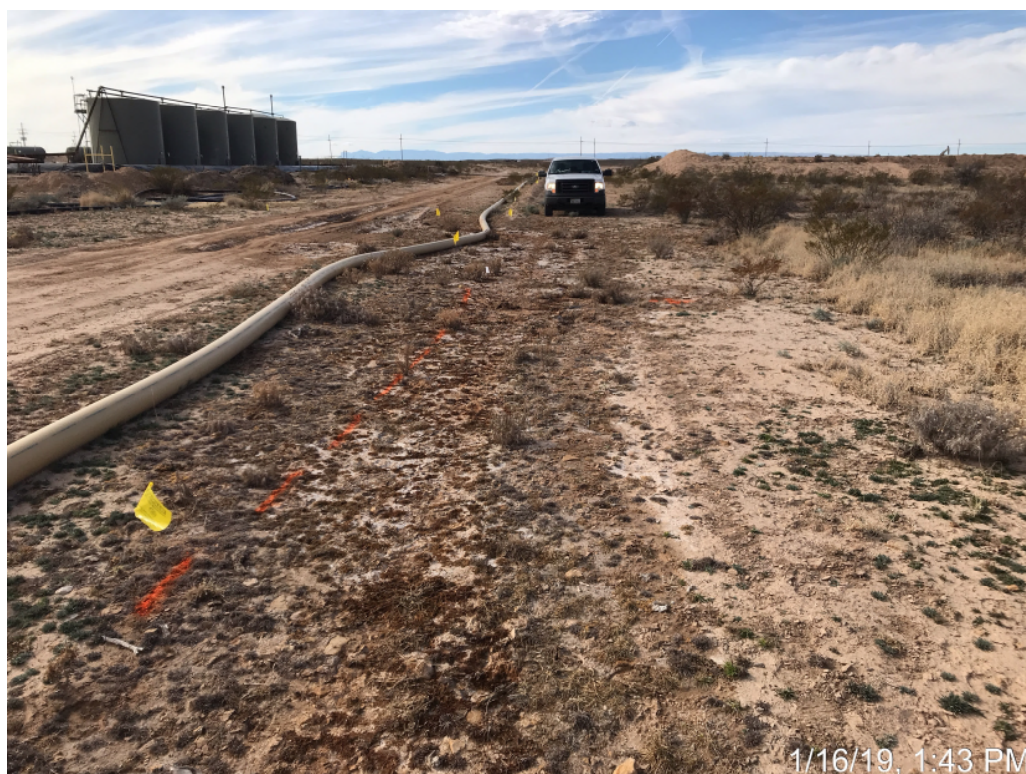
Area of AH-6 – View to West

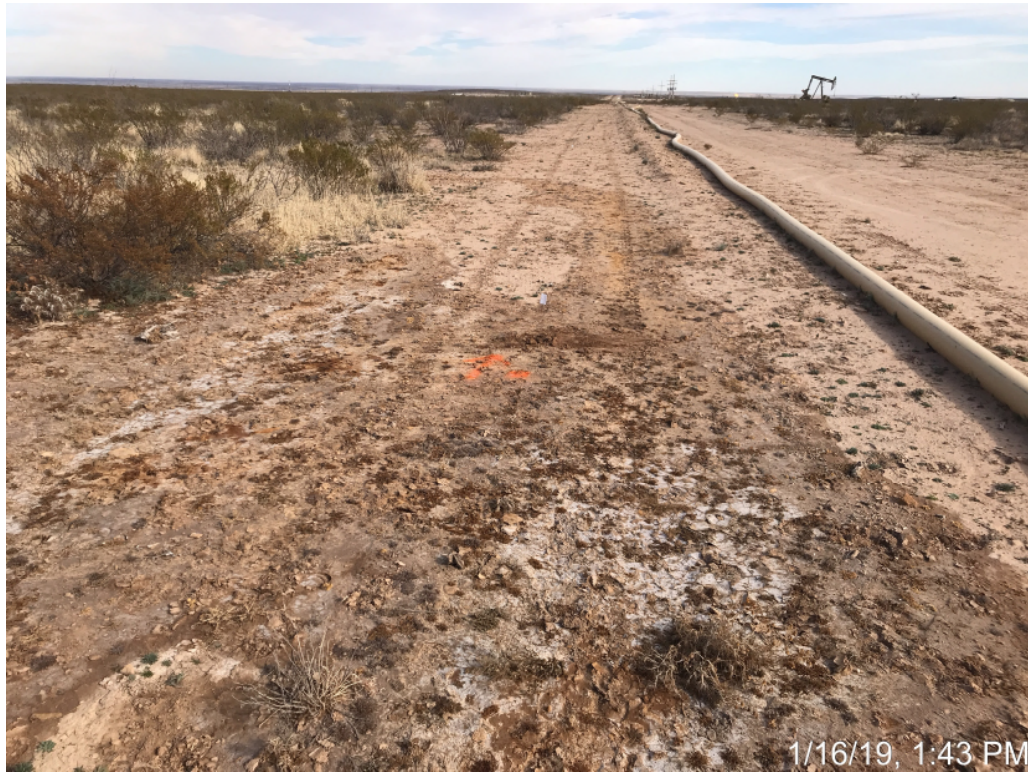
Area of AH-7 – View to East

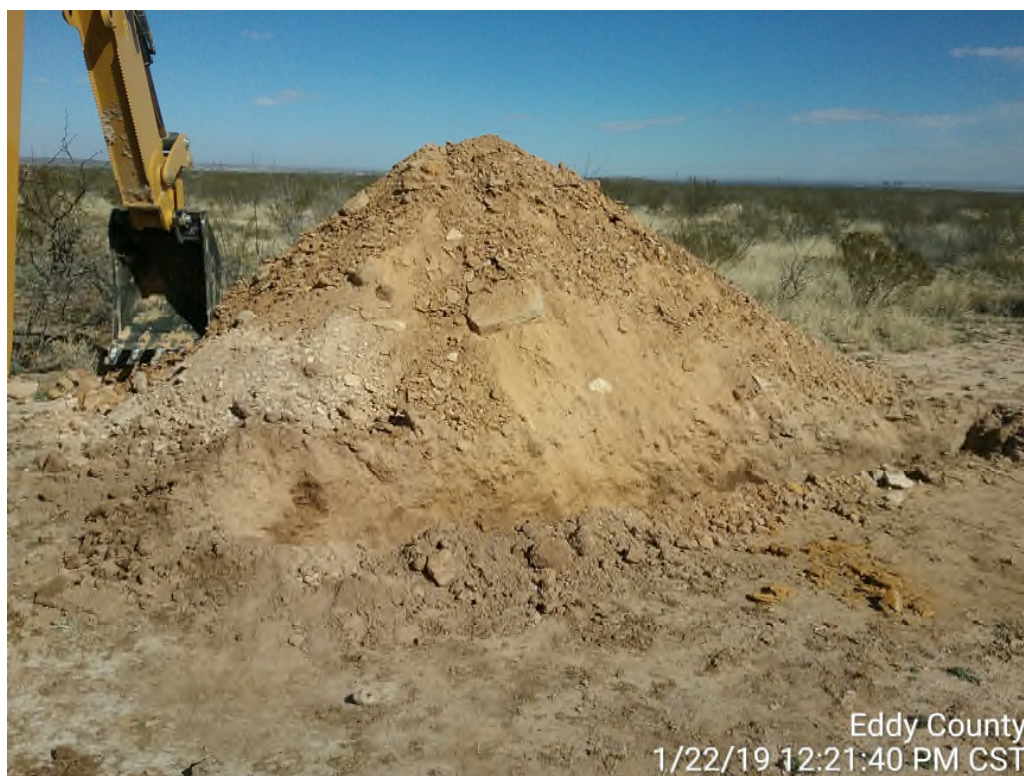
Area of T-1 – View to Northeast

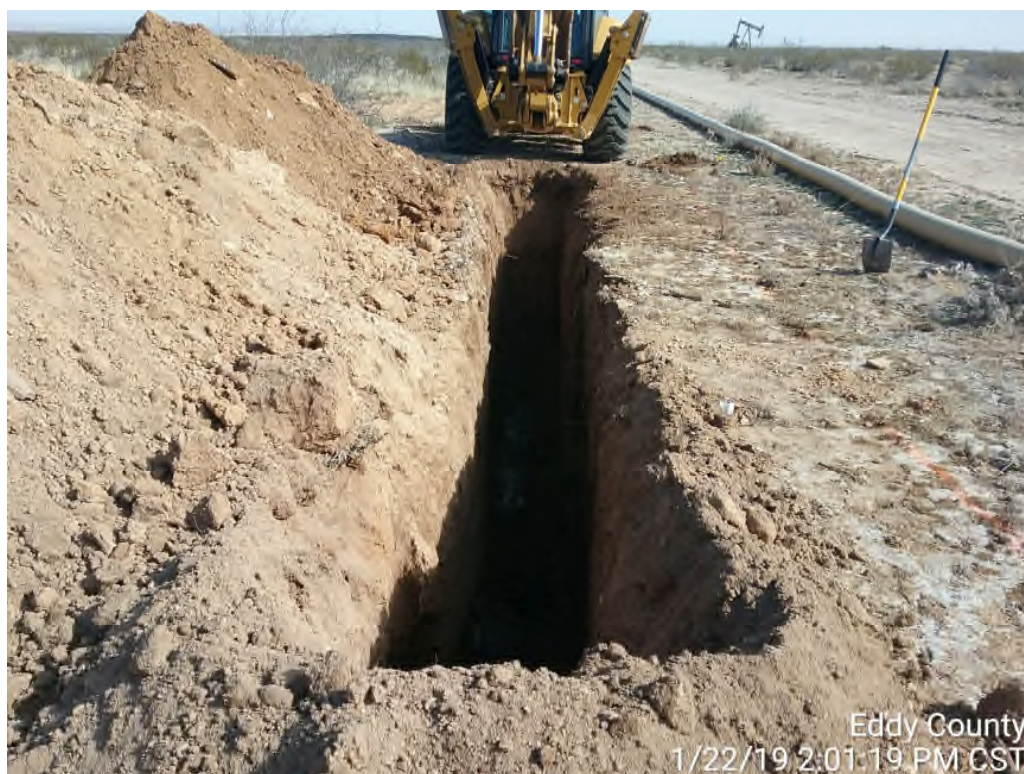
Area of T-2 – View to East

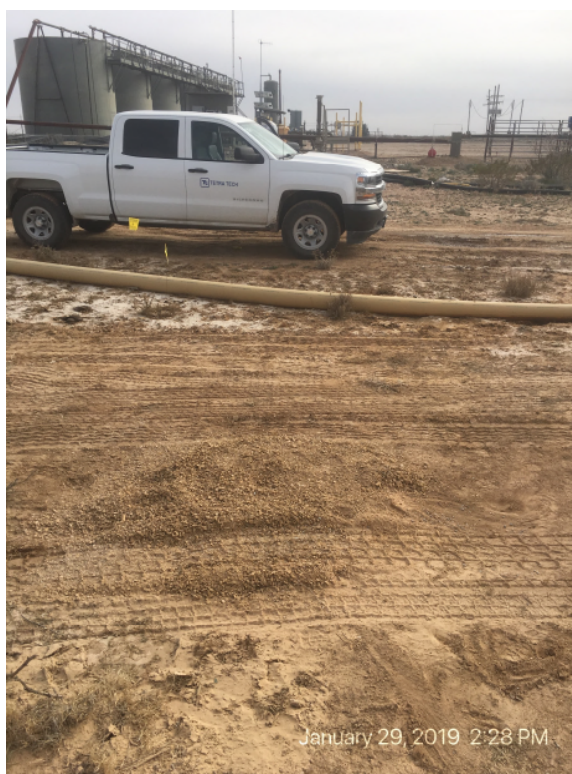
Area of BH-1 – View to South

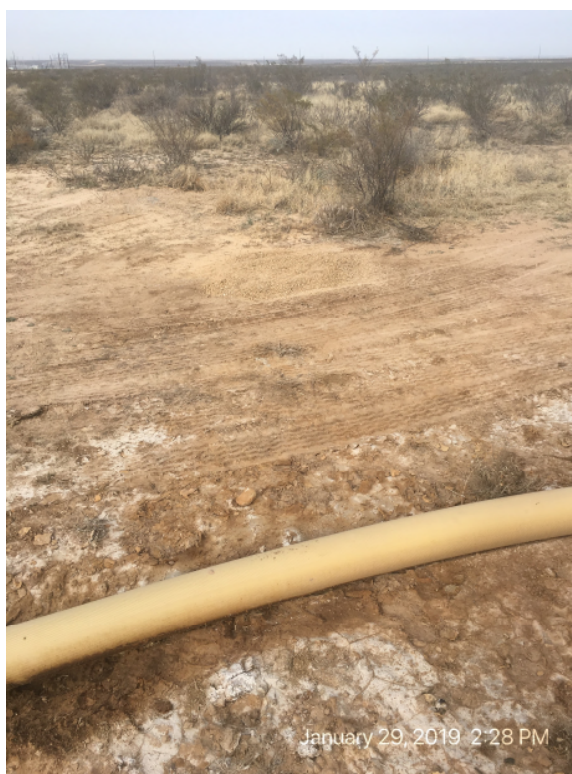
Area of BH-1 – View to North-northeast

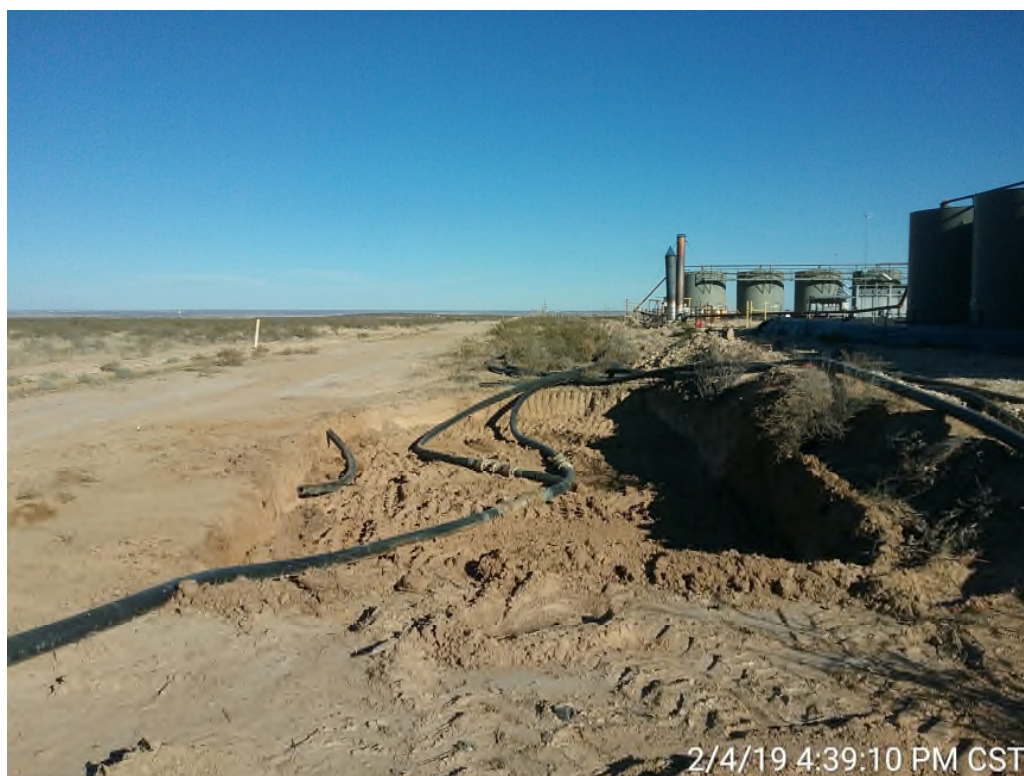
Area of Excavation – View to East

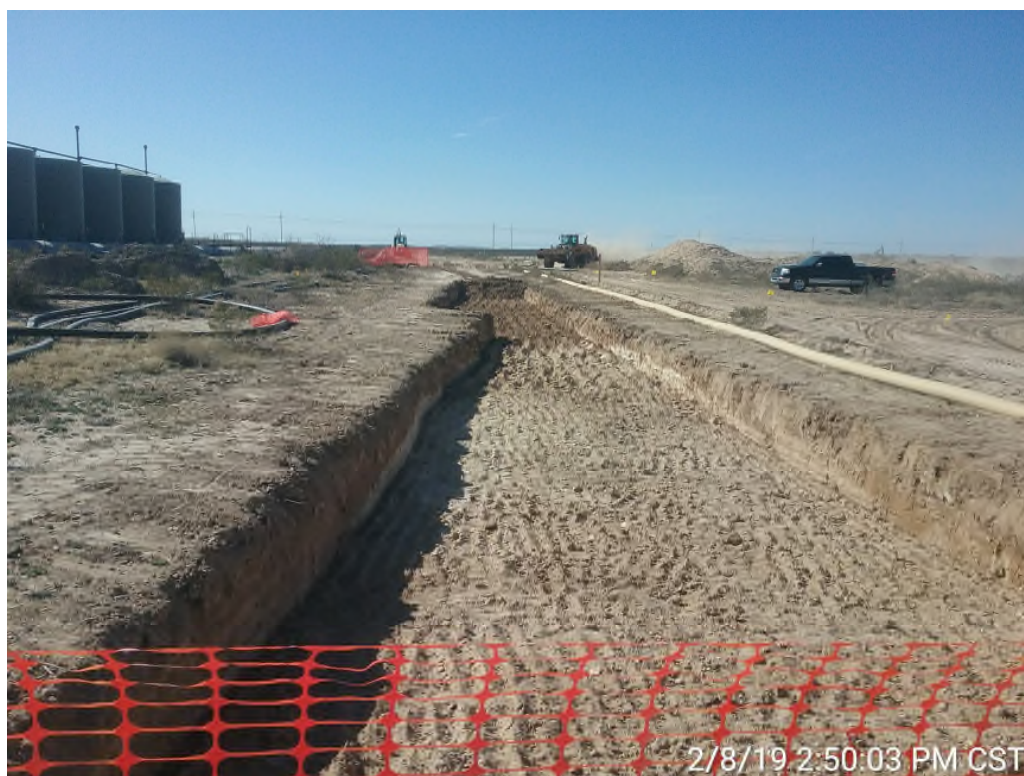
Area of Excavation – View to West

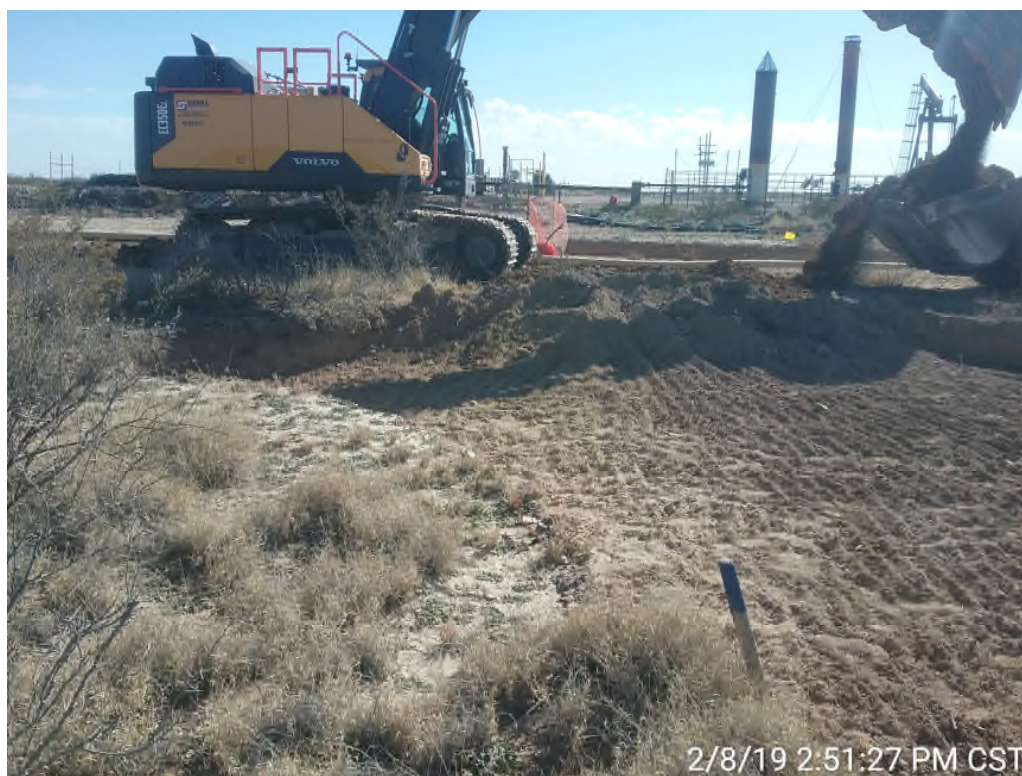
Area of Excavation – View to South

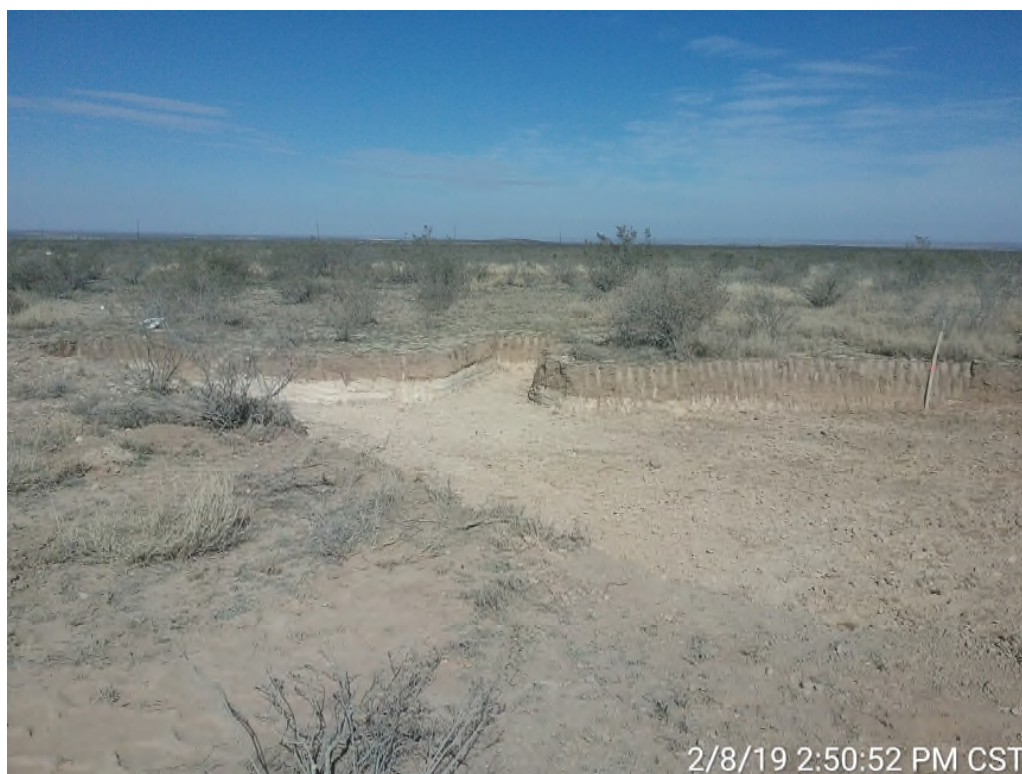
Area of Excavation – View to Northeast

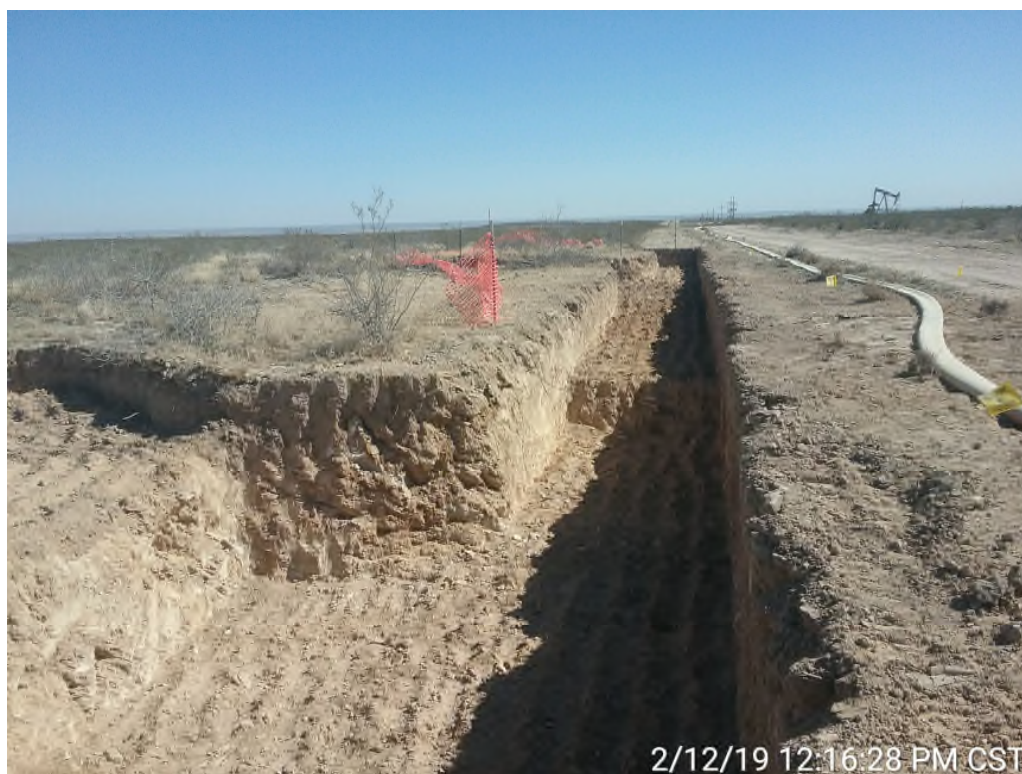
Area of Excavation – View to East

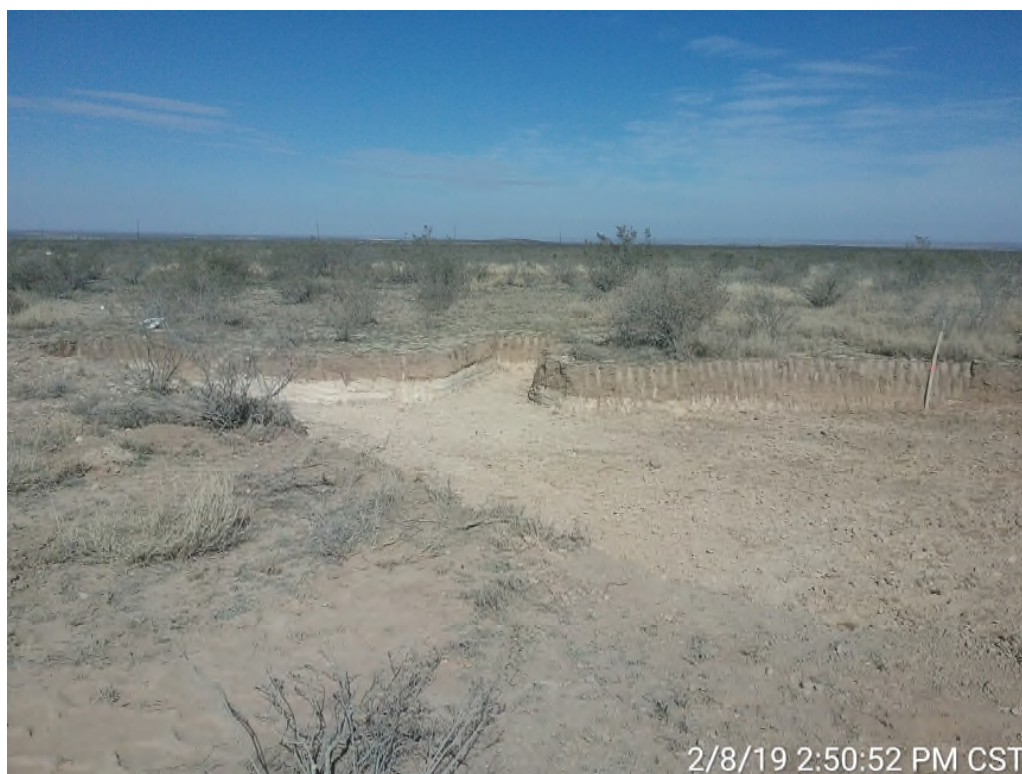
Area of Excavation – View to Northeast

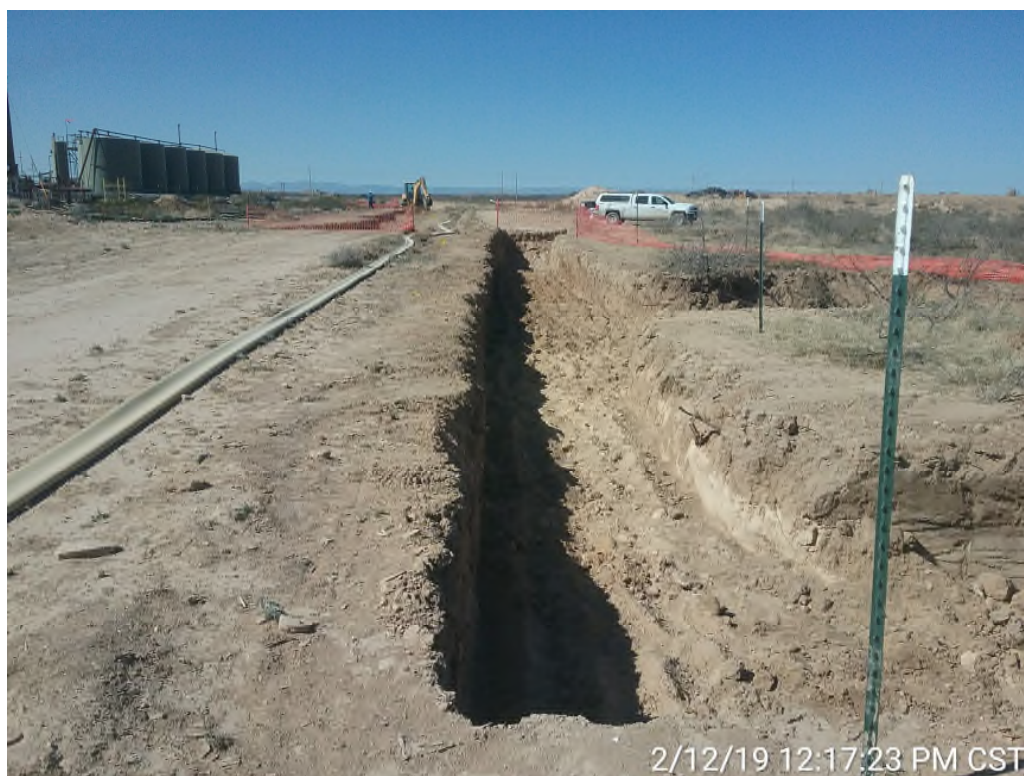
Area of Excavation – View to West

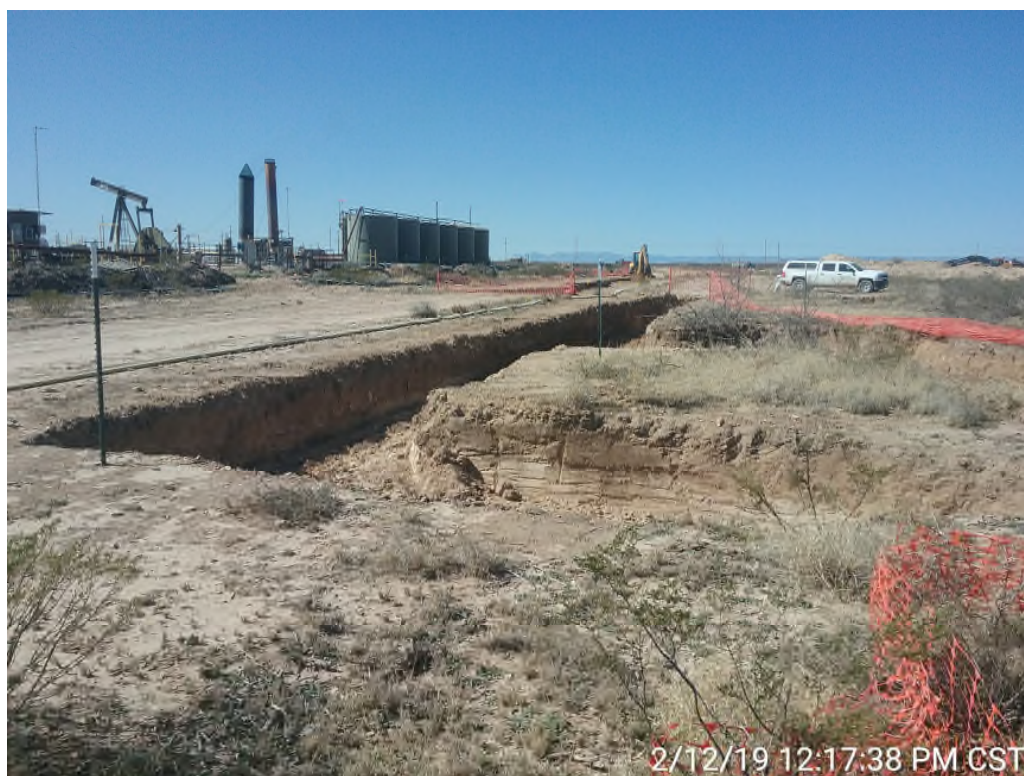
Area of Excavation – View to West-southwest
