Report Type: Work Plan 2RP-5041

Re: Work Plan for the COG Operating, LLC, SRO State Com #10H, Unit D, Section 03, Township 26 South, Range 28 East, Eddy County, New Mexico. 2RP-5041

**Table 1
COG
SRO State Com #10H
Eddy County, New Mexico**

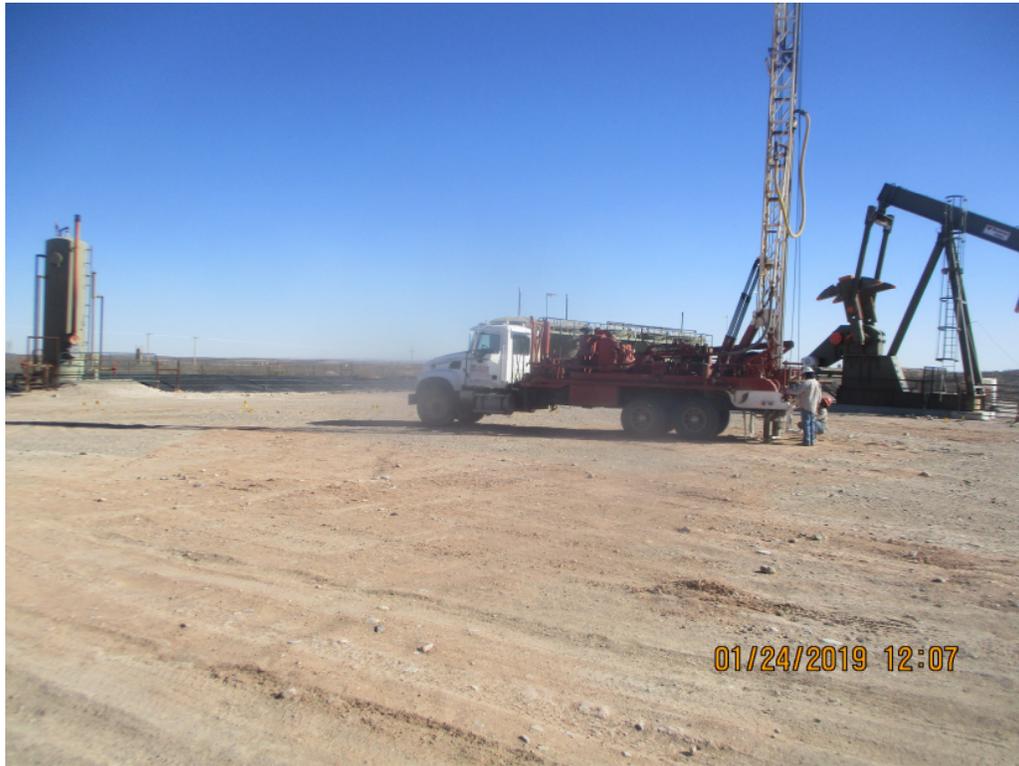
Referring to Table 1, the area of borehole (BH-1) did not show any benzene or total BTEX above the RRALs. However, the area of borehole (BH-1) showed a TPH concentration of 4,786 mg/kg at 0-1', which declined with depth to below the RRAL with a concentration of 38.2 mg/kg at 9'-10' below surface. Additionally, elevated chlorides above the background concentrations were detected at borehole (BH-1) to a depth of 19'-20', before declining below the RRAL at 24'-25'.

Area of BH-1 – View to Northeast

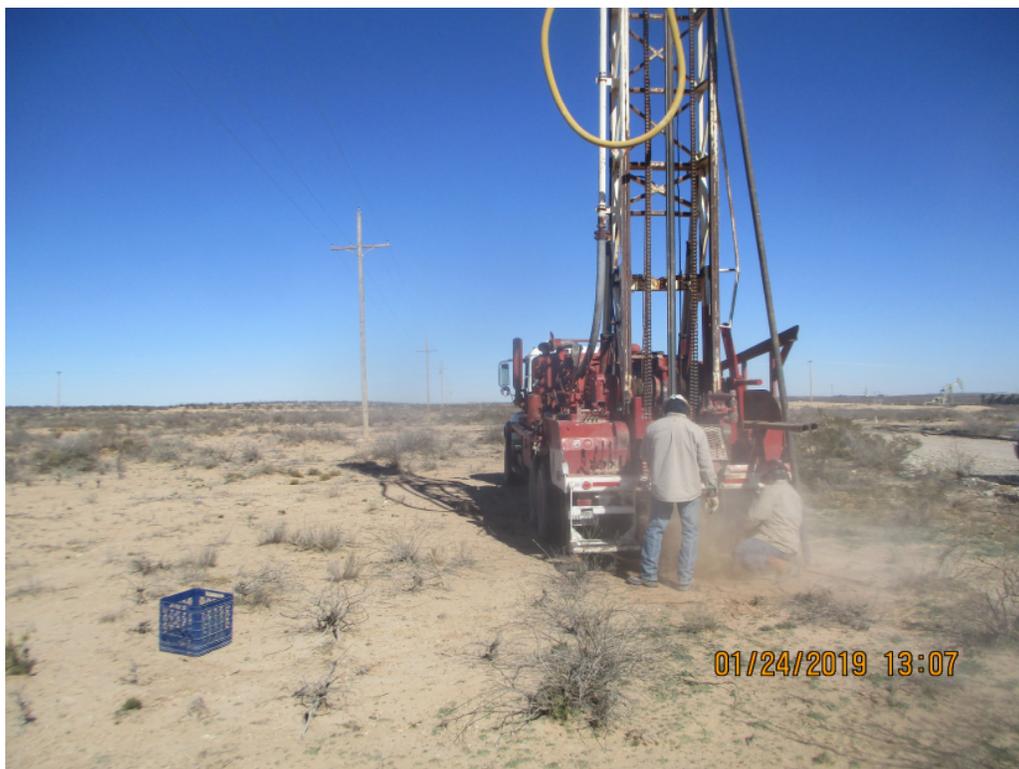
Referring to Table 1, the background borehole (Background) showed chloride concentrations that increased with depth to a chloride high of 768 mg/kg at 9'-10' below surface.

Area of Background – View North
