Re: Gissler B 3-1 Battery
B-11-17S-30E
Eddy County, NM
2RP-5252

Gissler B 3-1 Battery

Closure Report

2RP-5252

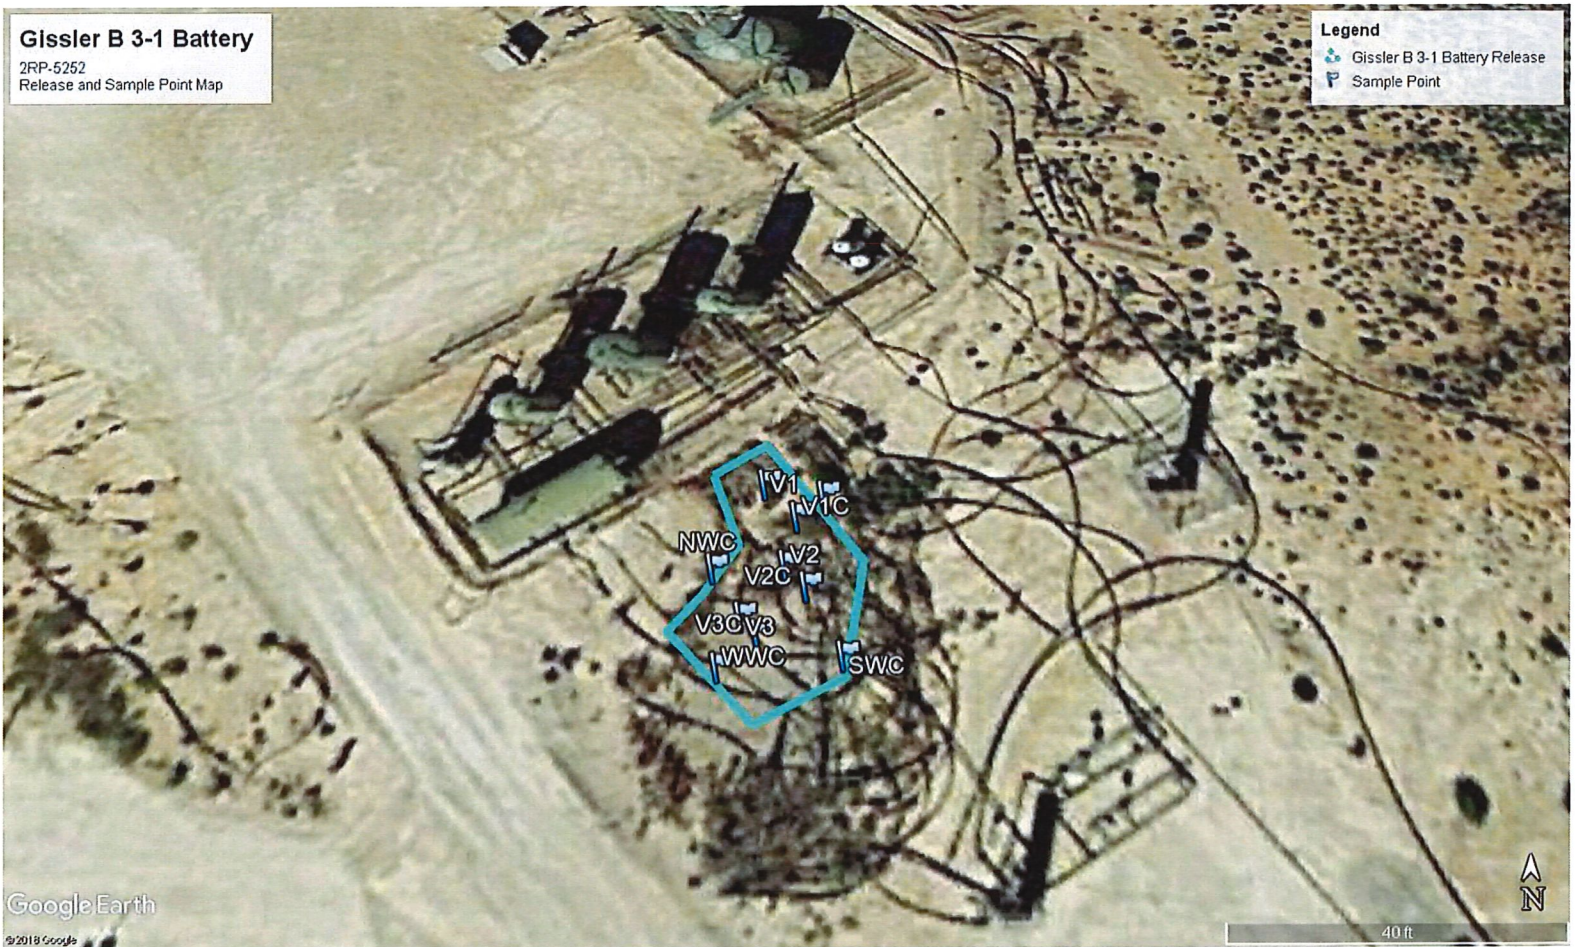
Figure 1

Site Map with Sample Points

2RP-5252
Release and Sample Point Map

Based on analytical results, a decrease in chlorides, TPH, and BTEX, and groundwater greater than 100 feet, EOG Resources, Inc. initially increased the excavation depth of the V1 impacted area to two (2) feet bgs and the V2 and V3 impacted areas to seven (7) and seven and a half (7.5) feet bgs before conducting confirmation soil sampling (04/09/2019, results enclosed) of the sidewalls and bottom of the excavation. Based off these confirmation sample results, the V1 and East Sidewall were excavated further with the V1 area having an additional half (1/2) foot removed and the East Sidewall being excavated out one (1) additional foot east. Confirmation samples were again collected (04/16/2019, results enclosed) with the V1 area still presenting higher than Table 1 standards, therefore the V1 area was excavated to four (4) feet bgs and again resampled (04/30/2019, results enclosed). Analytical data from that sampling activity displayed results to be below Table 1 standards. All confirmation samples represented less than 200 square feet. Notification for all confirmation sampling activities were sent to NMOCD and BLM, April 4, 9, and 22, 2019. All excavated soil was hauled to a NMOCD approved facility for disposal, then the excavated areas were backfilled to grade with locally sourced soil of similar type. A C-141 Final Report is hereby submitted to NMOCD requesting closure of the site.
