Report Type: Closure Report 2RP-4945

Site:	WD McIntyre E SW Tank Battery					
Company:	COG Operating LLC					
Section, Township and Range	Unit N	Sec. 20	T 17S	R 30E		
Lease Number:	NA					
County:	Eddy County					
GPS:	32.8150708			-103.995597		
Surface Owner:	Federal					
Directions:	From the intersection of Goat Ropers Road and Lovington Hwy in Loco Hills, NM, go west approximately 0.80 miles to the pad entrance. Turn left (south) onto pad and travel approximately 378 feet to lease road. Travel approximately 560 feet to fork, turn left (south) onto lease road. Travel approximately 0.21 miles to the McIntyre Battery.

**Re: Closure Report for the COG Operating, LLC, WD McIntyre E SW Tank Battery (08/18/18), Unit N, Section 20, Township 17 South, Range 30 East, Eddy County, New Mexico.
2RP-4945**

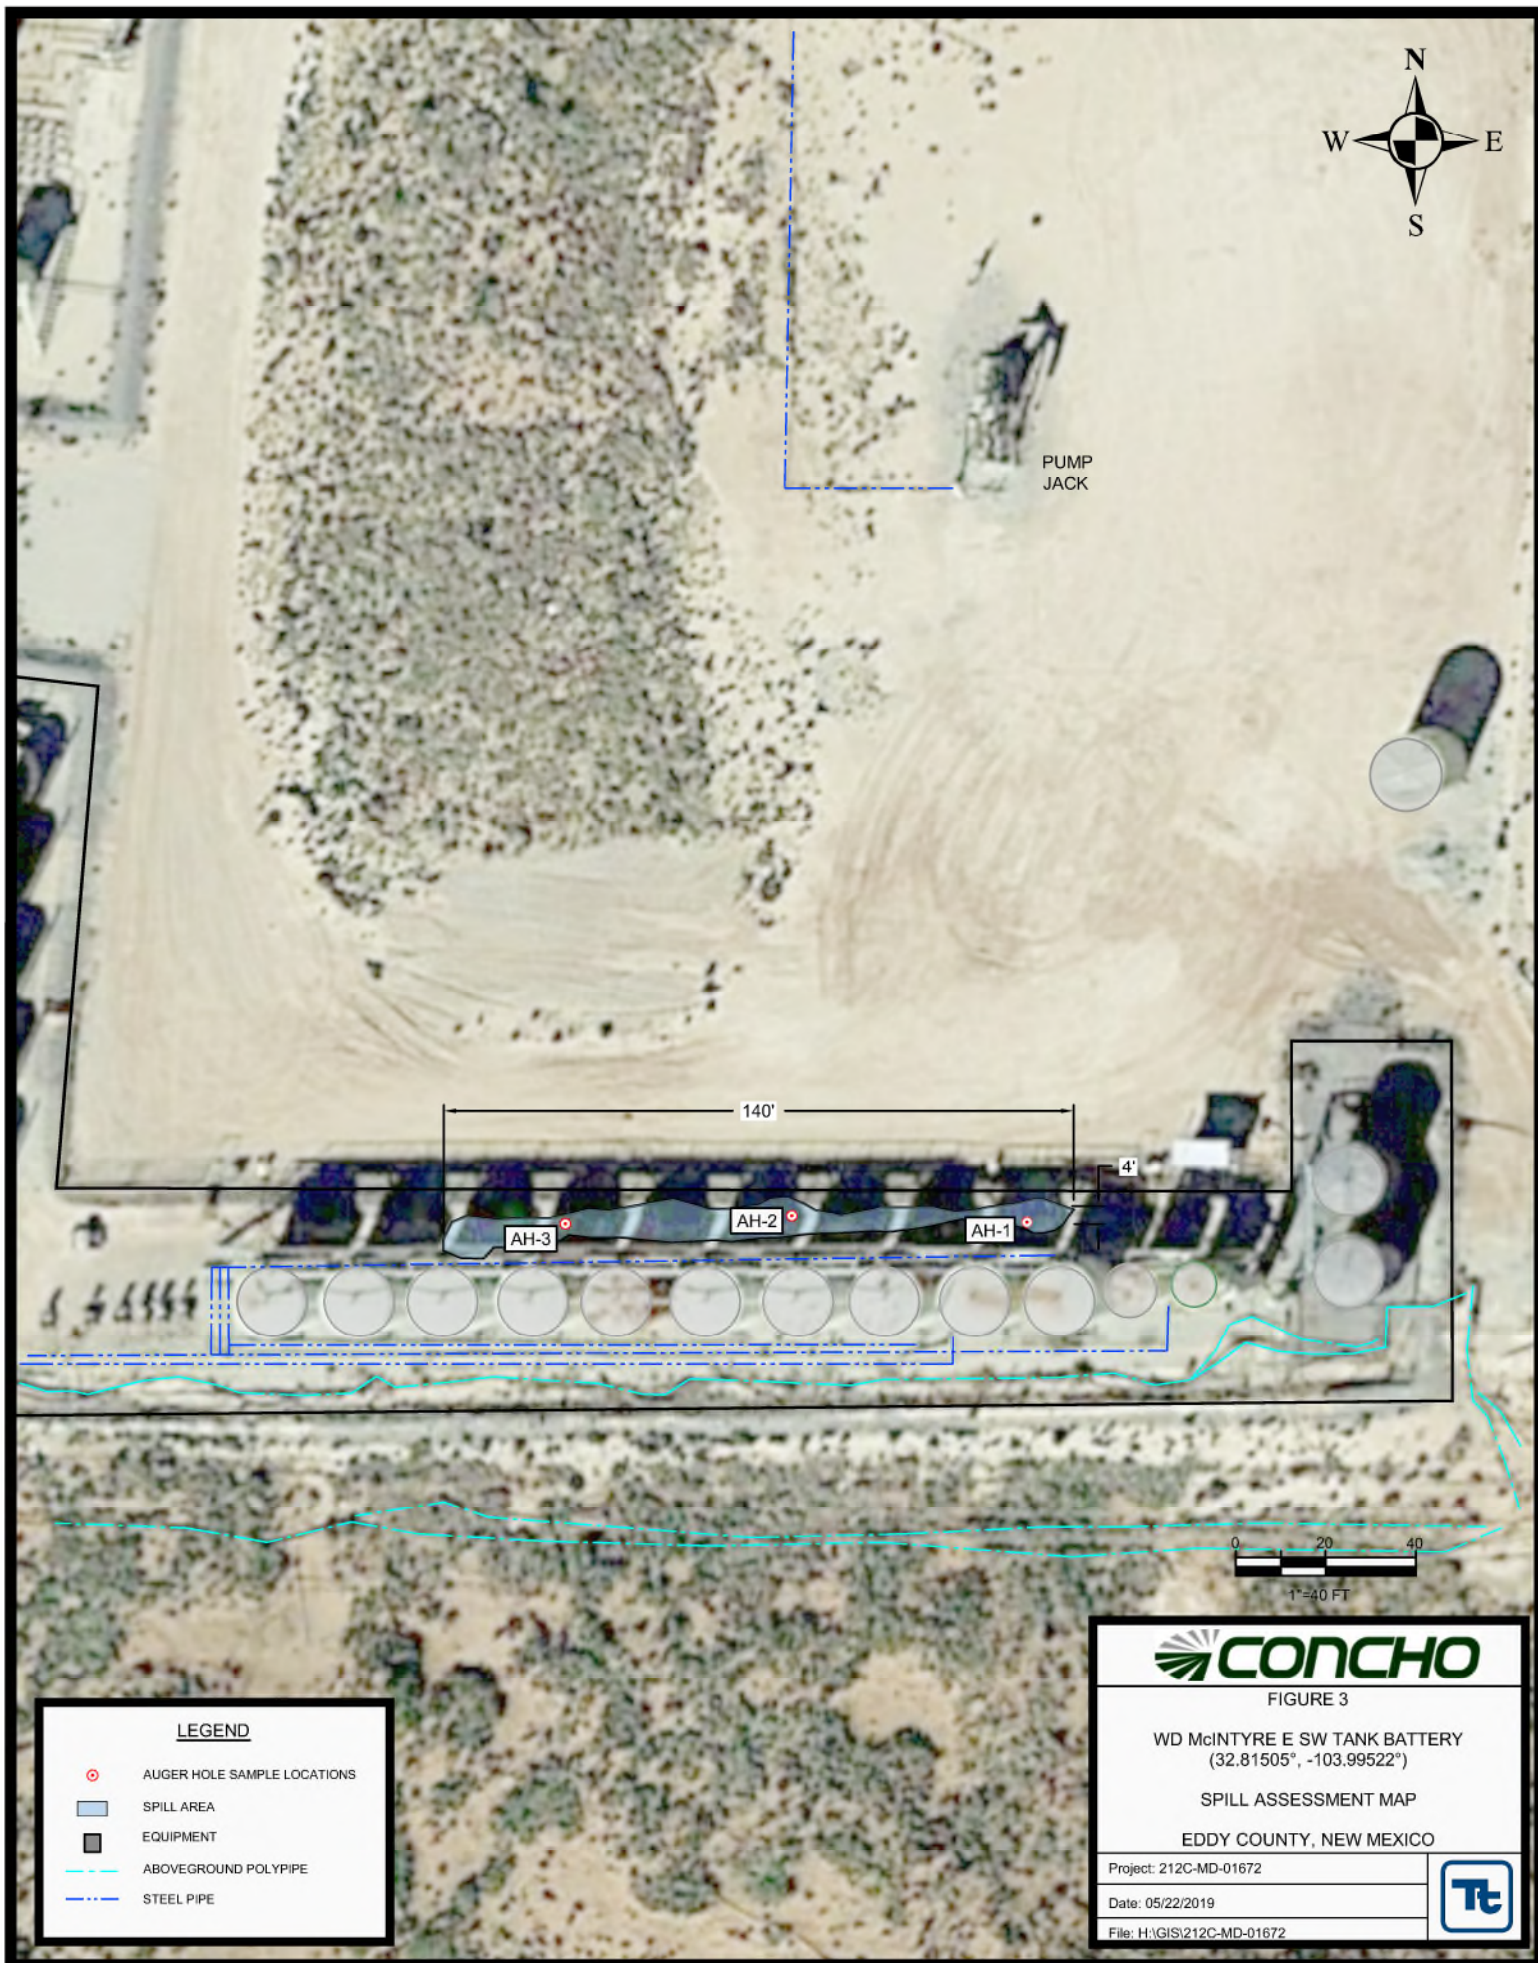
On August 23, 2018, COG personnel were onsite to assess the spill area. A total of three (3) Auger Holes (AH-1, AH-2, and AH-3) were installed until refusal to total depths of 2.0 – 2.5' below surface. Soil samples were collected and submitted to the laboratory for TPH analysis by EPA method 8015 modified, BTEX by EPA Method 8021B, and chloride by EPA method 300.0. Copies of laboratory analysis and chain-of-custody documentation are included in Appendix C. The results of the sampling are summarized in Table 1. The sample locations are shown on Figure 3.

Referring to Table 1, the sample locations not have benzene, total BTEX, or chlorides above the respective RRALs. The sample locations exceeded the RRALs for TPH in the shallow 0-1' interval but decreased with depth and did not exceed the RRAL in the deeper intervals. The TPH ranged from 2,079 mg/kg (AH-3 at 0-1.0') to 4,370 mg/kg (AH-1 at 0-1.0').

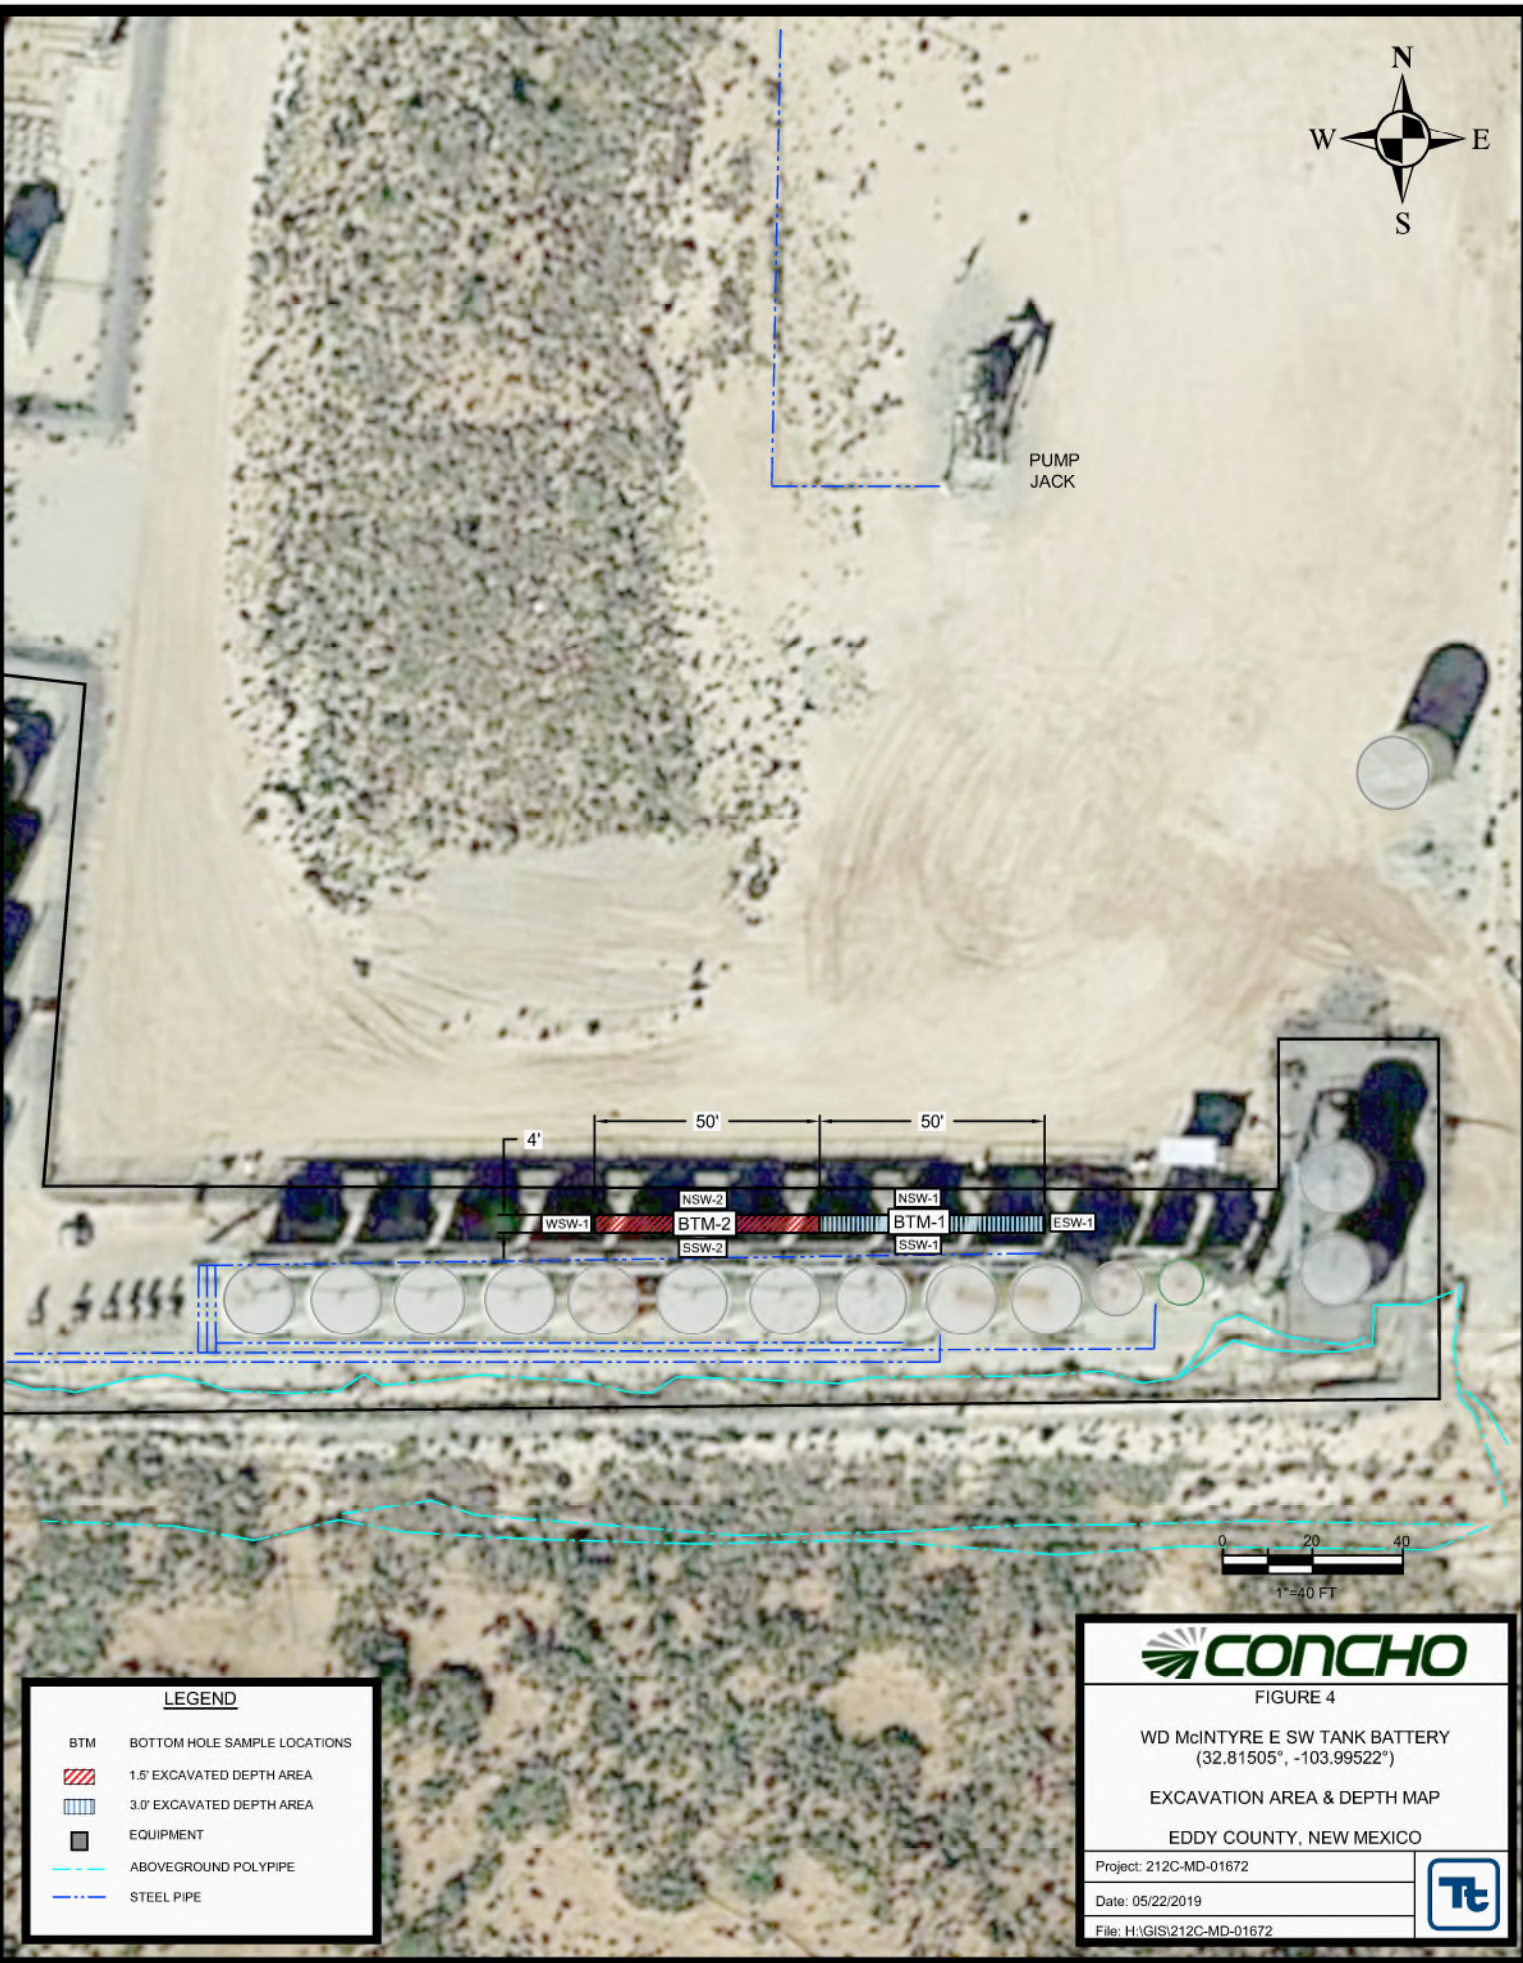
Tetra Tech personnel were onsite from March 28 – April 8, 2019 to supervise the remediation activities. The release area was excavated to total depth of 2.0 – 3.0' below surface. After excavation and confirmation of clean samples, the site was then backfilled with clean material to surface grade. Two (2) bottom hole and six (6) sidewall composite samples were collected every 200 square feet to ensure proper removal of the impacted soils. The samples were submitted to the laboratory to be analyzed for TPH method 8015 extended, BTEX method 8021B, and Chloride by EPA Method 300.0. The sampling results are summarized in Table 1. The excavation depths and sample locations are shown in Figure 4.

Referring to Table 2, all collected confirmation samples showed benzene, total BTEX, TPH, and chloride concentrations below the RRAL's.

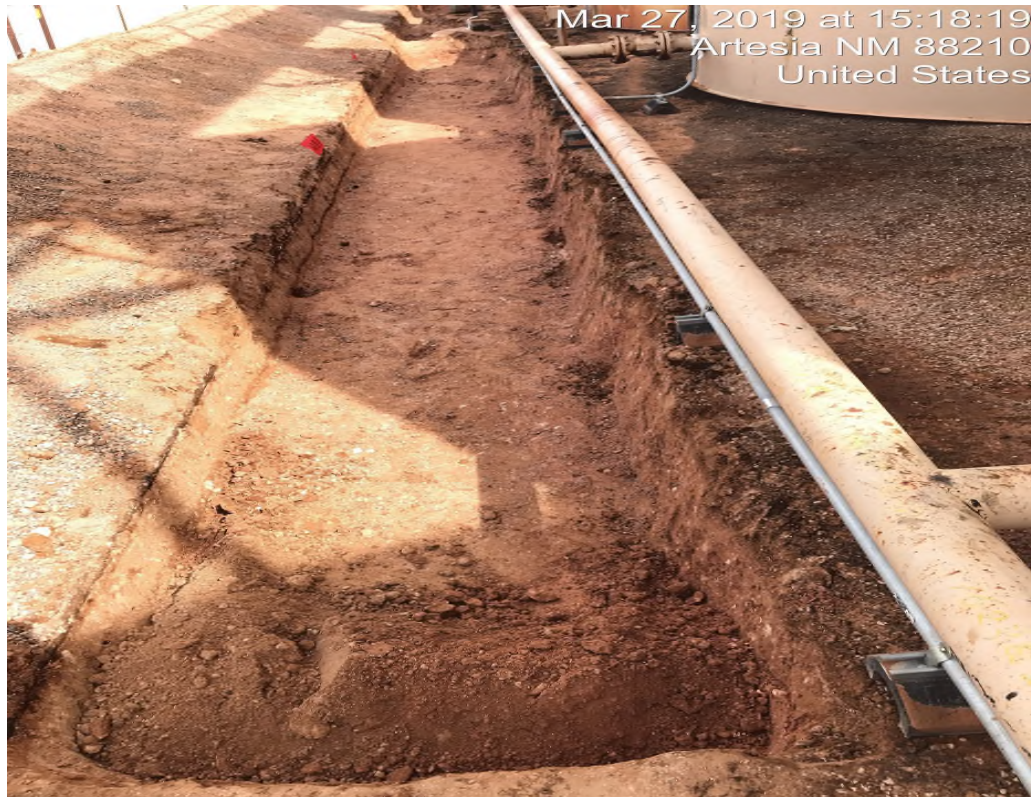
Facing East – View of Bottomhole-2

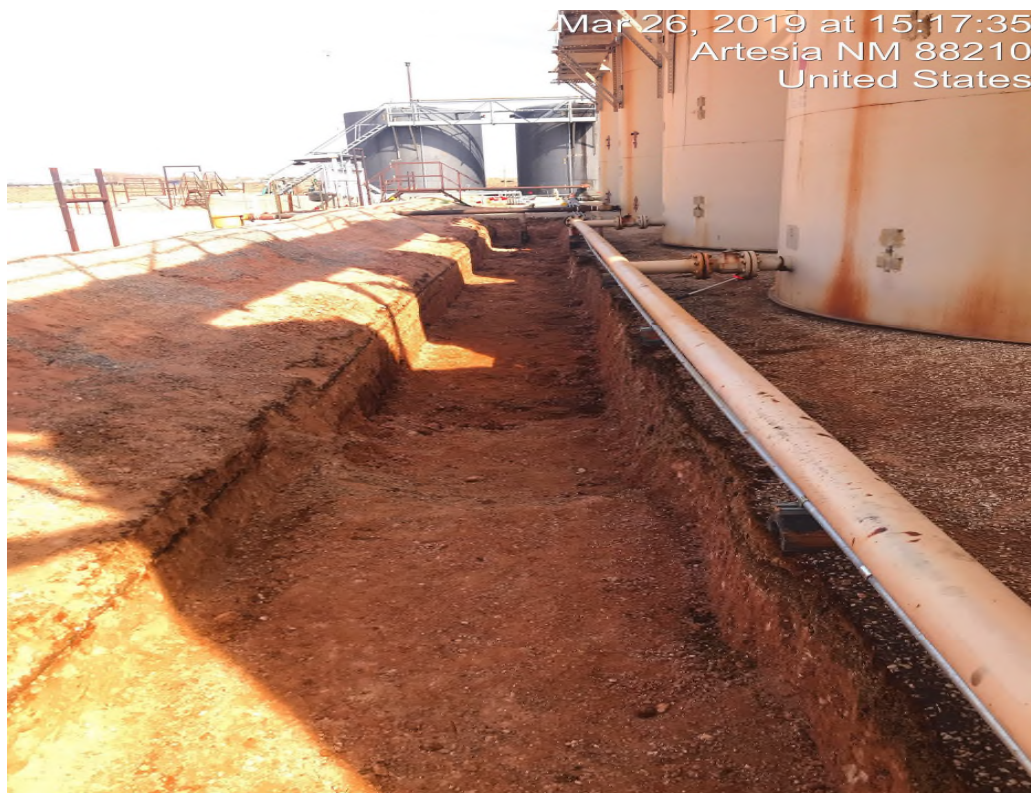
Facing East – View of Bottomhole-1

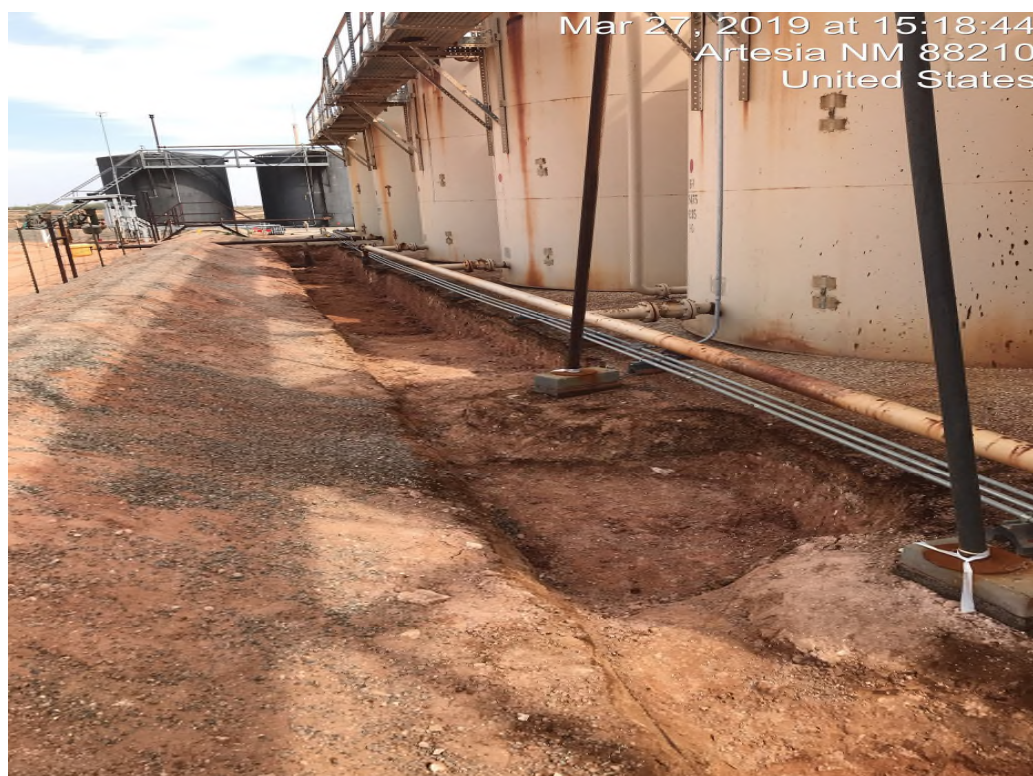
Facing East - View of Excavation Area

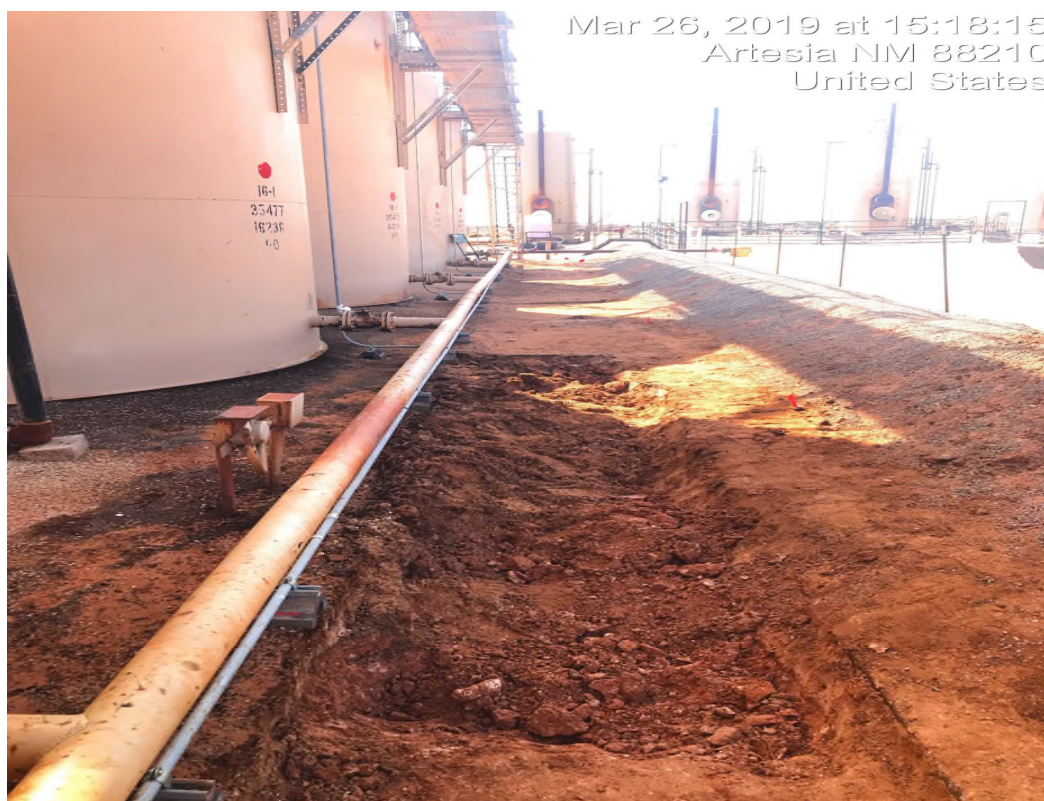
Facing West – View of Excavation Area
