May 24, 2019

#5E27962-BG1

SUBJECT: Remediation Closure Report Santo Nino 29 Fed 4 Release (2RP-5184), Eddy County, New Mexico

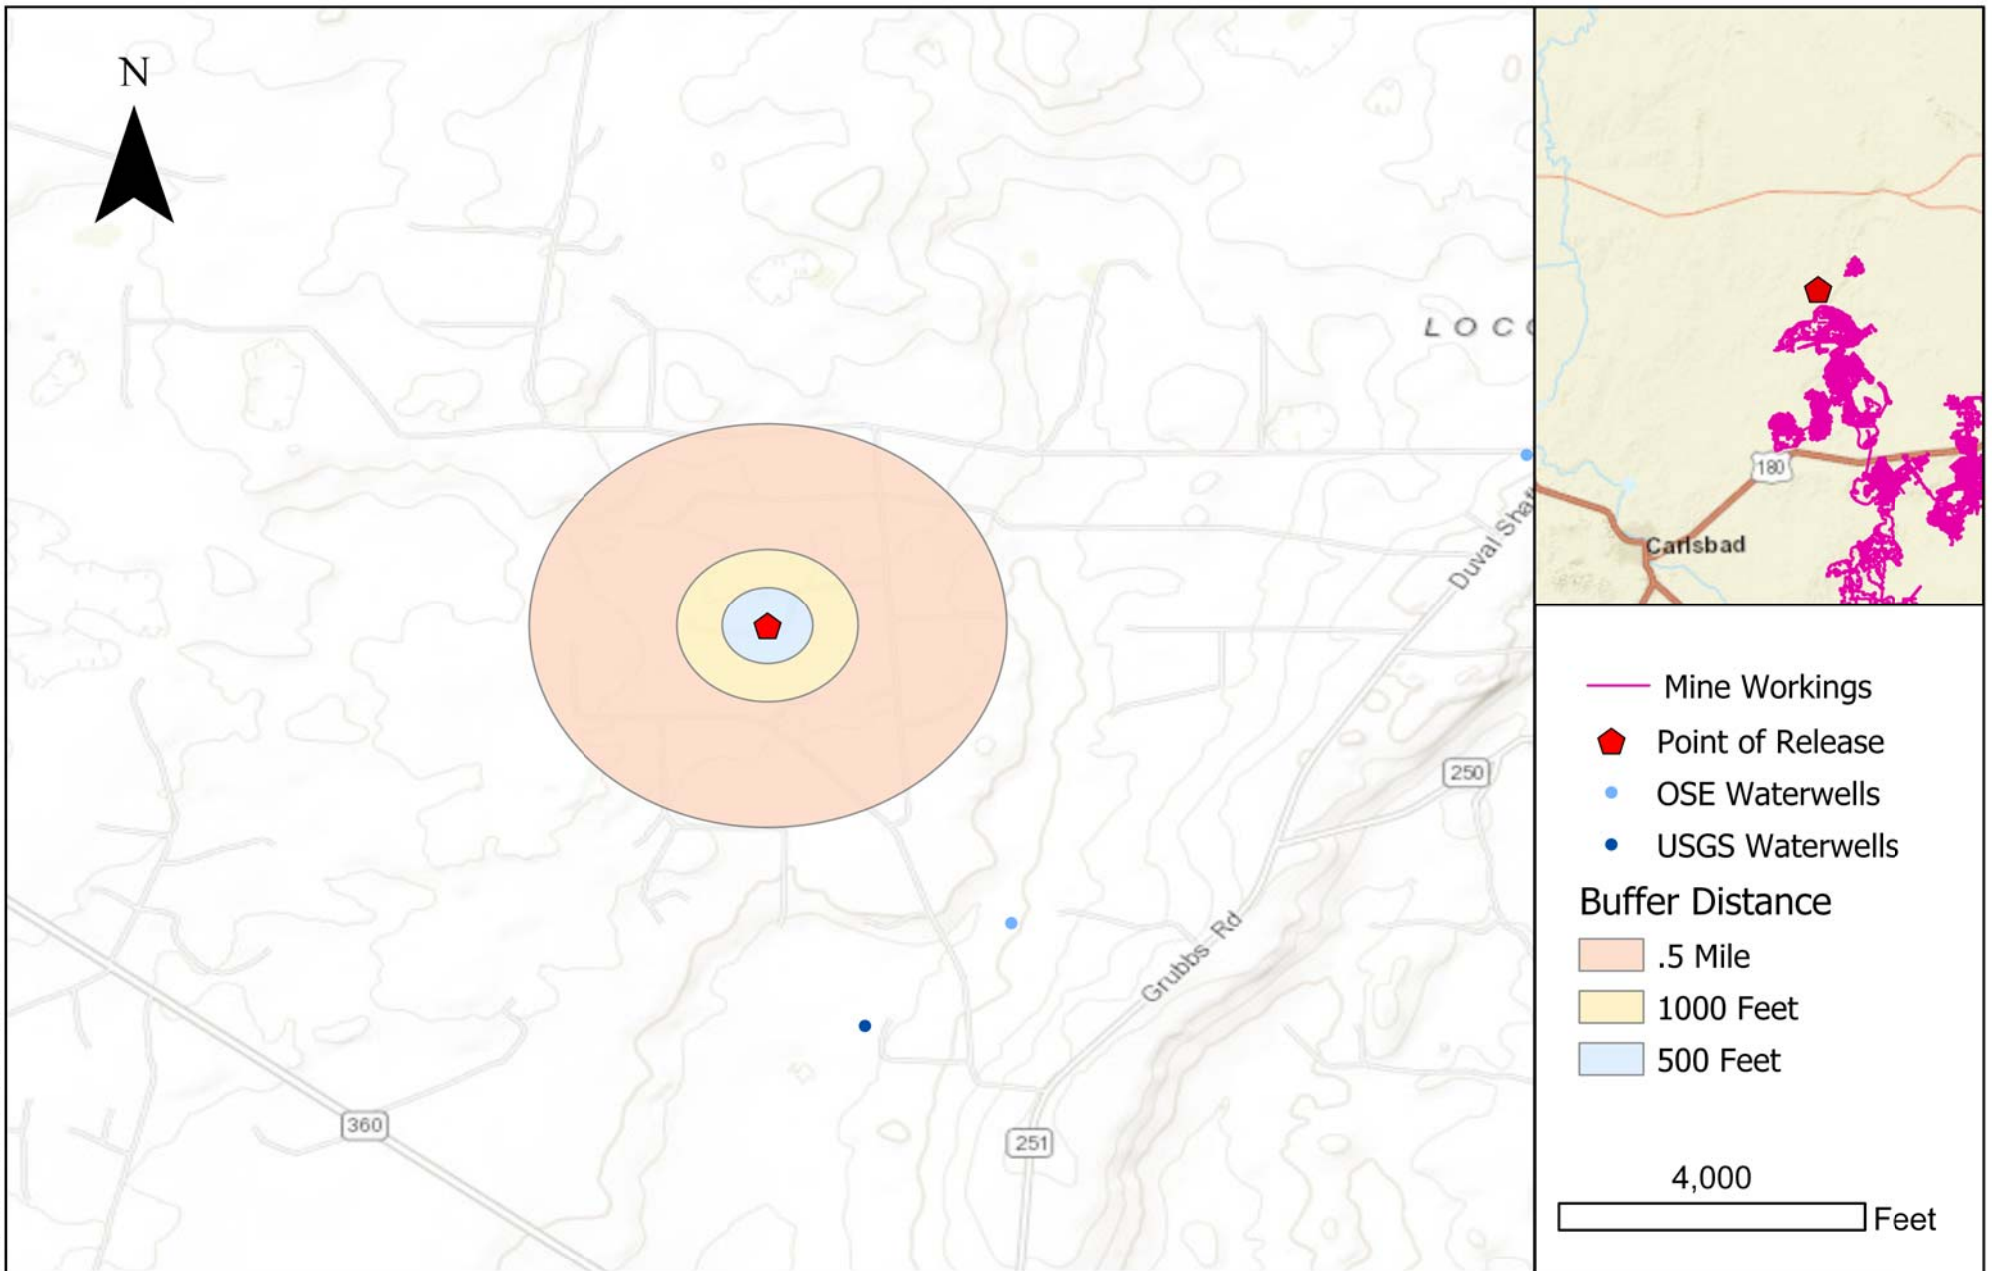
Figure 1

Regional Vicinity & Wellhead Protection Map
Santo Nino 29 Fed #4- Mewbourne

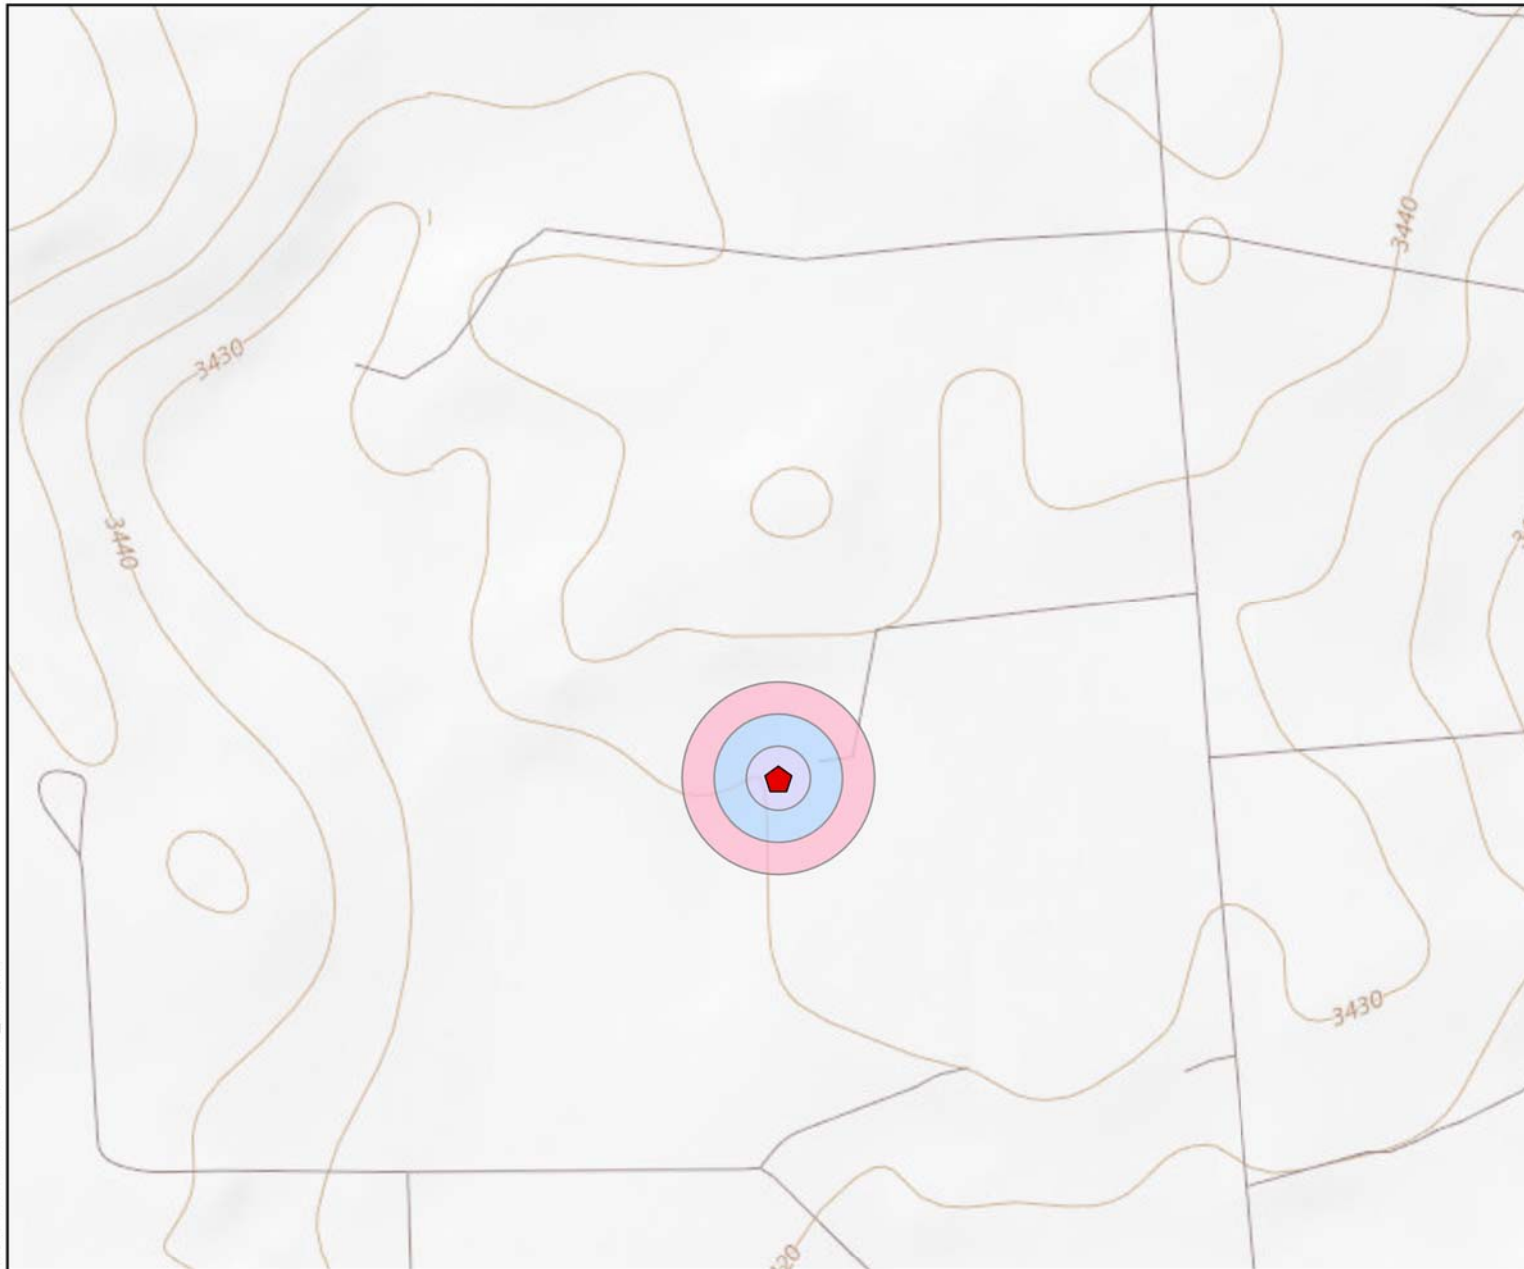
Surface Water Protection Map
 Santo Nino 29 Fed #4 - Mewbourne
 Eddy County , NM

Based upon U.S. Geological Survey (USGS) & New Mexico Office of the State Engineer (NMOSE) data (Appendix B), depth to groundwater in the area is estimated to be 217 feet below grade surface (bgs). There are no known water sources within ½-mile of the location, according to the NMOSE website (https://gis.ose.state.nm.us/gisapps/ose_pod_locations/; accessed 2/5/2019). The nearest significant watercourse is Walters Lake, located approximately 2.74 miles northeast of the Santo Nino 29 Fed #4. Figure 2 illustrates the site with 200 and 300-foot radii to indicate that it does not lie within a sensitive area as described in 19.15.29.12.C(4) NMAC.

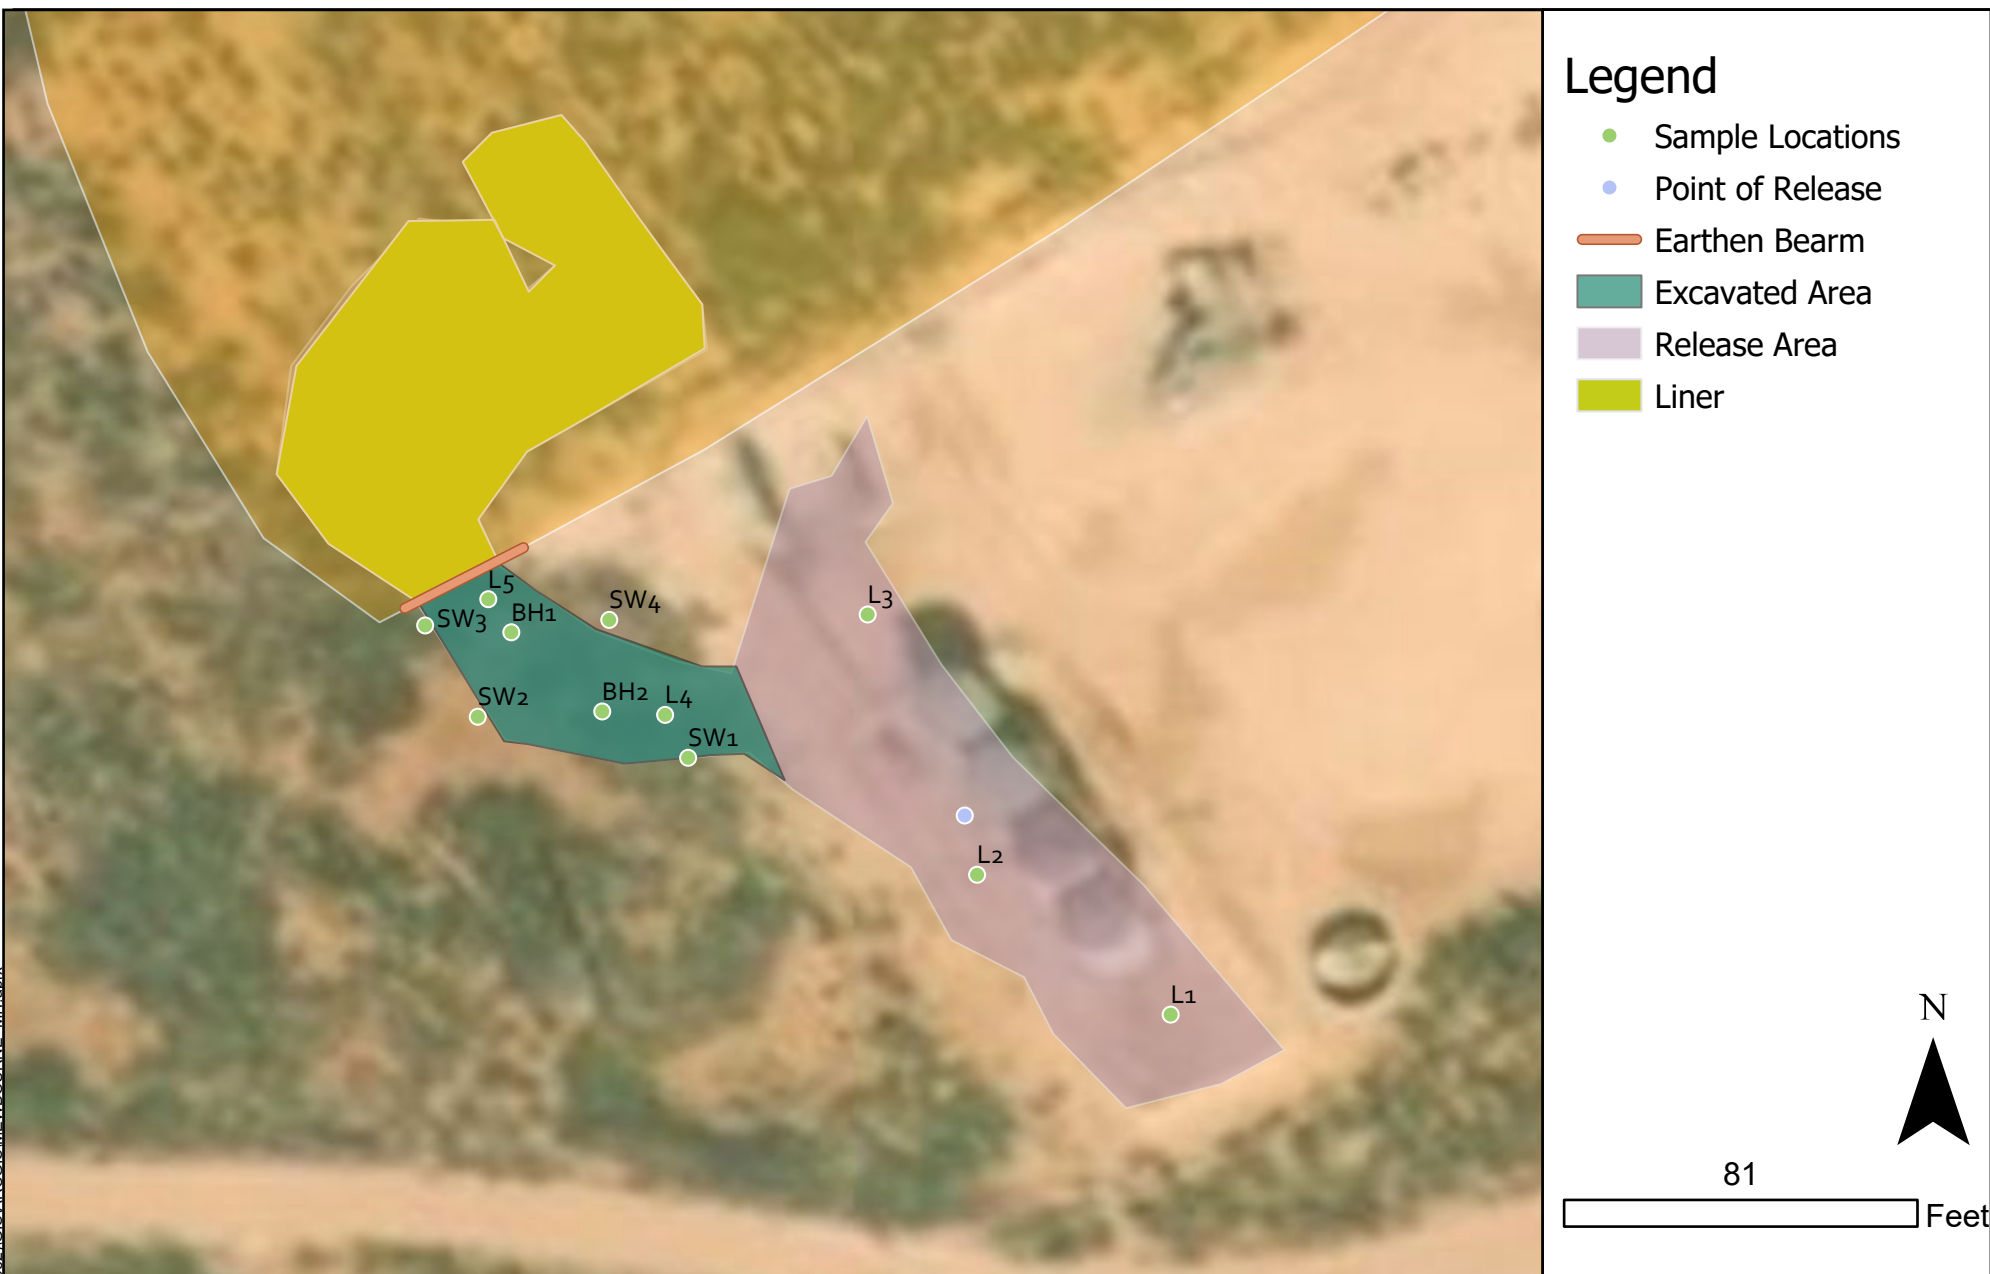
Figure 3 shows the extent of the excavation, sample locations, liner, and berm. All initial and confirmation laboratory results are summarized in Table 3. Laboratory reports are included in Appendix D.

Site and Sample Location Map
Mewbourne-Santo Nino 20 Fed #4
Unit Letter-N, Sec. 29, T18S, R30E. Eddy County, New Mexico

On April 26, 2019, SMA conducted confirmation sampling of the walls and base of the excavation. The confirmation samples were collected from within the excavation in accordance with the VSP sampling protocol included in Appendix C. As written in the approved workplan, confirmation samples were comprised of five-point composites of the base (BH1 & BH2) and walls (SW1-SW4).

The laboratory results for base sample BH1 indicated elevated TPH at 4 feet bgs. SMA returned to the location to extend the excavation vertically one more foot, and another confirmation sample was collected for BH1 at 5 ft bgs. The area representing BH2 was excavated to 5.5 ft bgs.

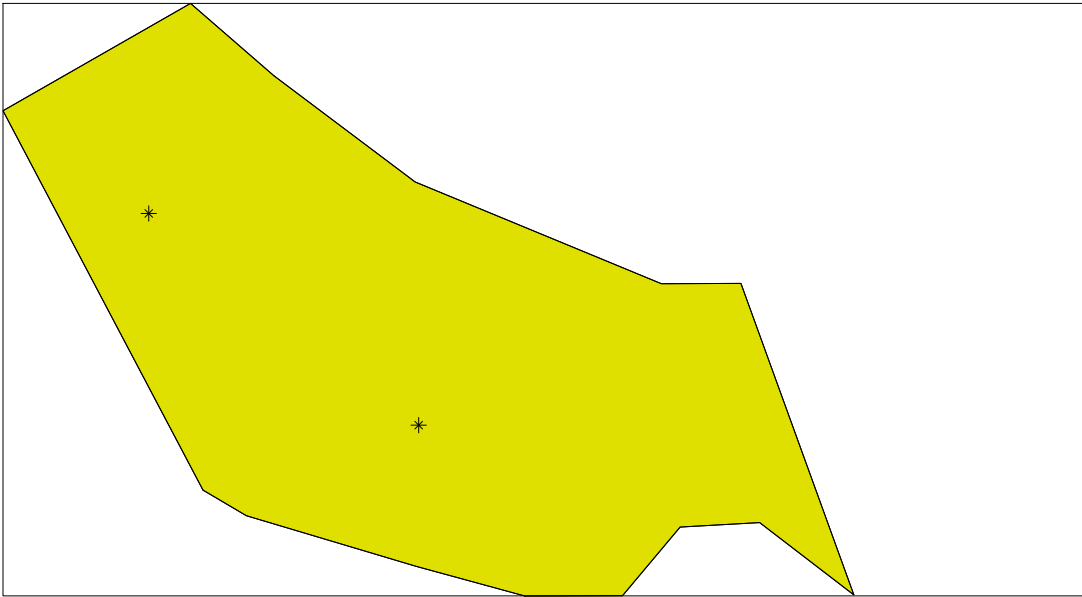
The following table summarizes the mean stratified sampling design developed. A figure that shows sampling locations in the field and a table that lists sampling location coordinates are also provided below.

Area: Area 1										
X Coord	Y Coord	Z Coord	Label	Value	Type	Historical	Surface	LX	LY	Sample Area
196554.0610	189966.2846	0.0000			Systematic		Floor	196555.0610	189967.2846	
196547.2050	189971.6605	0.6000			Systematic		Ceiling	196548.2050	189972.6605

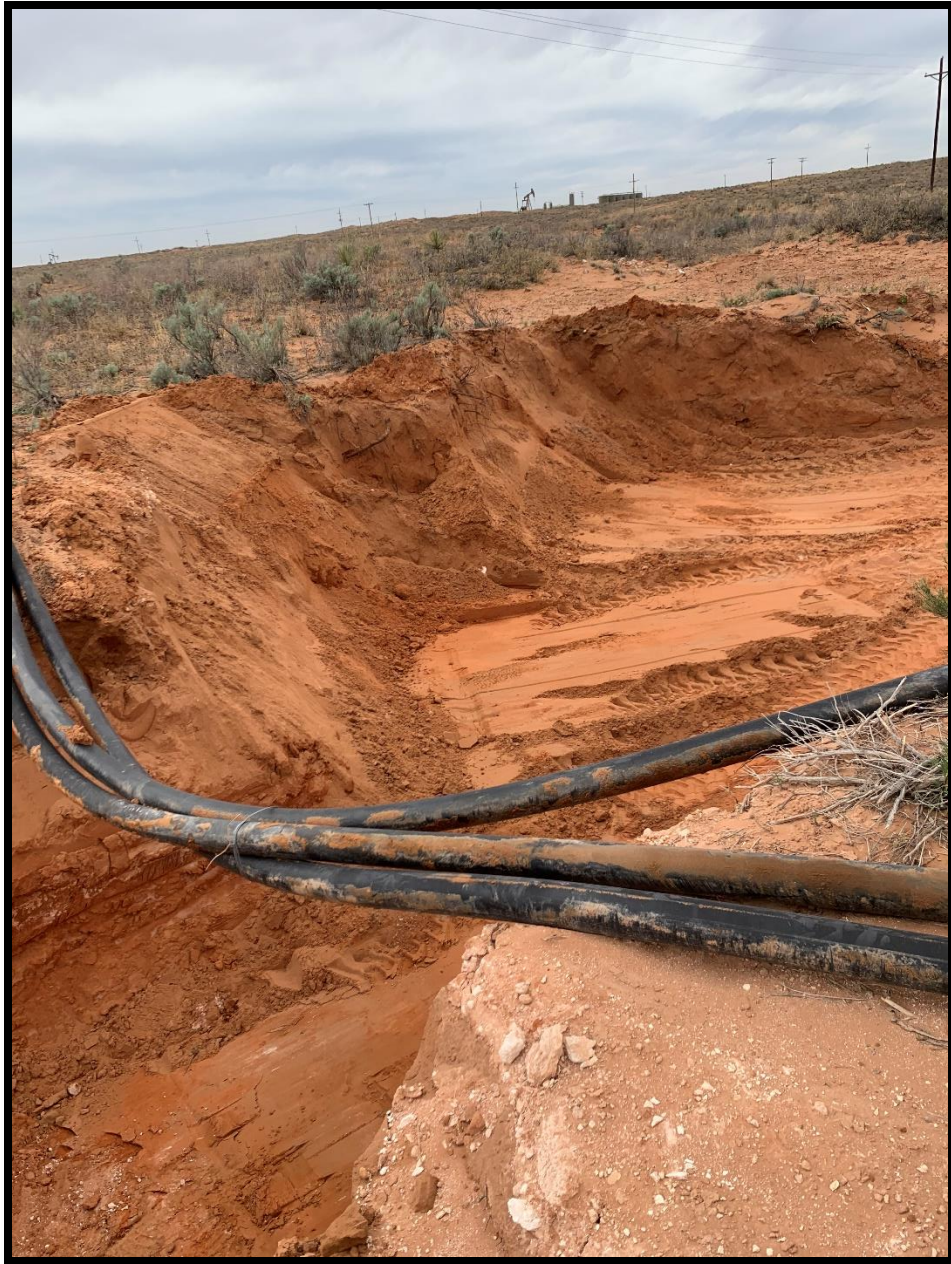
Photo of Excavation

Open excavation (Looking into excavation from pad)

In addition to meeting the Closure Criteria, the top four (4) feet of impacted areas off of the well pad meet the Reclamation requirement of 19.15.29.13(D)(1). Contaminated soils were removed and replaced with clean backfill material to return the surface to previous contours. The contaminated soil was transported and disposed of at an NMOCD permitted disposal facility.

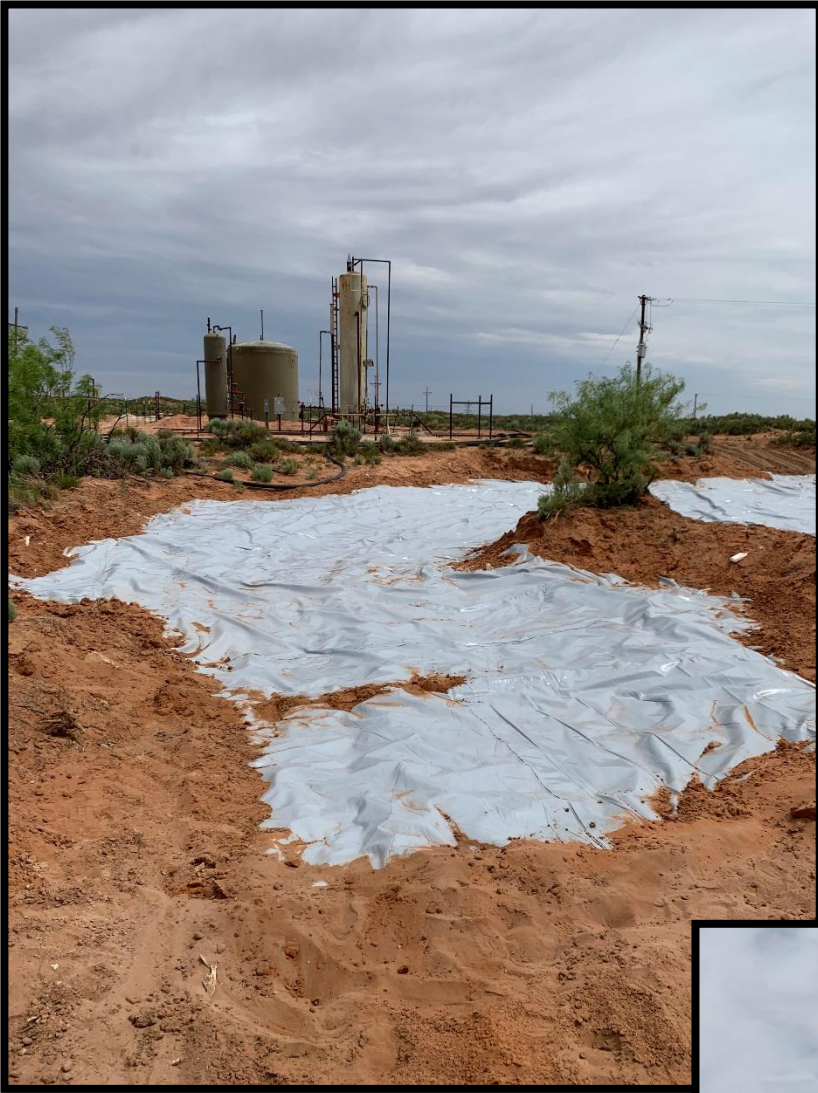
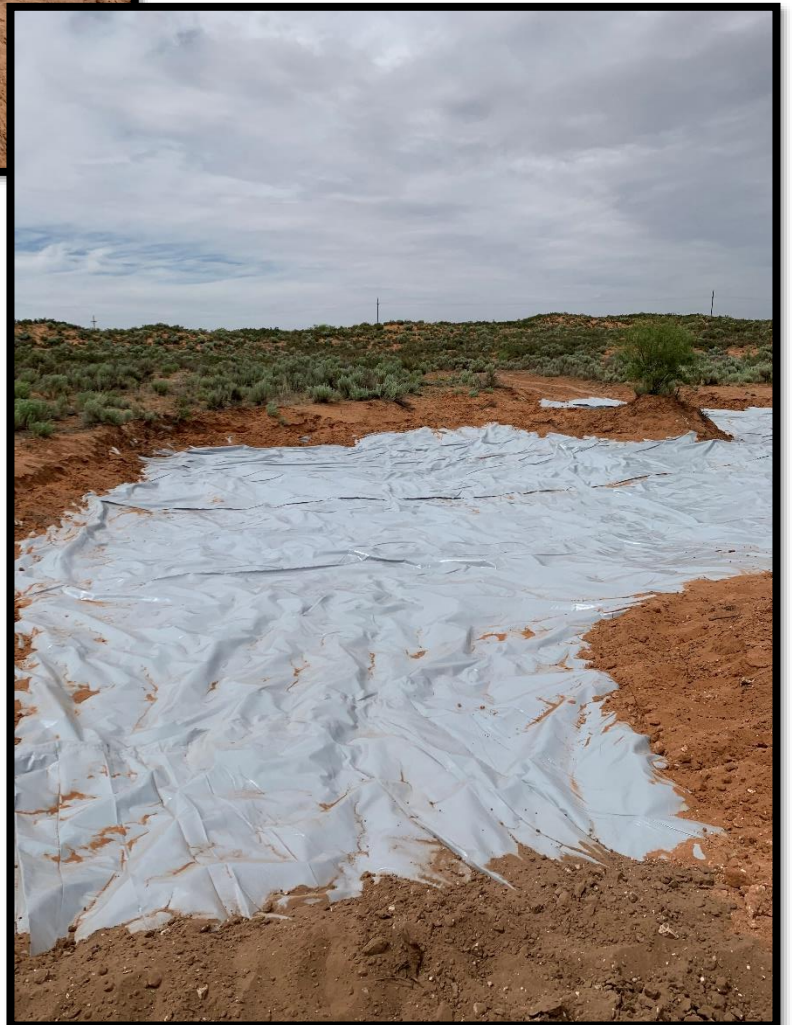
Photos of Liner

While sampling, SMA personnel observed pieces of white liner within the excavation area. After meeting with NMOCD, the decision was made to line the legacy pit area unearthed by excavation per ASTM standard. A berm would also be constructed between the pit area and remaining release area to prevent any additional or future impact. This proposed action was approved via email by Jim Amos and Deborah McKinney with the Carlsbad BLM Office. In accordance with 19.15.29.12.B(2) NMAC, a deferral was also requested in the area represented by L2 due to production pipelines in the area. The remaining contaminated areas (locations L4 and L5) were proposed to be excavated to meet NMOCD Closure Criteria and Reclamation requirements. The above-mentioned plans of action and deferral request were written into the remediation work plan dated February 26, 2019 and later approved by NMOCD on March 18, 2019.
