Report Type: Deferment Report 2RP-5127

Site:	McIntyre B #10 Tank Battery					
Company:	COG Operating LLC					
Section, Township and Range	Unit N	Sec. 20	T 17S	R 30E		
Lease Number:	NA					
County:	Eddy County					
GPS:	32.81505			-103.99522		
Surface Owner:	Federal					
Directions:	From the intersection of Goat Ropers Road and Lovington Hwy in Loco Hills, NM, go west approximately 0.80 miles to the pad entrance. Turn left (south) onto pad and travel approximately 378 feet to lease road. Travel approximately 560 feet to fork, turn left (south) onto lease road. Travel approximately 0.21 miles to the McIntyre Battery.

Re: Deferment Report for the COG Operating, LLC, McIntyre B #10 Tank Battery, Unit N, Section 20, Township 17 South, Range 30 East, Eddy County, New Mexico. 2RP-5127

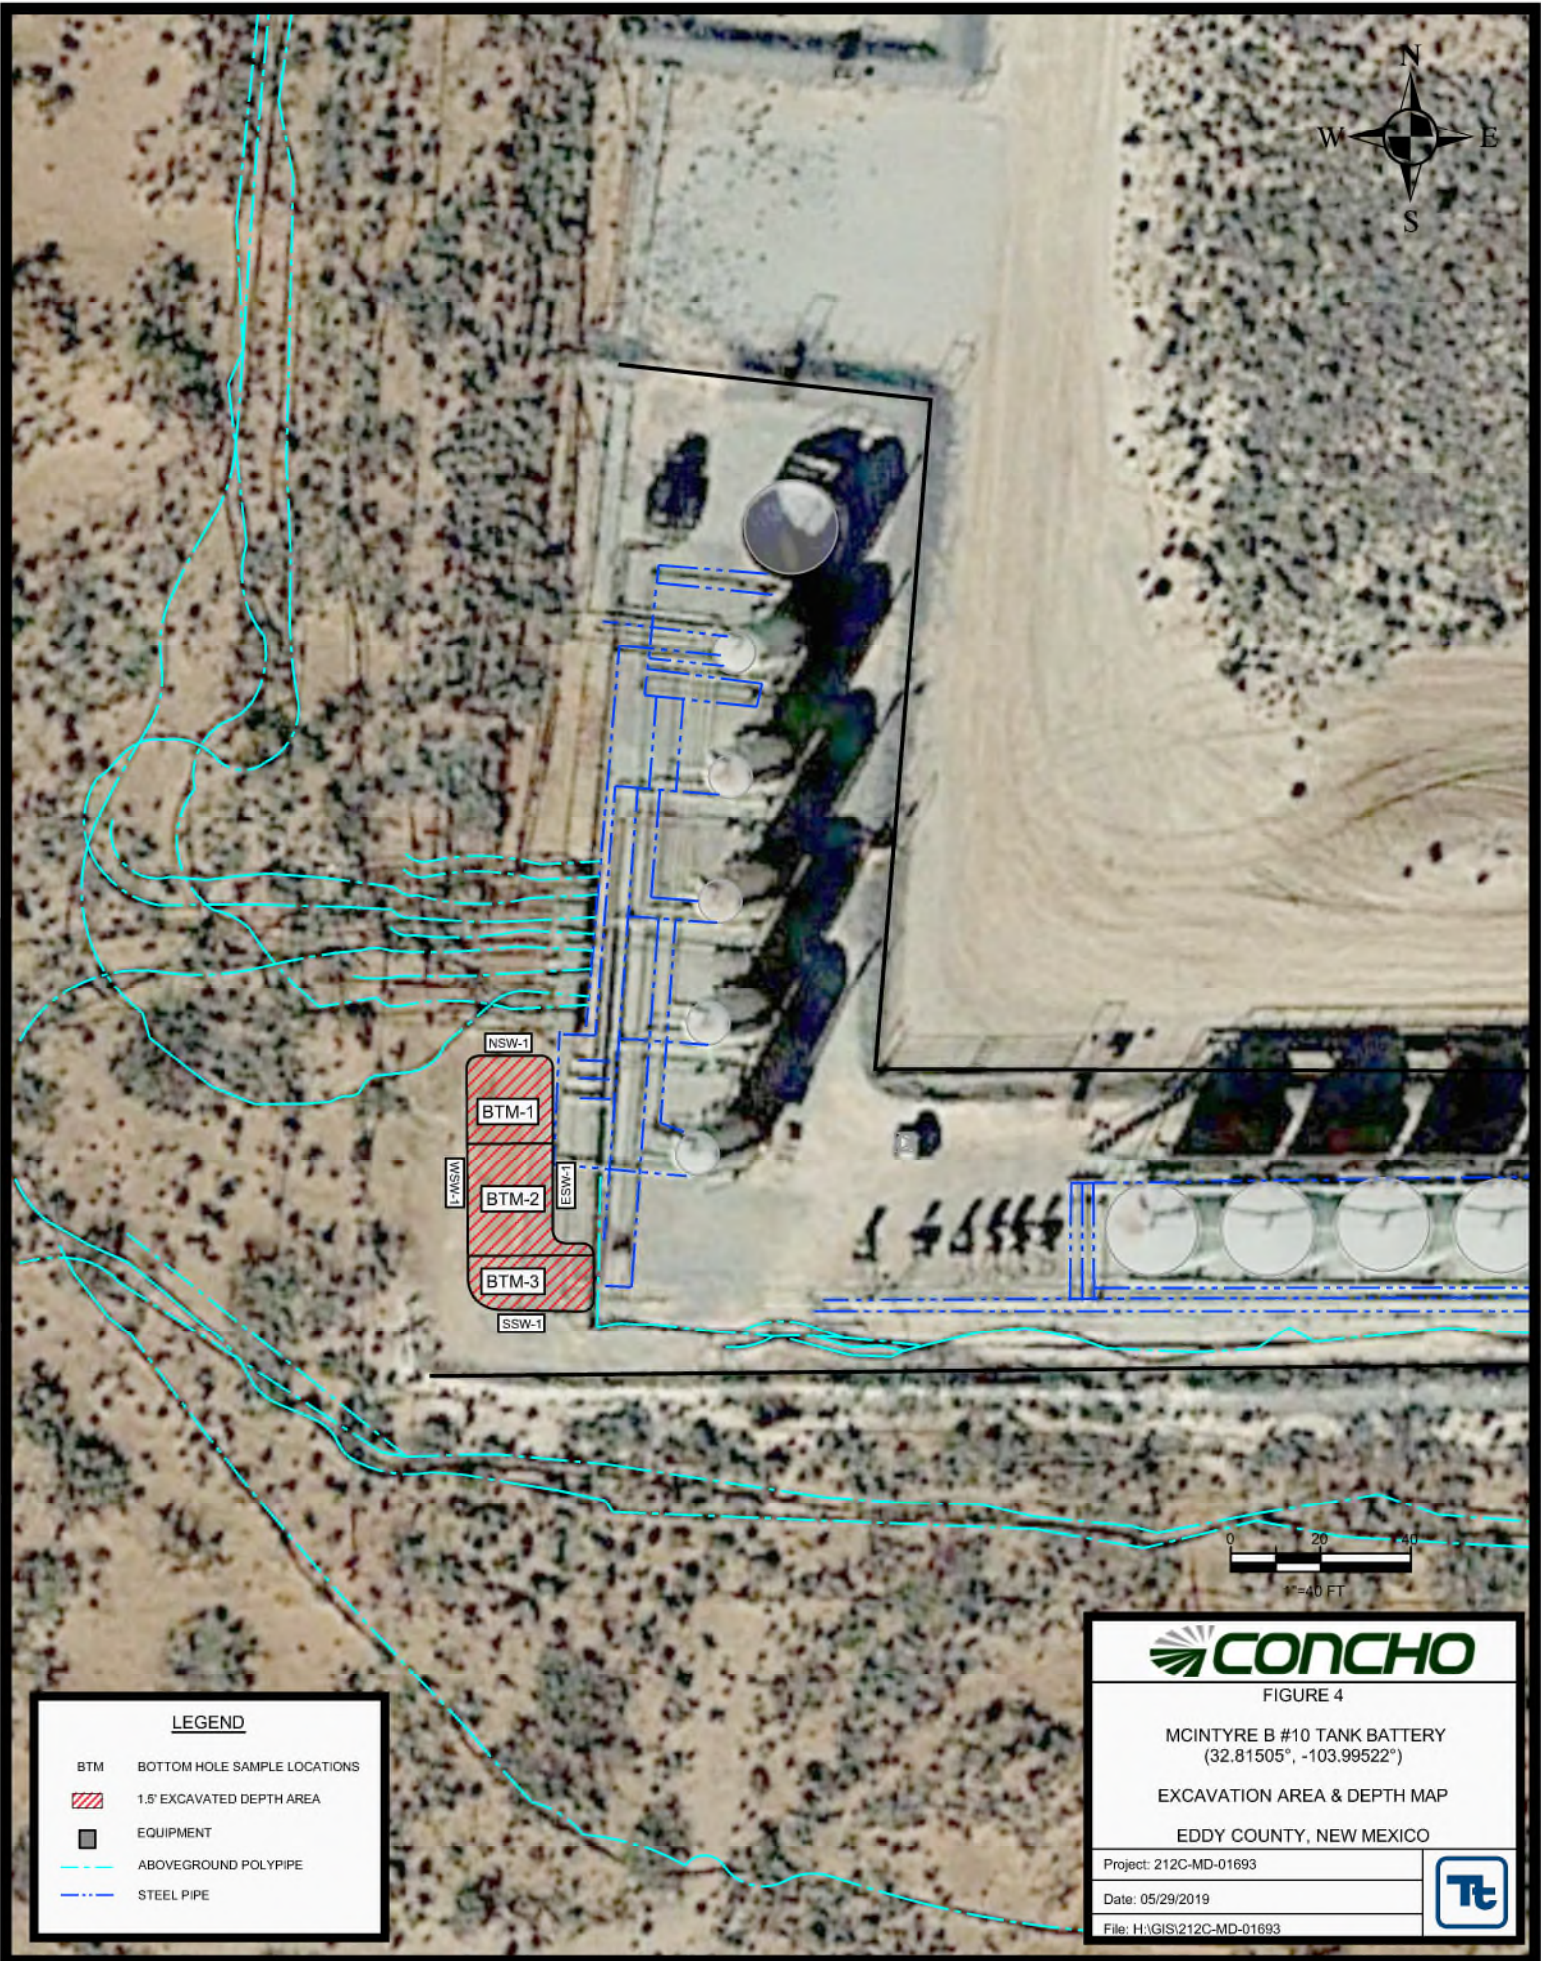
FIGURE 4

- BTM BOTTOM HOLE SAMPLE LOCATIONS
- 1.5' EXCAVATED DEPTH AREA
- EQUIPMENT
- ABOVEGROUND POLYPIPE
- STEEL PIPE

EXCAVATION AREA & DEPTH MAP

Tetra Tech personnel were onsite from March 28 – April 8, 2019 to supervise the remediation activities. The release area was excavated to total depths between 1.5' to 2.0' below surface. Three (3) bottom hole and four (4) sidewall composite samples were collected every 200 square feet to ensure proper removal of the impacted soils. The samples were submitted to the laboratory to be analyzed for TPH method 8015 extended, BTEX method 8021B, and chlorides by EPA Method 300.0. The sampling results are summarized in Table 1. The excavation depths and sample locations are shown in Figure 4.

Referring to Table 2, all collected confirmation samples showed benzene, total BTEX, TPH and chloride concentrations below the RRAL's except for sidewall NSW-1. The composite sample from NSW-1 had a documented TPH concentration of 8,860 mg/kg that exceeded the RRAL. However, due to safety concerns regarding pipeline encroachment, the excavation could not be extended.

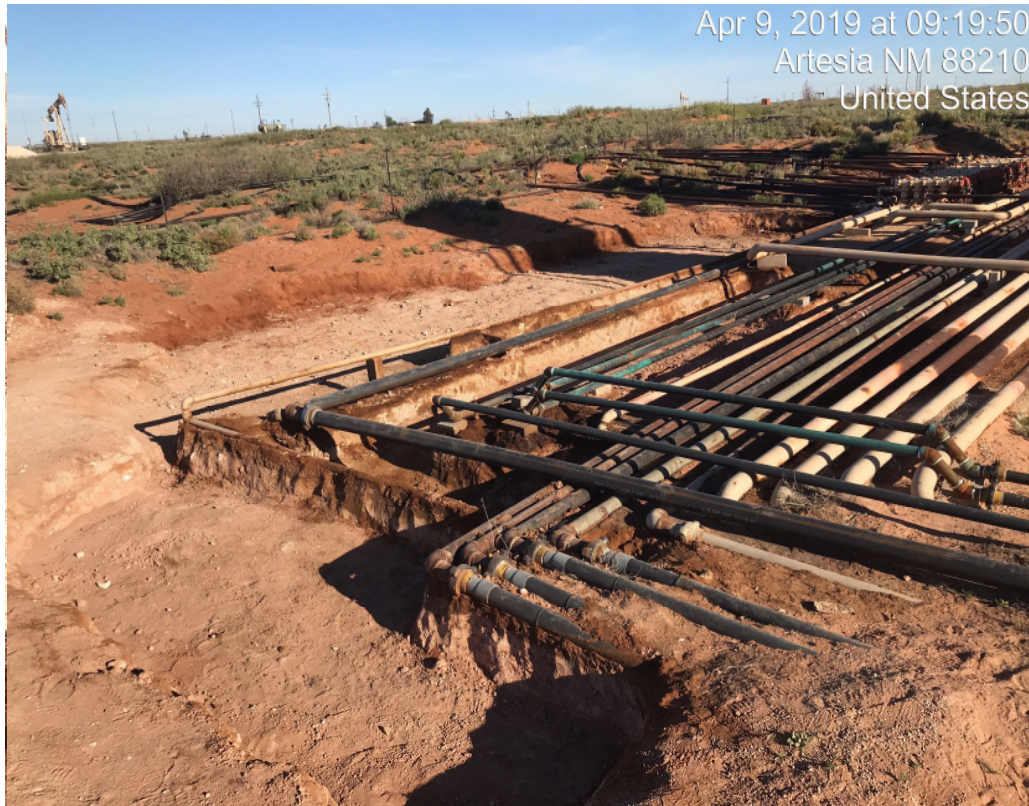
Facing West – View of Bottomhole-2, Bottomhole-3, and WSW-1

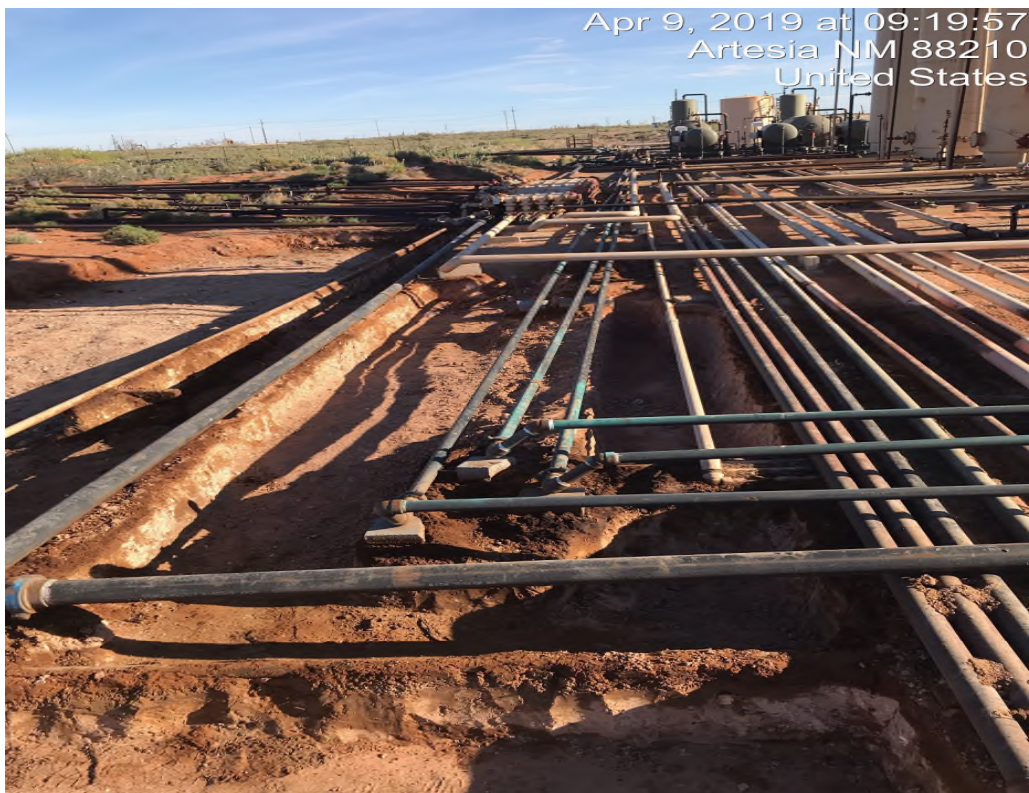
Facing North – View of Bottomhole-1, Bottomhole-2 and ESW-1

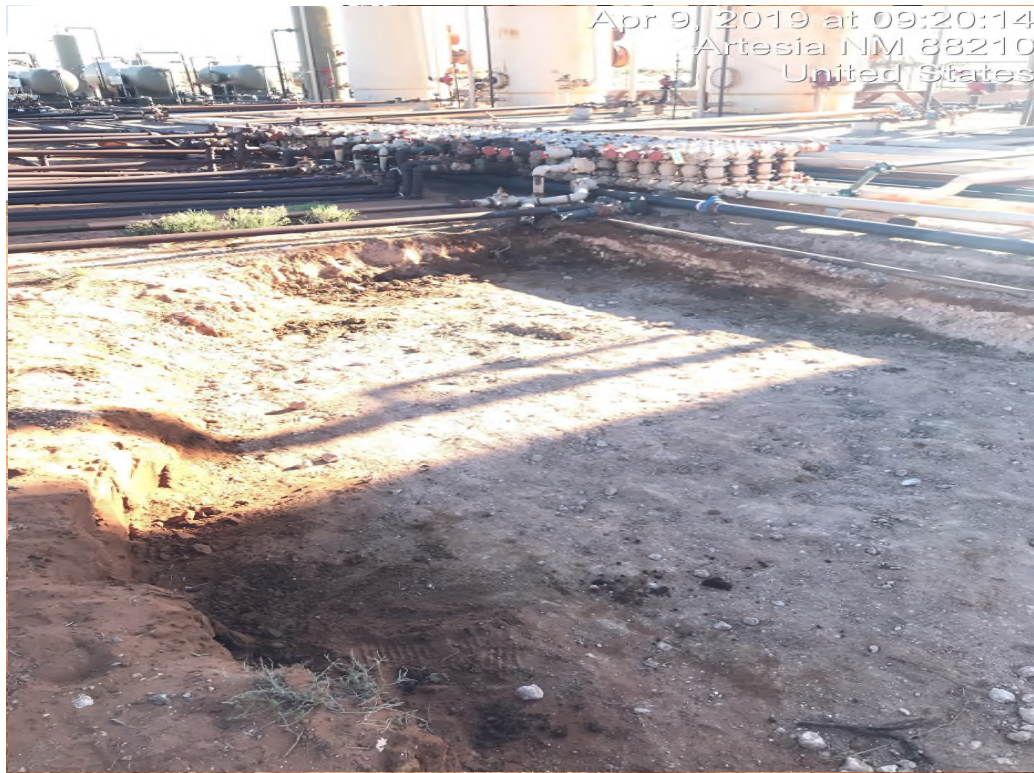
Facing Northeast – View of Bottomhole-1 and NSW-1

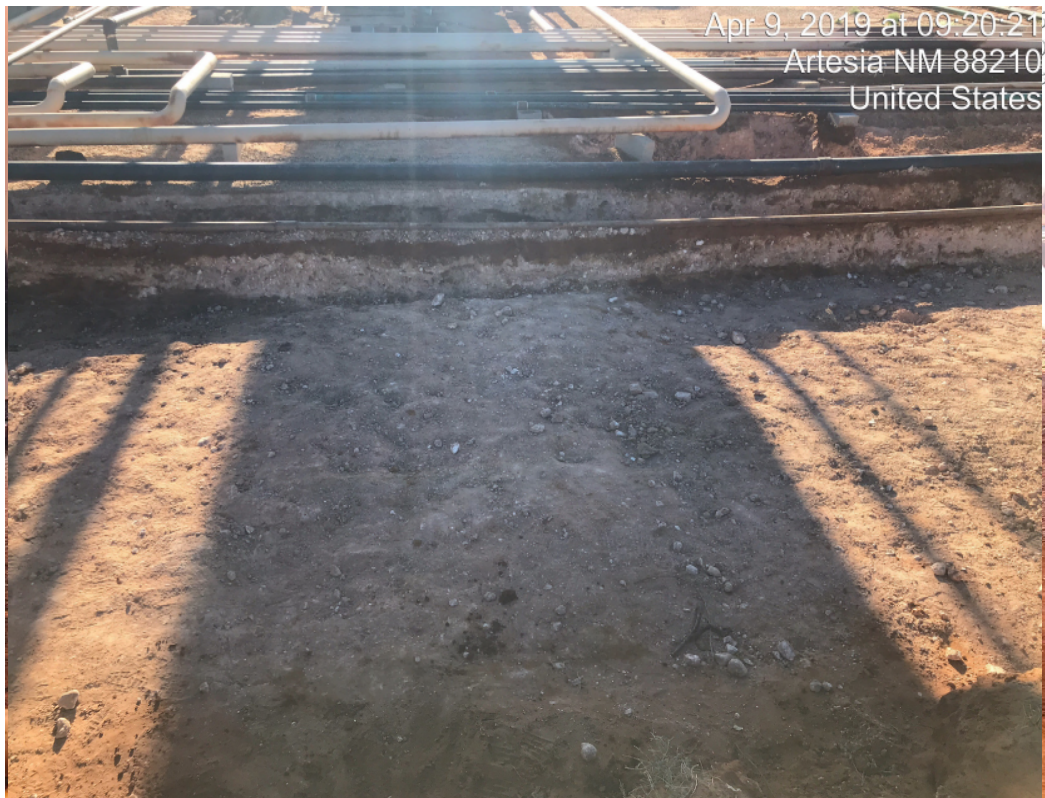
Facing East – View of Bottomhole-2 and ESW-1
