Reference No. 11192977

**Re: Closure and Deferral Request
SRO State Com #003H
Remediation Permit Number 2RP-5329
Eddy County, New Mexico**

GHD Services, Inc. (GHD), on behalf of COG Operating, LLC (COG), respectfully submits this Site Closure Report to the New Mexico Oil Conservation Division (NMOCD) District II office for the Remediation Permit Number 2RP-5329. This Site Closure Report provides documentation detailing delineation, soil sampling, remediation and restoration activities at the SRO State Com #003H (Site) located in NE/NE quarter (Unit Letter A) of Section 18, T-26-S, R-38E on surface lands owned by the State of New Mexico. The Site is located in Eddy County, approximately 26 miles south/southeast of Carlsbad, New Mexico and GPS coordinates for the Site are 32.04797 N, -104.11910 W (Figure 1).

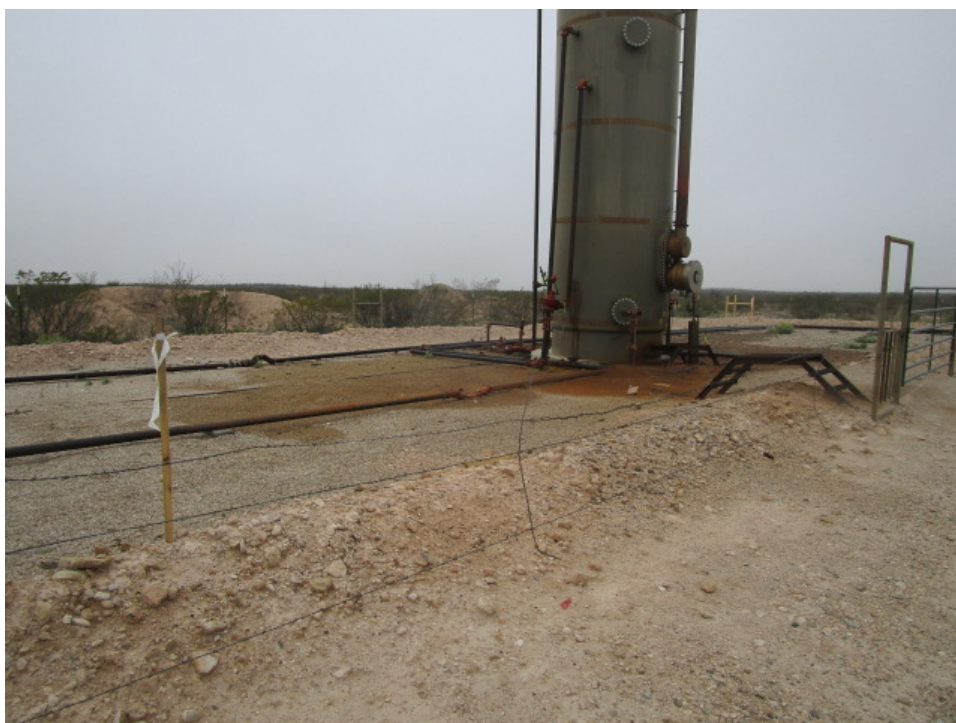
Photo 1 – Southwest view of release area dated March 28, 2019.

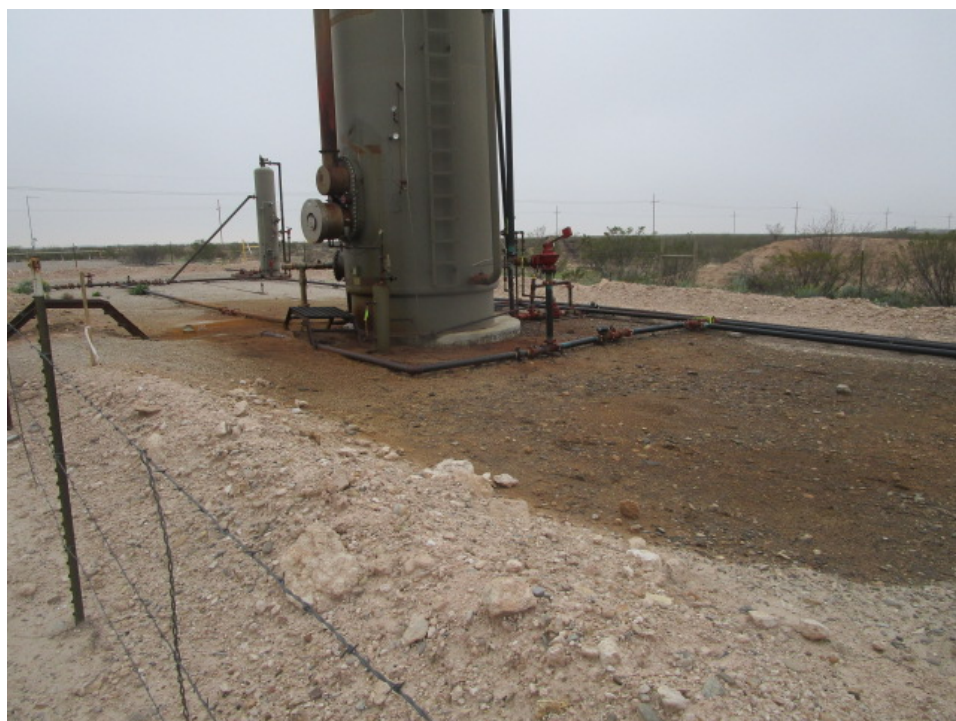
Photo 2 – Southeast view of release area dated March 28, 2019.

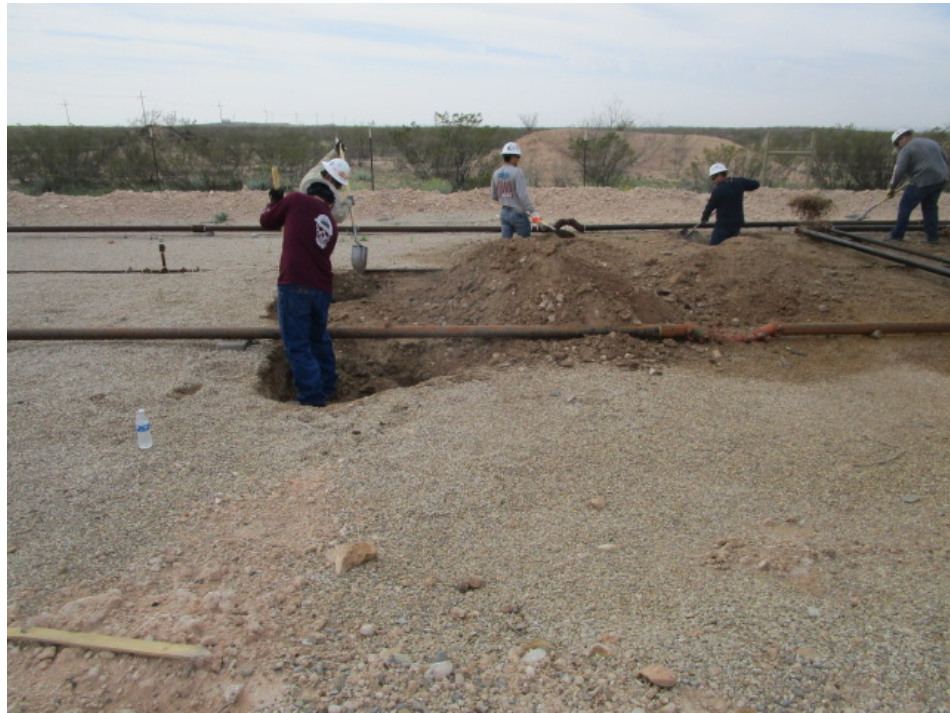
Photo 3 – South view of hand excavation activities east of heater treater dated March 29, 2019.

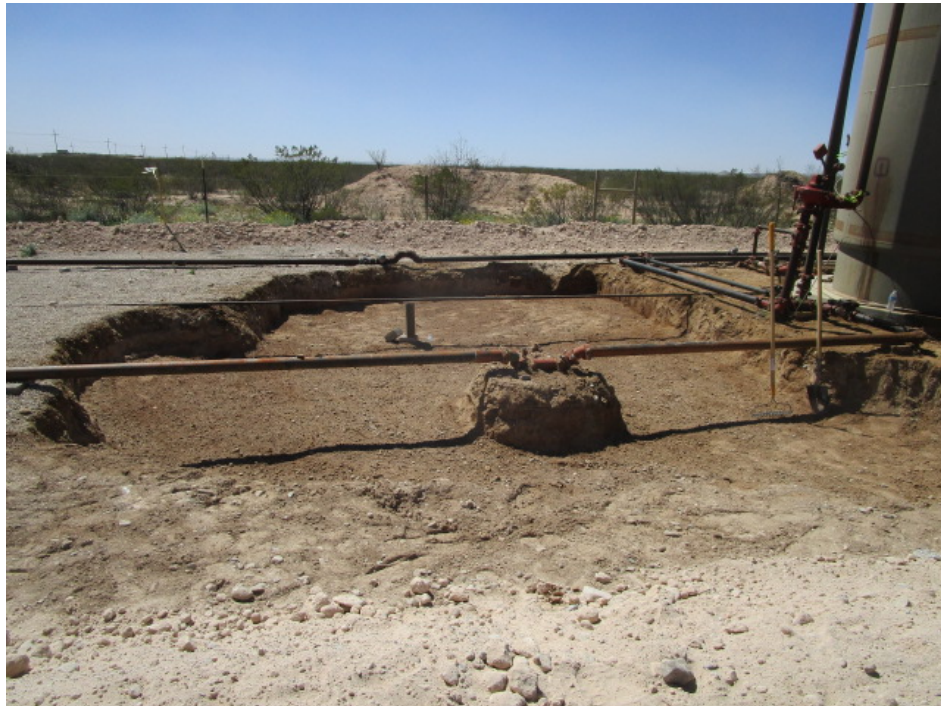
Photo 4 – South view of excavation east of heater treater dated April 11, 2019.

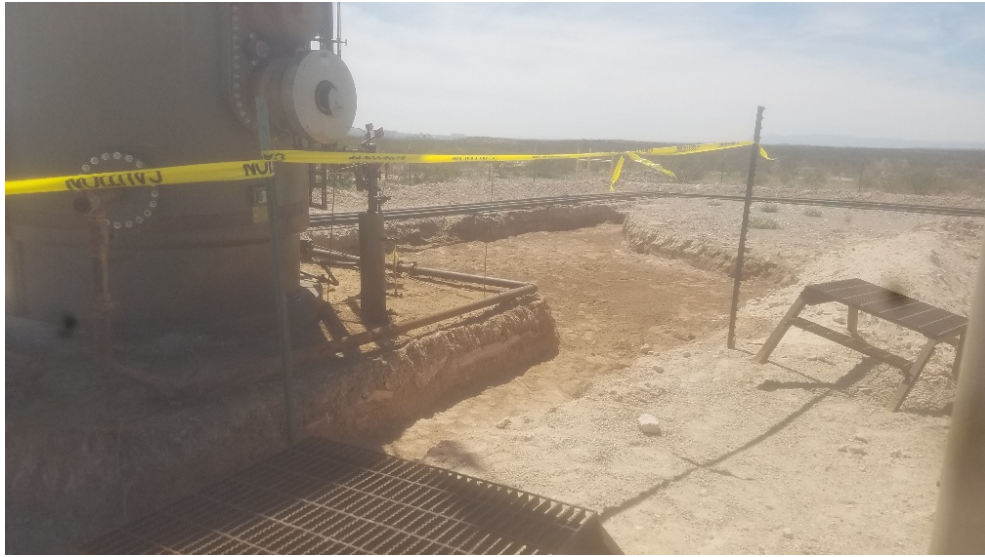
Photo 5 – Southwest view of excavation west of heater treater dated April 11, 2019.

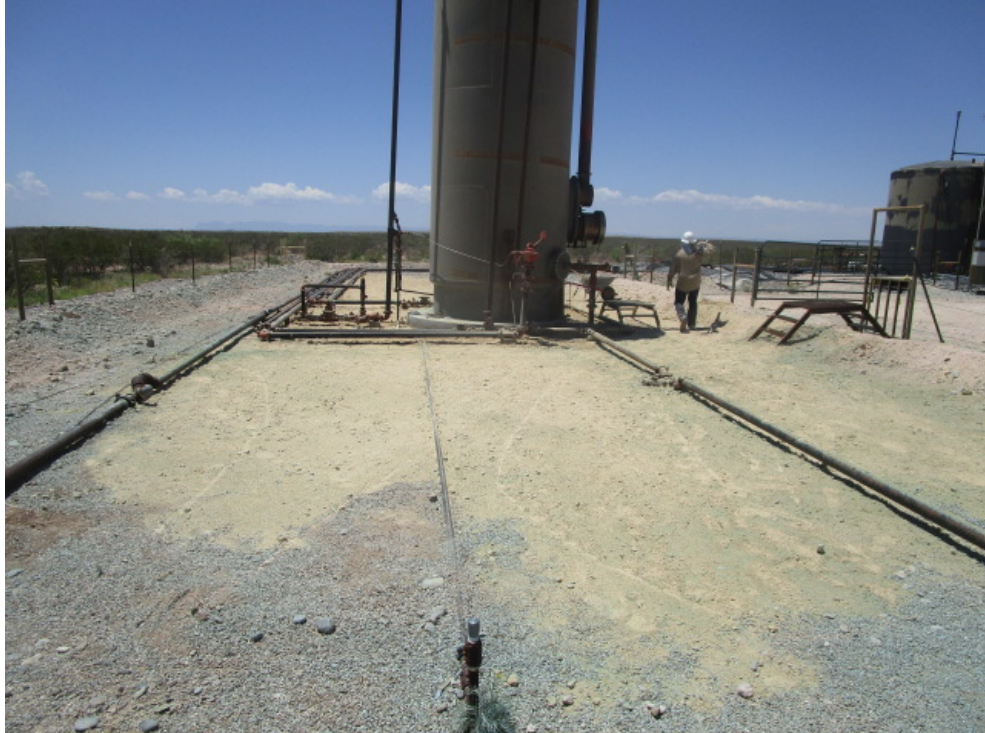
Photo 6 – West view of excavation backfilled with clean material dated May 15, 2019.

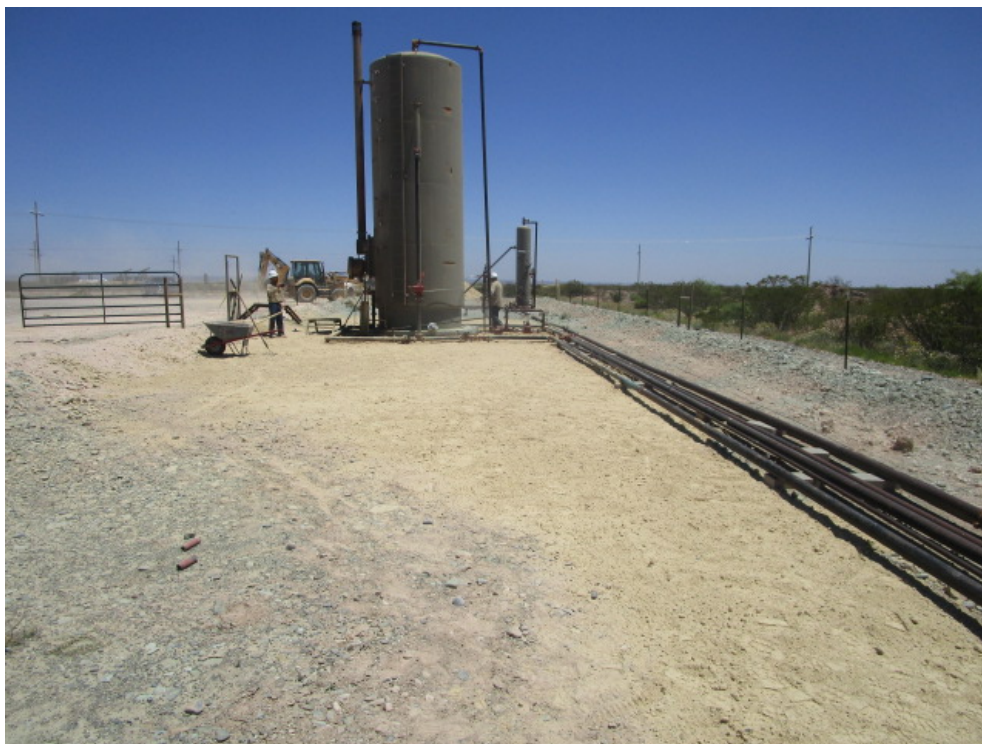
Photo 7 – East view of excavation backfilled with clean material dated May 15, 2019.
