**RE: Closure Request
Poker Lake Unit 36 DTD State SWD #1
Remediation Permit Number 2RP-5337
Eddy County, New Mexico**

FIGURE 1
SITE LOCATION MAP
POKER LAKE UNIT 36 DTD STATE SWD #1
UNIT A SEC 36 T24S R30E
EDDY COUNTY, NEW MEXICO
XTO ENERGY, INC.

FIGURE 2
DELINEATION SOIL SAMPLE LOCATIONS
POKER LAKE UNIT 36 DTD STATE SWD #1
UNIT A SEC 36 T24S R30E
EDDY COUNTY, NEW MEXICO
XTO ENERGY, INC.

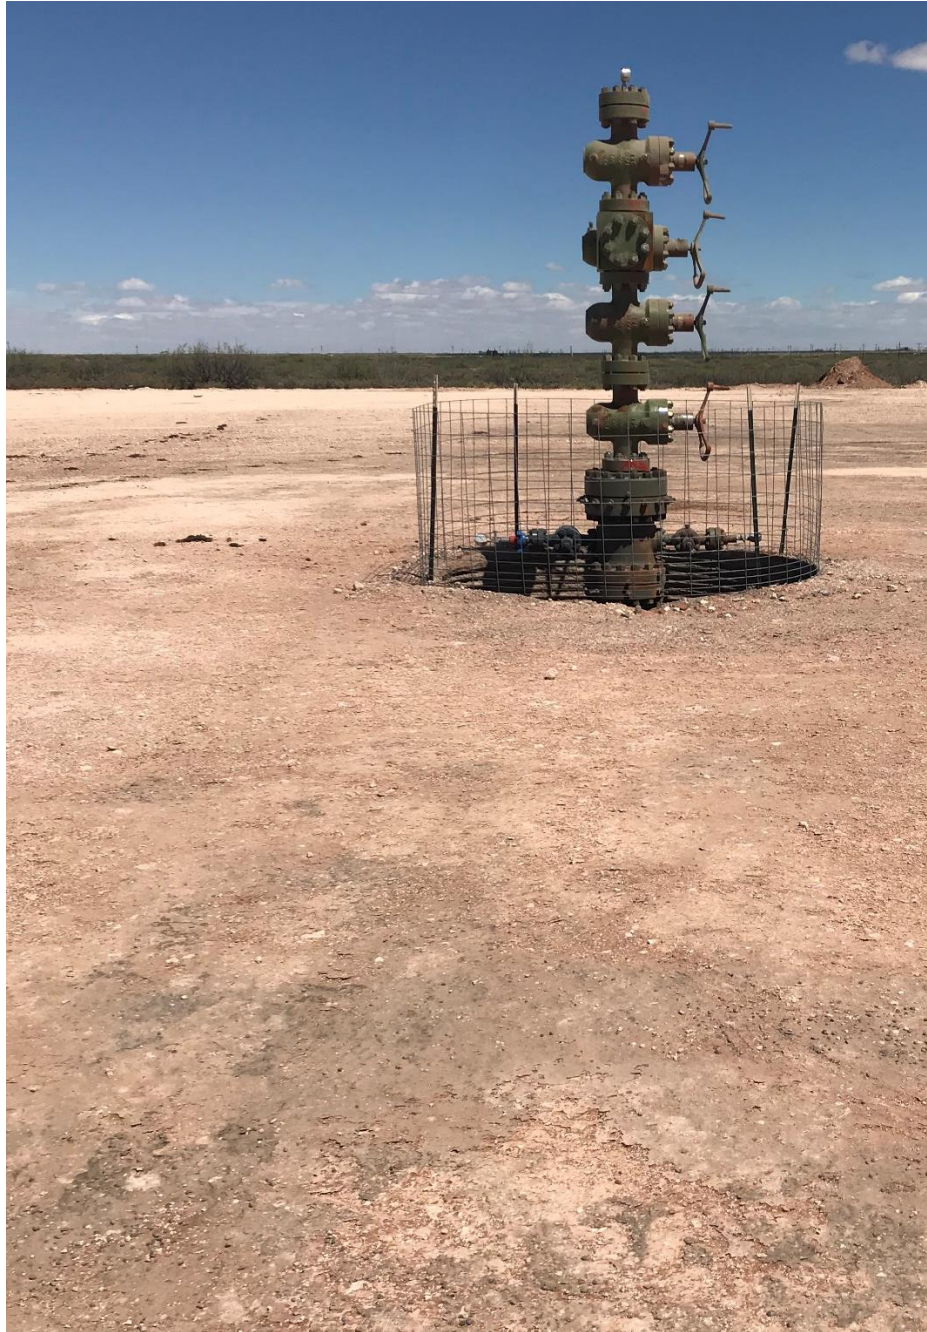
Southern view of wellhead and release area during delineation activities.

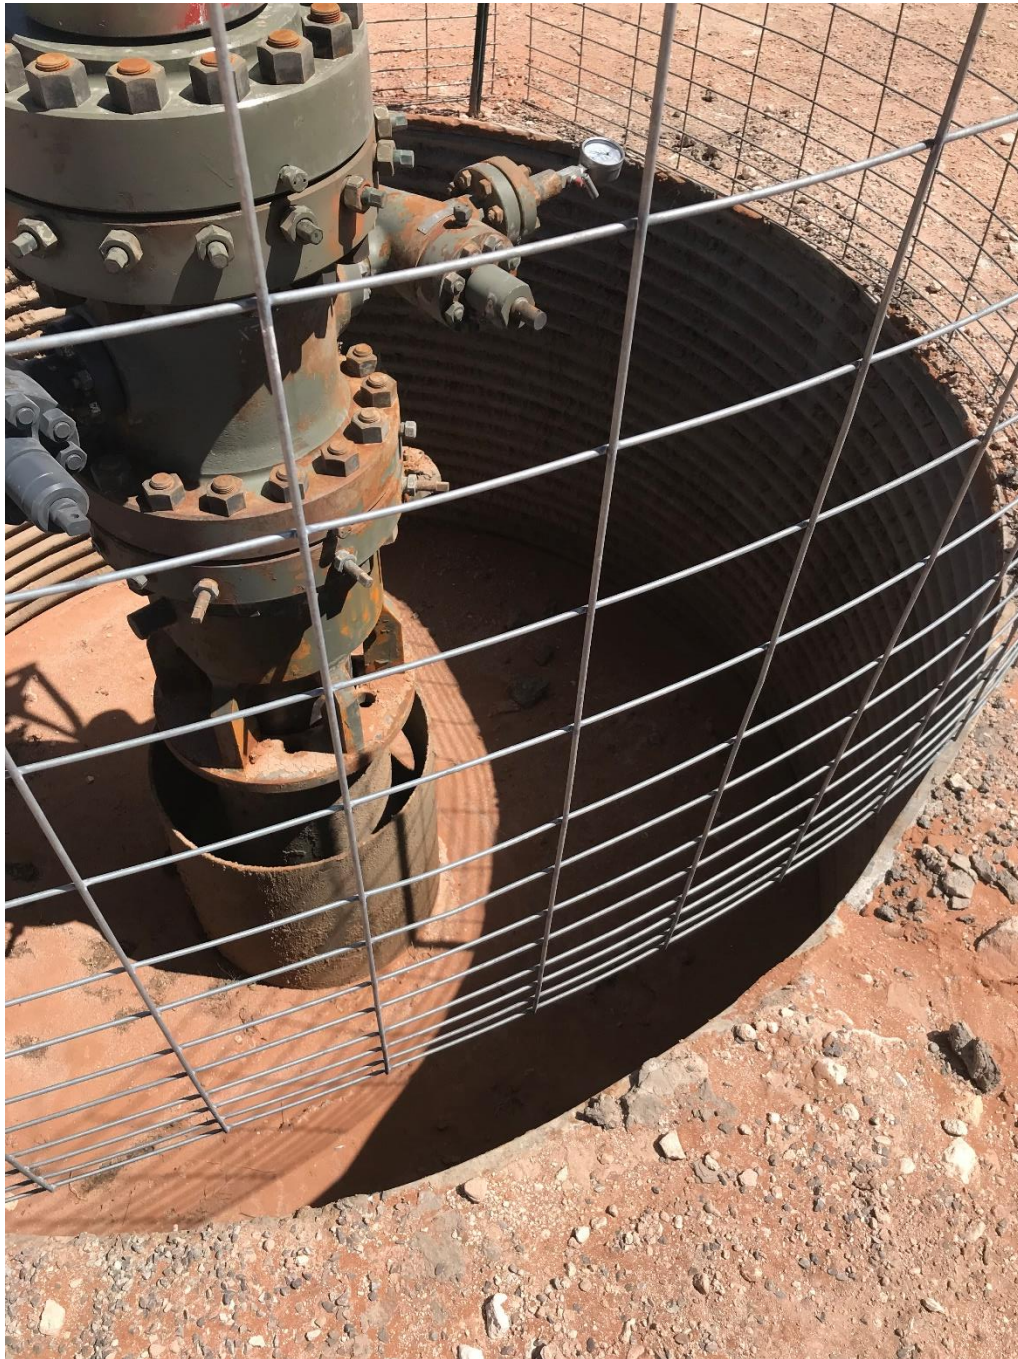
On March 18, 2019, a release of produced water occurred at the casing valve on the well head due to a failed plug. Fluids were released into well cellar. A vacuum truck was dispatched to the Site to recover free-standing fluid; approximately 65 bbls of produced water were recovered. XTO reported the release to the New Mexico Oil Conservation Division (NMOCD) via electronic mail within 24 hours and on a Release Notification and Corrective Action Form C-141 on April 1, 2019, and was assigned Remediation Permit (RP) Number 2RP-5337 (Attachment 1). Based on the results of the soil sampling events, XTO is submitting this closure report and requesting no further action for this release event.

Closeup view of point of release and well cellar.
