Breitburn Management

State 14C #009

2RP-4854

Closure Report

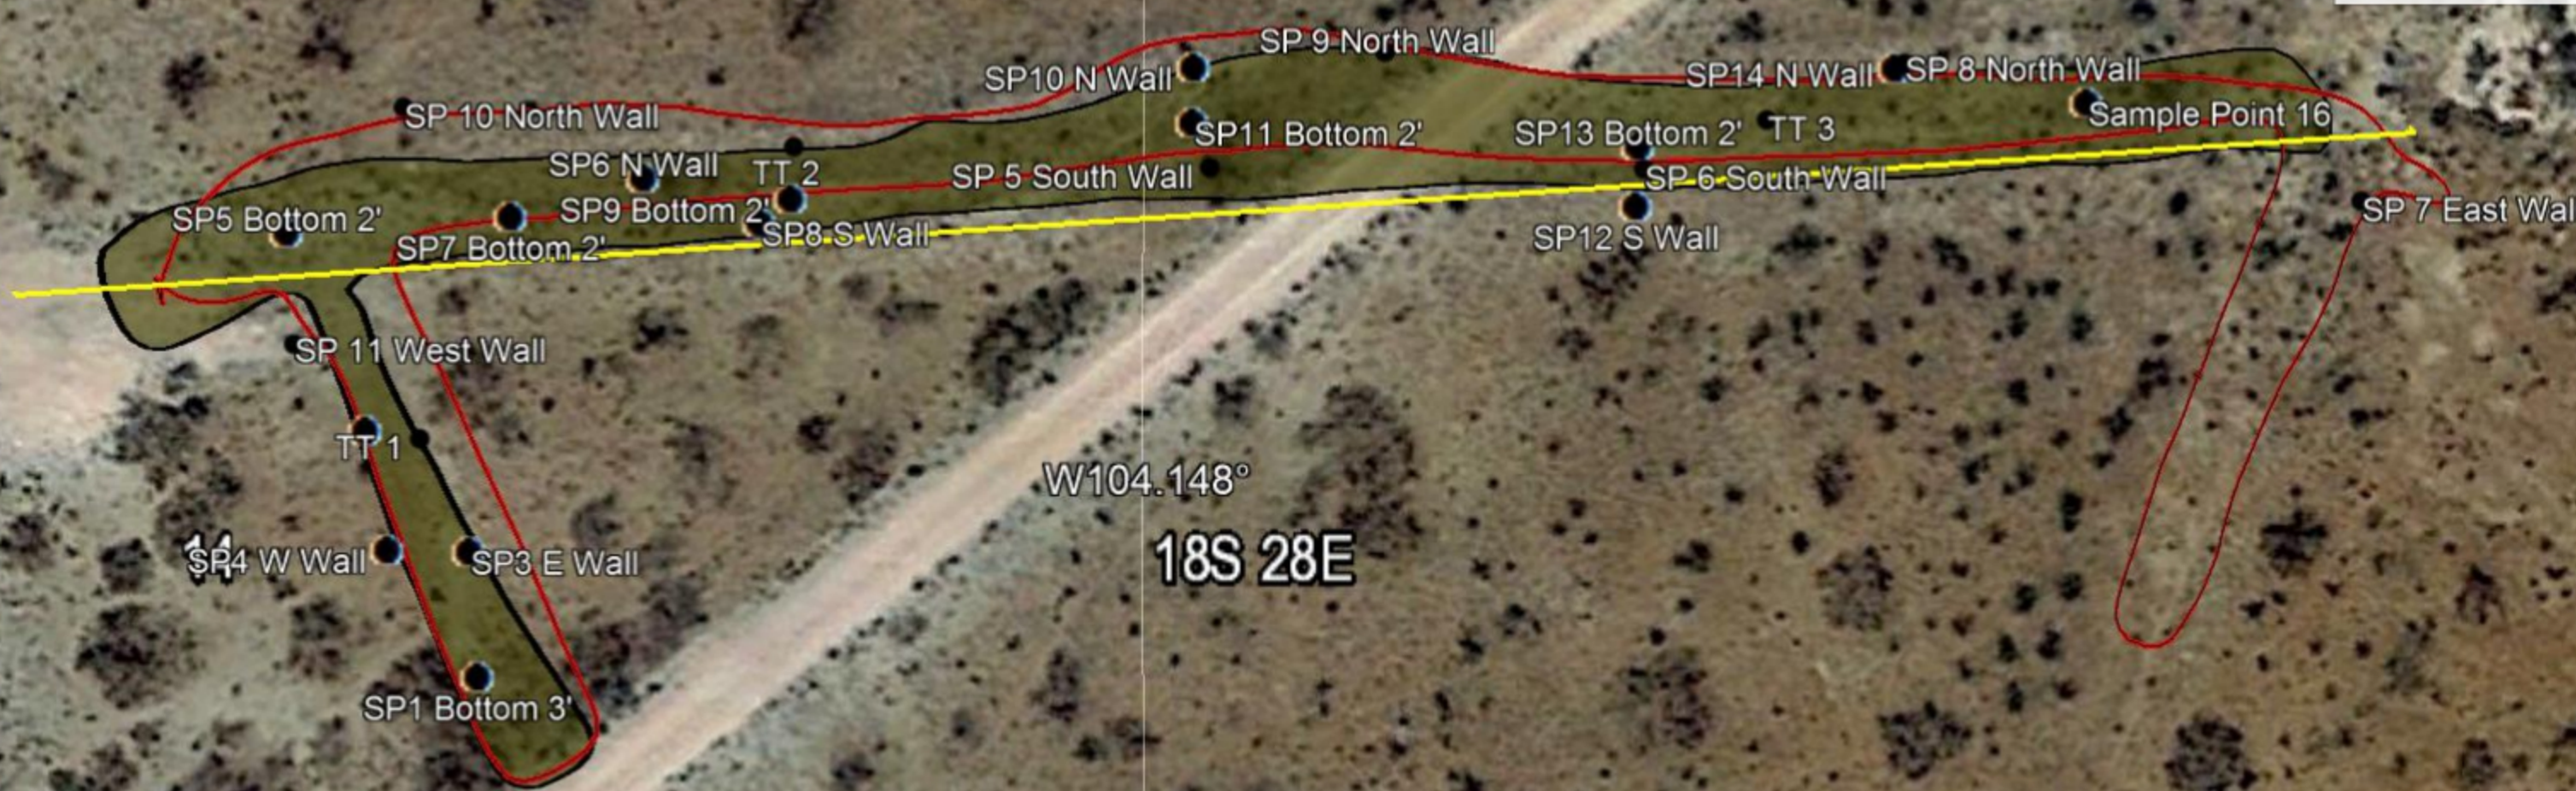
Figure 1

Site Map

Site Plan Remediation

On May 28, 2019 and based on the analyses from Hall Laboratories: SESI personnel together with personnel and equipment from Custom Welding of Hobbs, NM returned to the site in order to complete excavation of the impacted area, commence with backfill and dispose of all stockpiled soils. The excavated area is photographed, mapped and all sample point positions are marked as evidence of site characterization (Figure 1).

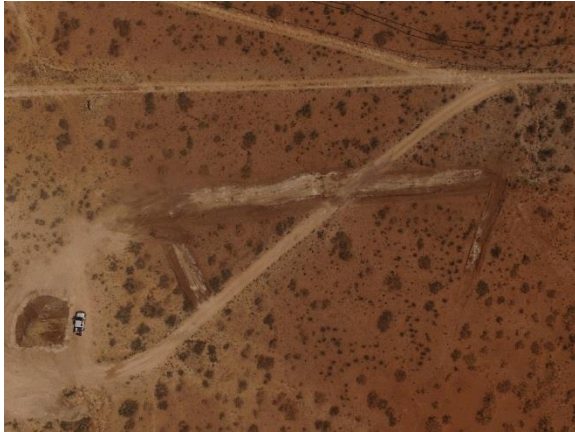
Aerial view of spill area

On July 2, 2018, SESI personnel were onsite at the Breitburn State 14 C #009 to begin delineation of the release. Breitburn personnel stated that the release had already been excavated by the use of a bull dozer. The release area was observed to have been excavated to the depth of one foot, with some small areas of hydrocarbon staining remaining. Four bottom surface soil samples were obtained from the excavated area and field tested for TPH and Chlorides. Due to levels above delineation requirements, the samples were not sent to the lab for analysis. The excavation was mapped using the Juno 3B and site photos were taken. Aerial photos of the location, release area, and excavation were also taken using a drone.

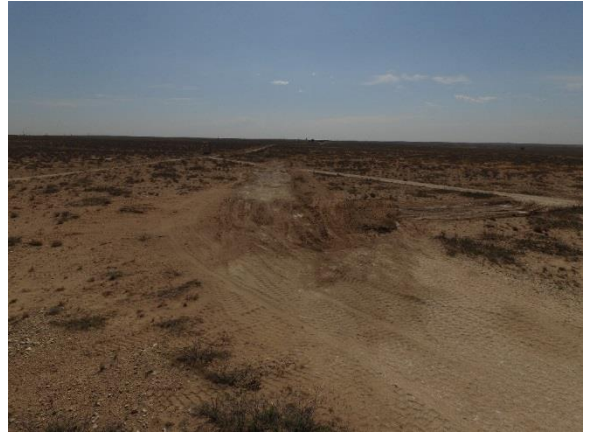
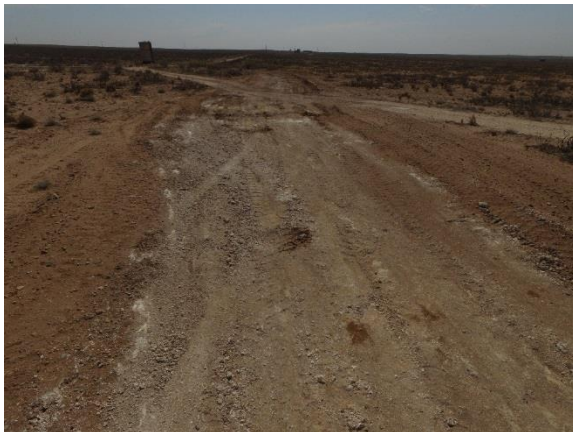
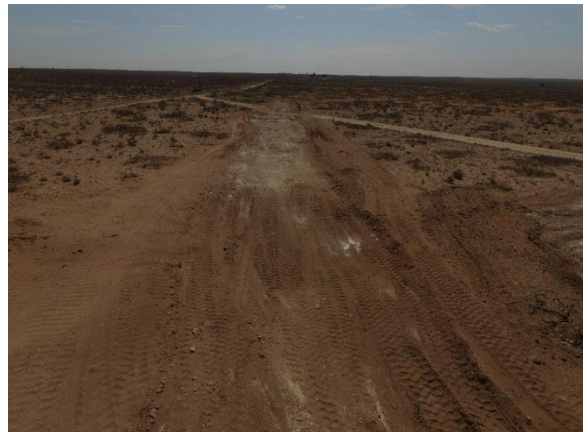
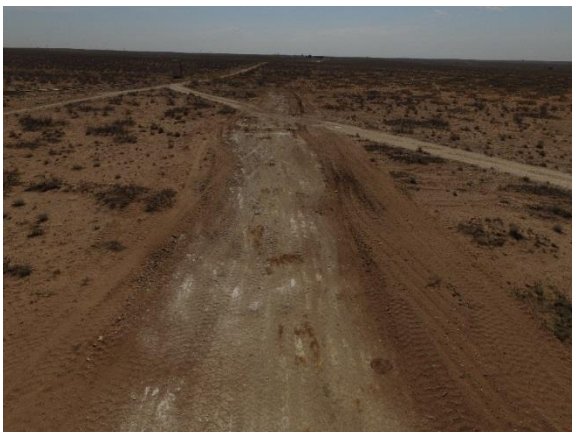
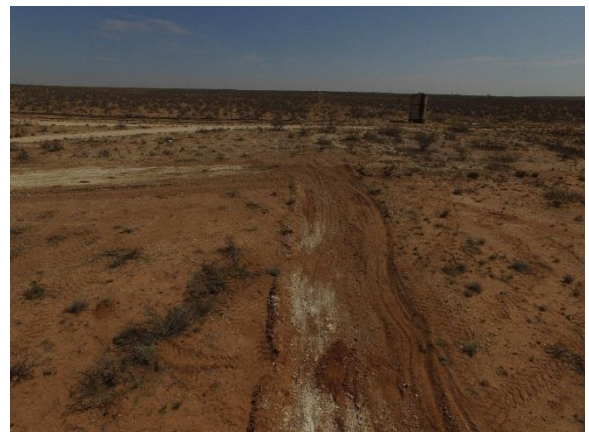
1' of surface removal (caliche)
