Report Type: Deferment Report 2RP-5161

Site:	Blue Thunder Federal Com #001					
Company:	COG Operating LLC					
Section, Township and Range	Unit H	Sec. 05	T 19S	R 31E		
Lease Number:	API No. 30-015-34991					
County:	Eddy County					
GPS:	32.69087			-103.88563		
Surface Owner:	Federal					
Directions:	From the intersection of 249 and 222 head north on 222 for 230 feet, turn southwest onto unnamed lease road and follow road 0.63 miles, turn south and go 365 feet, turn southwest and go 260 feet miles and arrive at location

Re: Deferment Report for the COG Operating, Blue Thunder 5 Federal Com #1, Unit H, Section 5, Township 19 South, Range 31 East, Eddy County, New Mexico. 2RP-5161

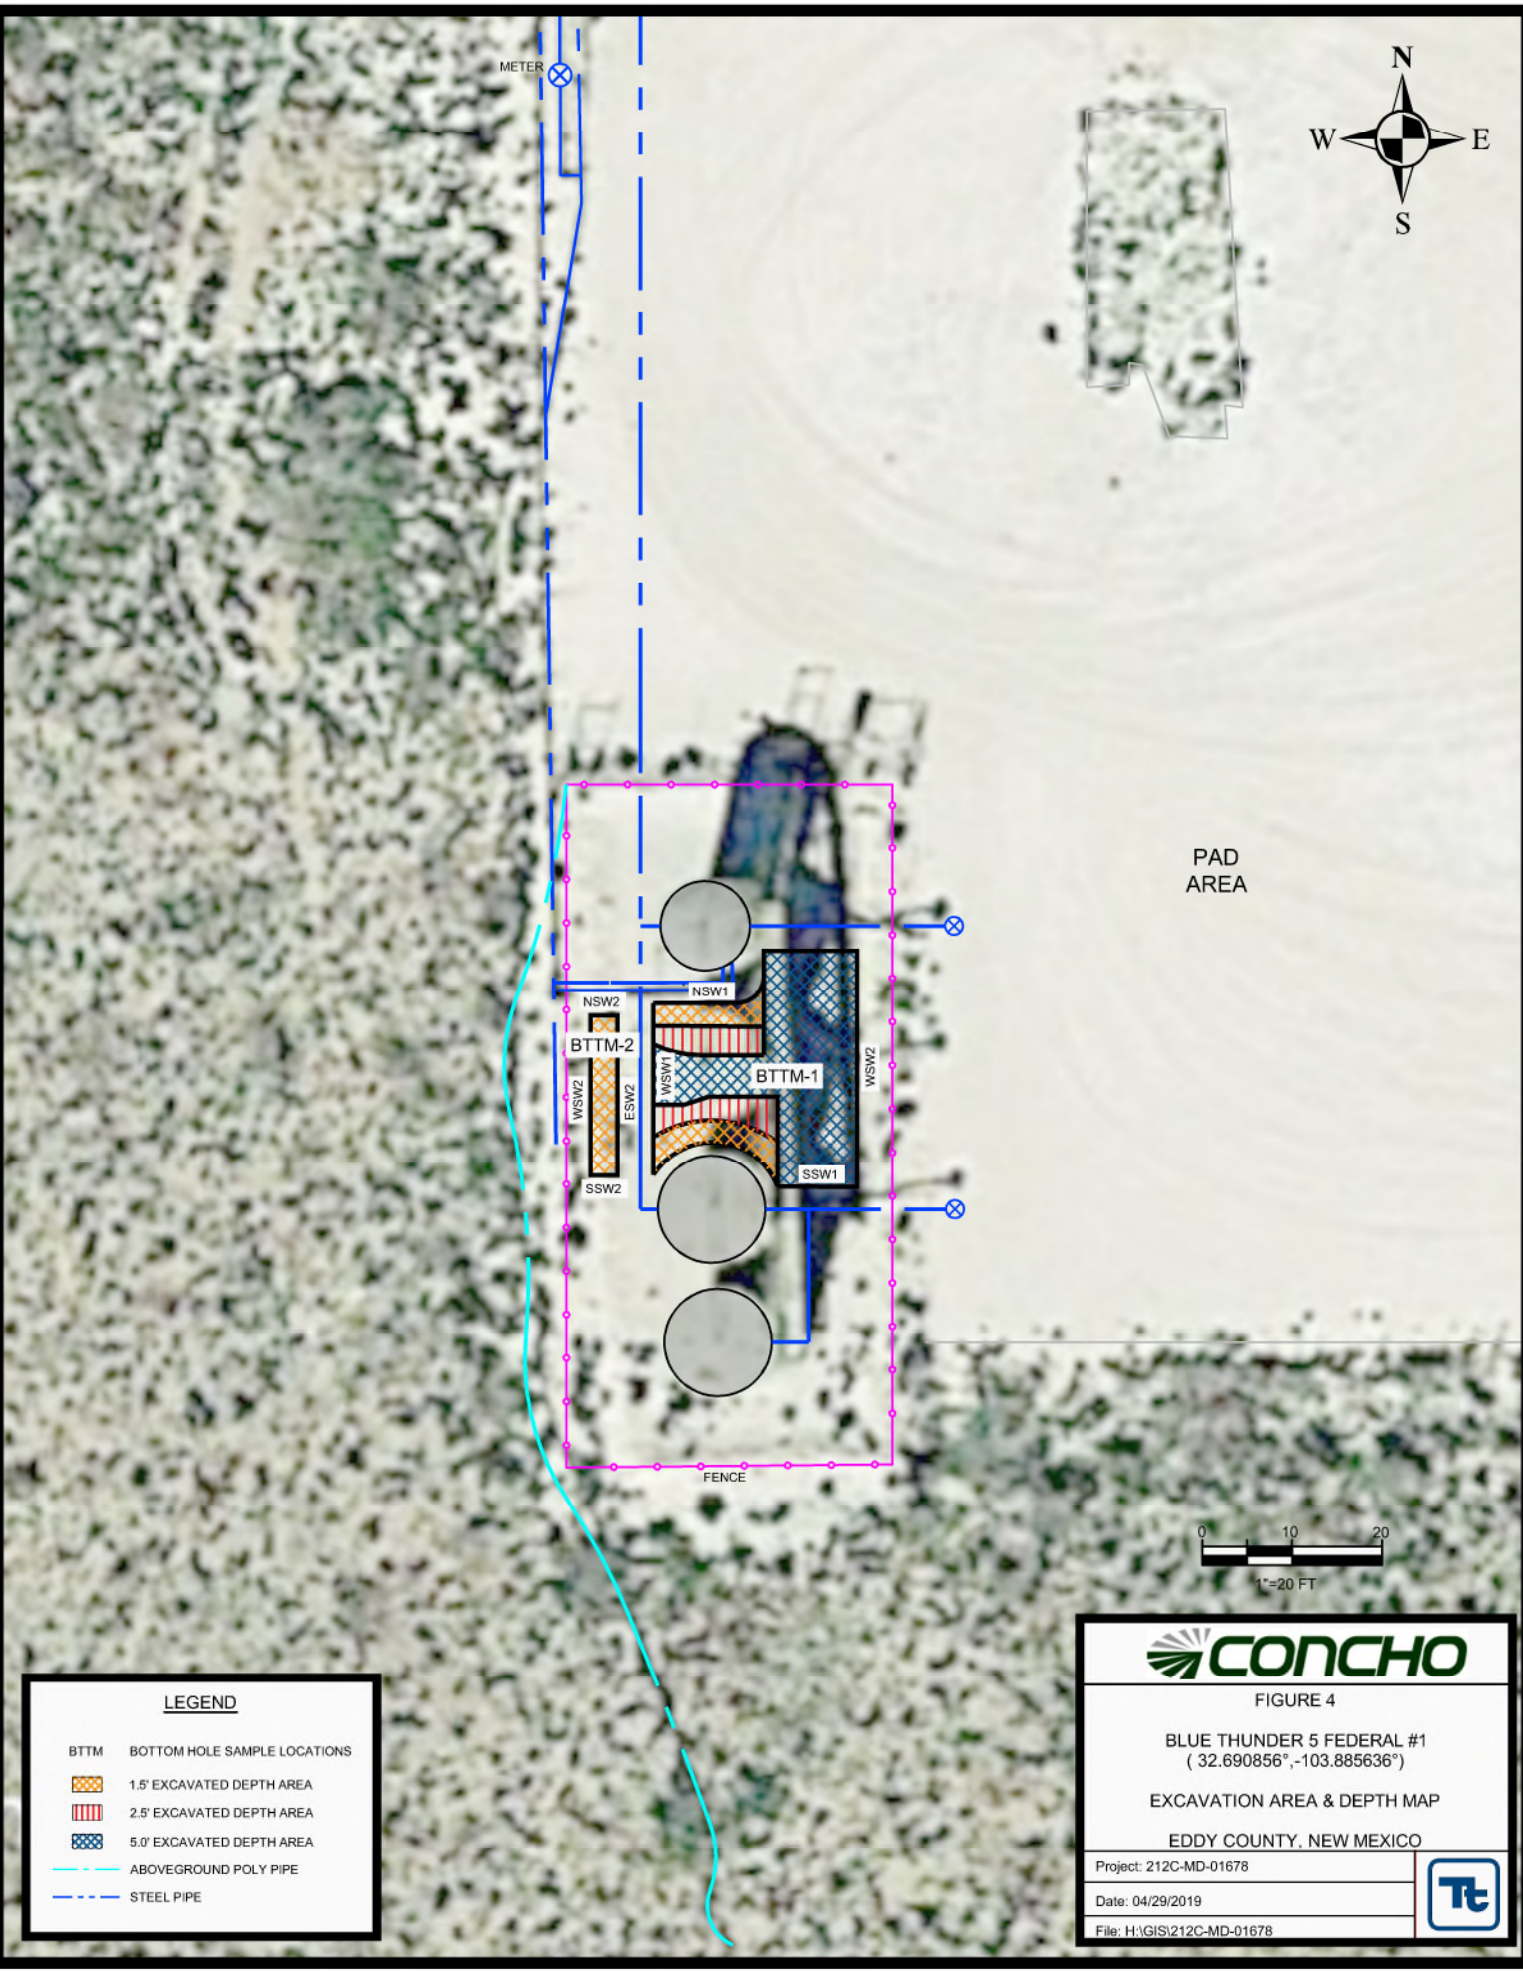
Excavation Depths

Tetra Tech personnel were onsite between March 3rd and 24th, 2019 to supervise the remediation activities. The release area was excavated to 1.5' below surface. Two (2) bottom hole composite samples (Bottom Hole 1 and Bottom Hole 2) and eight (8) sidewall composite samples (North Sidewall 1, North Sidewall 2, South Sidewall 1, South Sidewall 2, East Sidewall 1, East Sidewall 2, West Sidewall 1, and West Sidewall 2) were collected every 200 square feet to ensure proper removal of the impacted soils. The samples were submitted to the laboratory to be analyzed for TPH method 8015 extended, BTEX method 8021B, and Chloride by EPA Method 300.0. The sampling results are summarized in Table 1. The excavation depths and sample locations are shown in Figure 4.

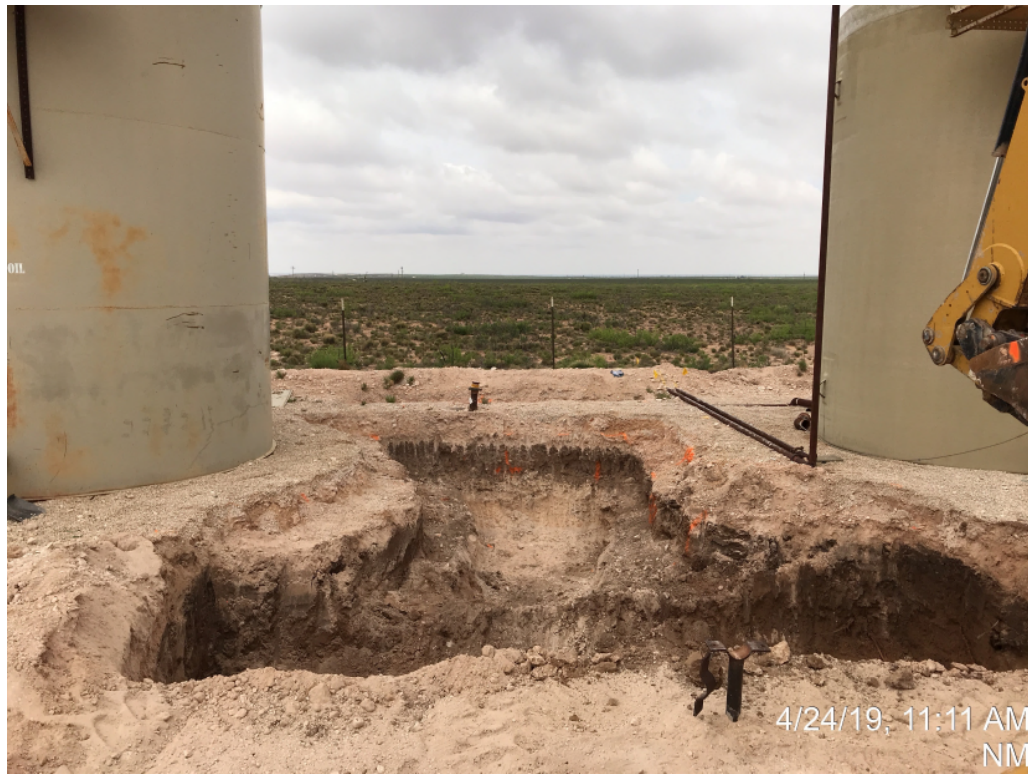
Area of Excavation – View West

The areas of confirmation samples (Bottom Hole 1 and West Sidewall 1) were then expanded to the maximum extent practical, with consideration given to the existing oilfield infrastructure and equipment in place. The area of Bottom Hole 1 was benched and excavated to 5.0' to remove the impacted material to the maximum extent safely possible, as vertically defined by trench (T-1). However, the area of (Bottom Hole 1) could not be resampled due to safety concerns for onsite personnel. The areas of (North Sidewall 1 and South Sidewall 1) could not be expanded due to the onsite tanks and equipment.

Approximately 30 cubic yards of material was excavated and transported offsite for proper disposal. The areas were then backfilled with clean material to surface grade.

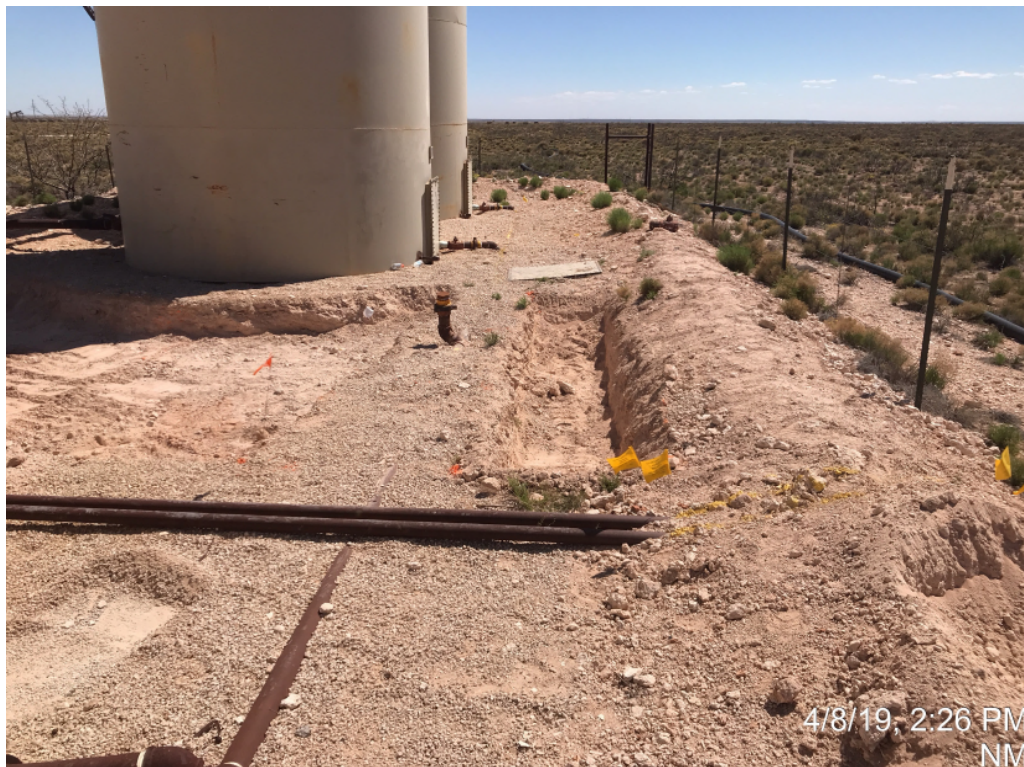
Area of Excavation – View South
