Breitburn Management
State 647-711

Closure Report

**Section 27, Township 18S, Range 28E
Eddy County, New Mexico
*2RP-4969***

June 25, 2019

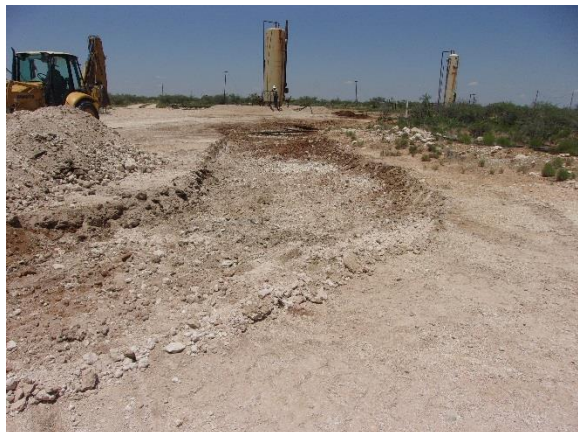
Excavation of pad -lease road

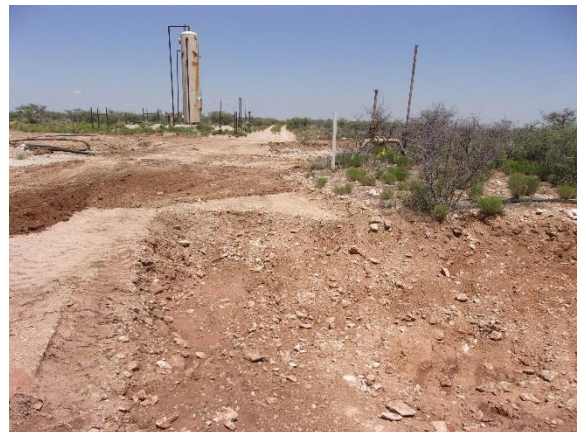
Remediation of Pasture

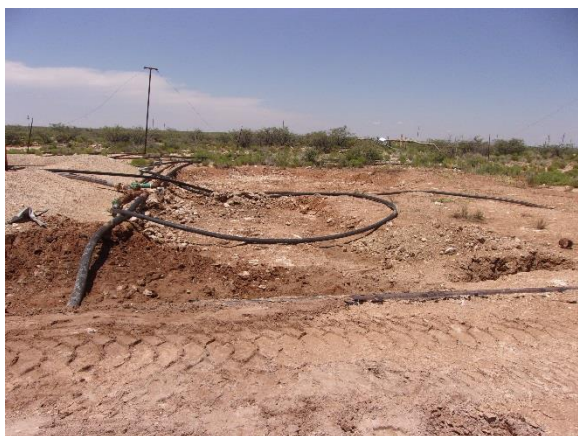
Unmarked Lines

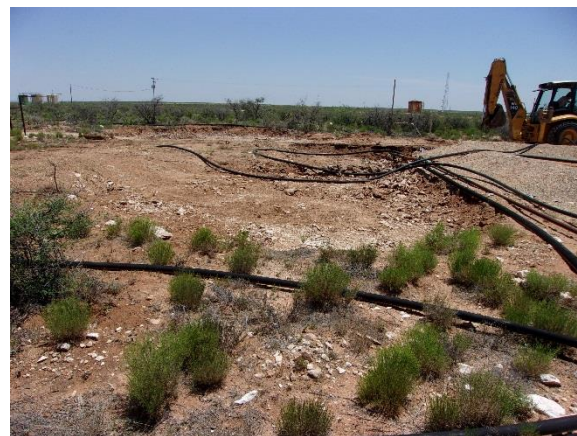
Lease road-pasture remediation

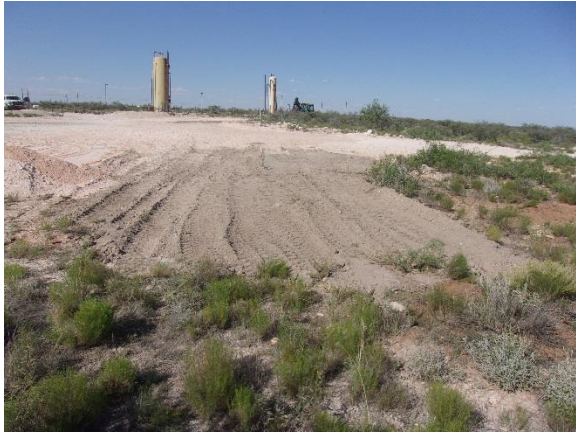
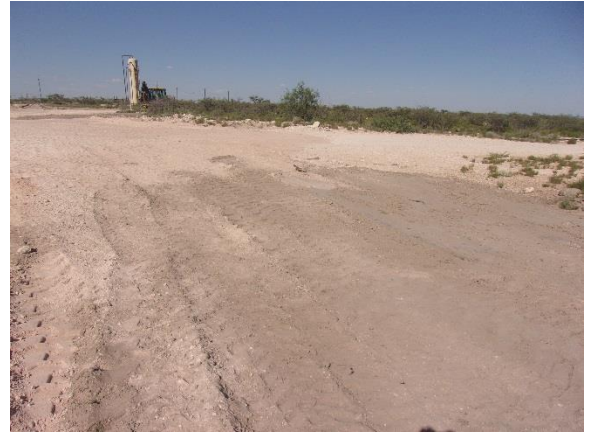
Pasture and Lease road restoration at completion

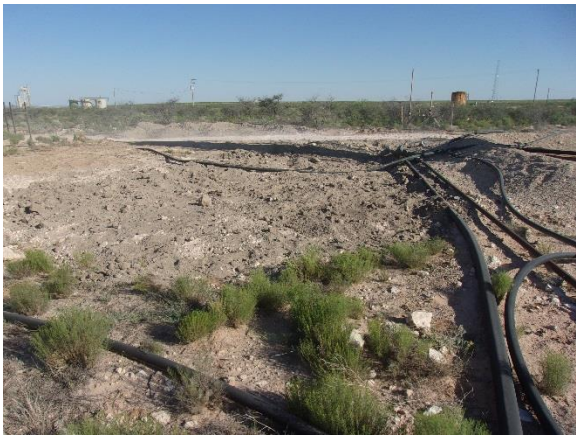
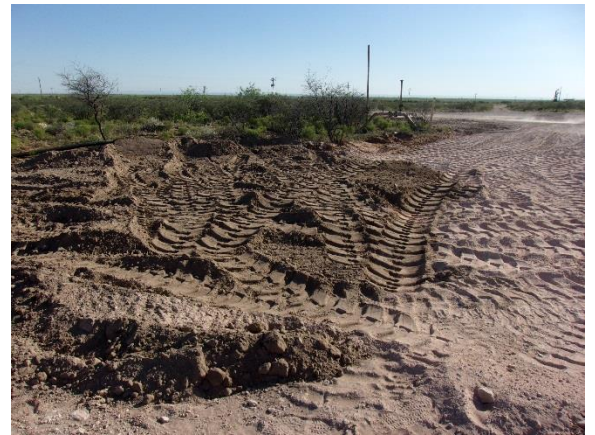
Pasture backfill area of flowlines

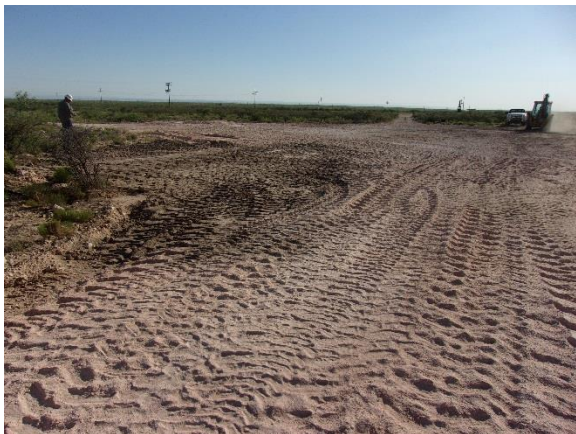
Pasture area of unmarked lines

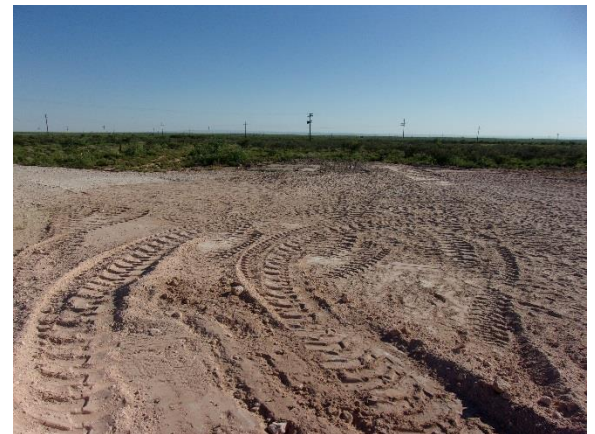
Lease road-pasture at completion
