SUBJECT: Remediation Closure Report for the Poker Lake Unit 18 BD #161H Release (2RP-5430),  
Eddy County, New Mexico

Regional Vicinity & Wellhead Protection Map  
Poker Lake Unit 18 BD #161H  
Sec 18 T25S R30E Eddy County, New Mexico

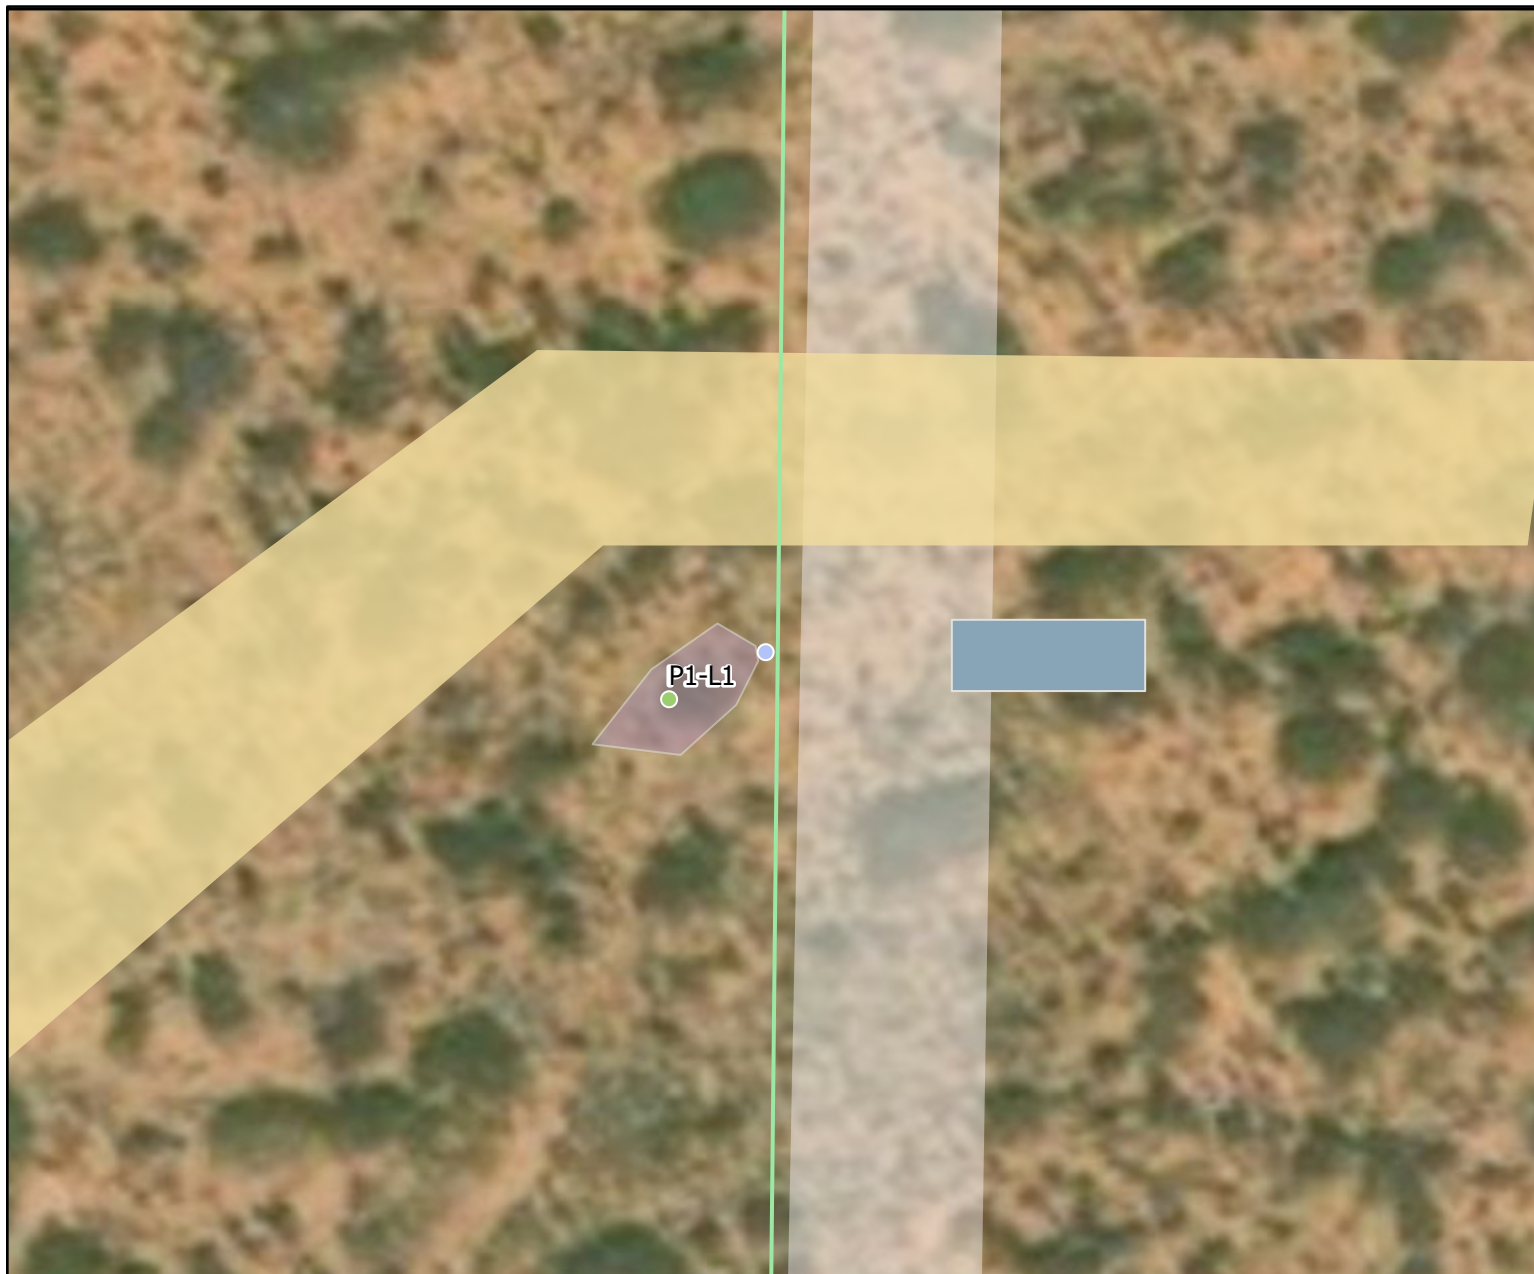
Figure 3a

A total of eleven sample locations (Part 1 = L1; Part 2 = L1-L10) were investigated using a hand-auger, to depths up to two feet bgs. A total of thirteen samples were collected for laboratory analysis of total chloride using EPA Method 300.0; surface samples near each failure point were additionally analyzed for benzene, toluene, ethylbenzene and total xylenes (BTEX) using EPA Method 8021B; and motor, diesel and gasoline range organics (MRO, DRO, and GRO) by EPA Method 8015D.

Figure 3 shows the extent of the release and sample locations. All field screening and laboratory results are summarized in Table 3. Laboratory reports are included in Appendix C.

Release Part 1 Site and Sample Locations  
Poker Lake Unit 18 BD #161H  
Sec 18 T25S R30E Eddy County, New Mexico

Laboratory analysis from this sampling event returned contaminant levels below NMOCD closure criteria; therefor SMA recommends no further for the Poker Lake Unit 18 BD #161 release.

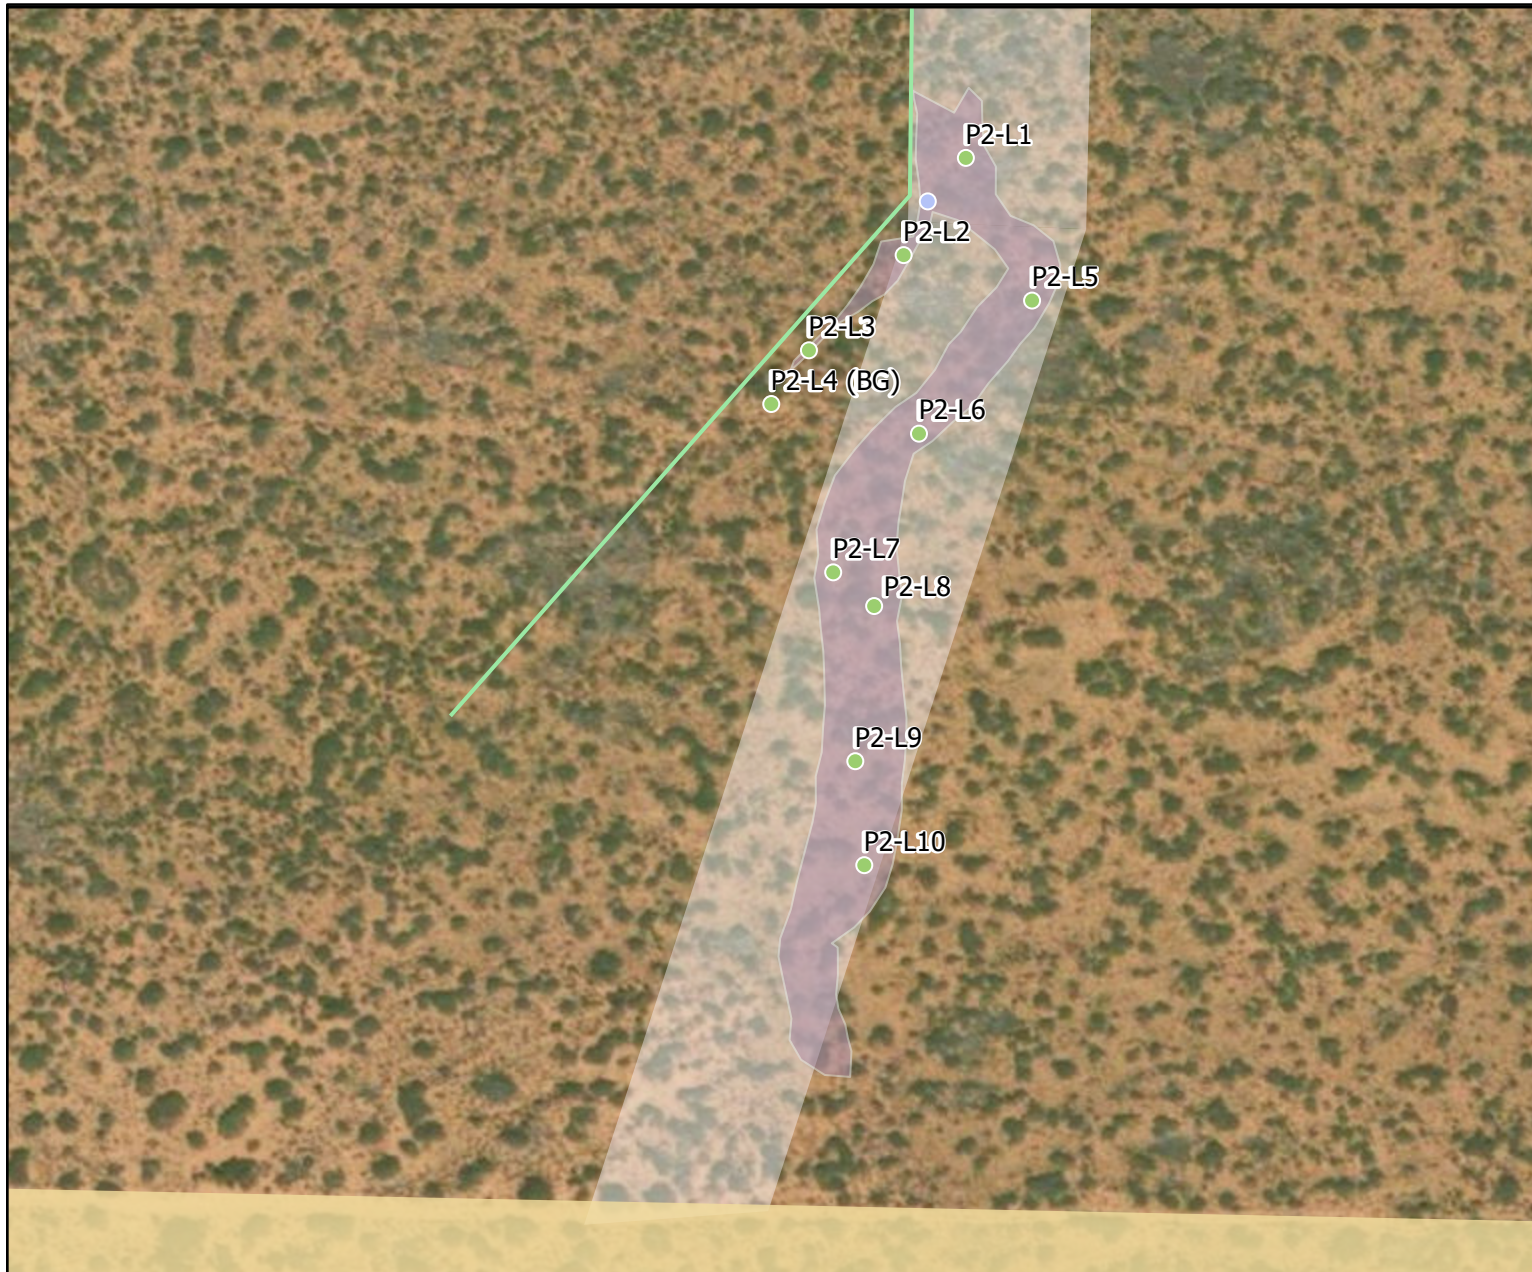
Figure 3b

Release Part 1 Site and Sample Locations  
Poker Lake Unit 18 BD #161H  
Sec 18 T25S R30E Eddy County, New Mexico
