**RE: Closure Request
Muy Wayno Frac Pond
Remediation Permit Number 2RP-5402
Eddy County, New Mexico**

LT Environmental, Inc. (LTE), on behalf of XTO Energy, Inc. (XTO), presents the following Closure Request report detailing soil sampling and excavation activities at the Muy Wayno Frac Pond (Site) in Unit C, Section 7, Township 25 South, Range 30 East, in Eddy County, New Mexico (Figure 1). The purpose of the soil sampling and excavation activities was to address impacts to soil following a produced water release at the Site. The caliche well pad at the Site has been recently constructed to allow for the storage and operation of a frac pond; there is no active well on site. Based on the excavation activities and results of the soil sampling events, XTO is submitting this Closure Request, describing remediation that has occurred and requesting no further action for this release event.

Project: 012919080	XTO Energy, Inc. Muy Wayno Frac Pond

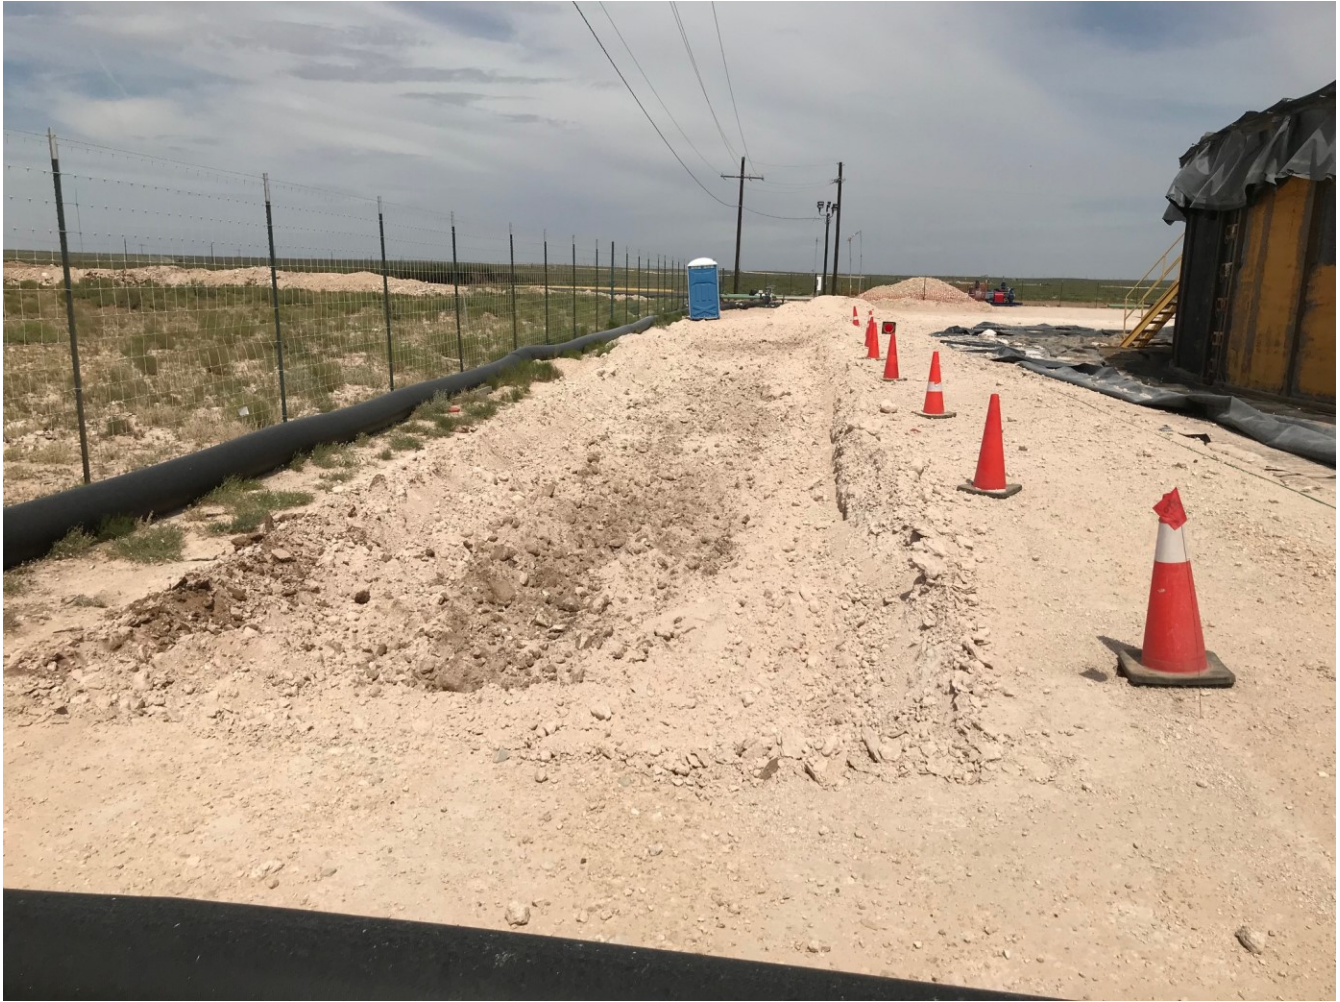
Western view of excavated area north of the AST containment.

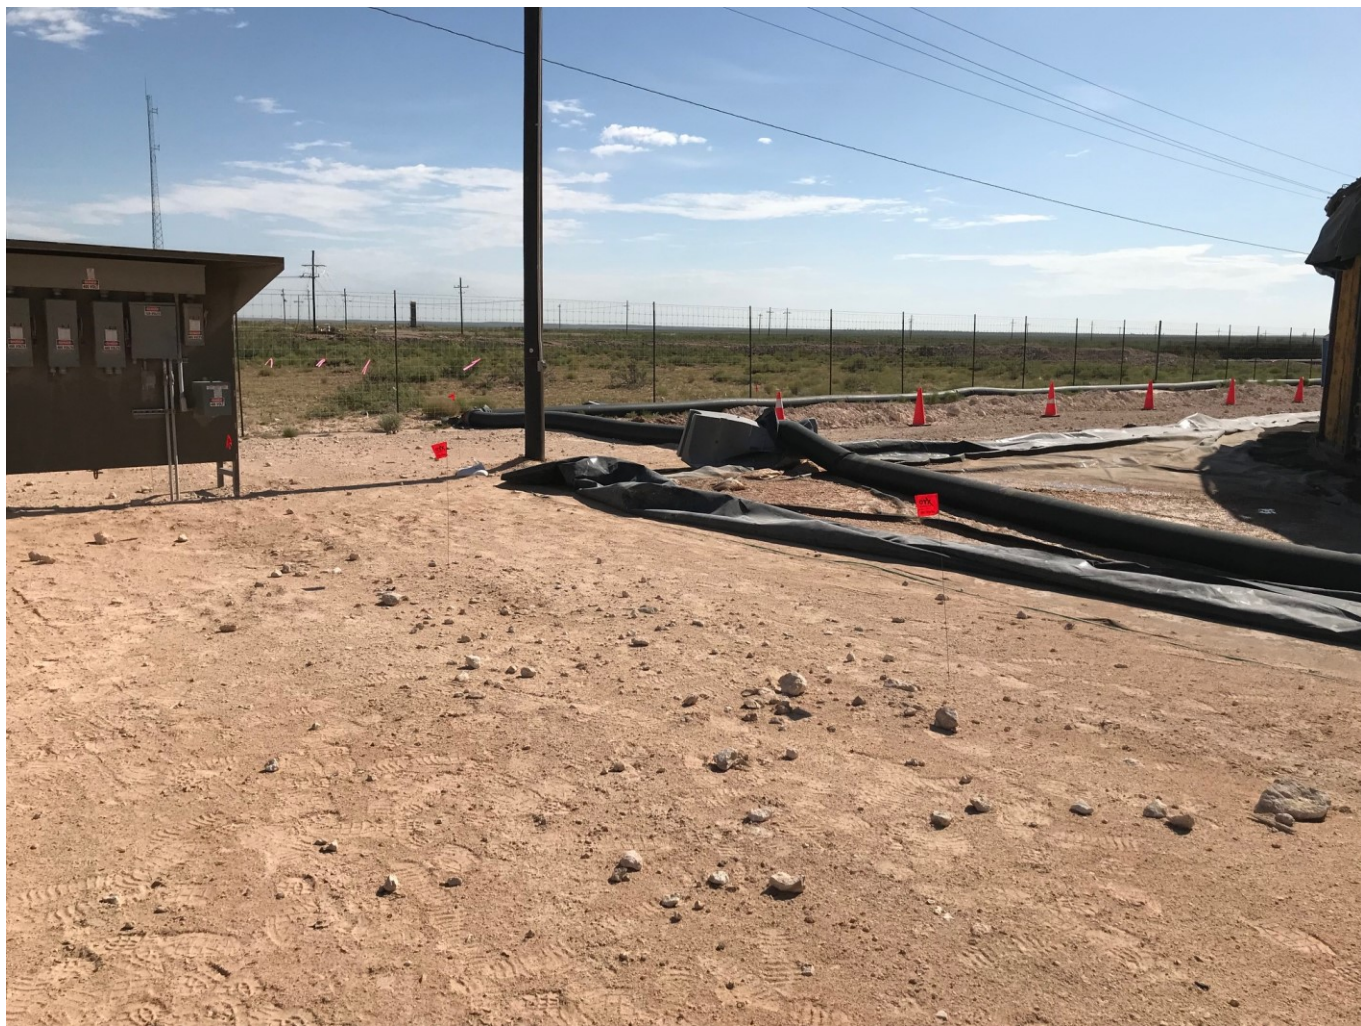
Northeastern view of the active pipelines area after the excavation was backfilled.
