**Site Investigation Report And Corrective Action Plan for the
Candelario 24 SWD
Eddy County New Mexico**

Rockcliff Energy LLC

Kane Environmental Engineering Inc.

June 2017

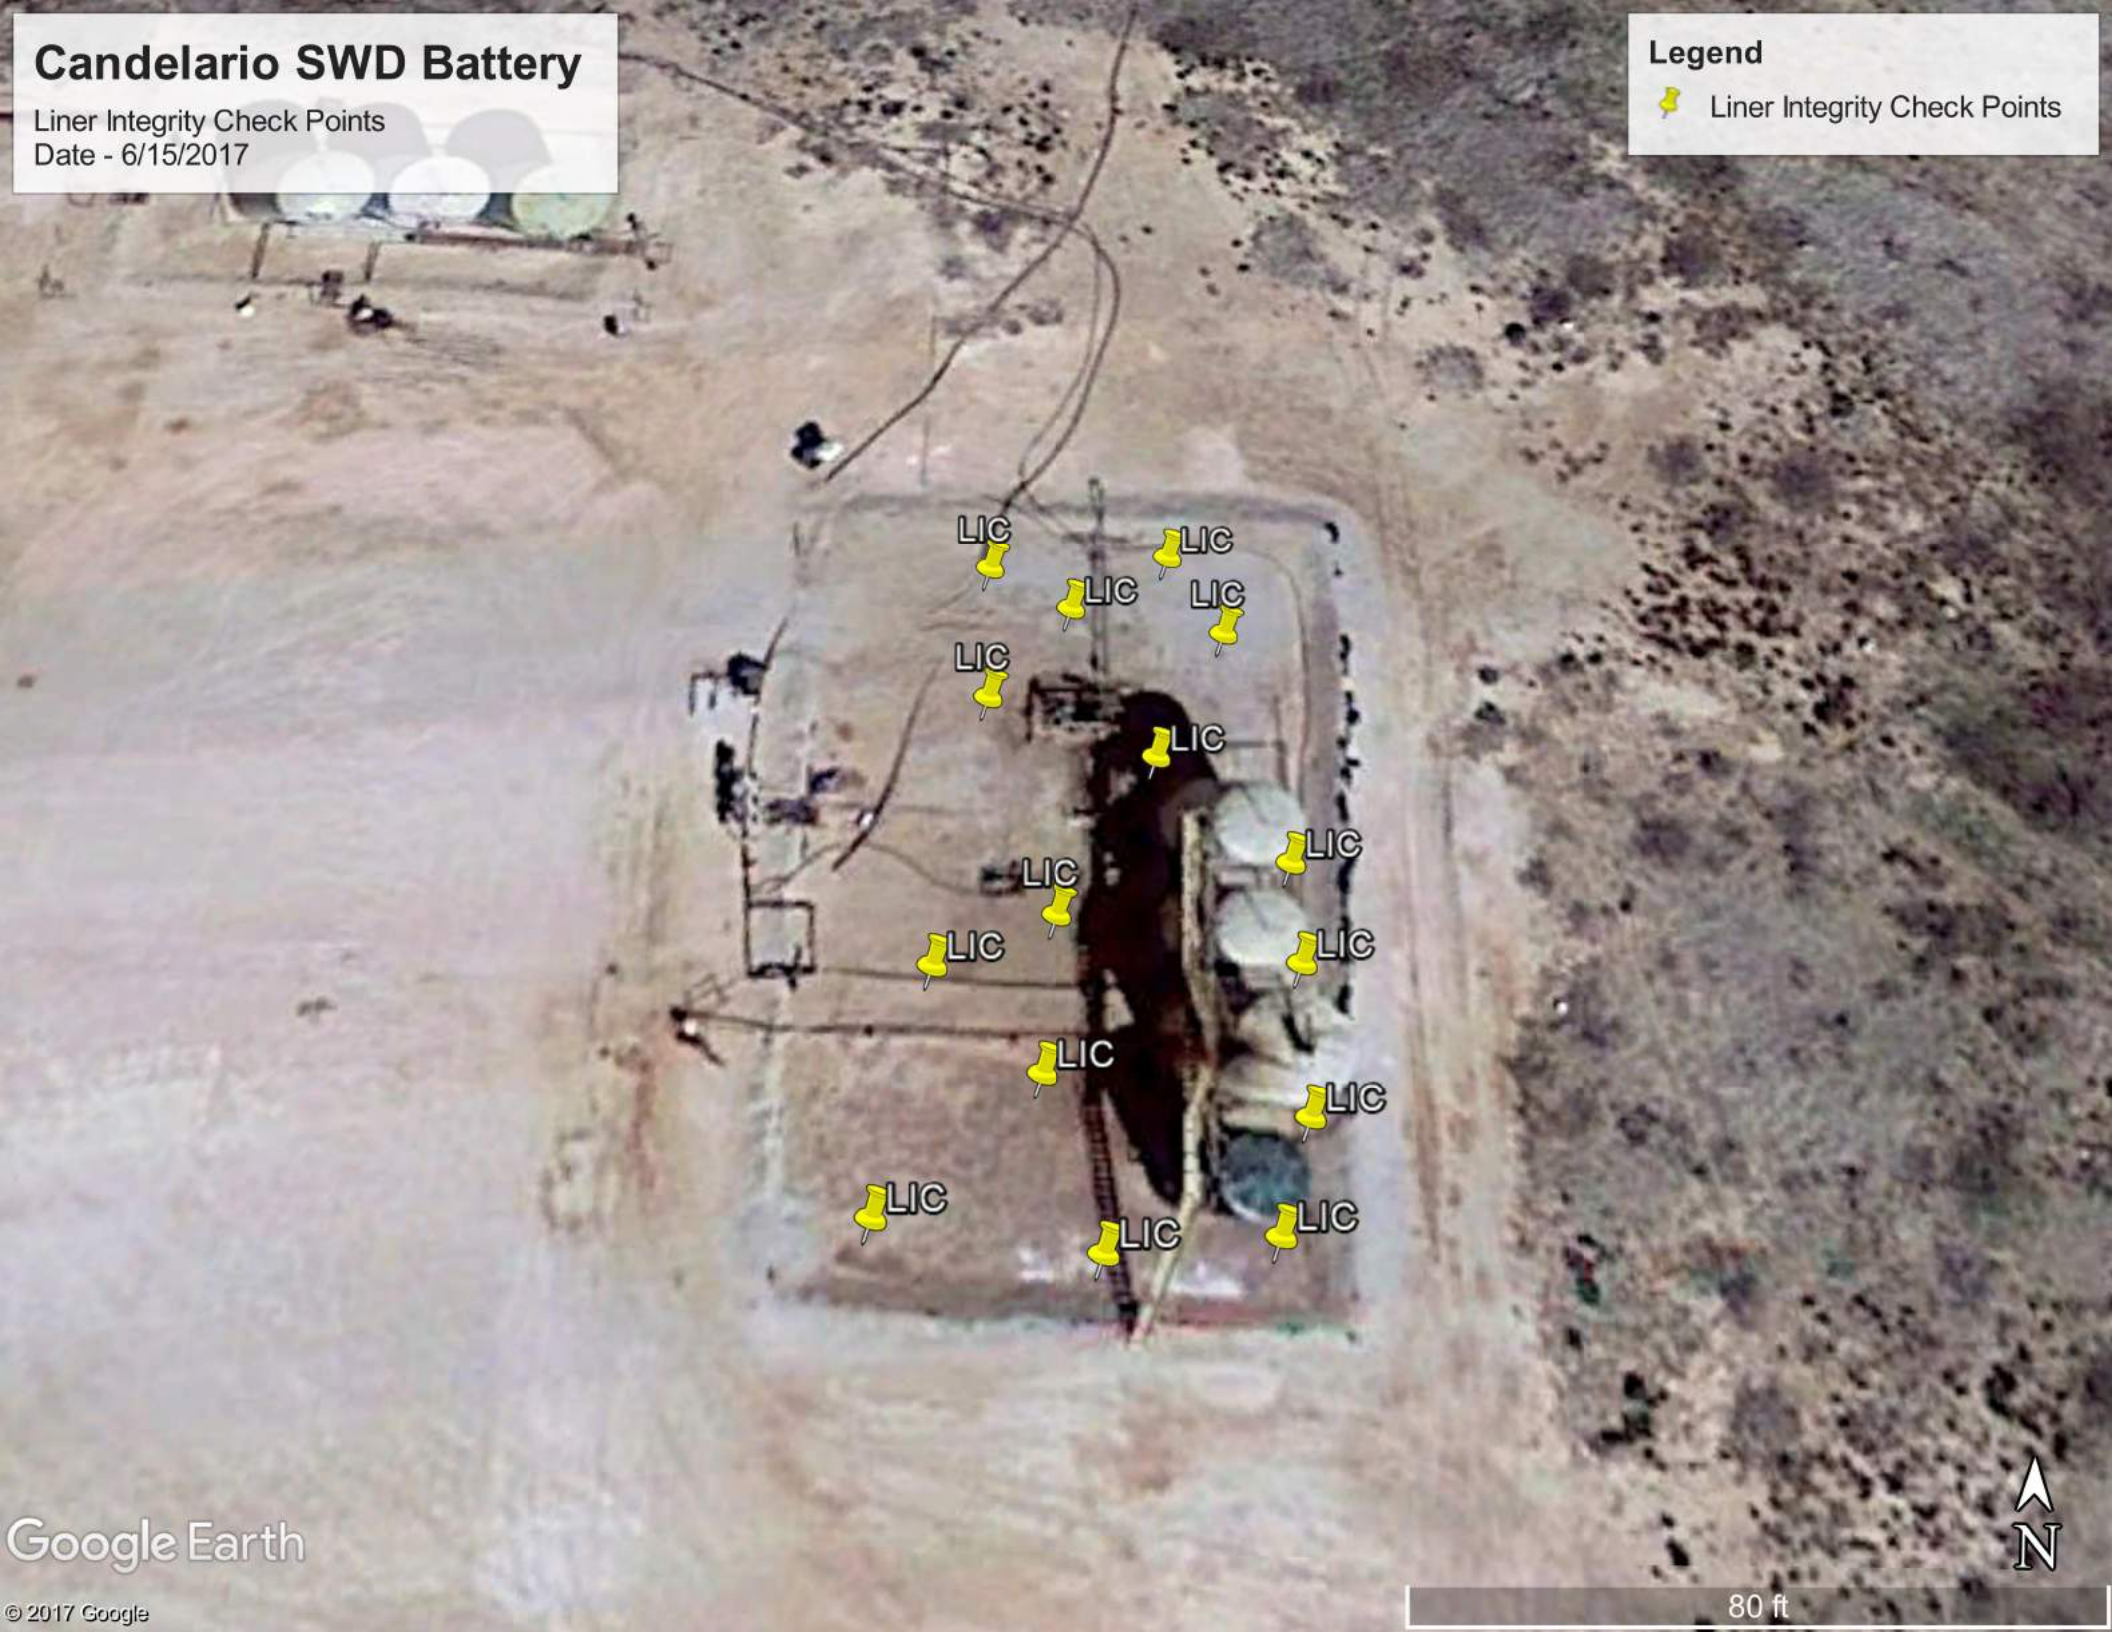
Figure 2

Candelario SWD Battery

Liner Integrity Check Points
Date - 6/15/2017

Liner Integrity Check Points

4. Kane personnel used a shovel and a hand trowel to determine the types of materials that cover the liner and evaluate the liner integrity. The liner was encountered across the secondary containment area from the surface on the containment berms to a depth of 12 inches below the soil surface within the secondary containment area (See Appendix A-Photographs). Approximately fifteen (15) test holes were excavated to evaluate the liner from various locations within the secondary containment and the berms. The approximate locations of the test holes is depicted in Figure 2.
5. Samples were then placed in the labelled samples jars, then on ice in a cooler and delivered to the Cardinal Laboratory located in Hobbs, New Mexico for analysis. All samples were analyzed for the following constituents:

Based on historical aerial photographs the liner was installed before June 2011. Visual inspections suggest that the liner appears to be constructed of a 30 millimeter, high density polyethylene material. The liner was exposed and visible in several areas along the eastern secondary containment berm and other various location along the berm (See Appendix A-Photographs). Based on the observations from the fifteen (15) test holes and the five (5) sample points. The liner was placed over the secondary containment berm and covers the entire secondary containment area. The liner was placed under the storage tanks. Each test hole and sample point exposed approximately one (1) square foot of the liner. Photographs were made and the liner was evaluated. In each of the test holes and sample points we observed water indicating that the liner was intact and working properly. The water was likely a result of flushing the impacted area with fresh water after the release.

- 9:53 AM
 - Sample point S5 Midpoint south of SWD pump near tanks
 - 0-2" sand
 - 2-8" gravel with sand 32 17.567
 - Liner found @8" visible liquid 104 02.830
 - Liner integrity good, photographed
 - EC Over Range @4"
 - Soil @4" PID 215
 - Sample collected at 10:05
- Conducted investigation across battery area for liner
 - Used shovel to uncover liner to depth for 6" to 12"
 - Photo documentation of sites (15) test holes
 - Documented presence of liner- integrity
 - Visible liquids in each
 - Liner was intact
