**Re: Candelario 24 #1 SWD Battery  
Site Deferral Request  
NMOCD Case No. 2RP-4201  
Eddy County, New Mexico**

Candelario 24 #1 SWD Battery  
NMOCD Case No. 2RP-4201  
Eddy County, New Mexico

SUBJECT: Remediation Closure Report for the Candelario #1 SWD Release (2RP-4201), Eddy County, New Mexico

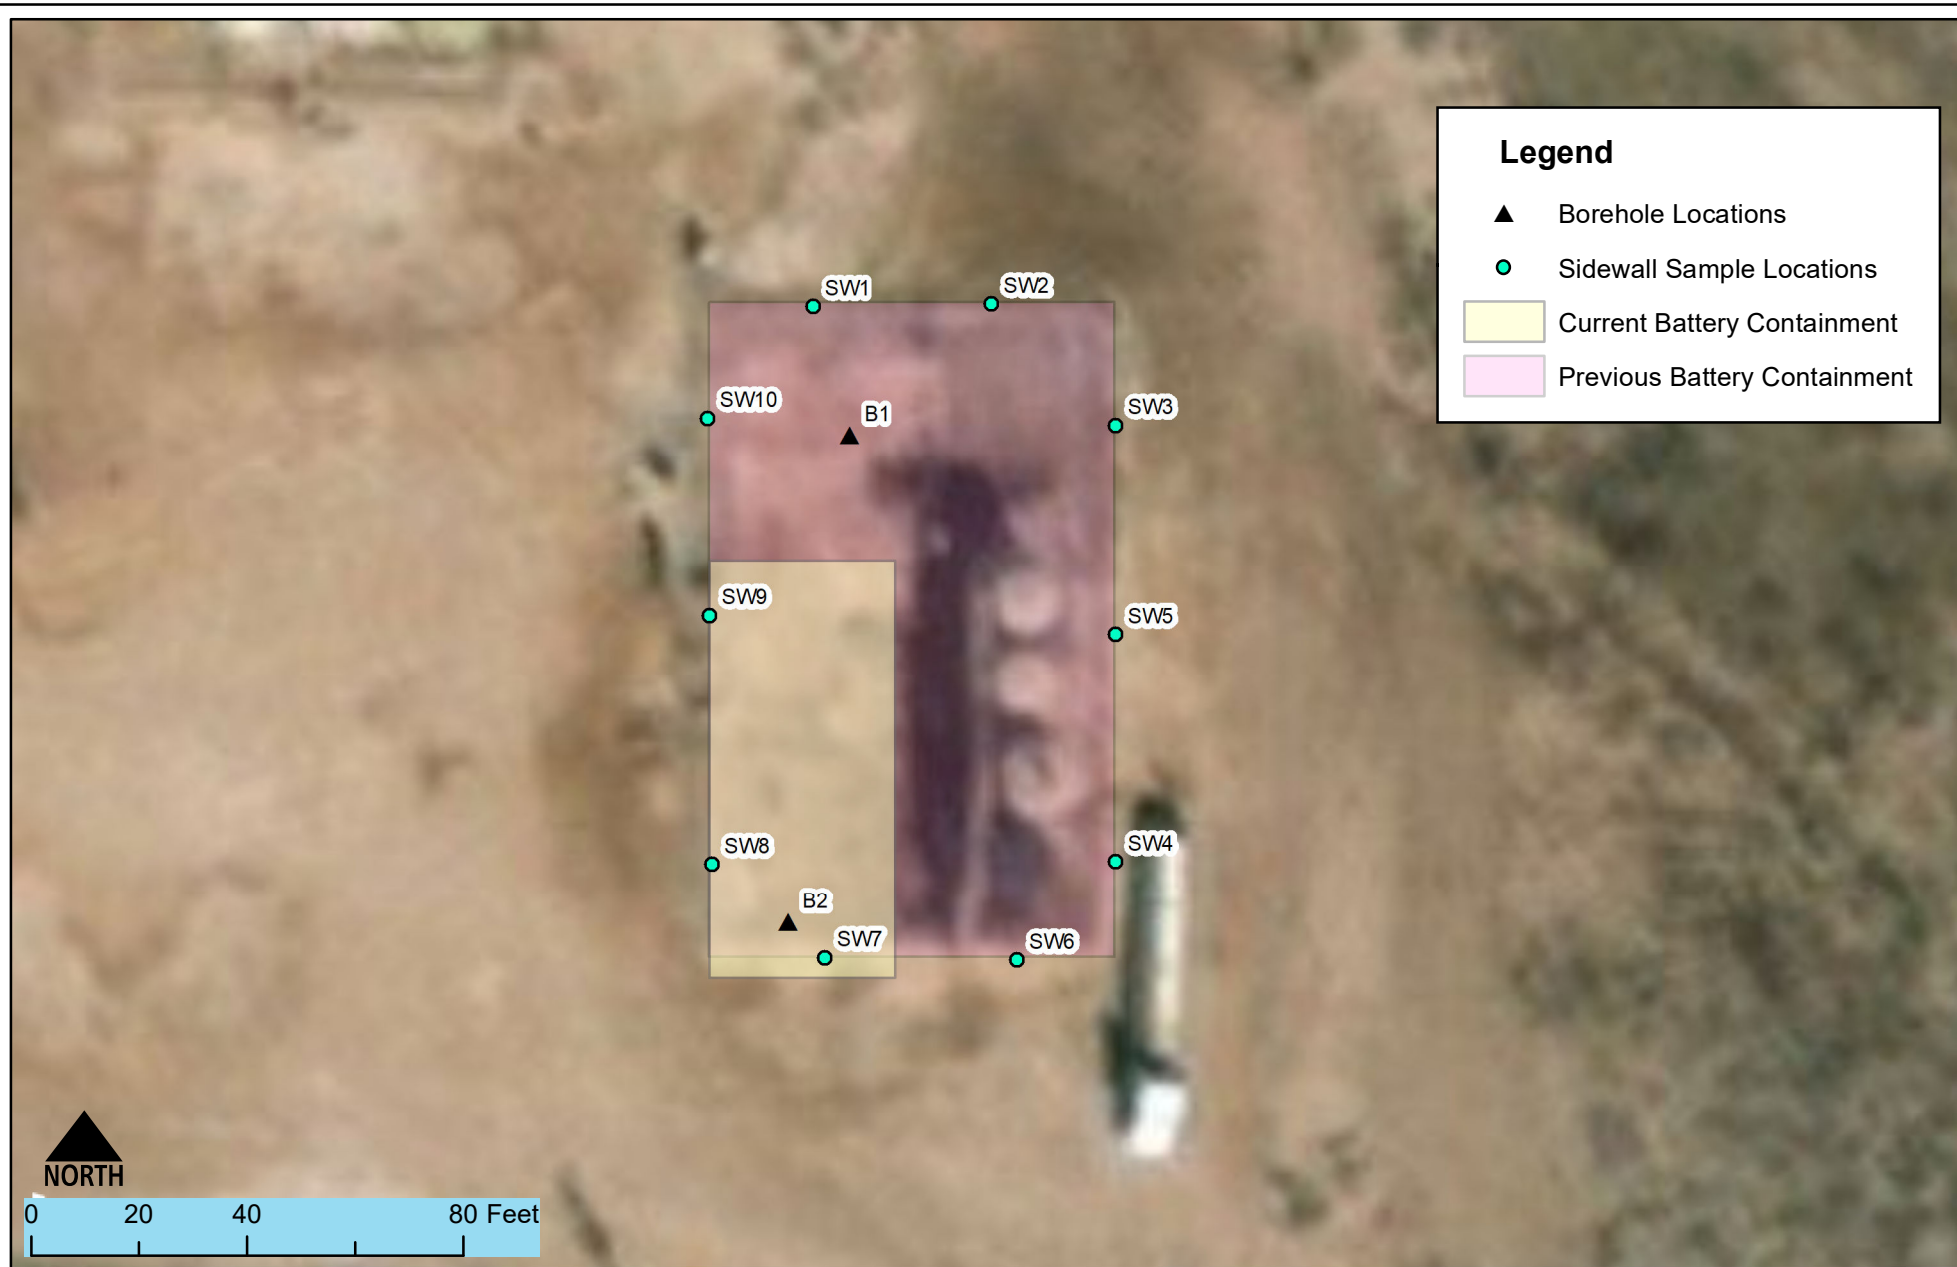
- ▲ Borehole Locations
- Sidewall Sample Locations
- Current Battery Containment
- Previous Battery Containment

<p>Site &amp; Sample Location Map</p> <p>Candelario #1 SWD - Rockcliff Operating New Mexico LLC</p> <p>Sec. 24, T23S, R28E Eddy County, New Mexico</p>				Figure 3	
<p>Date Saved: 9/26/2018</p> <p>By: _____ Date: _____</p> <p>By: _____ Date: _____</p> <p>Copyright 2015 Souder, Miller &amp; Associates - All Rights Reserved</p>	<p>Revisions</p> <p>Descr: _____</p> <p>Descr: _____</p>	<p>Drawn <u>Melodie Sanjari</u></p> <p>Checked _____</p> <p>Approved _____</p>

Soil boring locations (B1 and B2) were investigated using a hollow-stem auger drill rig, to depths of 19 and 24 feet bgs. A minimum of three samples were collected at each sampling location. A total of 7 samples were collected for laboratory analysis for total chloride using EPA Method 300.0; and five samples were collected for laboratory analysis of benzene, toluene, ethylbenzene and total xylenes (BTEX) using EPA Method 8021B; and motor, diesel and gasoline range organics (MRO, DRO, and GRO) by EPA Method 8015D. Table 3 itemizes the samples and field as well as identifying any variances from the typical specification of two samples per boring. Locations of the soil borings are depicted on Figure 3.

SMA and Rockcliff determined that, based upon the results, an effective remediation and source removal would be the re-building of the battery containment, which included excavation to 4 feet bgs and removal of contaminated soil (including the earthen berms) in the impacted area, as well as the placement of a liner. A downsized and upgraded containment was constructed within the former tank battery (Figure 3). Photos are included in Appendix C.

Figure 3 shows the extent of the excavation, new and previous facility areas and sample locations. All laboratory results are summarized in Table 3. Laboratory reports are included in Appendix D.

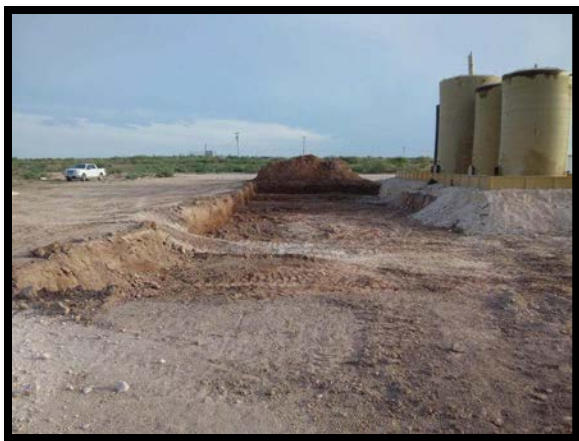
Open excavation facing North on the West side of the battery

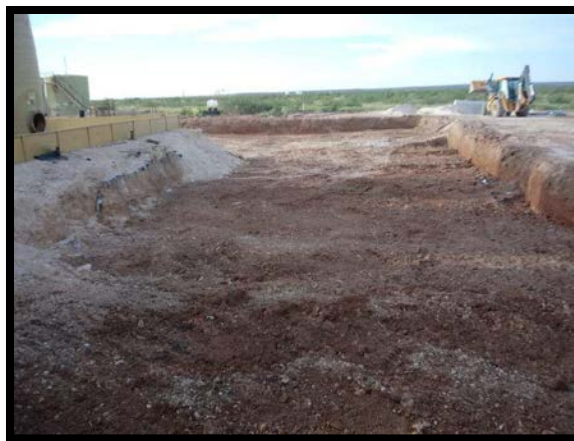
Open excavation of the east side of the battery, facing north.

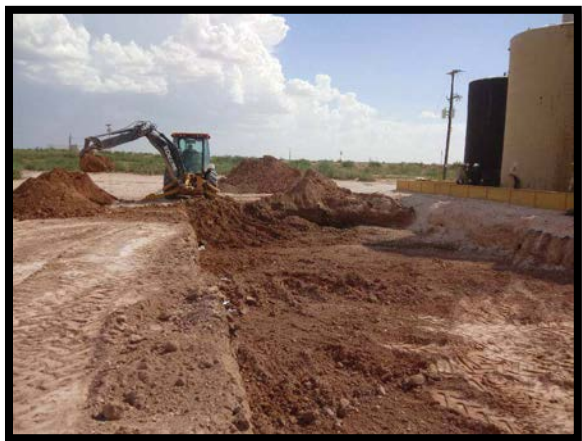
Northside of battery, open excavation facing east

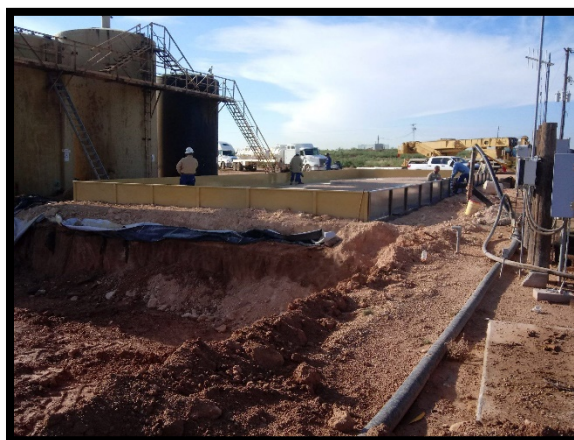
New containment installation and remainder of northwest excavation, facing south
