Vertex Project #: 19E-00614-006

**Spill Closure Report:** Aid State #008 (Section 13, Township 17 South, Range 28 East)  
API: 30-015-38142  
County: Eddy  
Incident Report: 2RP-5350

**Prepared For:** **Marathon Oil Permian LLC**  
4111 South Tidwell Road  
Carlsbad, New Mexico 88220

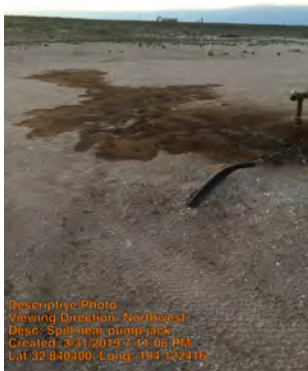
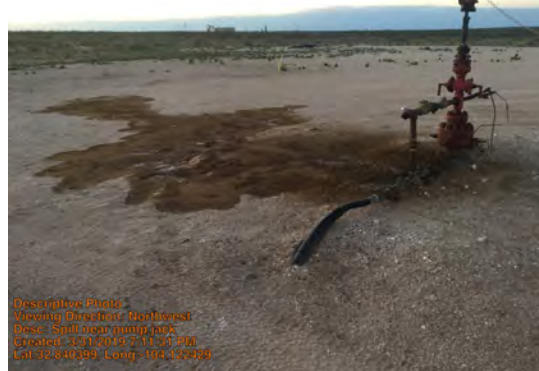
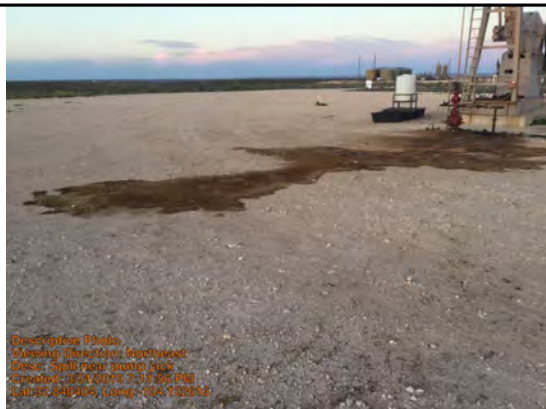
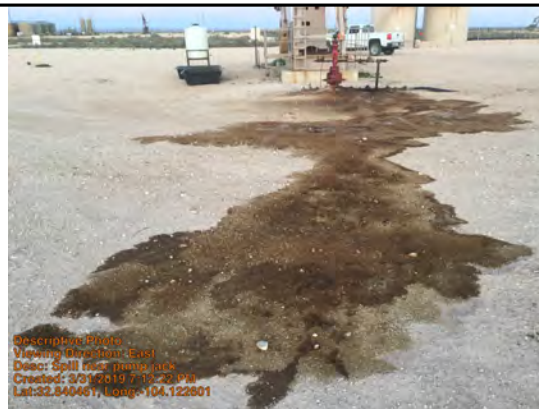
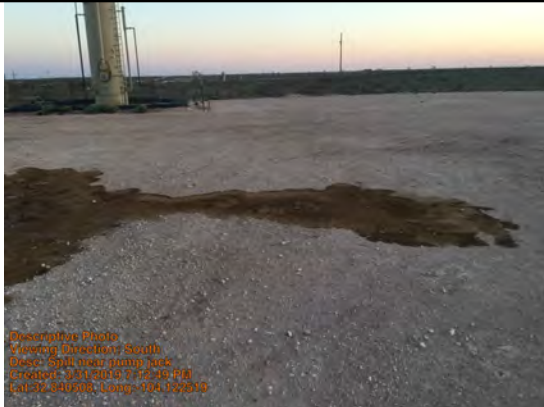
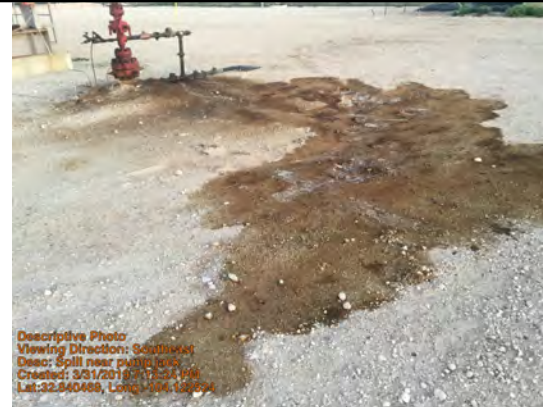
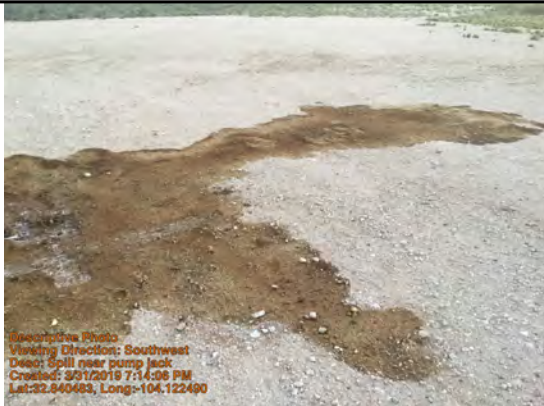
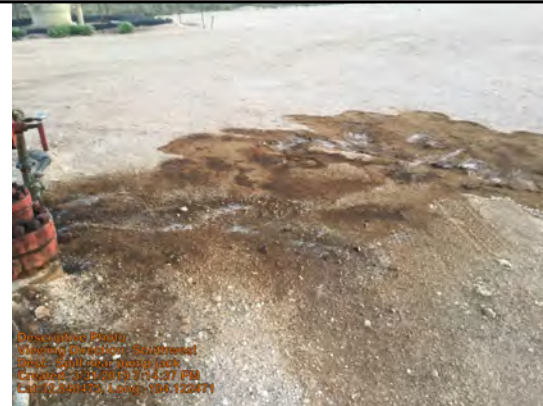
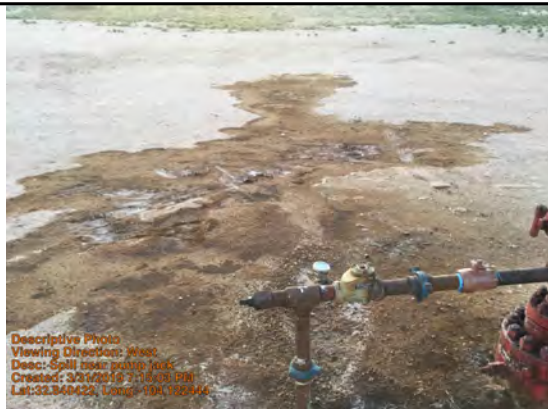
A spill occurred on March 31, 2019, due to the rubber top of a tubing gauge failing. The spill was reported March 31, 2019 and involved the release of approximately 9.97 barrels (bbls) of produced oil onto the pad. No free-flowing fluid was removed during the initial spill clean-up. The New Mexico Oil Conservation Division (NMOCD) C-141 Report: 2RP-5350 is included in Attachment 2. The Daily Field Report (DFR) and site photographs are included in Attachment 3.

Spill near pump jack

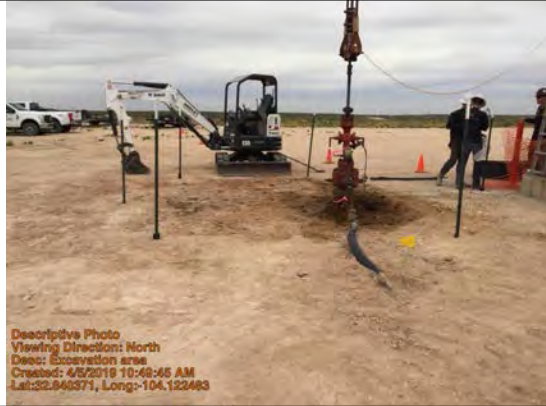
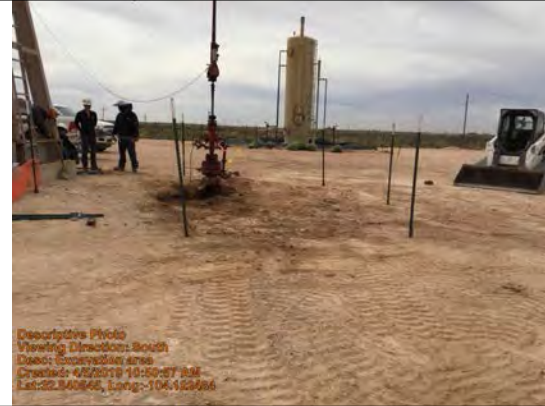
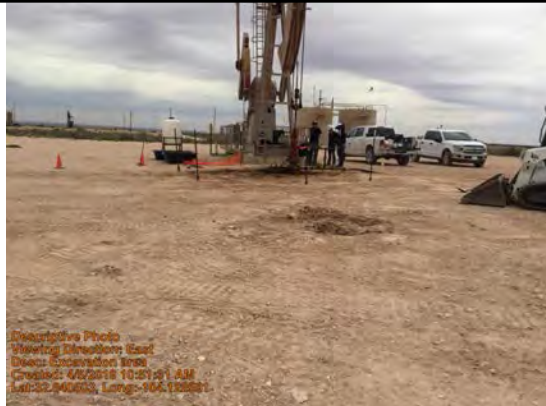
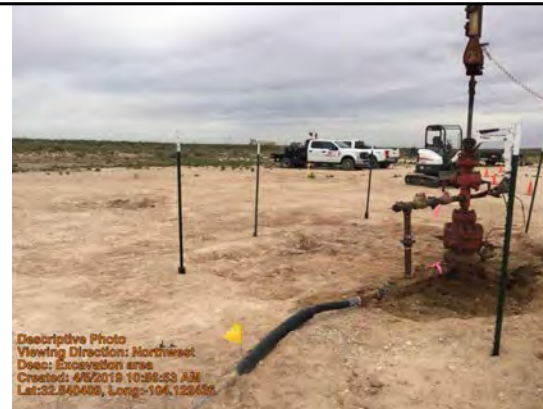
Excavation area

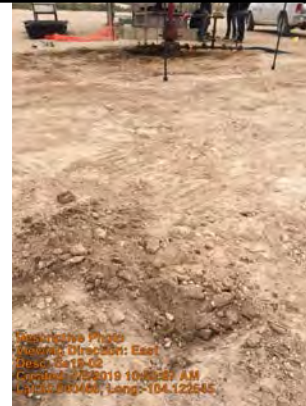
Descriptive Photo  
Viewing Direction: East  
Desc: Ss19-02  
Created: 4/5/2019 10:52:37 AM  
Lat:32.846346, Long:-104.122545

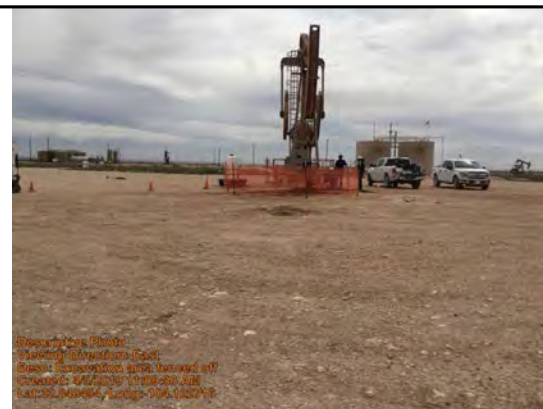
Excavation area fenced off

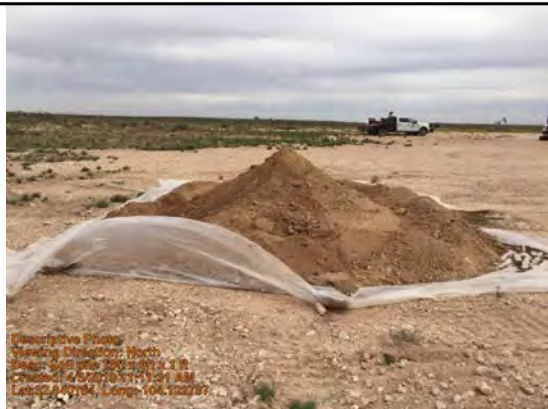
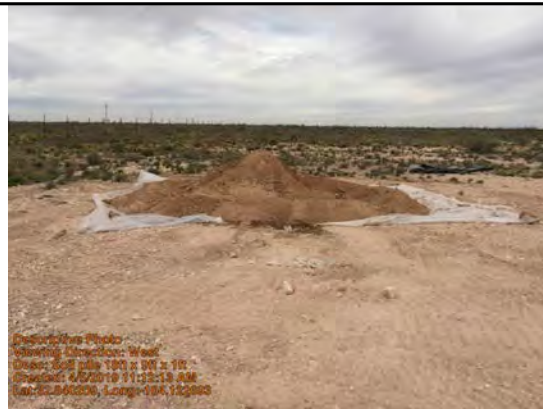
Soil pile 18ft x 9ft x 1ft

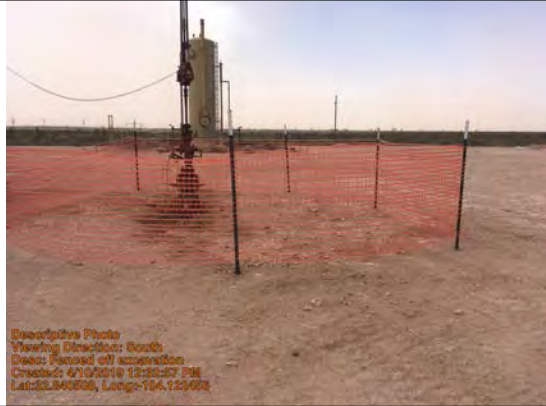
Fenced off excavation

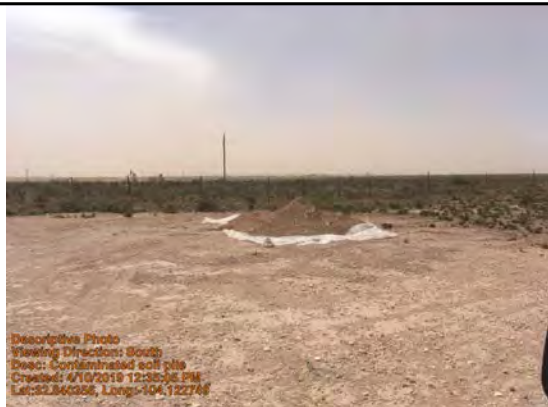
Contaminated soil pile

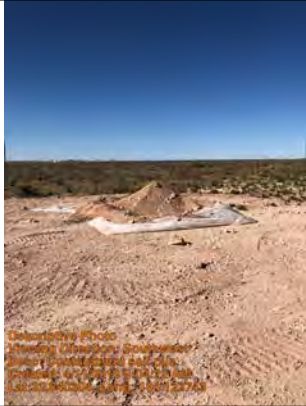
Containment soil pile.

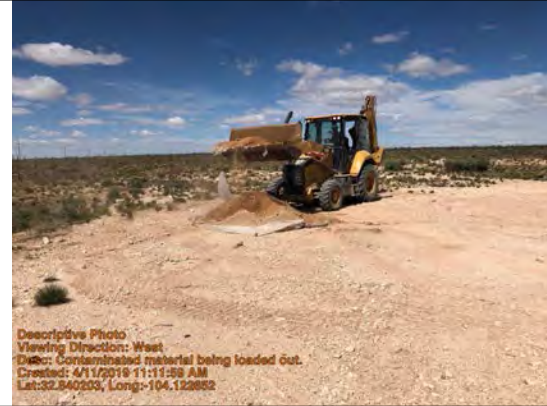
Contaminated material being loaded out.

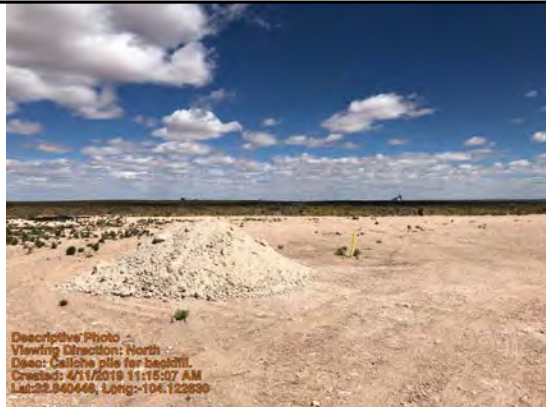
Caliche pile for backfill.

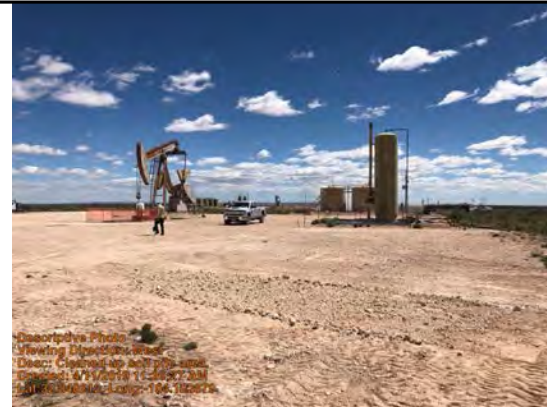
Cleaned up soil pile area.

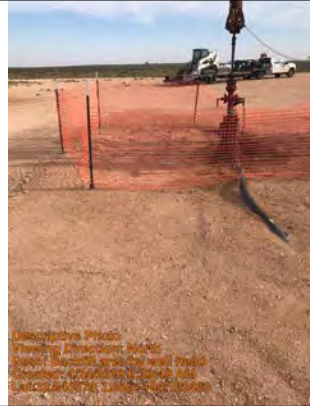
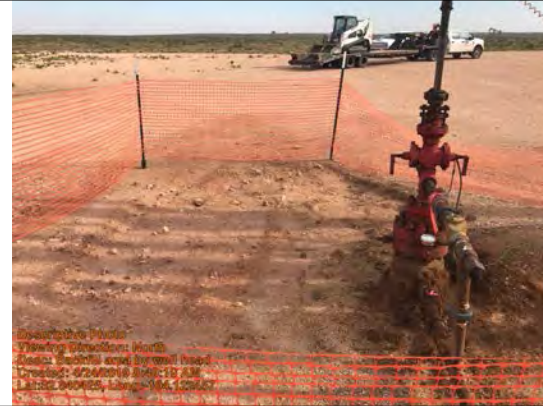
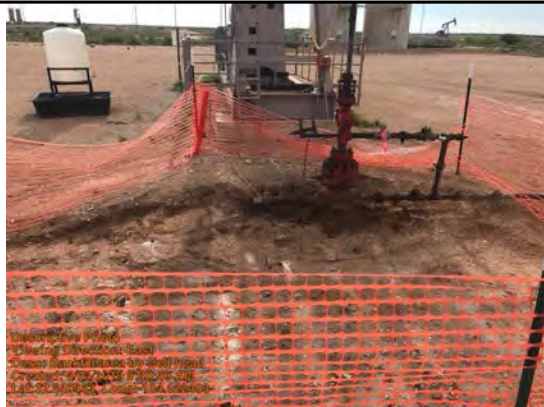
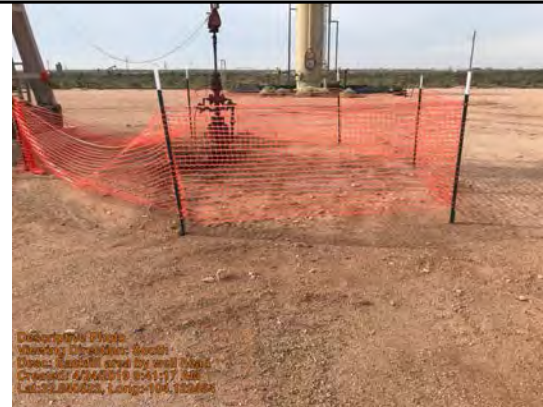
Backfill area by well head

The spill area was fully delineated, remediated and backfilled with local soils by April 24, 2019. Confirmatory samples were analyzed by the laboratory and found to be below allowable concentrations as per the New Mexico Administrative Code (NMAC) Closure Criteria for Soils Impacted by a Release, locations "51-100 feet". Based on these findings, Marathon Oil Permian LLC requests that this spill be closed.

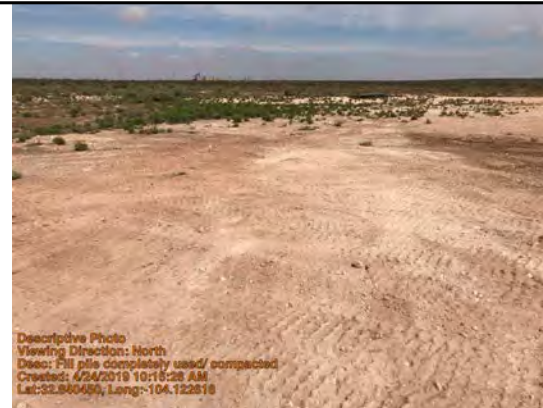
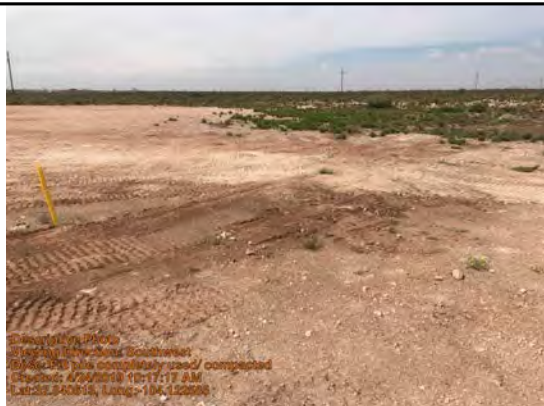
Fill pile completely used/ compacted
