Closure Report:

Magura 8 Federal #004H
API#: 30-015-39472
RP#: 2RP-5202
DOR: January 7, 2019
GPS: 32.063591 -104.316925
Unit Letter C, Section 8, Township 26 South, Range 26 East
Eddy County, New Mexico

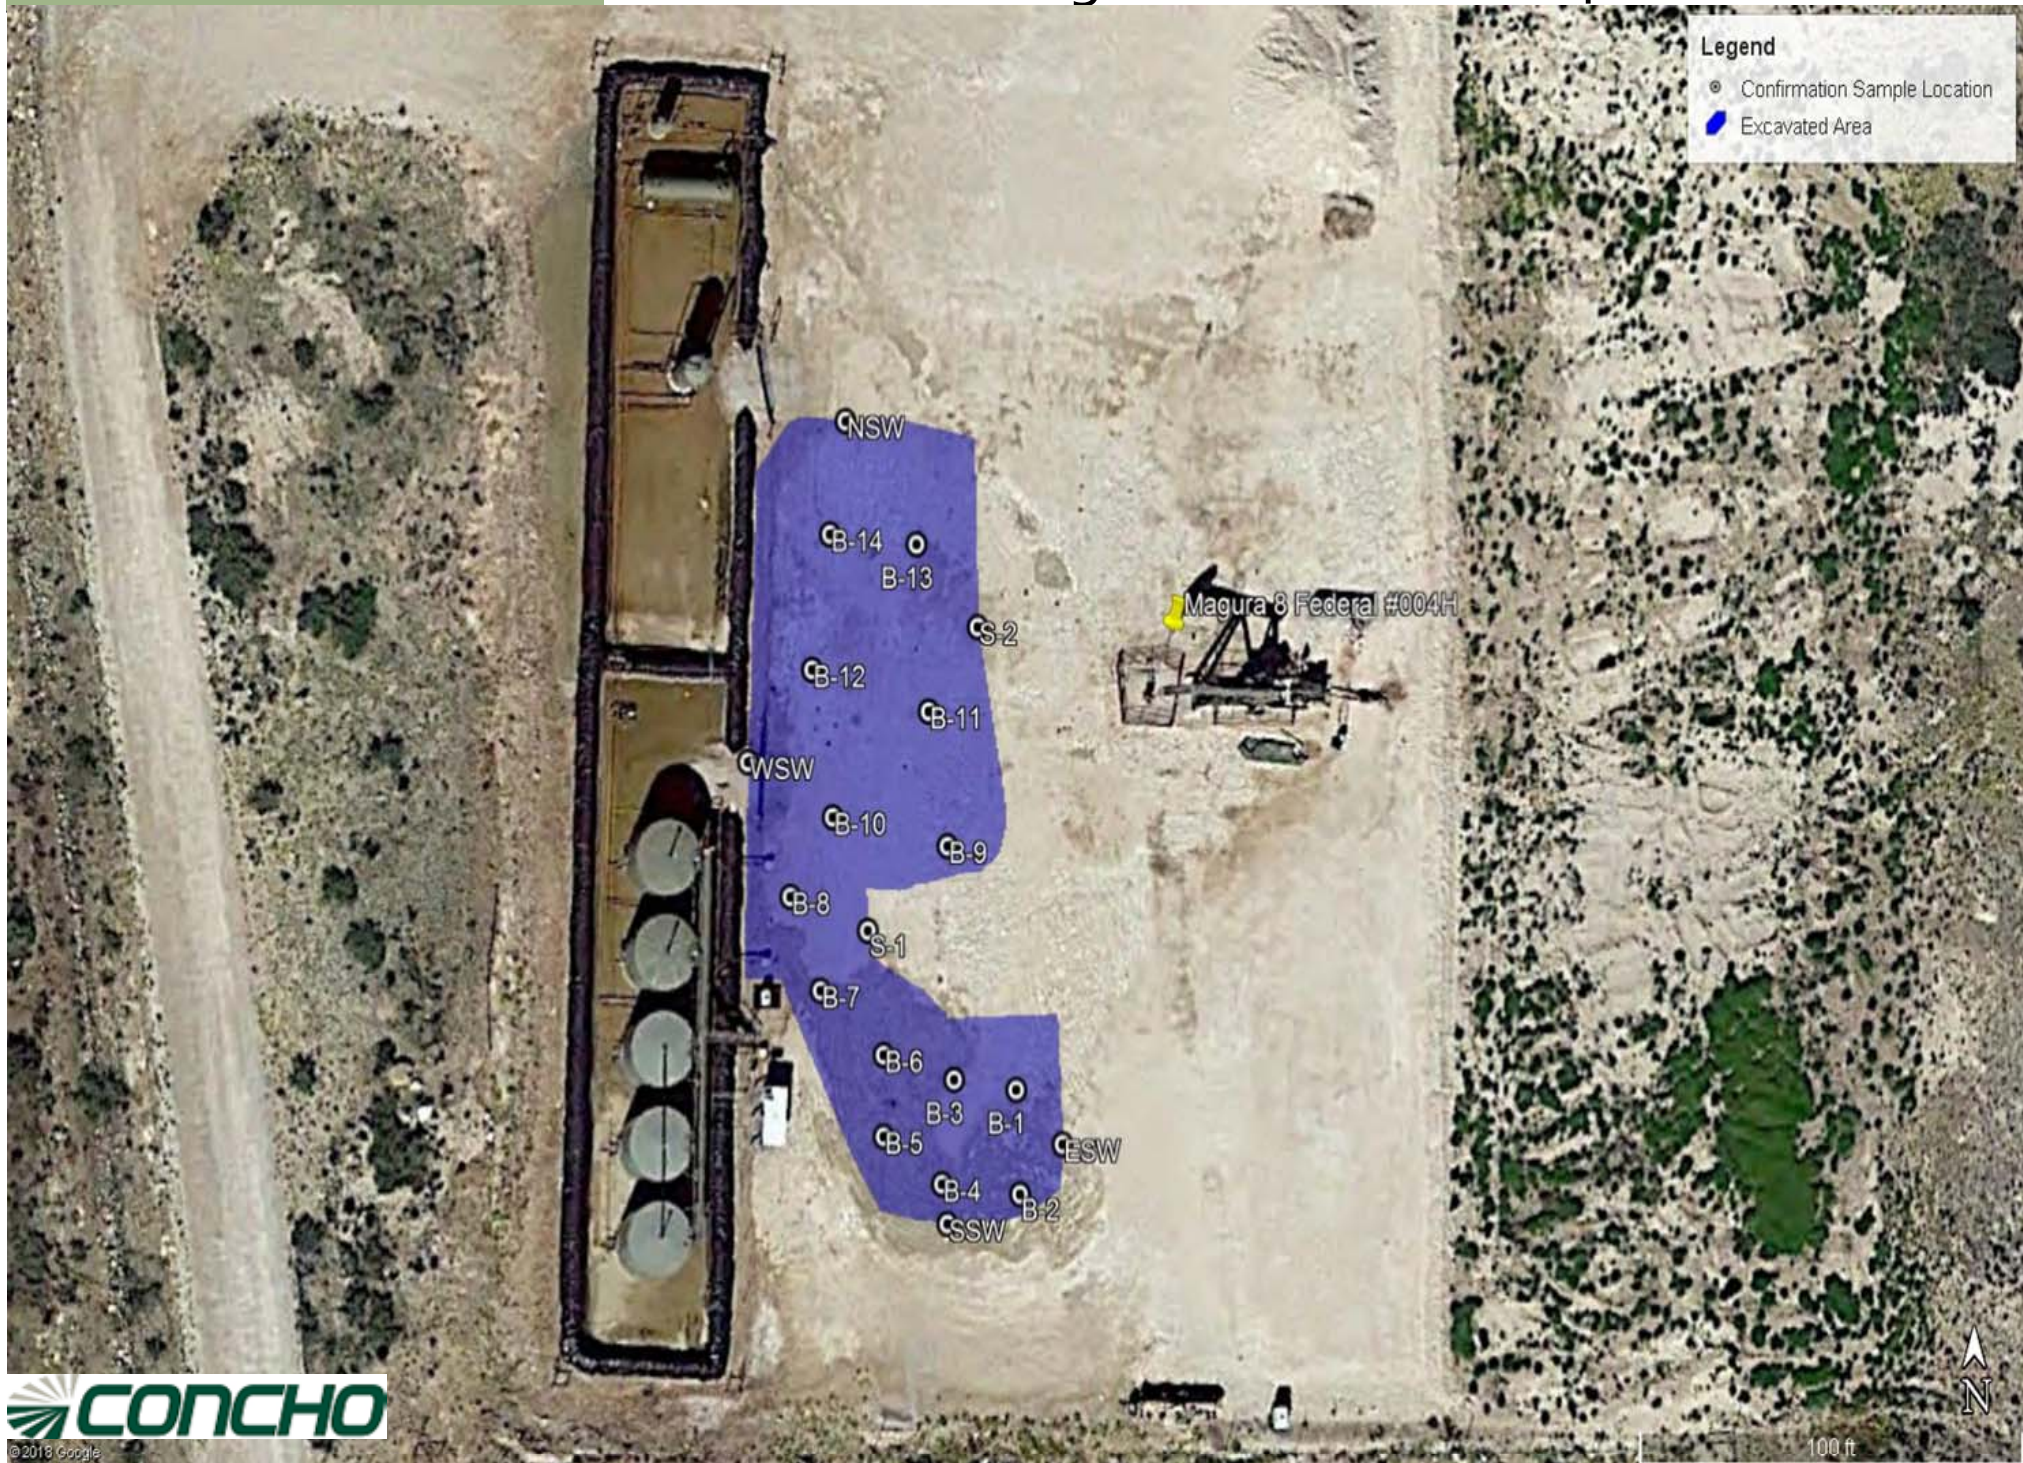
Magura 8 Federal #004H

January 7, 2019

- The impacted area was excavated to a depth of two (2) feet BGS. Upon receipt of analytical data from the confirmation soil sampling activities it was determined that the impacted area in the vicinity of sample location B-6 would require further excavation. This area was excavated to a depth of three (3) feet BGS and additional confirmation soil sampling was performed.
- All of the excavated material was hauled to an NMOCD approved solid waste disposal facility.
- Confirmation soil samples were taken from the bottom and sidewalls of the excavated areas per NMAC 19.15.29.
