Remediation and Closure Report

Logan 35 B Fed Battery
2RP-5388
Talon Project No. 701307.119.01

Lime Rock Resources II-A, L.P.
1111 Bagby St Suite 4600
Houston, TX 77002

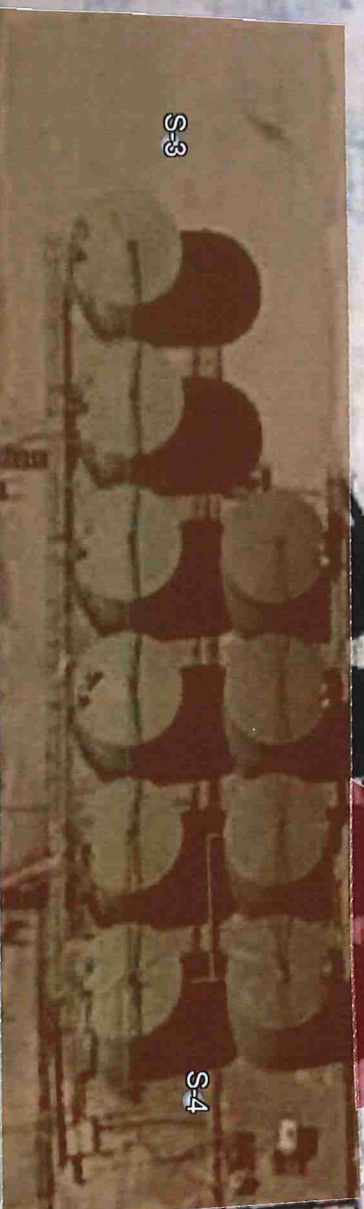
SITE PLAN

On April 11, 2019, Lime Rock dispatched vac trucks and roustabouts to begin recovery actions and was able to recover 304 bbls of produced water and 6 bbls of oil. Talon personnel also responded to do an initial assessment and to collect samples. A site plan is presented in [Appendix I](#) which illustrates the impacted area.

- Legend**
- Contained Spill Area
 - Over Spray Area
 - Samples

- The impacted area on location in the vicinity of S-1 and S-3 was hand and hydro-excavated to a depth of 1.0-foot BGS.
- The impacted area in the vicinity of S-3 and S-4 was hand and hydro-excavated to a depth of 2.0-feet BGS.
- This site had to be hand and hydro-excavated due to infrastructure such as lines, equipment and tanks. A total of 164 yards of contaminated material was removed without compromising the integrity of the tanks and equipment. The area was backfilled using 156 yards of clean caliche and 52 yards of gravel.

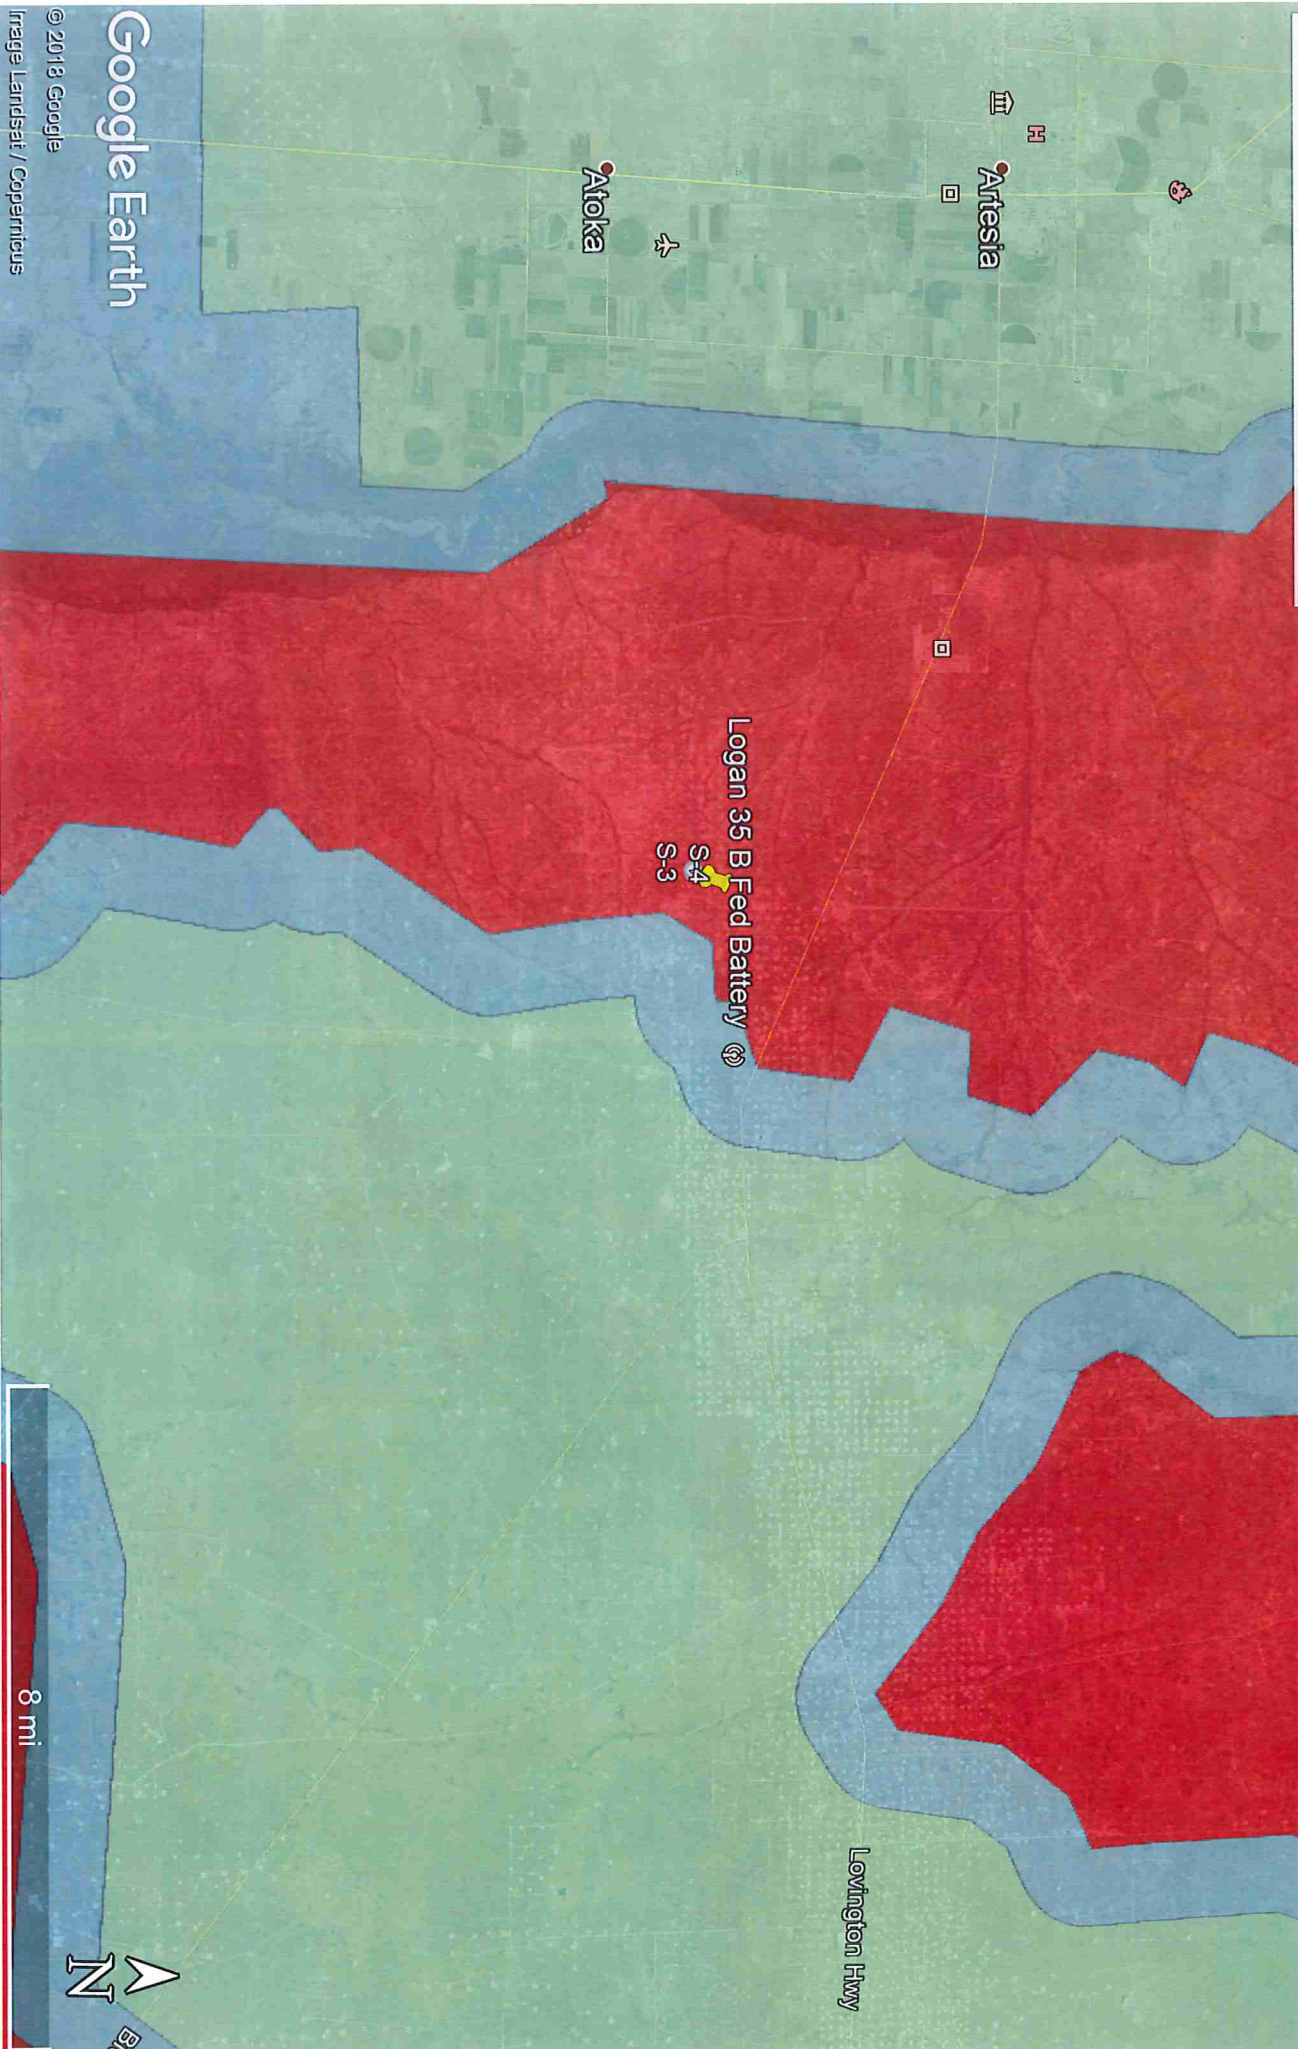
Lime Rock Resources
Eddy County, NM
2RP-5388
Karst Map

This location is in an area of High Karst as well as being in a no flood zone. See [Appendix II](#) for FEMA Flood Map and Karst Map.

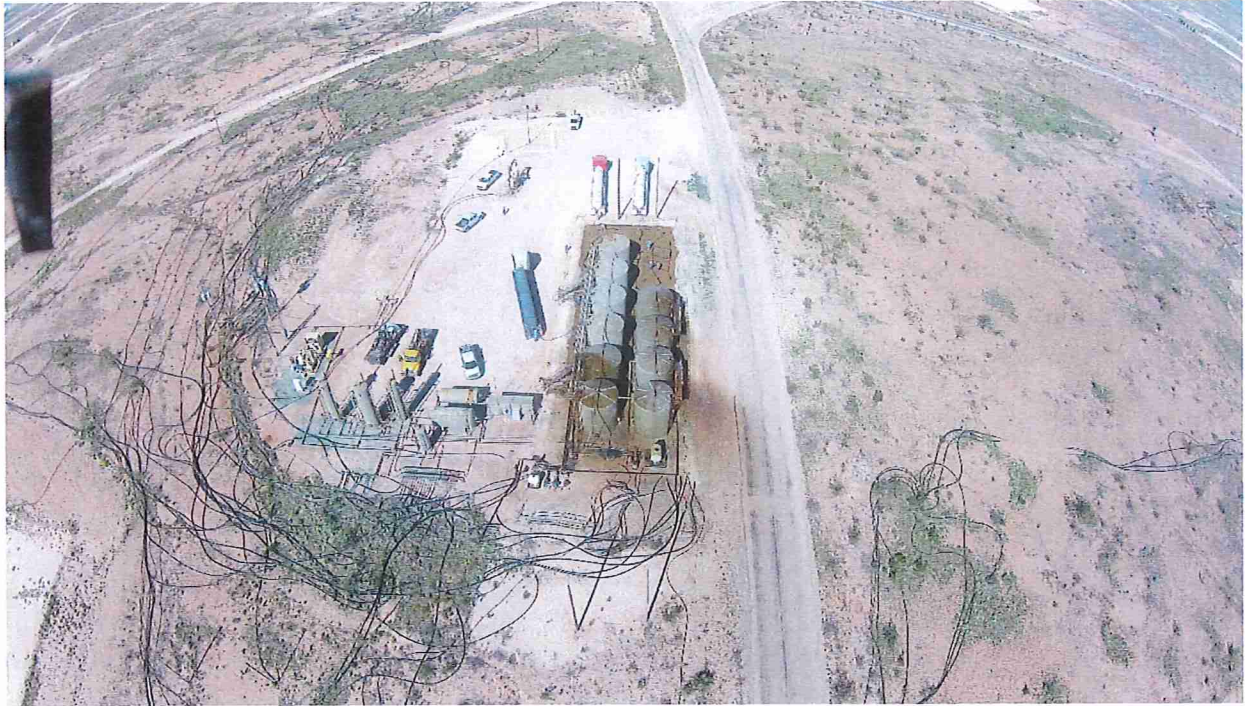
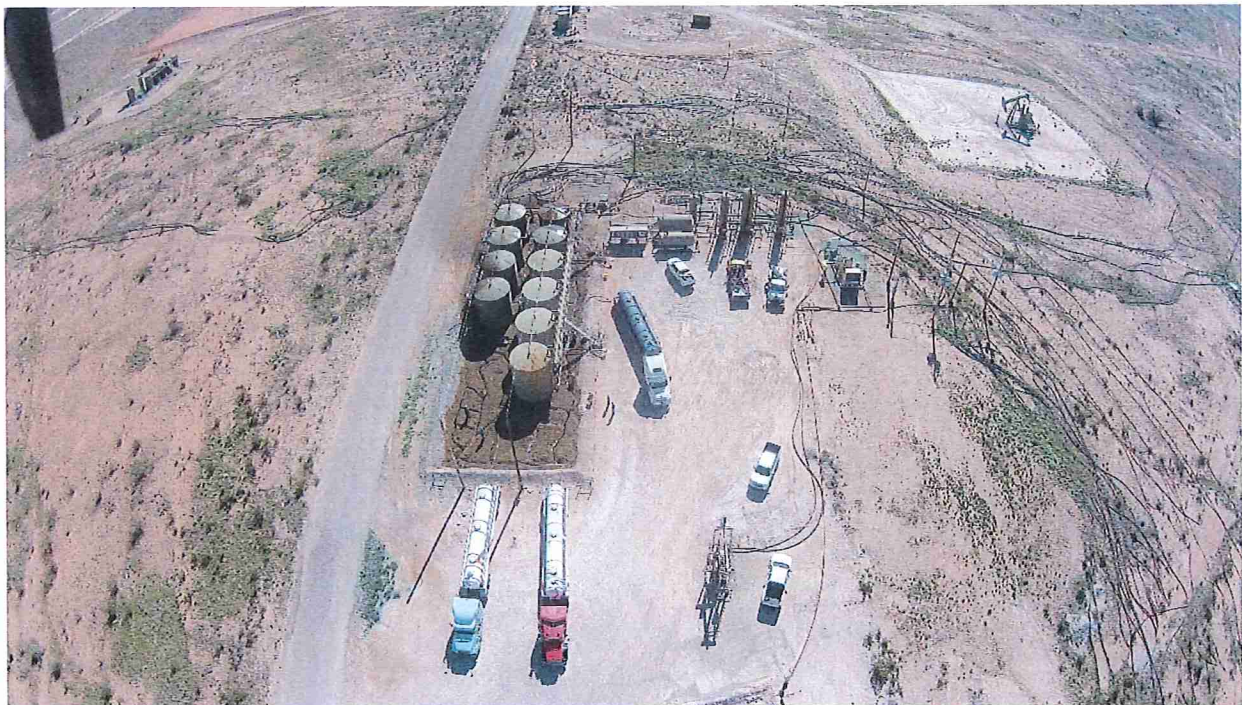
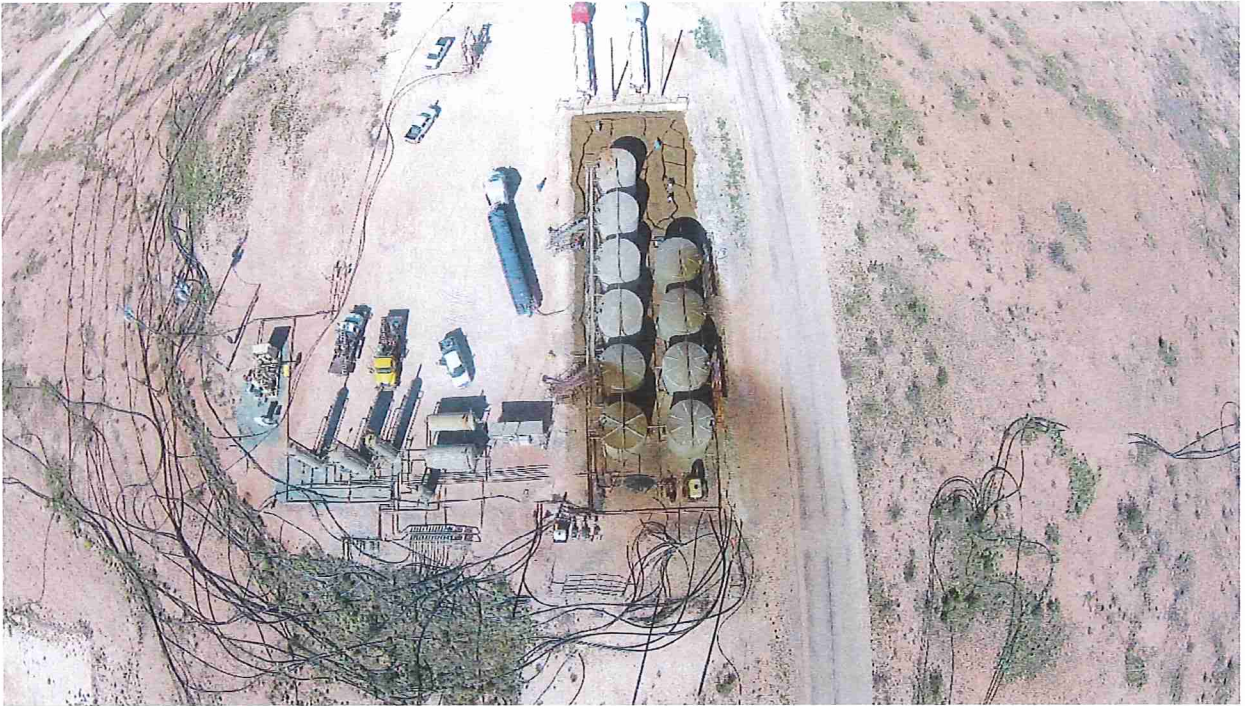
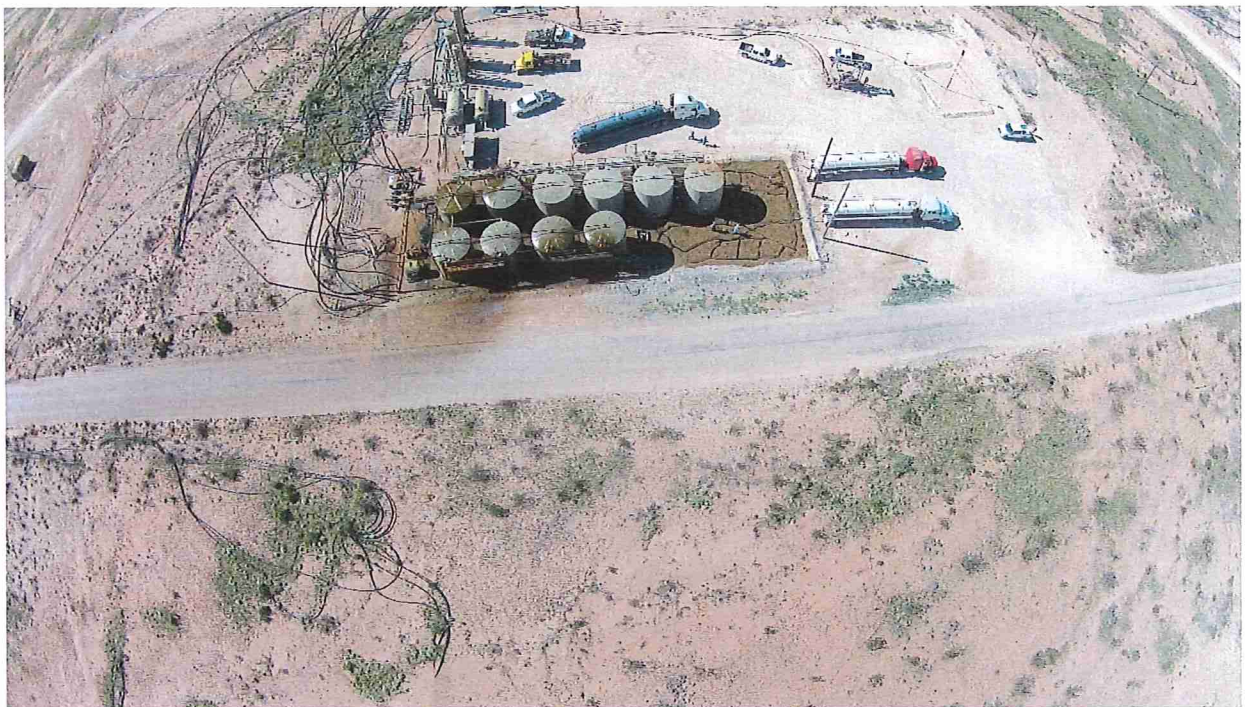
Spill

On April 10, 2019, a wind storm occurred causing a loss of power in the area of this battery. Due to the power loss the transfer pump was down and resulted in the produced water tank to overflow. The spill was contained within the bermed battery with a little over spray on the NE side outside the battery. Approximately 340 bbls of produced water and 10 bbls of oil was released. The tank was isolated to prevent any further release.
