Report Type: Closure Report      2RP-5018

Site:	Loco Hills 35 SWD #1					
Company:	COG Operating LLC					
Section, Township and Range	Unit P	Sec. 36	T 17S	R 30E		
Lease Number:	API No. 30-015-31635					
County:	Eddy County					
GPS:	32.785575			-103.919895		
Surface Owner:	State					
Mineral Owner:	State					
Directions:	From the intersection of Lovington Hwy. and Shugart Rd., head south on Shugart Rd. for 2.38 miles, take a hard right (west-northwest) onto unnamed lease rd. and follow road for 0.72 miles, take a right (northwest) and go 0.17 miles, keep left at the bifurcation and go west for 1 mile (follow jog in the road to the right (northwest)) and continue west for 0.3 miles,Turn right (north) and go 0.56 miles to location.

**Re: Closure Report for the COG Operating, LLC, Loco Hills 35 SWD #1, Unit P, Section 36, Township 17 South, Range 30 East, Eddy County, New Mexico. 2RP-5018**

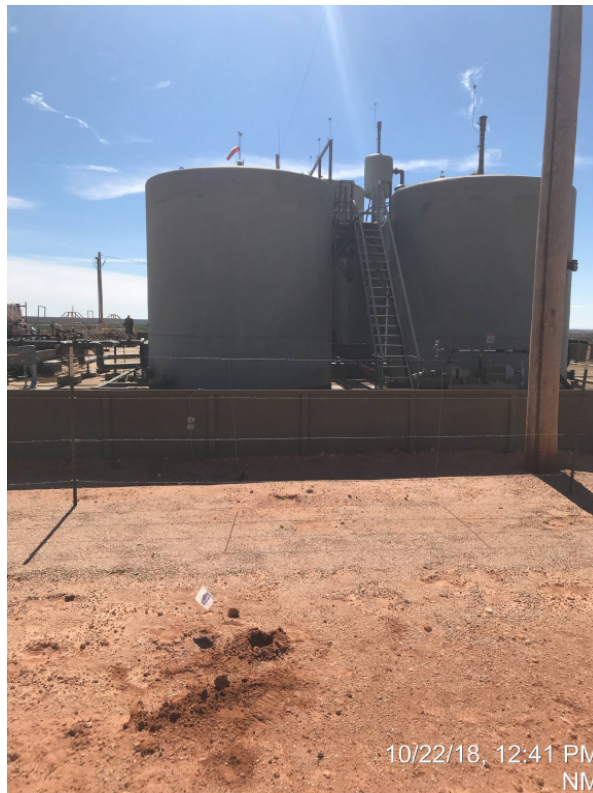
View South – Area of AH-1

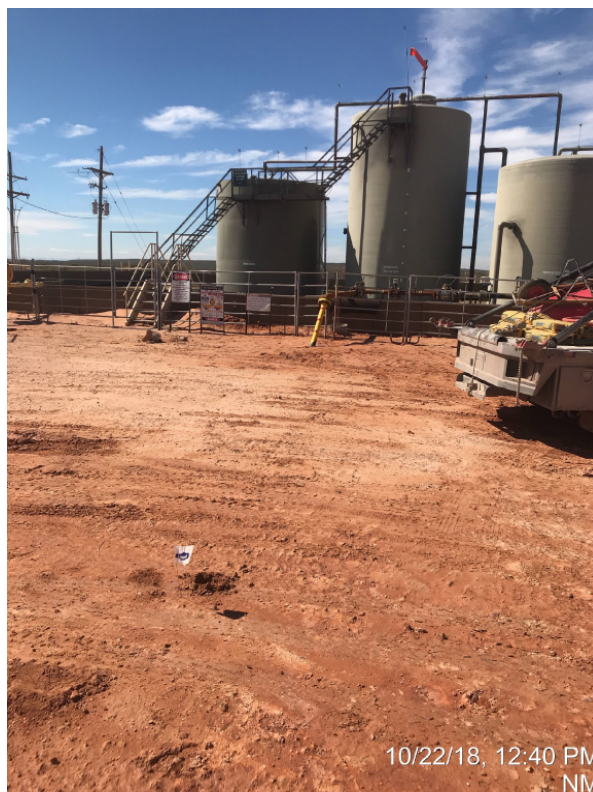
View West – Area of AH-2

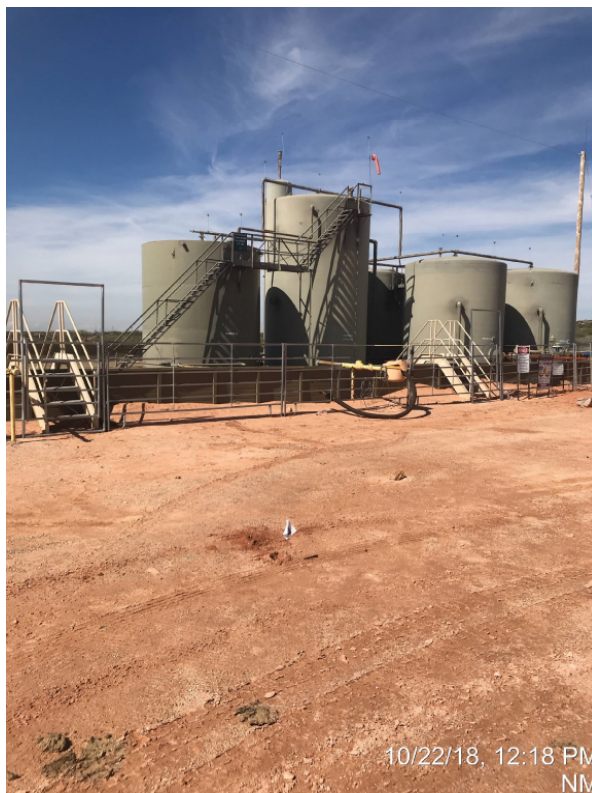
View Northwest – Area of AH-3

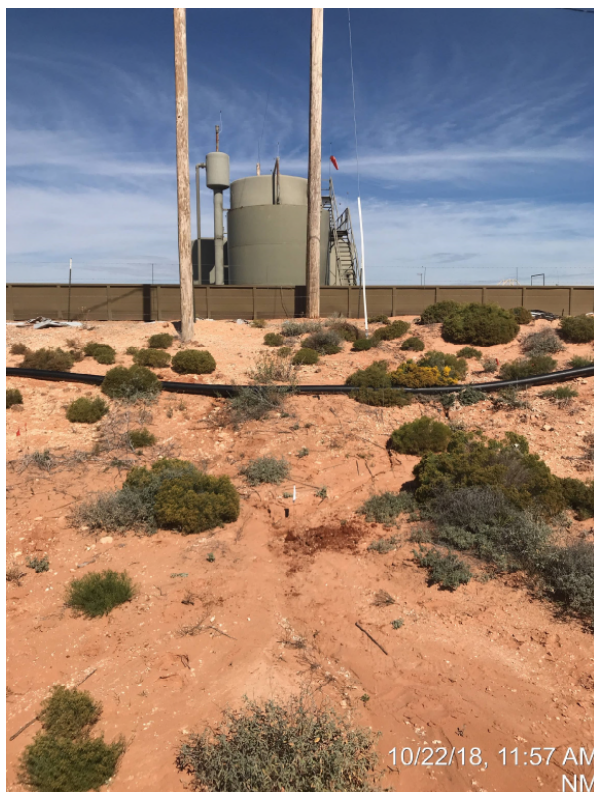
View North – Area of AH-4

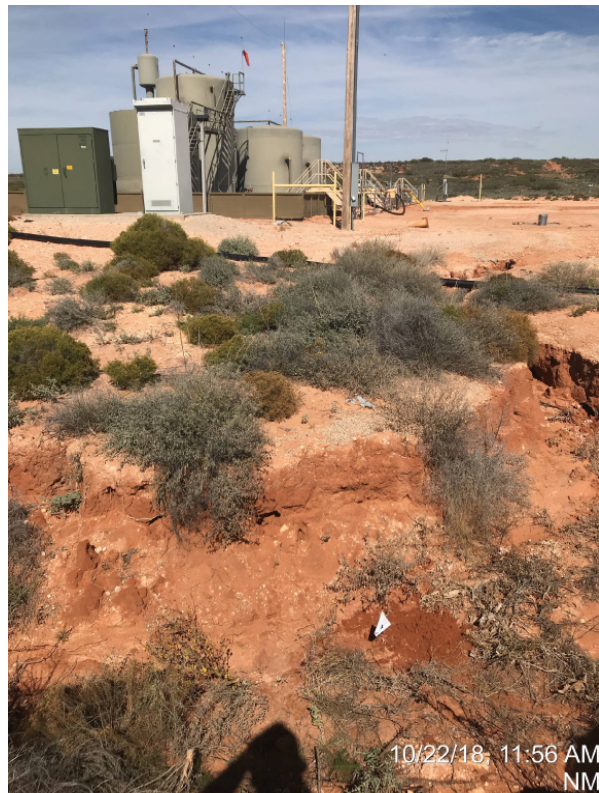
View North-northwest – Area of AH-5

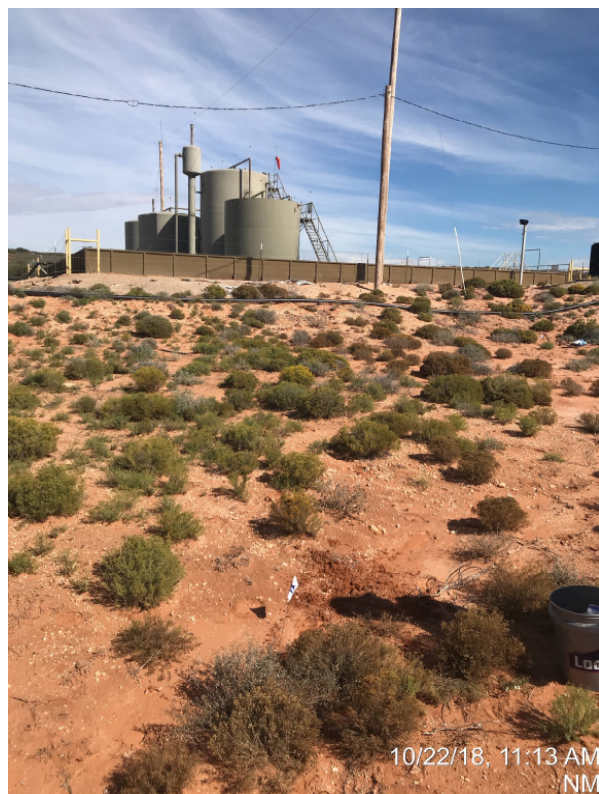
View North-northeast – Area of AH-6

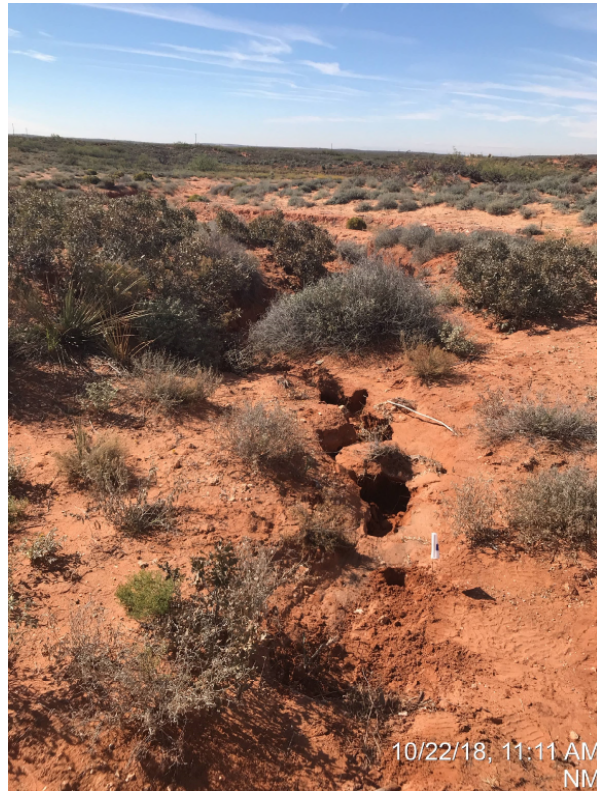
View South-southwest – Area of AH-7

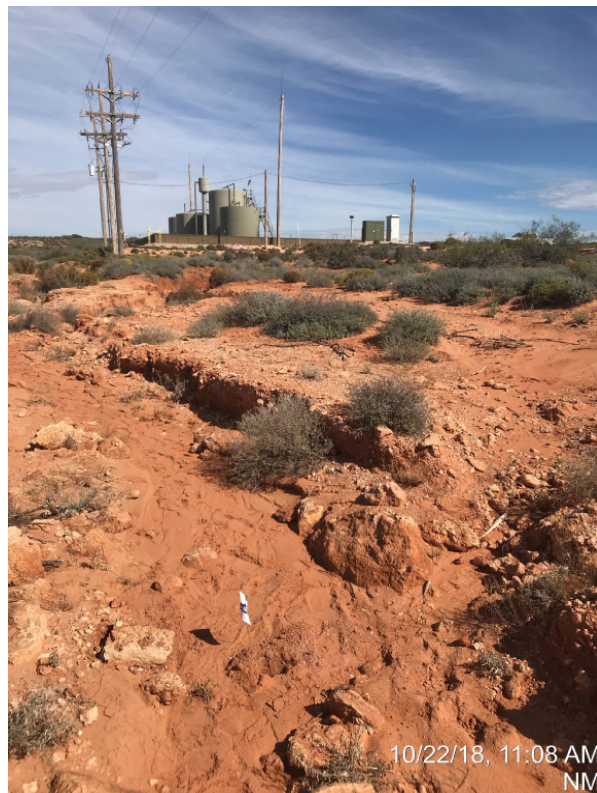
View North-northeast – Area of AH-8

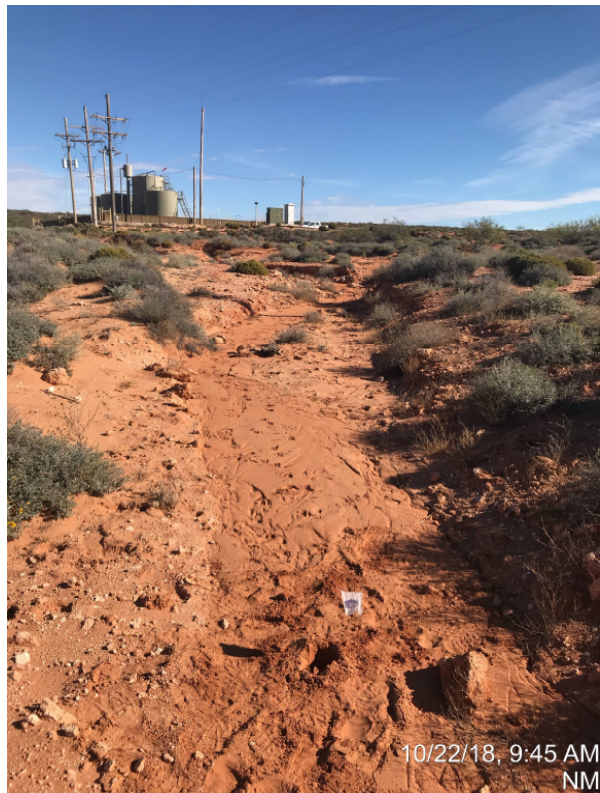
View Northeast – Area of AH-10

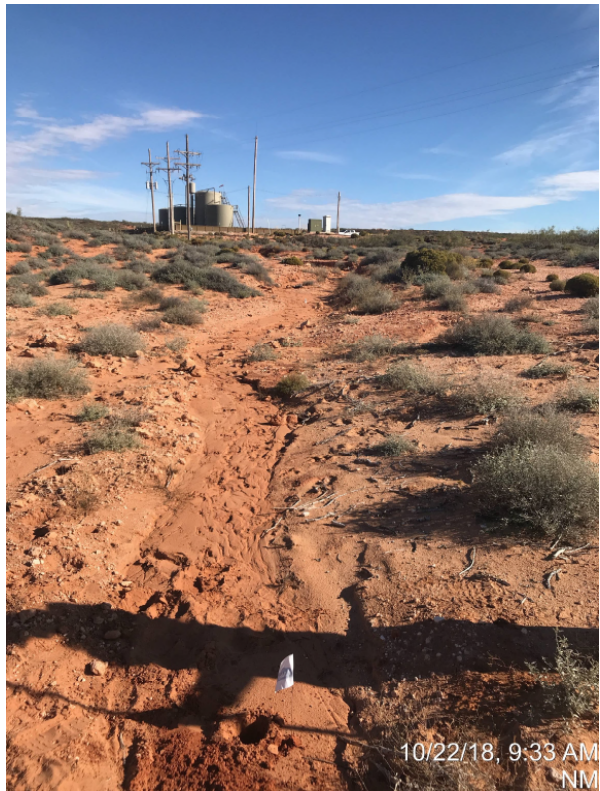
View Northeast – Area of AH-11

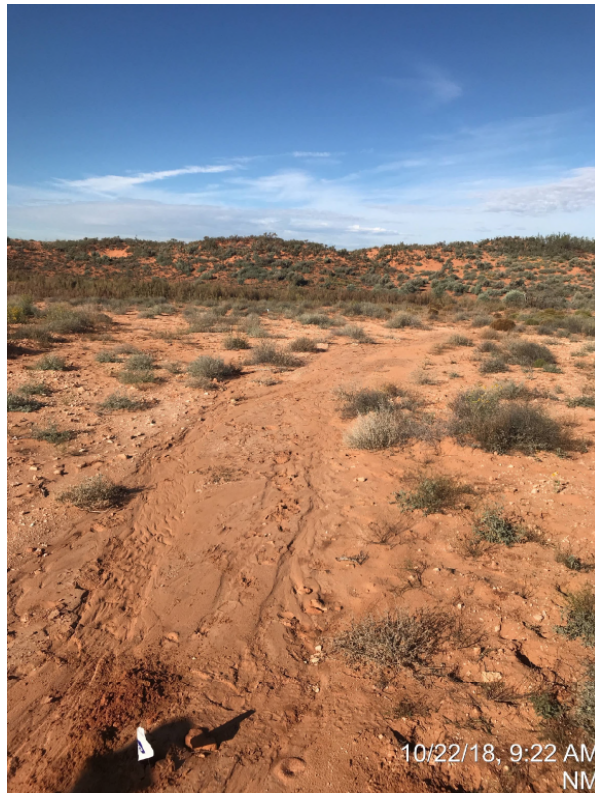
View West – Area of AH-12

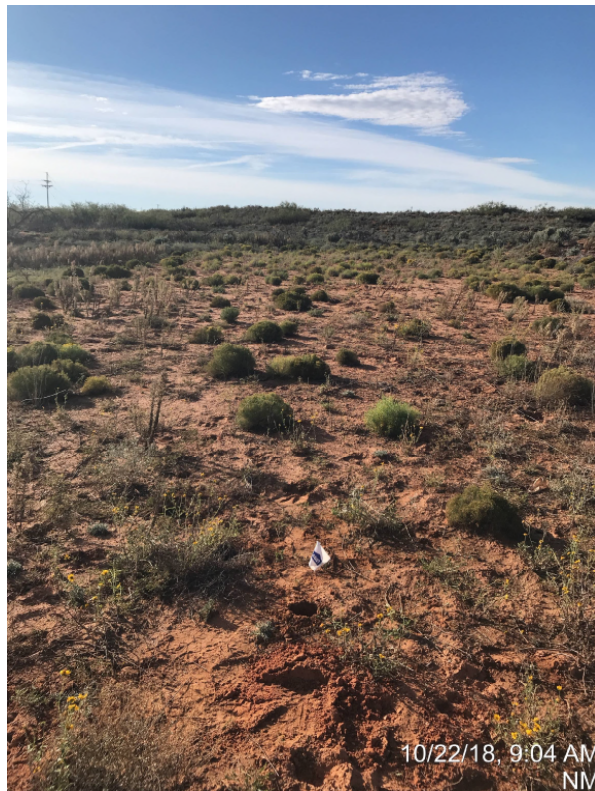
View North – Area of AH-13

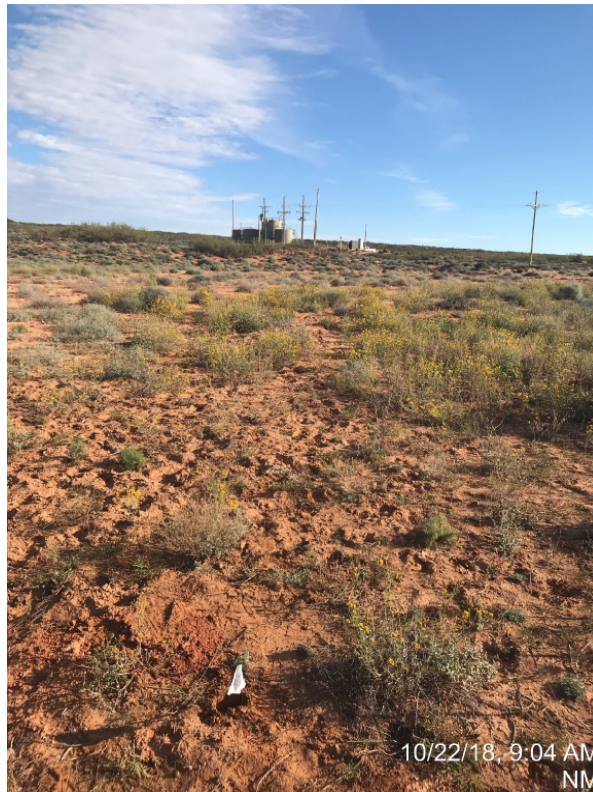
View Northwest – Area of AH-14

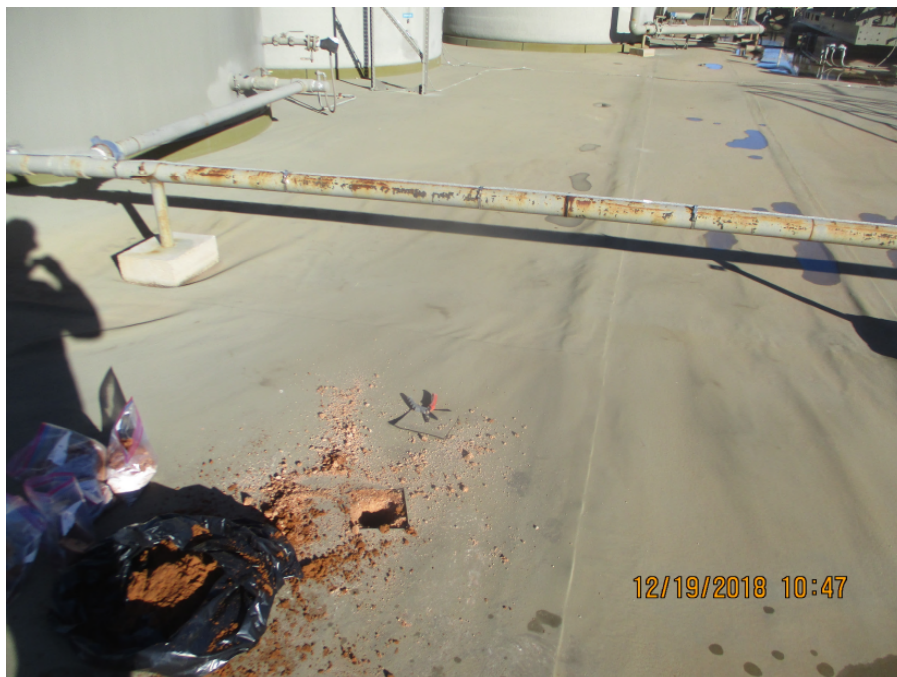
View North – Area of SP-1

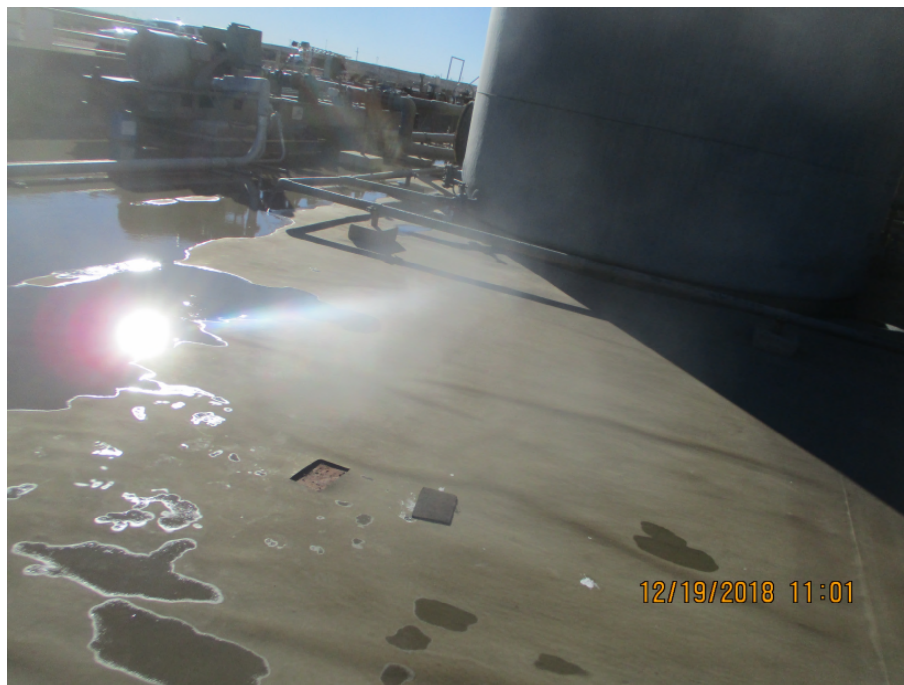
View South – Area of SP-2

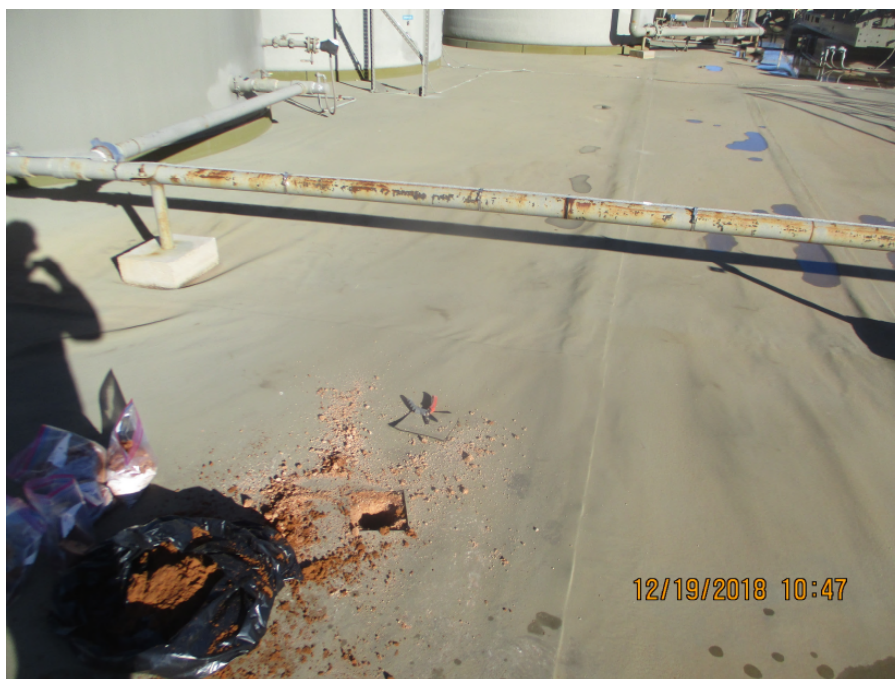
View North – Area of SP-1

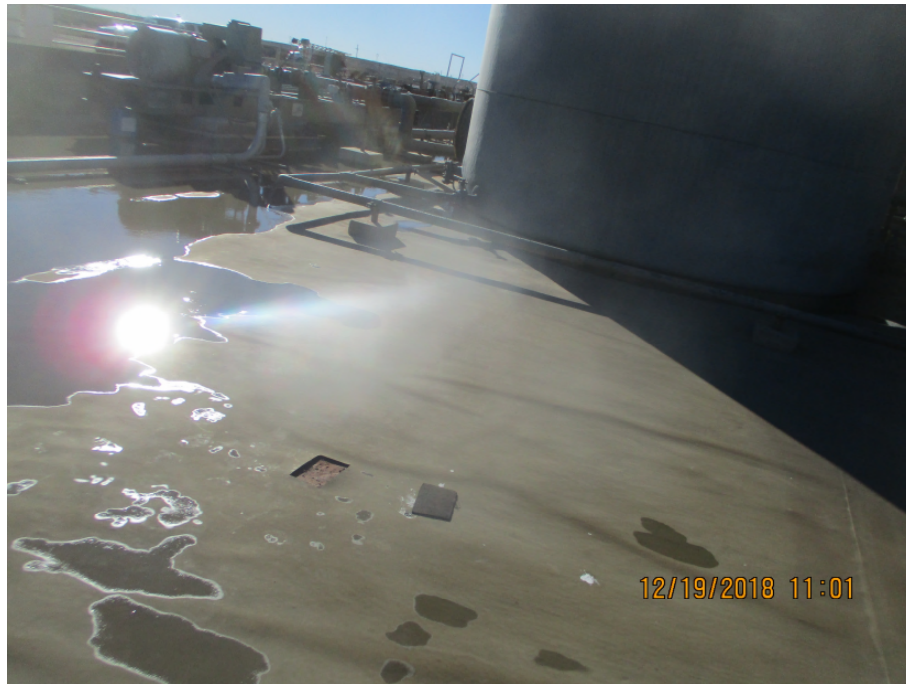
View North – Area of BH-1

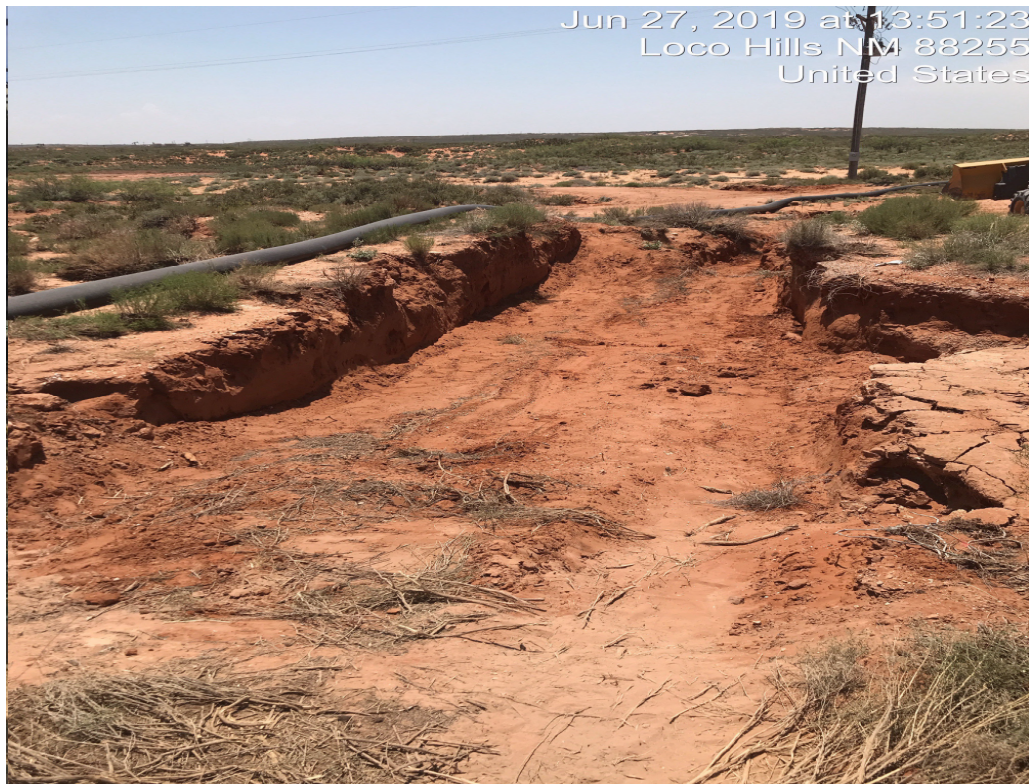
Facing West, viewing bottomhole-17 through bottomhole-19

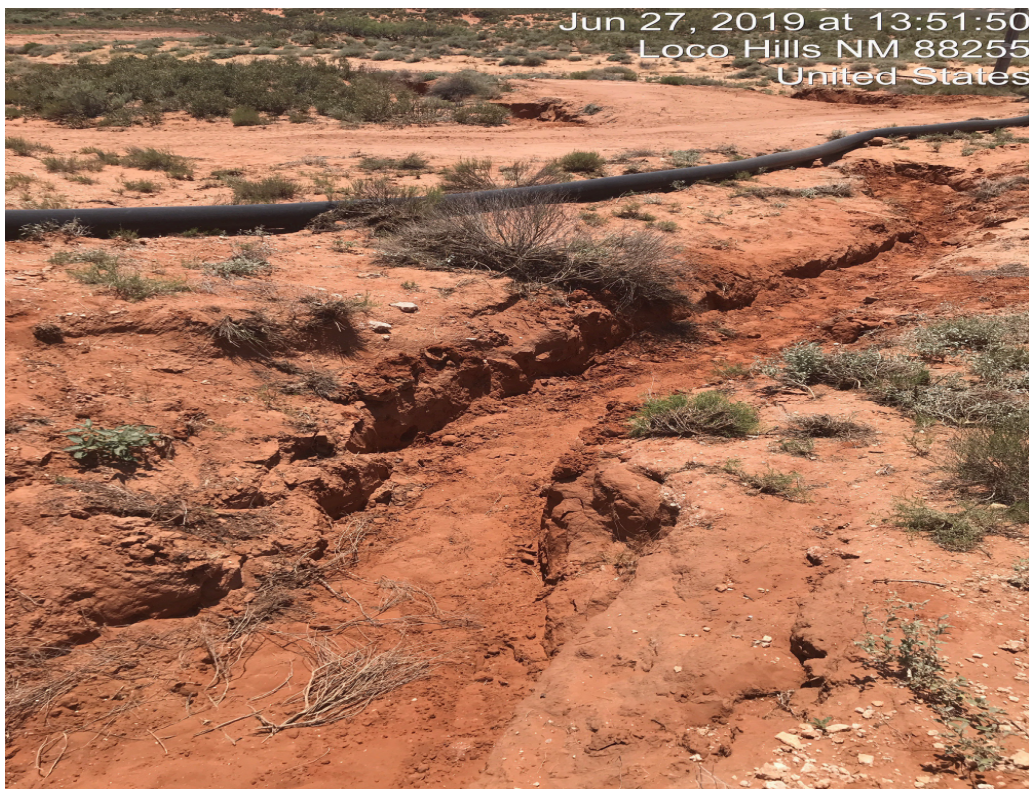
Facing Southwest, viewing bottomhole-16 through bottomhole-14

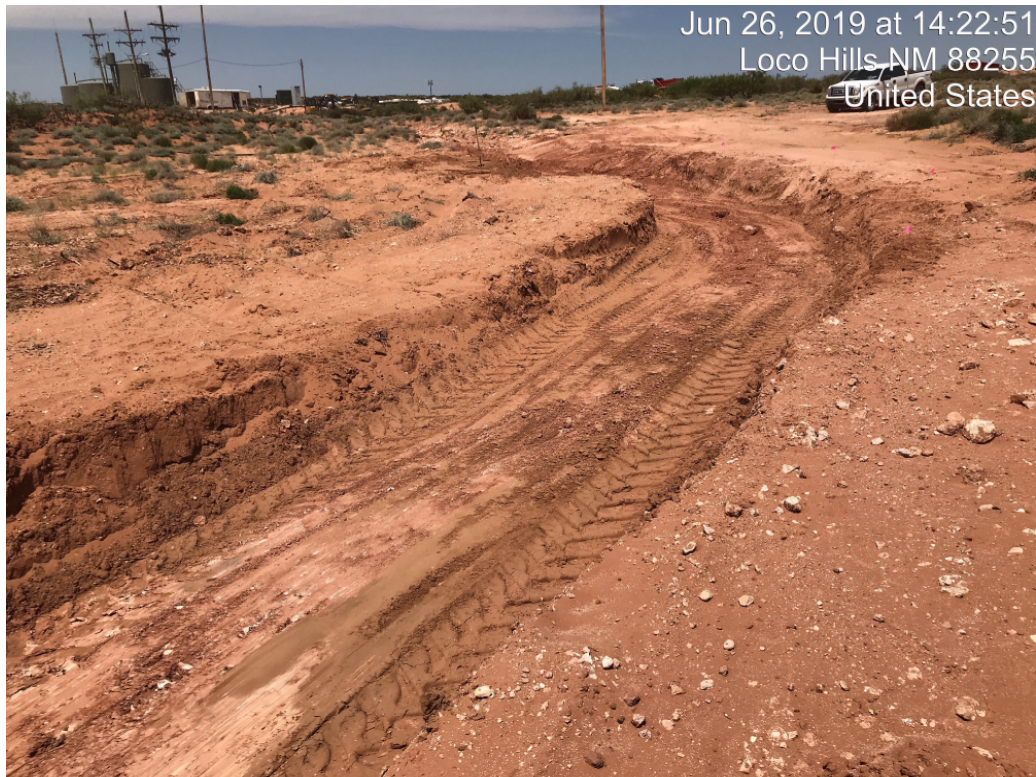
Facing East, viewing bottomhole-6 through bottomhole-9

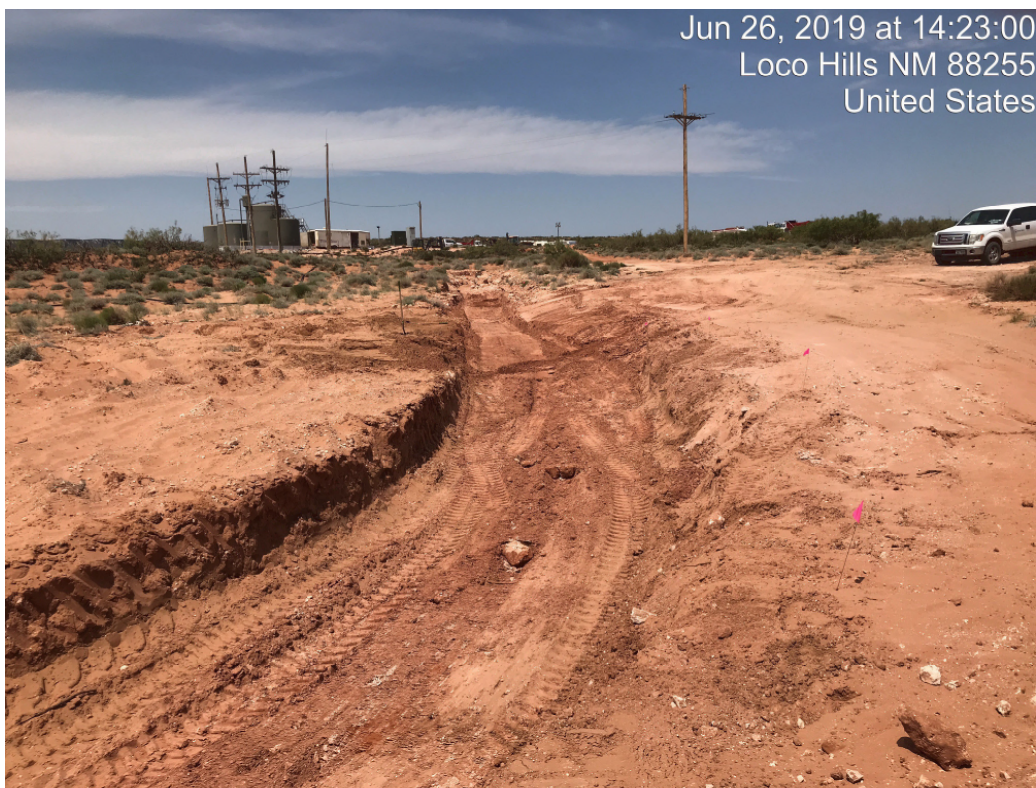
Facing North, viewing bottomhole-10 through bottomhole-13
