Site Assessment Report and Proposed Remediation Workplan

Goodnight Midstream Permian, LLC Serrano

Lea County, New Mexico
Unit Letter "C", Section 28, Township 23 South, Range 35 West
Latitude 32.279828 North, Longitude 103.373337 West
NMOCD Reference No. 1RP-5610

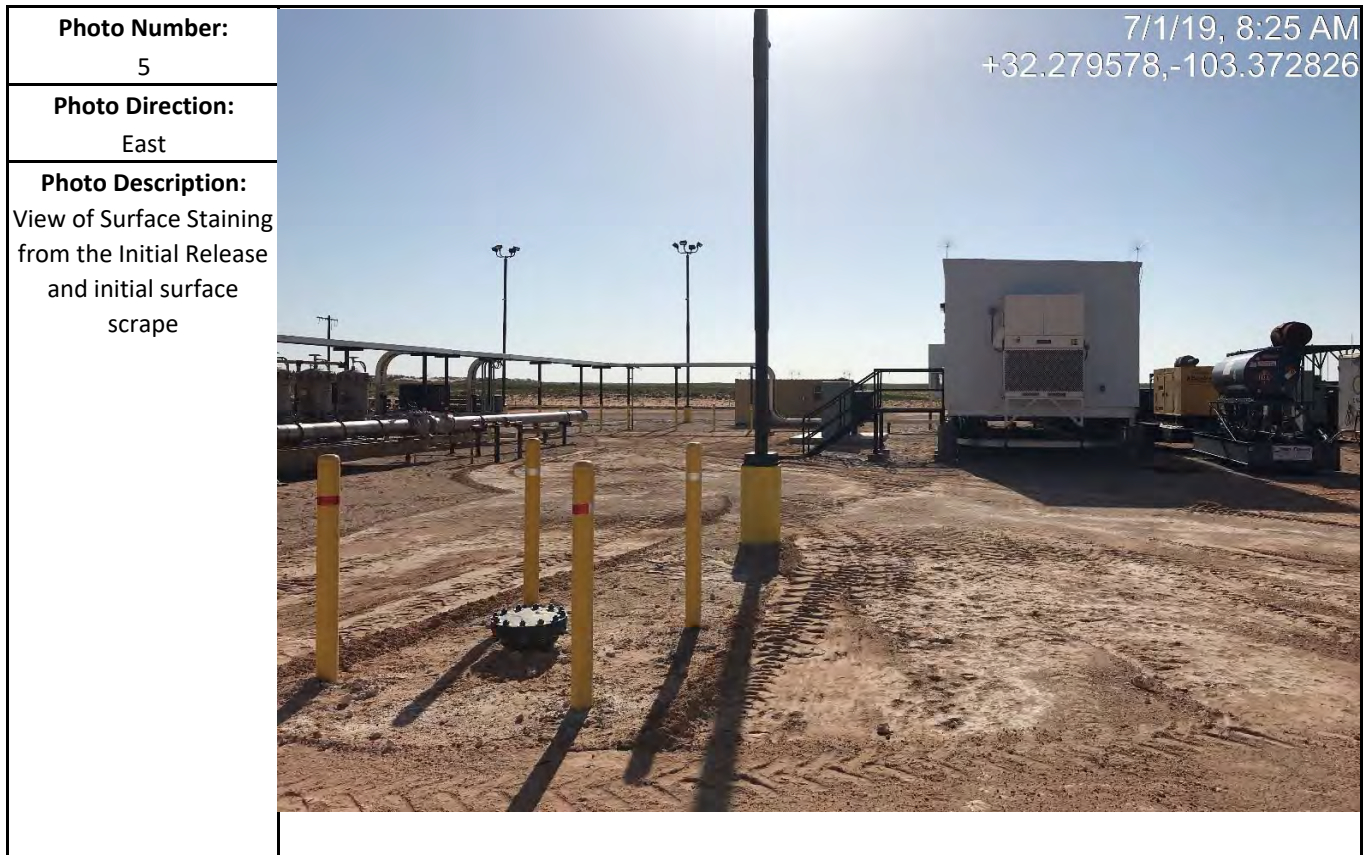
Photo Number: 3	 
Photo Direction: Northeast	
Photo Description: View of Surface Staining from the Initial Release and initial surface scrape

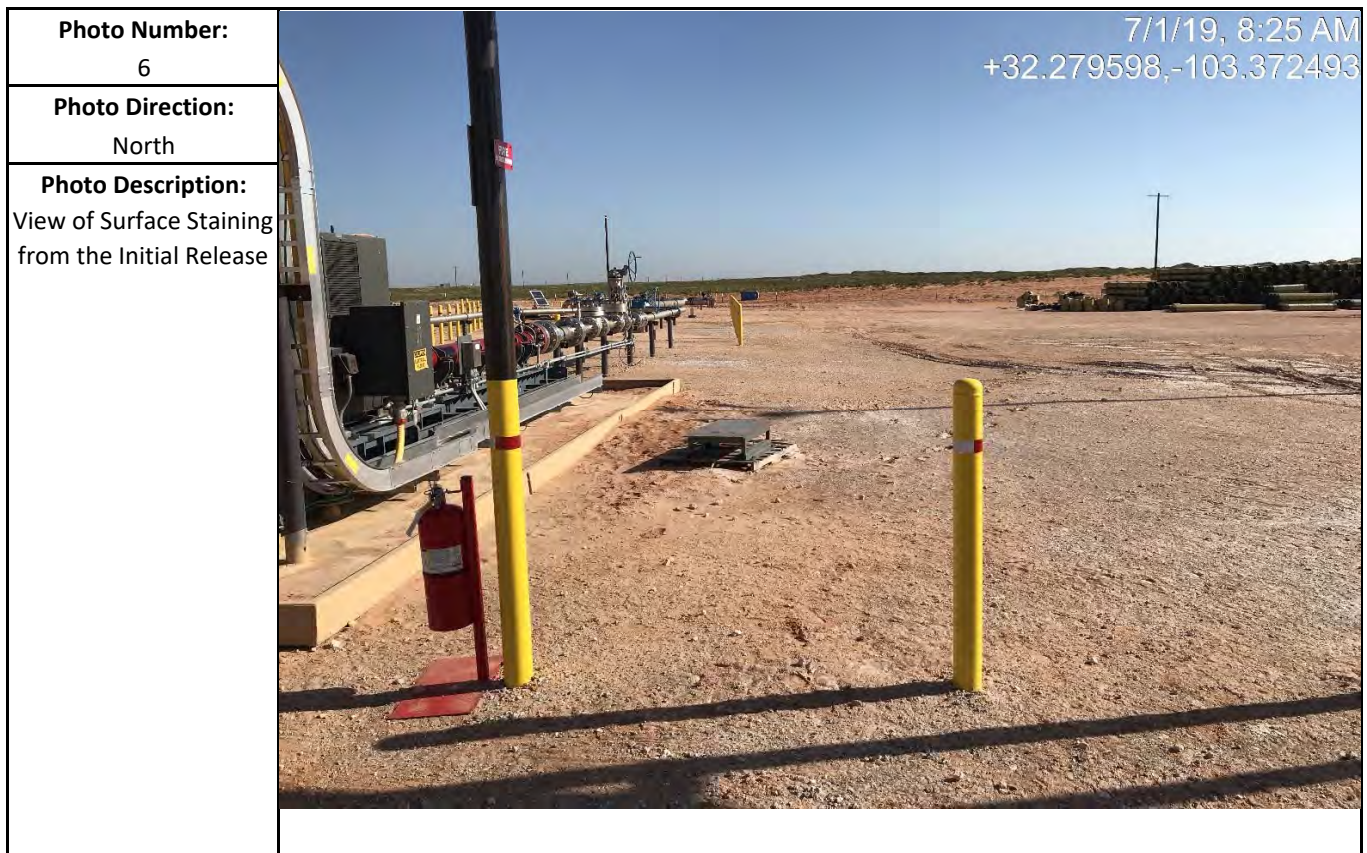
Photo Number: 4	 
Photo Direction: North	
Photo Description: View of Surface Staining from the Initial Release

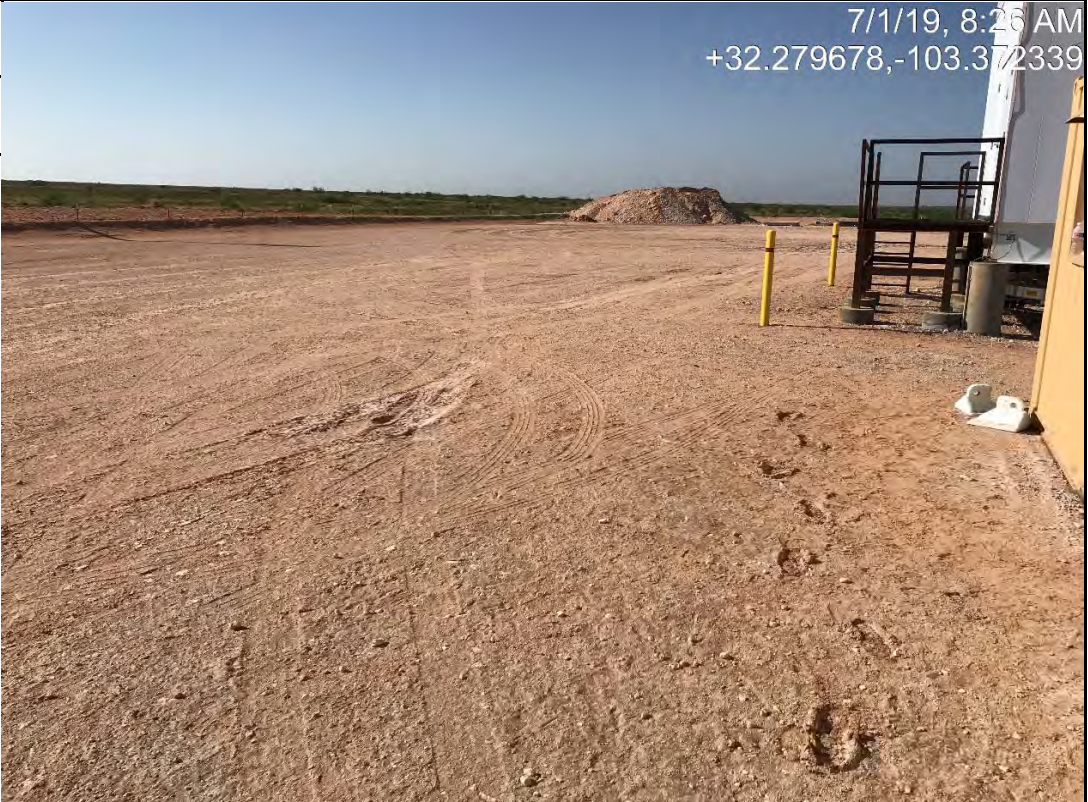
Photo Number: 8

Photo Direction: South	
Photo Description: View of Surface Staining from the Initial Release
